History of landslide susceptibility and a chorology of landslide-prone areas in the Western Ghats of Kerala, India

Keywords Landslides · The Western Ghats scarps · Kerala · Land use · Debris flows · Rainfall intensity · Pore pressure

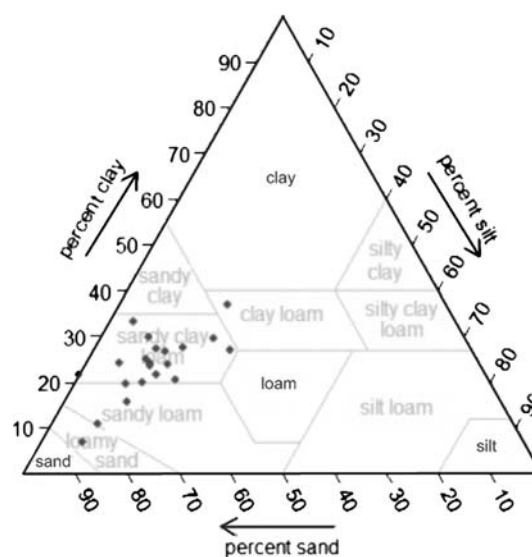
Fig. 3 Textural triangle of soil samples from the upper Meenachil River basin

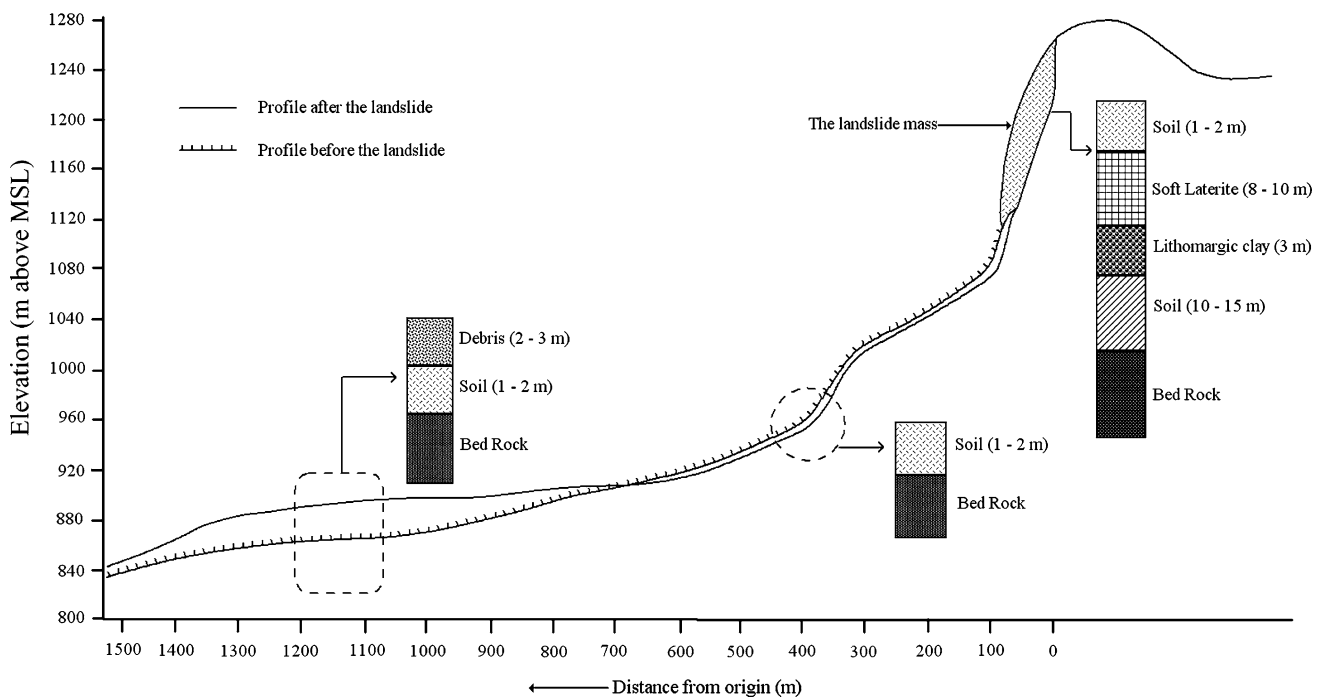
Fig. 5 Cross section of Mundakay landslide (Modified after Basak and Prasad 1985)

The landslide (see Table 1, S. no. 1) initiated in a reserved forest area in the Arunamala hills of Wayanad district at an altitude of 1,240 m (MSL). A rotational landslide that occurred liquefied and changed into a massive debris flow following the path of Arunapuzha stream at around 14.00 h. The debris flow had an average width of 150 m and it travelled 1.5 km from the initiation point to 840 m down hill (Fig. 5). The total area affected by the landslide was 32.3 ha. The volume of material that initiated the debris flow was estimated as $5 \times 10^4 \text{ m}^3$ and the material that was scoured off was $4.5 \times 10^3 \text{ m}^3$ making it the biggest landslide recorded in the state. The area predominantly had gneissic formations. Basak and Prasad (1985) reports that the initiation zone had 3–4 m lateritic deposit overlying micaceous Kaolinitic plastic clay bed of around 3 m thick underlain by a saprolite layer of 10–15 m depth resting over the bed rock. The weathered gneisses were observed to have two sets of joints (vertical and horizontal) and were dipping parallel to the terrain slope of approximately 35°. Rainfall records show that the region received 340 mm rainfall on the day of the landslide, which was the peak rainfall of the year in the middle of an above average south-west monsoon rainfall season. Increase of pore pressure in the already saturated clayey layer as a result of this high-intensity rainfall is considered as the cause of the

landslide. This is supported by evidences from the unconfined compression tests on various layers of overburden sampled from the region that indicated an 84% loss of strength for a 30% increase in moisture content.

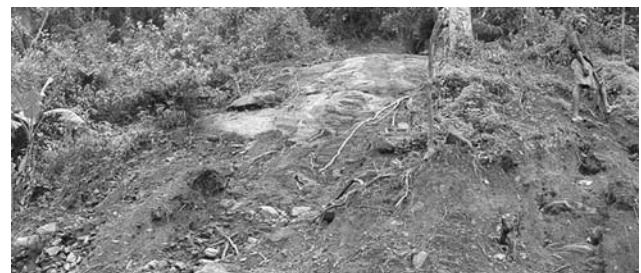
Fig. 6 A typical hollow after failure

plantations that obstructed ephemeral streams. Rubber plantations with tree sapling of <7 years of age were also seen to have been subjected to debris flows. The average dimension of the initiation locations was 5–10 m in width and 2–5 m in length, with the runouts reaching to the nearest confluence with a higher order stream. In all the cases, bed rock remained intact constraining instability to the overburden. The rainfall records from nearby Pullikannam show that the 2 day cumulated rainfall on 6th October was 315 mm. The year experienced 5,415 mm rainfall, almost 300 mm more than the mean annual rainfall from 1950–2007 for the region. A significant relationship was observed with the slope length and initiation locations; 157 of 182 surveyed events occurred in slopes of 150–450 m length (Thampi et al. 1998). Overburden of the region was identified as cohesion-less frictional soils having an average depth of 1 m resting over hard crystalline charnokites (Chandrakaran et al. 1995). The major land-use up to

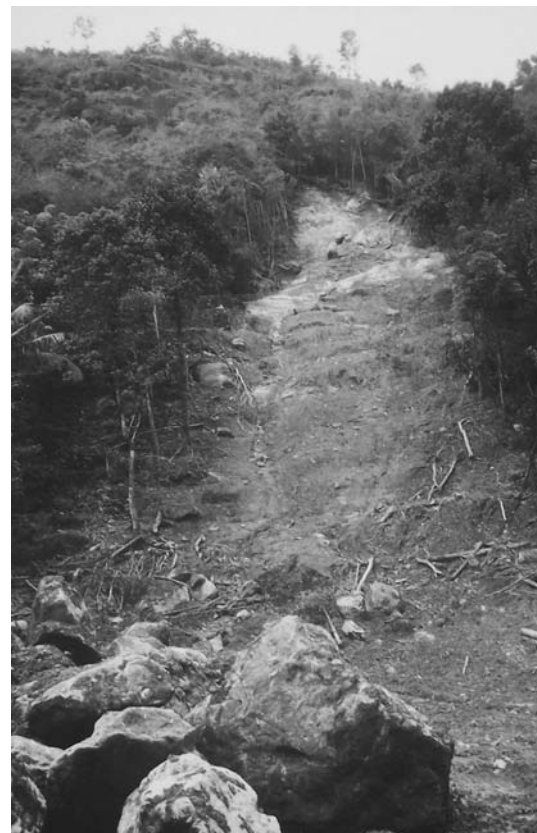
Fig. 7 Amboori landslide

Amboori landslide is a classic example of the influence of unsustainable land-use practises, careless developmental activity and unplanned housing on increasing the vulnerability to natural hazards in the state (see Table 1, S. no. 16). It was a debris flow (Fig. 7) that initiated in a convex slope of 38° that had accumulated an overburden of 1–2 m unconsolidated colluvium, boulders, laterite, saprolite and lithomargic clay. The approximate volume of material involved in the slide was $5,000 \text{ m}^3$. Lithology comprises highly migmatised metapelitic sequences banded with charnockites and gneisses. The slope was terraced for

rubber plantation and an ephemeral stream was obstructed near the initiation zone. The initiation zone was 245 m above (MSL) and the runout reached 155 m downhill as a confined flow that traced the original path of the ephemeral stream, travelling a distance of $\sim 1 \text{ km}$. Houses constructed in the lower reaches of the obstructed stream and the road that intercepted the slope just below the crown were all destroyed. The exposed bedrock at the hill summit routed significant amounts of water to the failure location. The upslope exposed side of the road, where the slope abruptly ended and created an overhanging phase, acted as a storm water discharge channel resulting in toe erosion of the already precarious slope. High-intensity rainfall of 82.4 mm from 08.30 h to 20.30 h (\sim time of the event), preceded by an above average seasonal rainfall, was identified as the trigger of the event.
