Investigation of a large collapse sinkhole affecting a multi-storey building by means of geophysics and the trenching technique (Zaragoza city, NE Spain)

F. Gutiérrez · J. P. Galve · P. Lucha · J. Bonachea ·
L. Jordá · R. Jordá

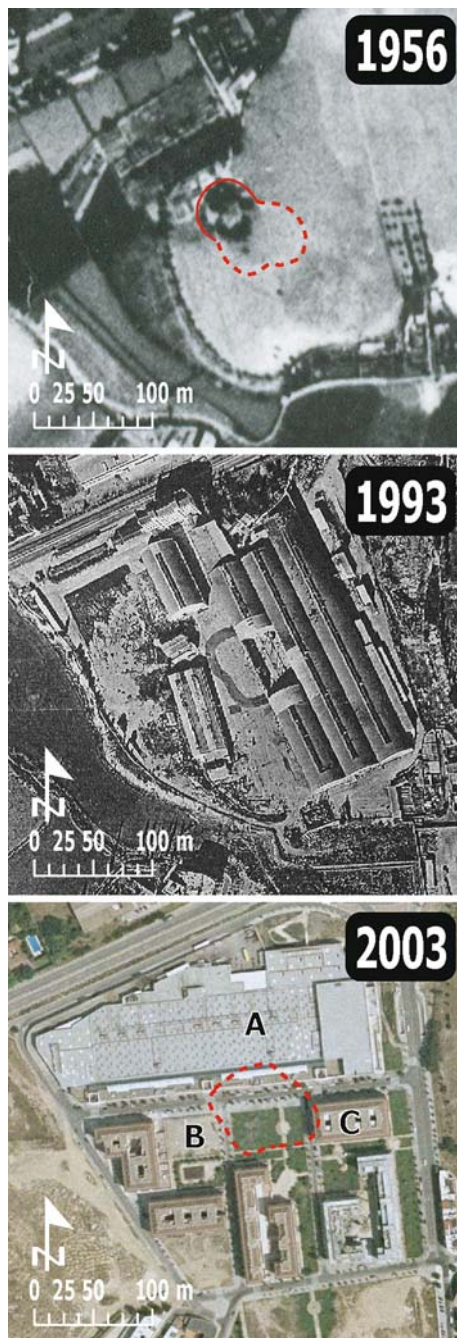
Fig. 2 Images of the sinkhole area taken on different dates. The edge mapped on the 1956 aerial photograph is based on stereoscopic interpretation. The 1993 image shows a dark band that defines the edge of the sinkhole and a gap in the demolished portion of a factory. The 2003 image shows the current urban distribution before the construction of building B. The sinkhole perimeter corresponds to that mapped by ENTECSA in 1996. The westernmost portion of building C is toppling towards the sinkhole

The studied sinkhole is clearly recognisable in the aerial photographs taken in August 1956 reproduced at an approximate scale of 1:30,000 (Fig. 2a). The depression mapped with a stereoscope using these images shows an elongated geometry and a major axial length of approximately 90 m. The topographic basin hosts a scarp-edged depression around 60 m long in the western sector. The dark bottom of this nested collapse feature reveals the presence of abundant vegetation in the 1956 images. The eastern sector of the depression shows a smaller scarp and displays a general inclination towards the west.

In 1962 a factory was built on the eastern sector of the sinkhole (Fig. 2b). Soon after its construction, the portion

beginning of the ‘80s, in order to stop the deformation of the structure and safeguard its integrity, several piles were driven into the Quaternary alluvium down to a depth of 18 m. These piles did not transfer the load to stable ground, and consequently the factory continued sinking. Subsequently, the part of the factory built on the sinkhole was demolished and in 1992 the facility was abandoned. An aerial photograph taken in 1993 shows a dark band defining the edge of the sinkhole and a gap in the factory coinciding with the sinkhole location (Fig. 2b).

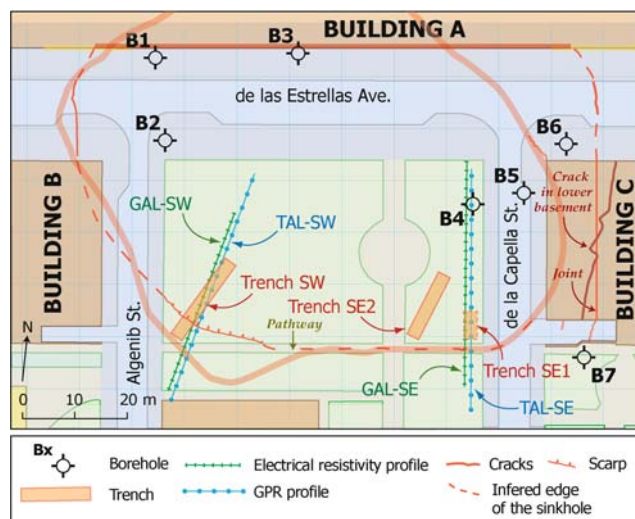
Fig. 3 Map produced in August 2006 showing the distribution of deformation in the ground and structures. The sketch also shows the location of boreholes, geophysical profiles and trenches as well as the edge of the sinkhole mapped by ENTECSA in 1996. The crack of the lower basement of building C was mapped on March 7, 2008

Building B, whose NE corner was built with slab foundation, to date does not show any evidence of deformation in the façades (Fig. 3). Conversely, the western sector of building C has been affected by differential settlement. This building, with two basement floors and six storeys including the ground floor, hosts 100 flats. The value of this property has been estimated at 52 million Euros. The structure was founded with pads of reinforced concrete that transfer the load to the Quaternary alluvium. The pads are continuous beneath the walls of the structure (strips), and above the footings the structure is divided into five blocks separated by transverse dilation joints. The westernmost block of the building started to topple in January 2003 soon after the occupation of the building. The deformation is concentrated in the western joint resulting in its progressive widening upwards. In the upper part of the building, the toppling shows a main displacement component to the west and a minor component to the north. A

In August 2006 we produced a detailed map of the sinkhole and related damage using a metric tape, a compass and graph paper (Fig. 3). The southwestern marginal sector of the sinkhole showed a scarp 15–20 cm high in the park located between buildings B and C. Conversely, we were not able to find any obvious deformation in the southeastern sector of the sinkhole. The area affected by active subsidence next to the southern flank of building A was clearly identified by means of cracks and tilting in the pavement (Fig. 4b). Here, the settlement affects an area larger than the perimeter mapped by ENTECSA in 1996, which coincides with the crack that connects with the NW corner of building C (Fig. 3). This indicates that since 1996 the sinkhole has enlarged in this sector. The vertical displacement of around 30 cm measured in 2006 on the sidewalk with respect to building A, constructed in 1997, provides a subsidence rate of ca. 3 cm/year (Fig. 4b).

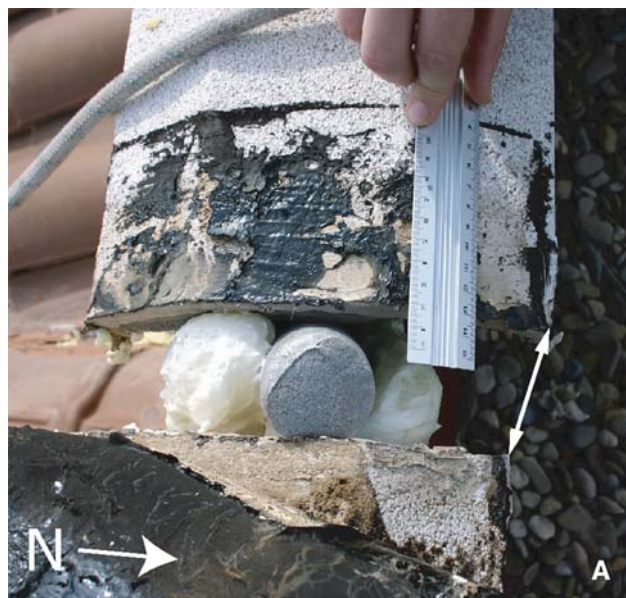
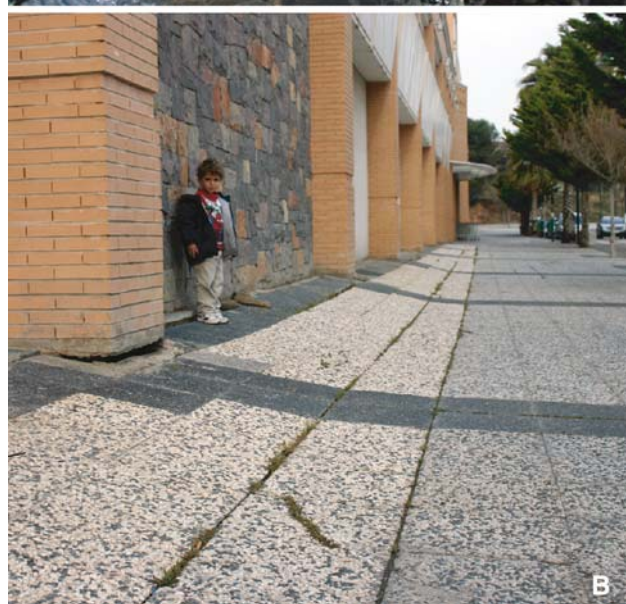
Fig. 4 a Opened joint in the upper part of the building showing a main longitudinal displacement and a secondary transverse displacement component (Photograph taken on March 7, 2008). **b** Tilting and cracking caused by subsidence next to the stable building A (Photograph taken on April 2007)

cumulative displacement of around 75 mm has been measured in the upper part of the joint on March 7, 2008 (Fig. 4a), yielding a mean deformation rate of 1.4 mm/year for a time interval of 5.2 years (from January 2003). The floor of the lower basement also shows a crack several millimetres wide which intersects the western joint with a NNE orientation (Fig. 3).

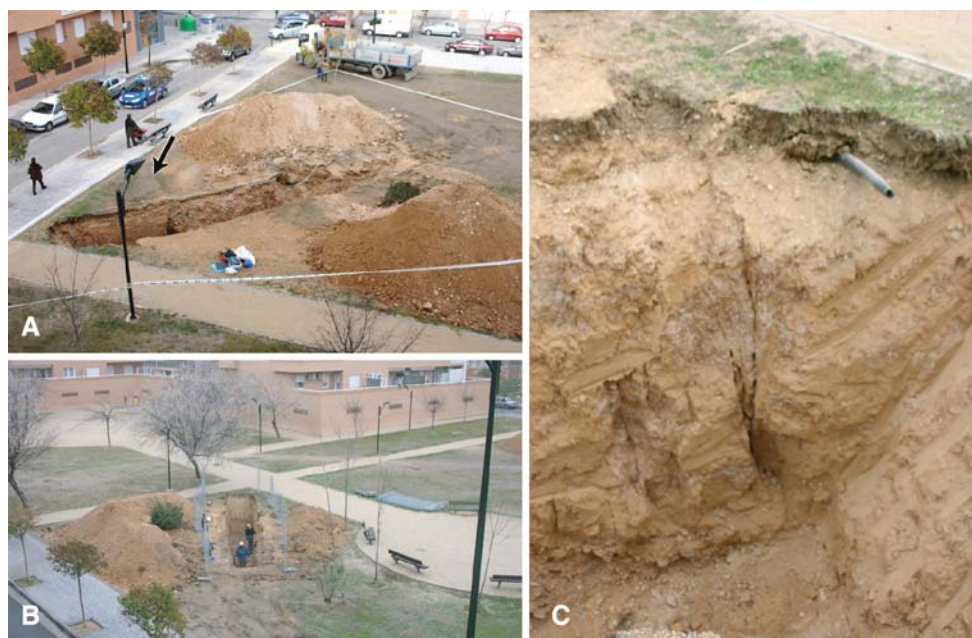
Fig. 8 **a** View of trench SW. *Arrow* points to the scarp affecting the recent artificial soil. **b** View of trench SE2. **c** Open cracks in the SE wall of Trench SW, next to its southwestern edge. Images taken on January 2008

The terrace deposits in the SW block of fault F1 dip around 4° to the NE and subunit TU3 is affected by prominent extensional cracks in which we were able to introduce our fingers (Fig. 8c). This evidence, in accordance with the information provided by the geophysical profiles GAL-SW and TAL-SW and the map produced by ENTECSA in 1996 (Figs. 3 and 6), indicates that the limit of the subsidence structure is located at an unknown distance to the SW of the scarp created by fault F1. For this reason, there may be failure planes with vertical displacement, but without geomorphic expression to the SW of the trench.

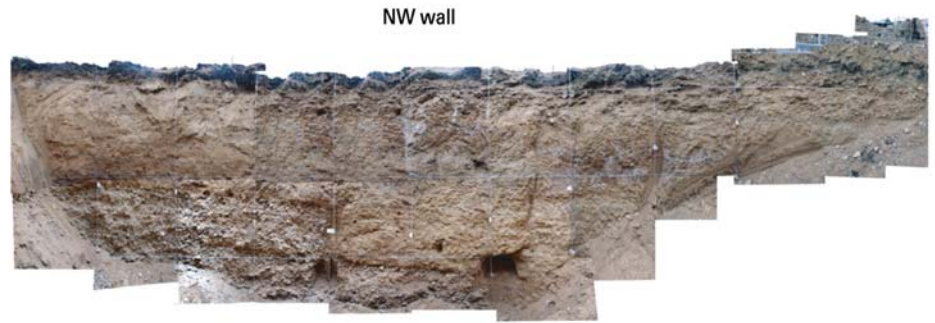
TRENCH SE Orientation: N32E

Fig. 10 Orthorectified photomosaic and logs of the Trench SE2

This trench, with a N32E orientation, was 11.3 m long, 3.5 m deep and around 2.5 m wide. We mapped both walls of the trench since they showed different deformation structures. Figure 10 shows the log of the SE wall and the mirror image of a portion of the opposite wall. Three types of deposits have been differentiated:

In the NW wall of the trench the terrace deposits are tilted 5–7° towards the central sector of the sinkhole and offset by two antithetic faults dipping 75° to the SW. Fault F1, with a N94E strike, offsets the terrace deposit by 67 cm vertically. This failure plane is truncated by unit A2 and consequently has been inactive at least since the accumulation of this anthropogenic deposit, probably younger than 1956. The tilting of the terrace deposits in the upthrown block of fault F1 suggests that there may be more failure planes to the SW of the trench. The geophysical profiles and the map produced by ENTECSA in 1996 indicate that the outer limit of the subsidence structure is located approximately beneath the path located to the SW of this trench (Figs. 3 and 7).

Fault F2 has vertically displaced the terrace deposits by around 43–55 cm. We have not been able to measure the strike of this plane. The slight tilting to the NE of the downthrown block has generated a fissure 5 cm wide filled with A1 deposits. Fault F1 affects unit A1 and is truncated by unit A2. Consequently, this structure has undergone at least one displacement event in historical times after the accumulation of unit A1 (probably post 1956) and before the accumulation of unit A2. These geometrical

Fault F2 of the NW wall has not been identified in the opposite side of the trench, which shows a fissure generated by the tilting of a block towards the central sector of the sinkhole. This fissure 10–15 cm wide, with sharp dip changes, has a N55E strike oblique with respect to the trench orientation (N32E). This is the reason why the fissure looks much wider in the log. The fissure is filled with
