Analyzing the effects of historical and recent floods on channel pattern and the environment in the Lower Omo basin of Ethiopia using satellite images and GIS

Lulseged Ayalew

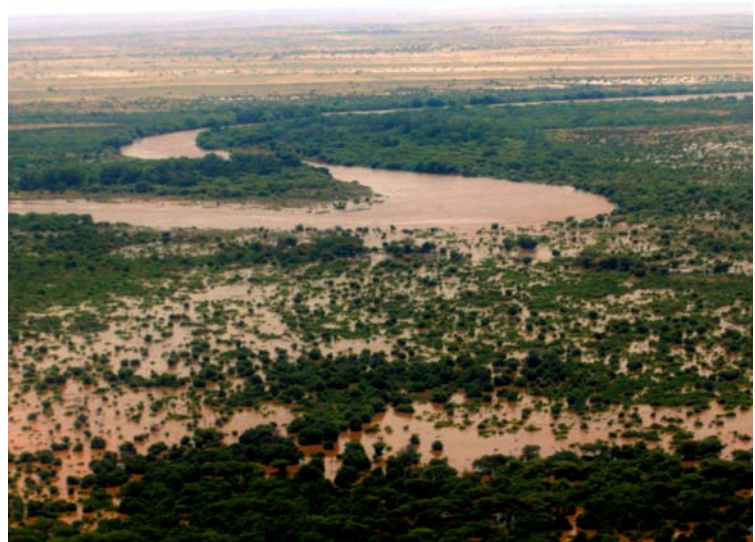
Fig. 5 An aerial view of the effect of the August 2006 flood of the Omo River

The immediate impact of the August 2006 flood was the inundation of around 14 villages and the subsequent death of 364 people. As the inhabitants of the area are pastoralists, they normally live close to the river or within the floodplain, where there is enough grass for animals. They were then suddenly caught by rising water levels unaware of the high amount of rains that fell in the upper part of the Omo River. In the process, many cattle and wild animals were stranded and parts of the basin became inaccessible. Much of the damage was concentrated in the upper part of the meander belt (around Karodus village), where the river overflowed its banks (Fig. 5), and back-swamps and oxbow lakes became full.

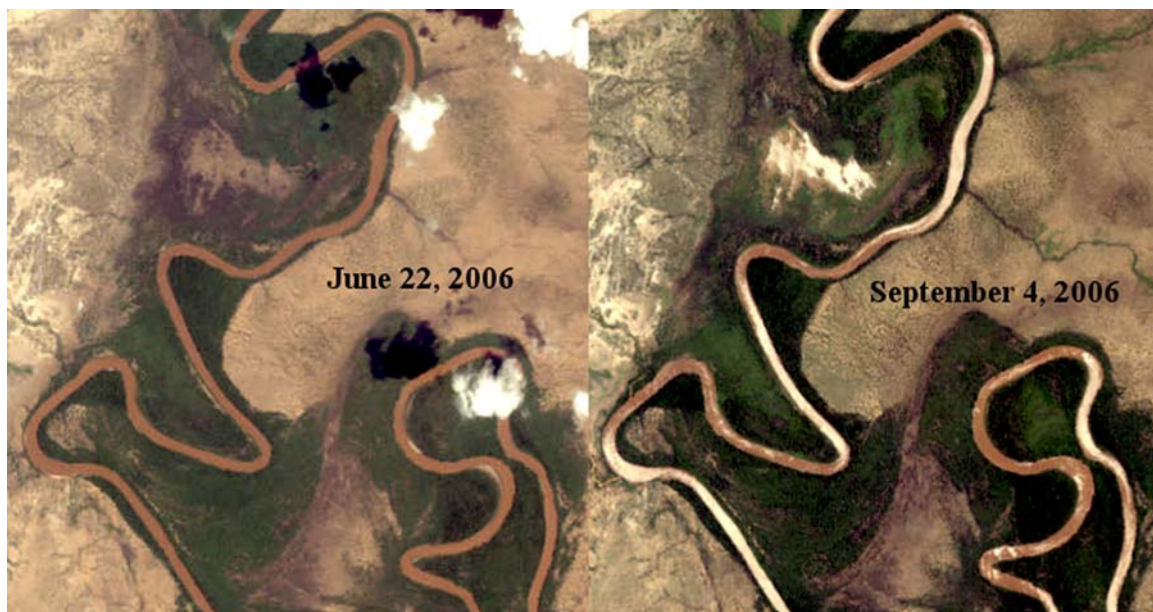
Fig. 7 Images showing the accumulation of sediments in the lower part of the meander belt after the flood in 2006

As shown in Fig. 7, most of the sediments were accumulated in the riffle portion of the channel, although some were laid down in the pool areas. The development of the riffle-pool sequence indicates the transportation of coarse sediments in significant proportion up to this point of the river course. The sediments could be either from the source areas of the river or the pool portion of the meanders. But, since deposition had also occurred in the inside part of pools, it is safe to think that much of the sediment load was supplied from the highlands.

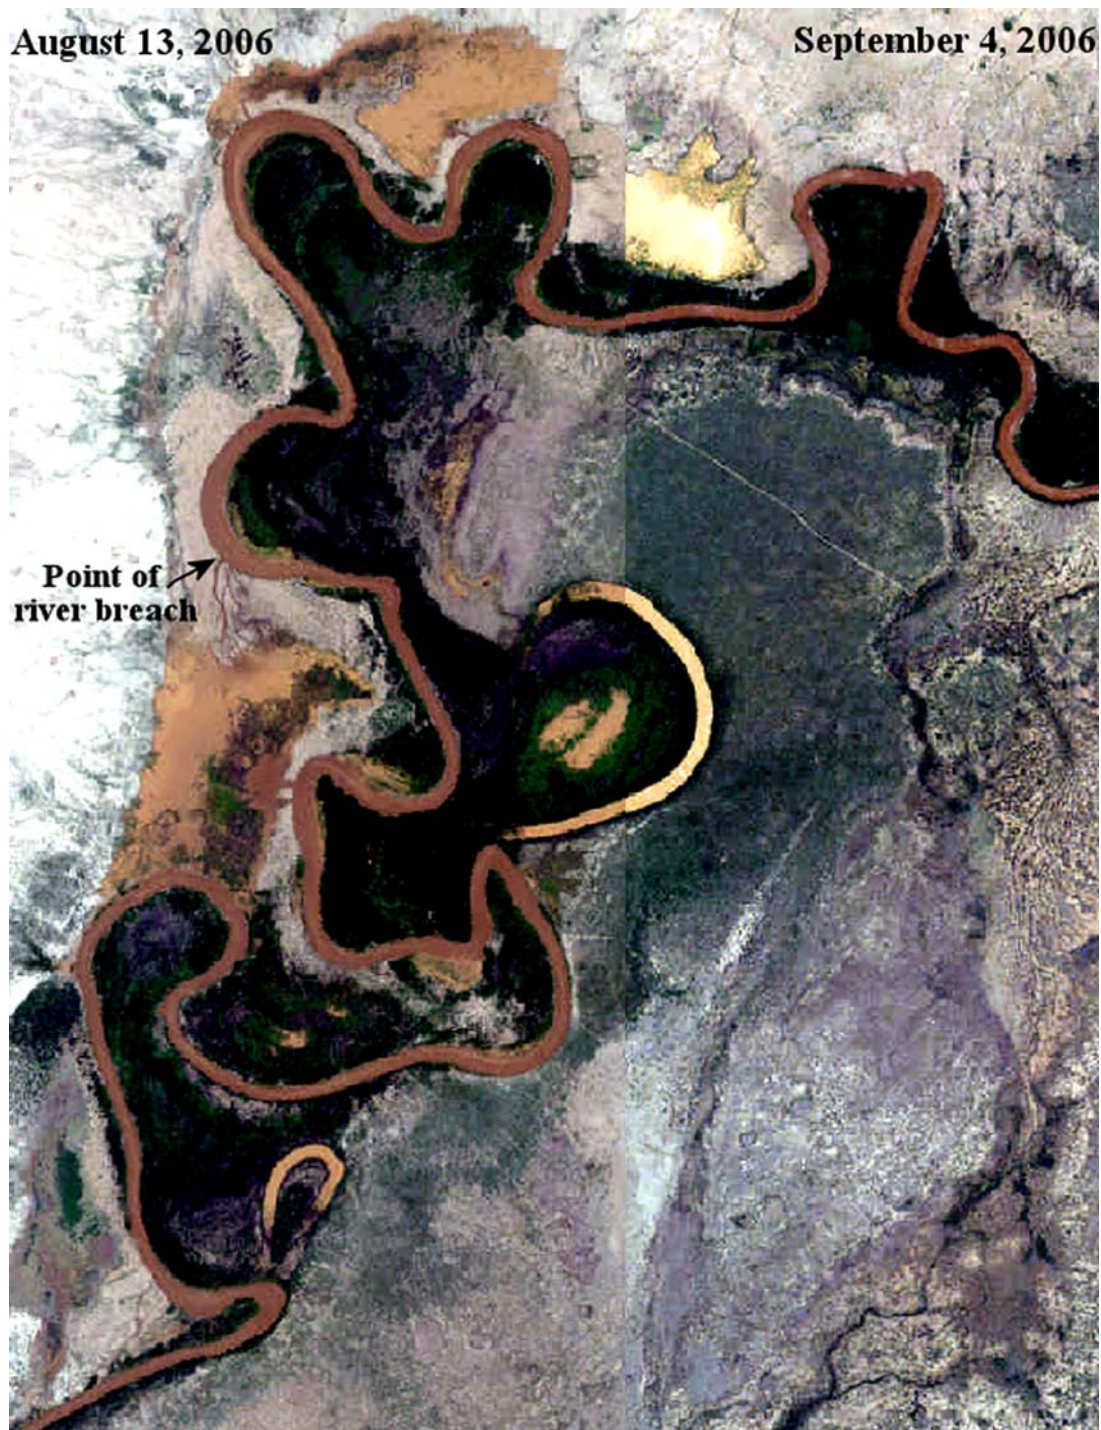
Fig. 8 Signs of river breach during the 2006 flood and the effect of evaporation on oxbow lakes and back-swamps

Apart from sedimentation, signs of channel shortening were also observed in meanders of Bulkay plain, near the oxbow lakes, after the August 2006 flood (Fig. 8). Levees are frequently breached by the Omo River at the time of
