Understanding rainfall-landslide relationships in man-modified environments: a case-history from Caramanico Terme, Italy

J. Wasowski

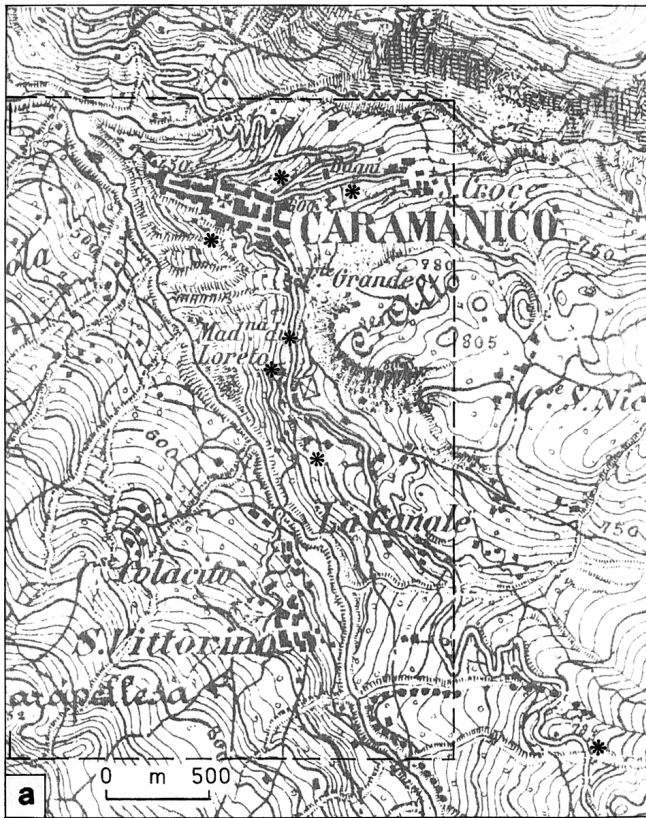
Fig. 2a,b
 Comparison of two topographic maps illustrating urban expansion of Caramanico Terme in this century and related changes in surrounding environment. **a** Situation at the beginning of the century as shown on the 1907 map; to facilitate a comparison with landslide distribution on part b, the same locations of recent mass movements are indicated with asterisks; the dashed line rectangle, defined so as to include two areally equal zones on the SW and NE valley sides of the Orta river, represents the sample area used for semiquantitative estimates of the human-induced changes in the Caramanico territory; although not marked on part b, the equivalent area on the 1986 map was considered for comparison. **b** Current situation with 1986 data on urban development (the topographic base map is from 1955); dark areas indicate densely populated zones; locations of landslides (marked by asterisks with associated capital letters A–G), and their dates (year) refer to following events discussed in the text: A = municipal swimming pool rotational slide, B = Cappuccini Monastery rotational slide, C = long-lived Pisciarellò slump-earthflow (with main scarp shown), D = 1992 route SS 487 failure, E = Case Mancini failure, F = 1989 Caramanico landslide (with main scarp and lateral limits shown), G = 1989 route SS 487 earthflow; small open circles mark locations of springs and black arrows indicate flow directions of Orta and Orfento rivers; note also positions of checkdams on the Orta river reach extending from the old town to northern flank of 1989 Caramanico landslide (dams are marked with short black lines); line 1–1' marks the location of the geological profile shown in Fig. 7

Expansion of Caramanico this century led to the urbanization of marginally stable hillslope areas on the middle-upper valley slopes of the Orfento and Orta rivers. The changes which took place can be appreciated from the comparison of two topographic maps, one from the beginning of the century and the other from 1986 (a and b of Fig. 2a, respectively). The 1907 map shows the town developing principally in a narrow zone which follows the ridge dividing the two rivers. This area is not susceptible to landsliding because the outcropping limestone substratum forms a flat-topped topography of the ridge

summits. The 1986 map illustrates that the main town has grown considerably outside its old limits, and that new housing development has taken place in its peripheries. This new urbanization occurred mostly in hilly areas subject to mass movements in the past.

In fact, the construction of a thick embankment (locally up to 8–9 m in thickness) increased overburden of the slope. Furthermore, as stressed by Wasowski (1996a), in the cemetery area the fill material was placed across a morphologic depression characterized by the presence of an intermittent watercourse. Most importantly, it was a zone of concentrated subsurface flow as indicated by the presence of a medium discharge spring further downslope on the 1955 topographic map (Fig. 2b).

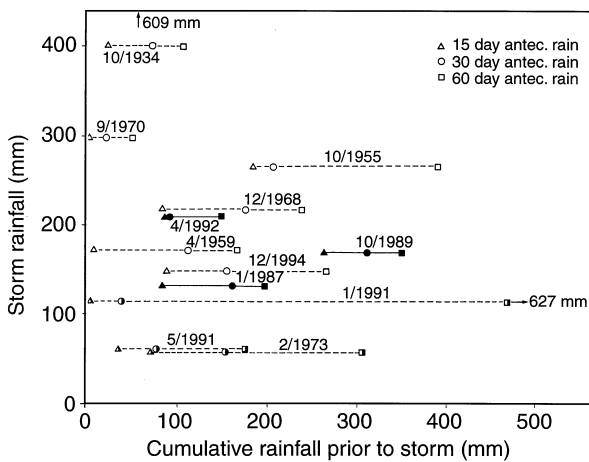
Fig. 7 Storm and antecedent cumulative rainfall for 12 storms in Caramanico. *Filled symbols* indicate meteoric events which resulted in most damaging deep (>10 m) landslides; *half-filled symbols* denote precipitation associated with predominantly shallow mass movements; *empty symbols* refer to six selected heavy rainfall storms which apparently did not cause landslides; for storm durations see Fig. 8

The early spring 1992 storm (9–11 April), characterized by total precipitation of 210-mm, with a 127-mm peak on 10 April (Figs. 7 and 8), resulted in several mass movements in the Caramanico area (Fig. 2b). In particular, two complex rotational slope failures, named the municipal swimming-pool and Cappuccini Monastery slides (~60 and ~50 m in length, respectively), created major damage (Wasowski 1996a). The overall displacements were limited to a few meters, and the slide depths ranged from several to less than 20 m.

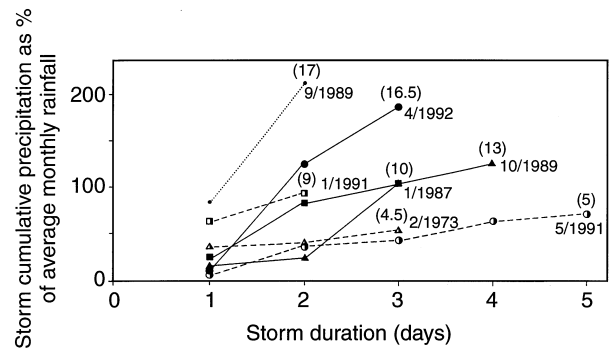
Fig. 8 Storm duration and storm cumulative precipitation expressed as percentage of average monthly rainfall for seven storms in Caramanico; numbers in parenthesis indicate storm rain totals expressed as percent of average annual precipitation; *filled symbols* indicate meteoric events which resulted in most damaging deep (>10 m) landslides; *half-filled symbols* denote precipitation associated with predominantly shallow mass movements; the *dotted line* indicates rain record of the very intense storm of September 1989, which alone did not trigger any mass movement, but represented an important preparatory causal factor for October 1989 landsliding

The rainfall data pertaining to six storms capable of producing mass movements are also shown in Fig. 8, where the storm durations are plotted against their cumulative rainfalls expressed as percentages of relative average monthly precipitation. The storm rainfall totals are indicated as percentages of average annual precipitation to facilitate comparisons with other environments. Meteoric events which generated deep slides and those associated predominantly with shallow mass movements are characterized by rainfall totals representing at least 10 percent average annual precipitation and exceeding 100 percent of average monthly rainfall. The May 1991 event with the most widespread shallow landsliding registered in recent years in Caramanico was related to prolonged low intensity storm (5 and 70 percent of average annual and monthly rainfall, respectively).

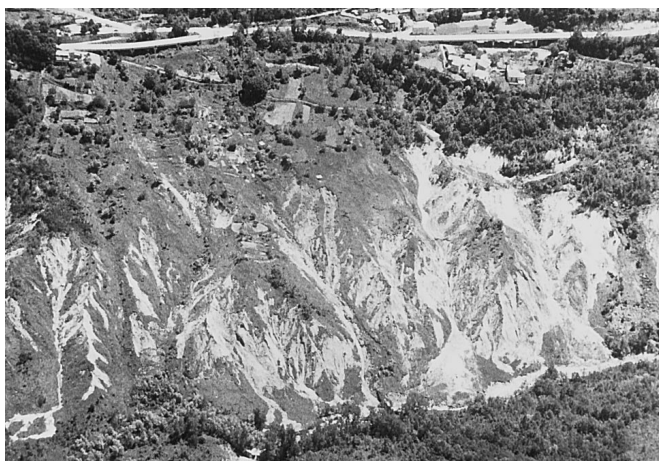
Fig. 9

Widespread mass movements on May 1991 in a zone between Pisciareello landslide (just left of photo), and Case Mancini locality (group of houses in upper right corner just below route SS 487); view is to ENE; in foreground note Orta river eroding toes of gully-channeled earth and debris flows
