Strategies for head and inlay exchange in revision hip arthroplasty

Martin Pospischill · Karl Knahr

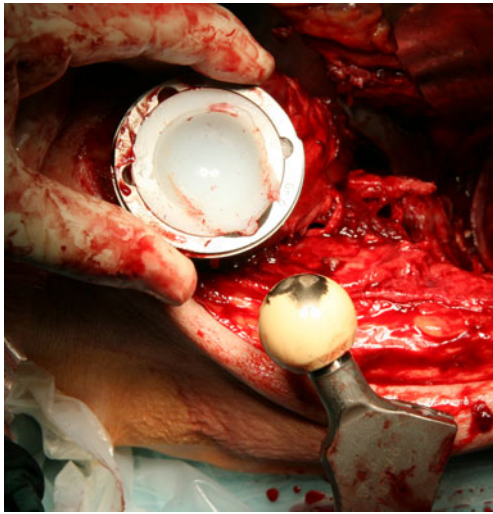
Fig. 1 Extensive wear due to impingement (ceramic-on-polyethylene)

The major reason for revision of these couplings is increased polyethylene wear which leads to subsequent osteolysis (Fig. 1). As the annual wear rate of metal-on-polyethylene is approx. 0.1–0.3 mm/y and the rate for ceramic-on-polyethylene is about 0.05–0.15 mm/y [9], the onset of visible wear and osteolysis occurs later in ceramic articulations than in metal articulations [10].

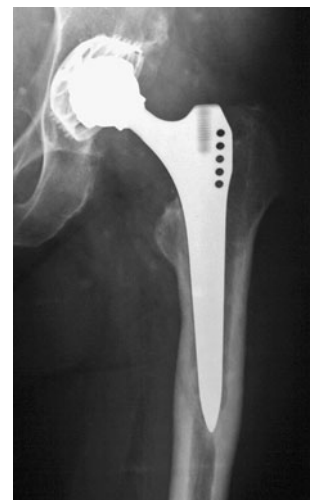
Fig. 2 Early osteolysis due to hypersensitivity to metal three years postoperatively

reaction can lead to early osteolysis and aseptic loosening of components (Fig. 2) [18–21]. Clinical data suggest an association with a delayed hypersensitivity type IV to metal, mainly cobalt. It is still unclear whether the allergy to metal alloys exists preoperatively or the patients became hypersensitive secondary to metal particles. As a consequence, in patients with postoperative persisting or early recurrent, load-dependent thigh pain—with or without radiographic signs of osteolytic lesions—a possible hypersensitivity to metal should be considered.

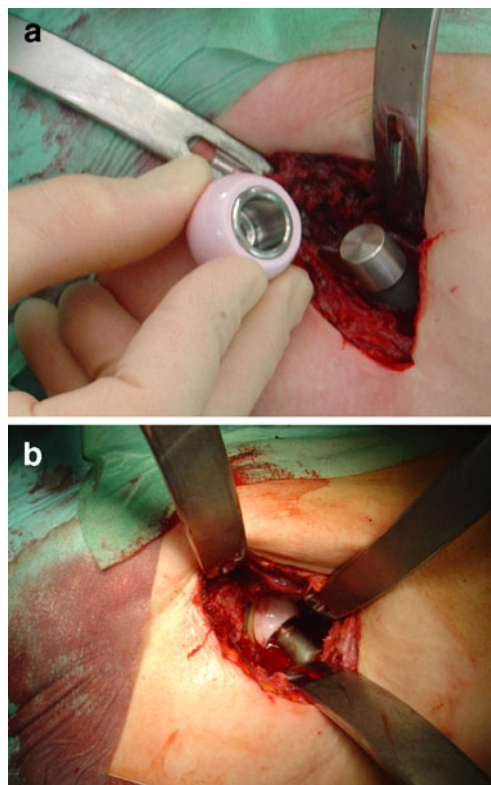
Fig. 3 a, b Revision ball head system by CeramTec. Inner metal sleeves allow ceramic XL neck sizes

described above or by using the ceramic revision ball heads with an inner metal sleeve. Since the introduction of the revision head system femoral neck lengths can be extended up to size XL (Fig. 3a, b).

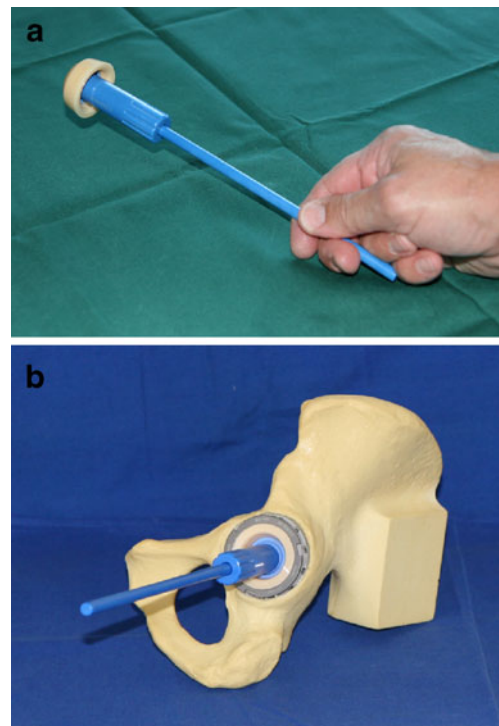
Fig. 4 a, b The suction cup instrument

To avoid any damage to the ceramic liner during insertion a special suction cup instrument was created [28]. This allows a simple and secure manipulation of the liner in the titanium shell and can also be used to easily remove the liner in case of revision (Fig. 4a, b). It is important to align the ceramic liner into the exact final position into the cup. After verification of the proper position without impingement of soft tissues, one single soft blow with the impactor will fix the liner.
