Retrieval analysis of ceramic-coated metal-on-polyethylene total hip replacements

Abstract

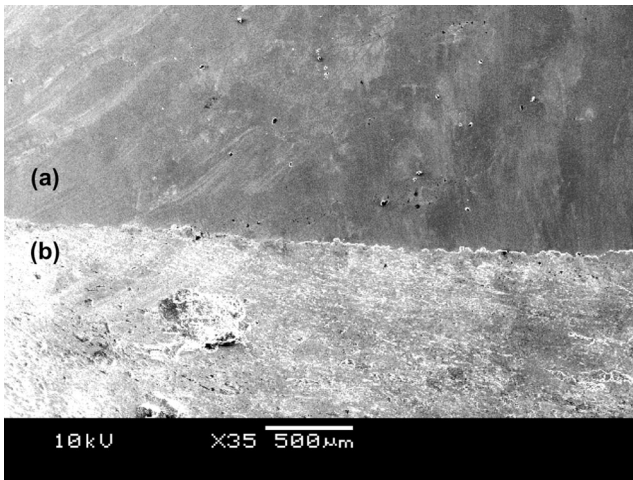
Fig. 2 SEM analysis revealed (a) minimal scratching on the coated surface regions and (b) considerable scratching of the exposed surfaces with coating loss

Examination of the head surfaces under SEM revealed considerable evidence of scratching on the exposed metal

surfaces, possibly due to third bodies such as coating fragments (Fig. 2). There were small localised regions of coating loss visible in the coated areas however there was notably less evidence of scratching.

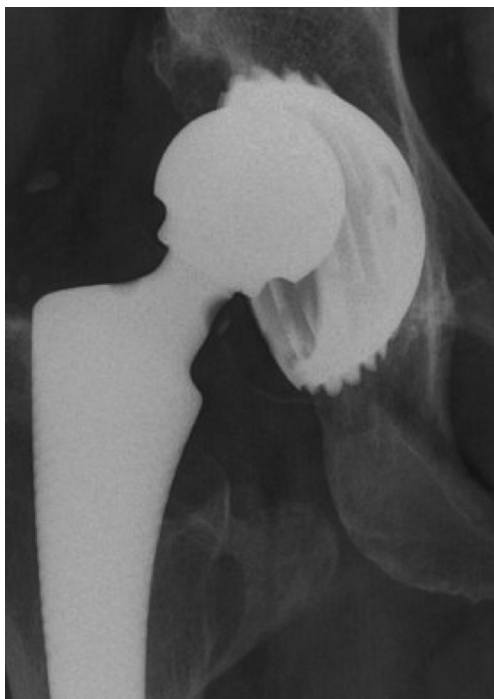
Fig. 3 Gross polyethylene wear was characterised if the X-ray demonstrated implant head penetration in a supero-lateral direction

Of the 35 cases available for radiographic analysis, 37 % (n = 13) revealed evidence of gross polyethylene wear (Fig. 3). All implants that were categorised as

demonstrating polyethylene wear upon radiographic analysis were revised due to a malfunctioning acetabular component, either due to cup loosening or gross cup damage.

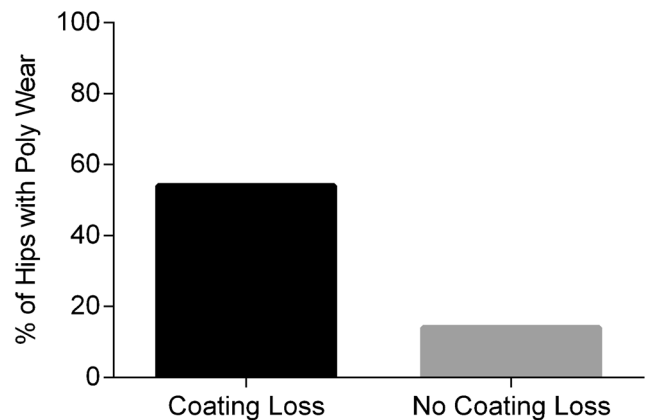
Fig. 5 Plot of the distribution of hips with gross poly wear with femoral heads exhibiting evidence of coating loss or no loss visible

The incidence of polyethylene wear in samples with coating loss was 54 %, which was significantly (p = 0.02) elevated compared to samples with intact coatings (14 %) (Fig. 5).
