Prosthetic Breast Implant Rupture: Imaging—Pictorial Essay

Giuseppe Colombo · Vittorio Ruvolo ·
Roberto Stifanese · Marco Perillo ·
Alessandro Garlaschi

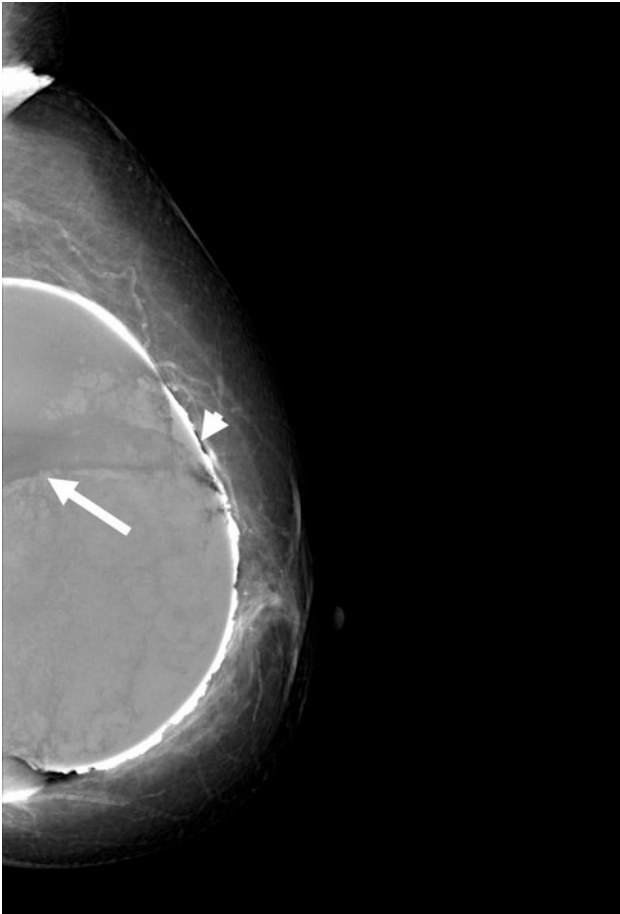
Fig. 1 Calcified thickening of the fibrotic capsule. The digital mammogram image in the craniocaudal projection on the left shows a marked calcified thickening of the fibrous capsule (*arrowhead*) in a patient with a prosthetic intracapsular rupture, demonstrating heterogeneity of the capsular content (*arrow*)

Sometimes, in the presence of an ill-defined and irregular border, the depth of the implant content may be an indicator of intracapsular rupture. The high radiopacity of silicon, however, makes the distinction between an intact implant and an intracapsular rupture extremely difficult. This limitation is now partially solved by the new digital technology, which with its ability to regulate the display of images provides information on both the parenchyma and the state of the system at the same time, sometimes even in the case of intracapsular rupture. Sometimes mammography, because it is effective for the study of calcifications and well equipped with good panoramic views, is extremely useful in the pre-operative surgical planning for women with major calcification thickenings of the fibrous capsule (Fig. 1).

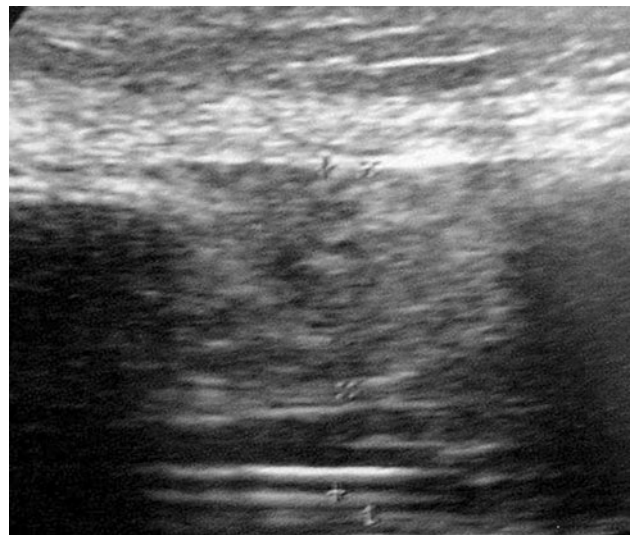
Fig. 2 Sonographic signs of extracapsular rupture: the “snow storm.” The ultrasound image, performed with a high-frequency probe, shows an interruption of the prosthetic implant, with the classic appearance of a “snow storm” caused by the silicone

- Hyper- and hypoechoic assets caused by a leakage of the intraprosthesis content, resulting in inflammation of the periprosthetic tissue.
- Multiple hyperechoic elements in the breast parenchyma caused by microscopic accumulations of silicone outside the fibrous capsule, which determine dispersion of the ultrasound beam. This finding is recognized by the appearance of a “snow storm” (Fig. 2).

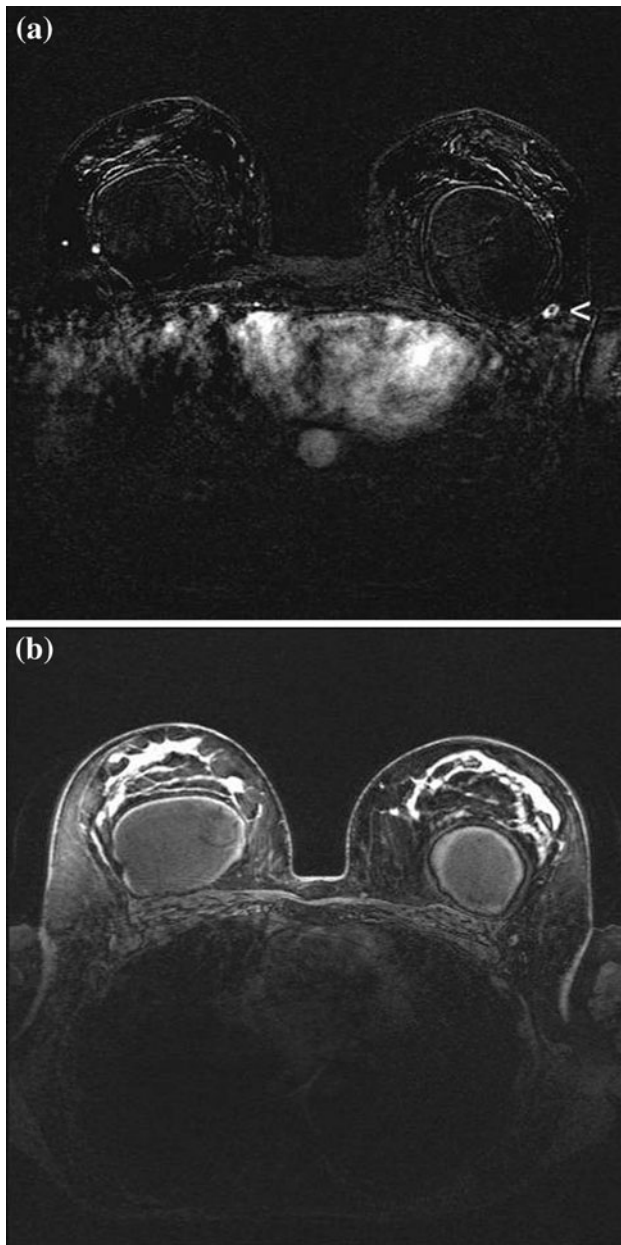
Fig. 3 The phenomenon of “gel bleeding.” **a** The postsubtraction magnetic resonance imaging (MRI) sequences (*arrowhead*) and **b** the T1-weighted three-dimensional flash gradient echo postcontrast sequence, both on the axial plane, show the presence of an indirect sign of “gel bleeding” on the left axillary. It is in fact an axillary “siliconed” lymph node with an intact prosthetic capsule

Before listing the phenomenon of folding and the signs of breast implant rupture, it is necessary to discuss the phenomenon of “gel bleeding” (Fig. 3). The so-called gel bleeding is a phenomenon closely related to the chemical affinity between the outer shell of the silicone elastomer and the gel contained therein. Indeed the gel, if in contact with the outer shell, can break the noncovalent molecular bonds between the polymer chains, causing swelling and weakening of the shell itself. Once it separates from its shell, silicone can migrate, even reaching the upper limbs, the liver, the inguinal lymph nodes, the synovium, the skin, and the pleural fluid [17–19]. With the introduction of new cohesive gel implants, the phenomenon of gel bleeding has not been found.

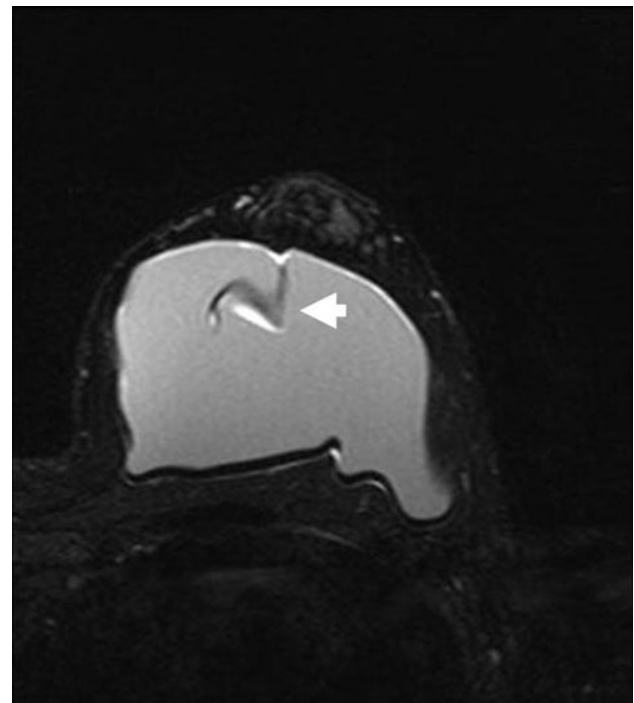
Fig. 4 Magnetic resonance imaging (MRI) signs: the “radial folds.” The MRI T2-weighted sequence on the axial plane shows the presence of a radial pleat on the anterior wall of the prosthesis (*arrow*), which has only one end in connection with the fibrous capsule (plications sometimes appear with a complex, branched structure). A small flap of periprosthetic liquid, likely the source of chronic inflammatory, also is noted

- *Radial folds.* These folds are observed in single-chamber implants and frequently found in patients with intact implants. They represent a major cause of error in the diagnosis of prosthetic rupture. They comprise a small number of folds that radiate from the periphery in a centripetal direction [20, 21]. A key feature of these folds is that they form an acute angle with the fibrous capsule. Different types of folds can be distinguished, namely, simple (Fig. 4), short and straight, complex, and long and curved [22].

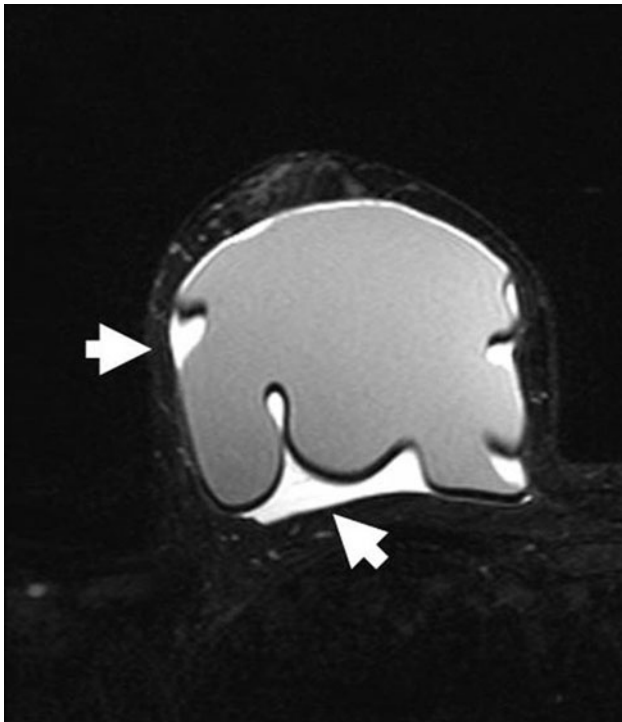
Fig. 5 Magnetic resonance imaging (MRI) signs: the “seromas.” The T2-weighted MRI axial sequence shows a large serous collection of the left breast that significantly impresses the prosthetic implant, especially in the chest wall area or areas

- *Seromas.* The presence of fluid collections in the periprosthetic area can sometimes be a diagnostic problem in cases of suspected implant rupture. In such situations, it is necessary to use T2-weighted MRI sequences with suppression of the water signal. In the case of a seroma, the water-suppressed signal should display the hypointense collection versus the hyperintense signal of the prosthetic implant. On the other hand, in the case of a capsular rupture or gel bleeding, both the collection and the intracapsular content show the same signal intensity (Fig. 5).

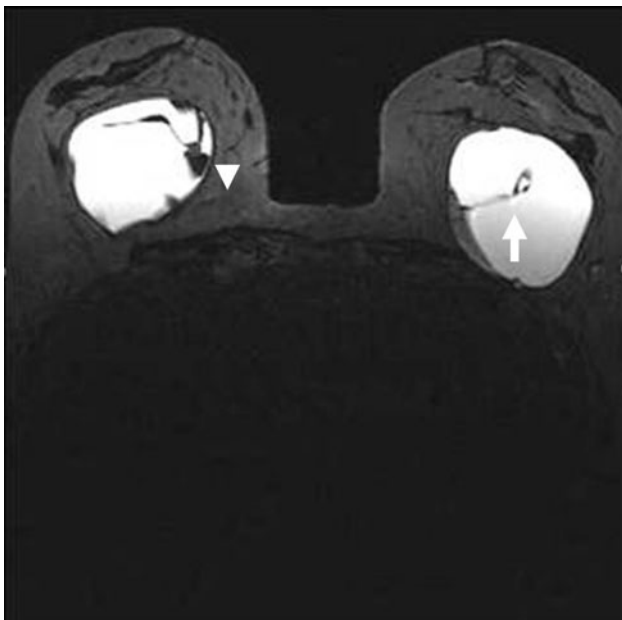
Fig. 6 Magnetic resonance imaging (MRI) signs of entrapment of silicone: the “keyhole sign.” The water saturation (WAT-SAT) short tau inversion recovery (STIR) axial MRI sequence shows a minor collapse of the left prosthetic breast implant (on the medial wall) with a collapsed prosthetic edge due to the “keyhole sign” (arrow). In the contralateral prosthesis is observed a radial fold (arrowhead)

these signs take their names, namely “keyhole sign” (Fig. 6) or “noose sign.” In diagnostics, it is possible to refer to one sign rather than the other to indicate a silicone entrapment [4, 23, 24]. Sometimes, as in the case of the “keyhole sign,” the presence of silicone with an intact capsule may be due to the phenomenon of “gel bleeding.”

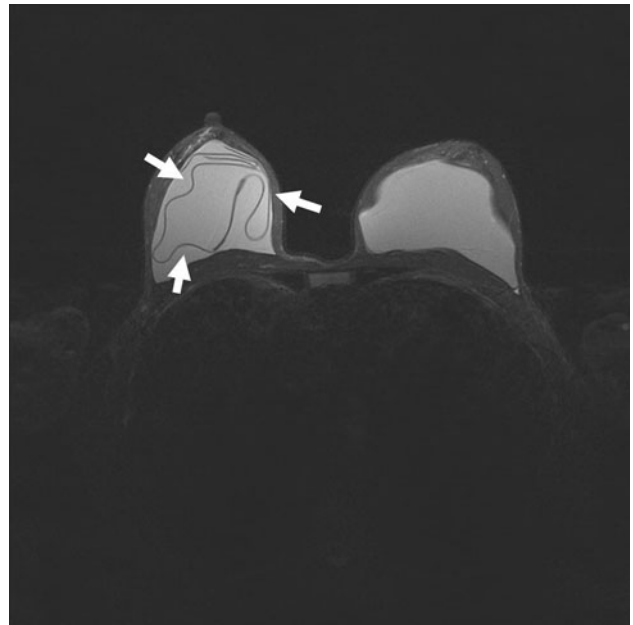
Fig. 7 Magnetic resonance imaging (MRI) signs: the “linguine sign.” The T2-weighted STIR MRI sequence on the axial plane shows that the wall of the prosthesis is broken, whereas the fibrous capsule is intact. Thus, the wall is collapsed in its content of silicone on the right prosthetic implant (arrows). This sign is commonly known as the “linguine sign.”

- *Linguine sign.* In this case, it is possible to see curvilinear hypointense lines, which contrast with the interior of the capsule filled with silicone and therefore are strongly hyperintense. The formation of these lines can be due to parts detached from their collapsed prosthetic shell. Identification of these lines is of great help in making an ultimate diagnosis of intracapsular rupture [25]. In some cases, it is necessary to differentiate this finding from the radial folds (Fig. 7).

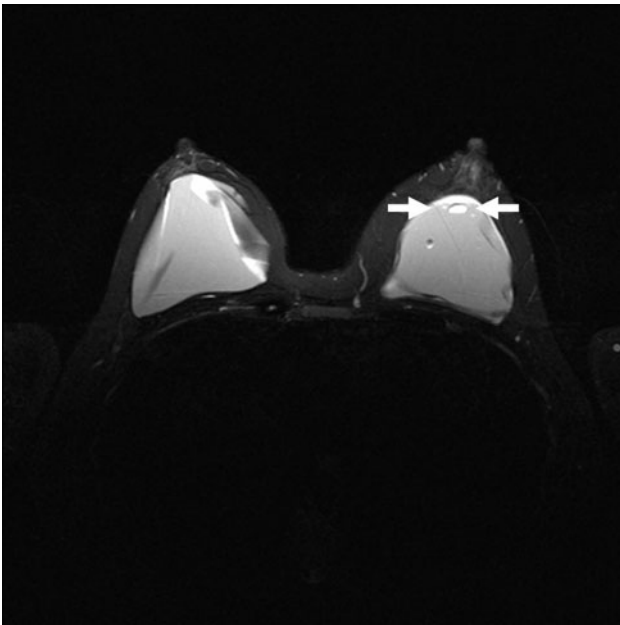
Fig. 8 Magnetic resonance imaging (MRI) signs: the “salad oil sign.” The turbo inversion recovery (TIRM) axial plane MRI sequence shows an intracapsular rupture of the left prosthetic implant (double lumen) with admixture of the contents (saline and silicone). This sign is commonly known as the “salad oil sign” (arrows)

- *Teardrop sign or salad oil sign.* This sign comprises actual water drops of extracapsular origin that penetrate through the semipermeable prosthetic shell. When more droplets merge to form larger droplets, the sign known as the “salad oil sign” appears (Fig. 8). The penetration of an abundant quantity of liquid at the intracapsular level is indicative of implant rupture [27].
- *C-sign.* This sign originates from a variant of the previous sign when a real patch of silicone forms on the back of the capsule. When capsular collapse occurs, this patch takes precisely the form of a “C,” hence its name of “C-sign” [28].
- *Bulging.* This phenomenon occurs when the fibrous capsule meets minor resistance (Fig. 9). It occurs with intact implants but can seriously lead to a possible rupture [29].

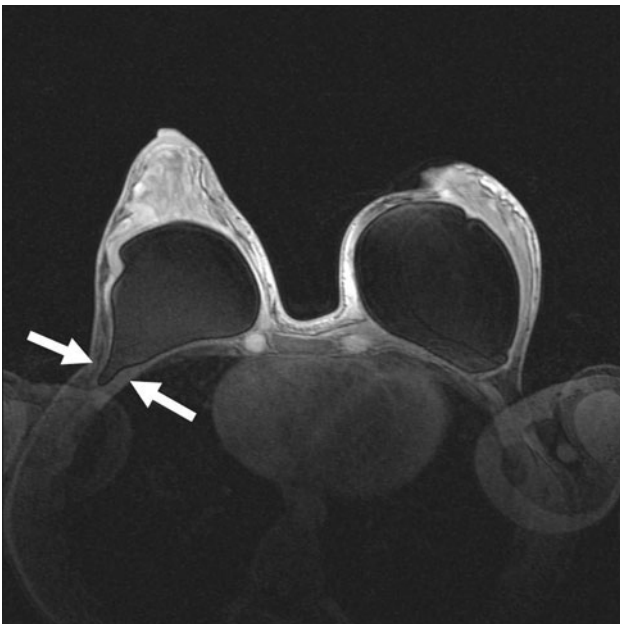
Fig. 9 Magnetic resonance imaging (MRI) signs: herniation of the prosthetic implant: the “bulging.” The T2-weighted axial plane MRI sequence with suppression of silicone (silicone saturation) shows an initial bulging of the right prosthetic implant on the ipsilateral axillary extension, which was clinically determined only as a small asymmetry of the breasts (arrows)

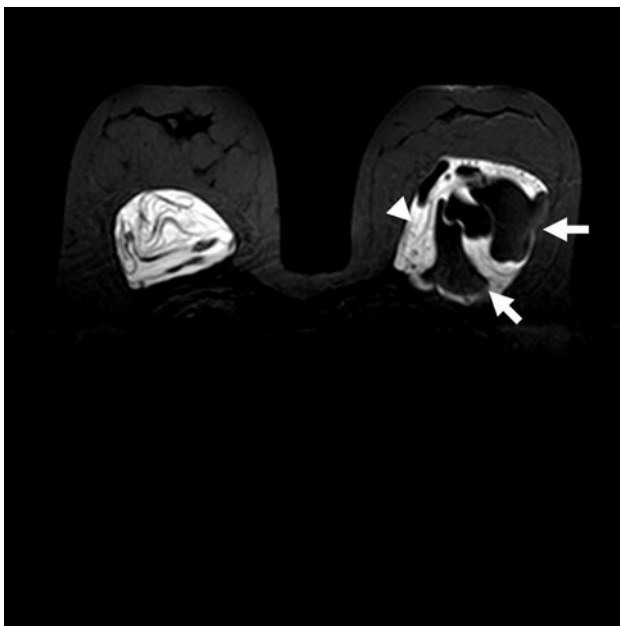
Fig. 10 Magnetic resonance imaging (MRI) signs: double-chamber implant intraprosthesis rupture. Admixture of silicone with hydrosaline solution occurred. The T2-weighted axial plane MRI sequence with suppressed water signal shows the rupture of two standard double-lumen implants. This rupture is significantly more pronounced in the left implant, in which the collapse of prosthetic limbs was observed. Moreover, the hydrosaline solution (*arrows*) still is present in the outer lumen but now is admixed with silicone gel deriving from the rupture of the inner lumen (*arrowhead*). The implant as a whole is intact

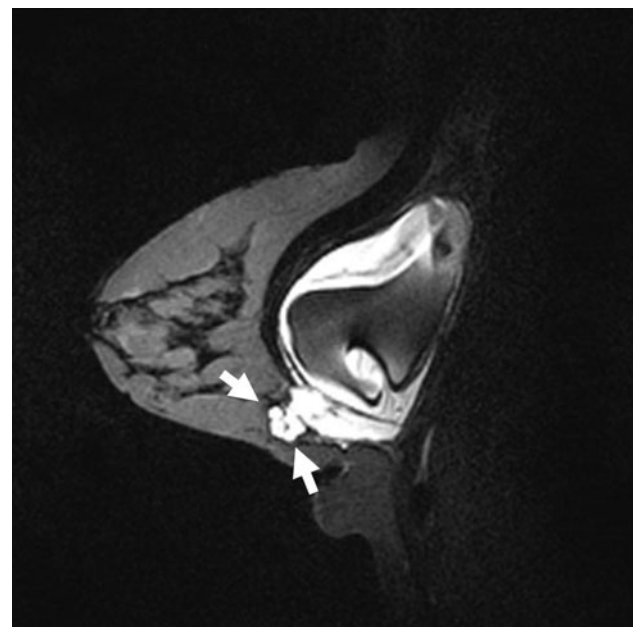
Fig. 11 Magnetic resonance imaging (MRI) signs: extraprosthesis rupture of double-chamber implants with leaking of silicone. The WAT-SAT STIR T2-weighted sagittal plane MRI sequence shows an initial extraprosthesis rupture of a double-chamber implant, with rupture of the lower capsular wall and leakage of silicone in breast tissue periprosthesis (*arrows*)

the hydrosaline solution. In such cases, at a clinical level, there is deformation and volumetric reduction of the prosthetic implant (Fig. 11). This type of rupture leads to systematic accumulation of silicone in the periprosthetic tissues and sometimes in the axillary fold and the lymph nodes, a phenomenon also well evaluated with MRI.

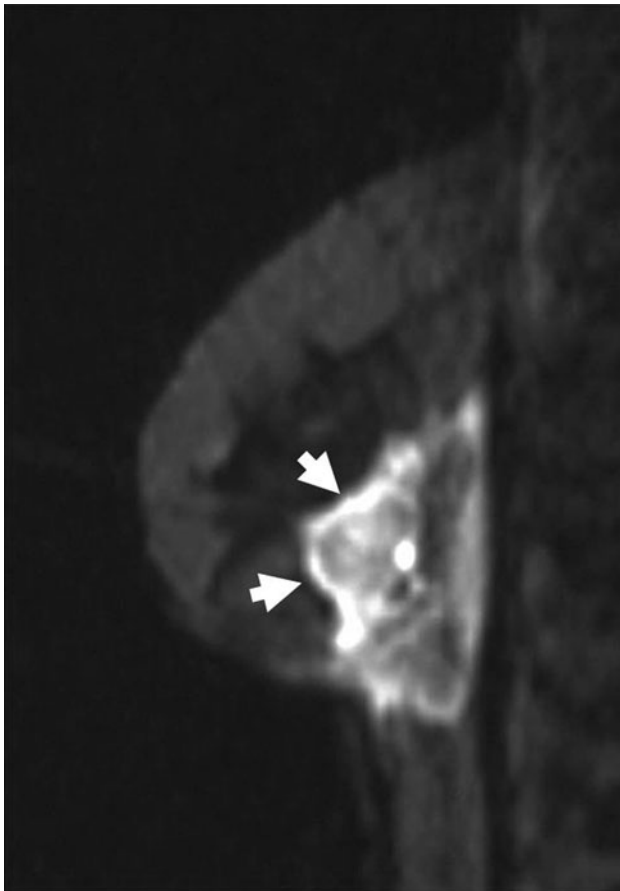
Fig. 12 Magnetic resonance imaging (MRI) signs: extraprosthetic rupture of double-chamber implants with leaking of silicone and siliconomas formation. The sagittal T-weighted spin-echo fat saturation sagittal plane MRI sequence shows the presence of a massive siliconoma that occurs in the form of a pseudonodular inhomogeneous hypointense area (*arrows*) as the result of an extraprosthetic rupture

The leaking of silicone in the periprosthetic tissues may lead to the formation of siliconomas, which are well differentiated from seromas with the use of specific MRI sequences (Fig. 12) and from silicone cysts. Siliconomas, which give a high signal on T1 and T2 and a low signal on fat-suppression sequences, are frequently placed in differential diagnoses with seromas and require surgery.
