# Identification of Land-Cover Changes Through Image Processing and Associated Impacts on Water Reservoir Conditions

ABSTRACT / A temporal assessment of land-cover changes of the province Beykoz in Istanbul has been documented in

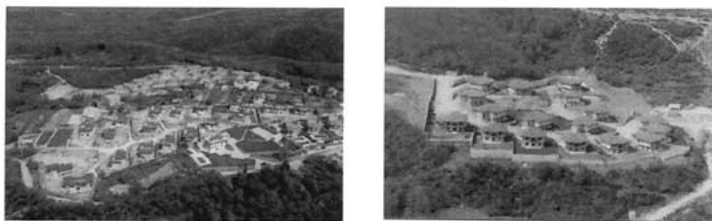
**Figure 5.** Aerial photographs for year 2000 showing the recent established residential sites within forest areas.
