Fracture of ceramic heads in total hip replacement

B. Habermann · W. Ewald · M. Rauschmann ·
L. Zichner · A. A. Kurth

Abstract After introduction of ceramics in total hip replacement, there have been several studies on wear and fracture of the femoral head component. Though reports on fractures are few, we saw four fractures within 2 months. In all patients, a cementless hip prosthesis by four different surgeons was implanted between 3/2001 and 2/2004. In three patients, a ceramic-on-polyethylene pair and in one, a ceramic-on-ceramic pair was used. Only one patient suffered an adequate trauma. The mean survival of the ceramic head was 27 months (11–42). In two patients with polyethylene inlays, the inlay showed signs of wear out due to the fractured head. All four revision surgeries had a good outcome with satisfying results and no complications. Though we observe the postoperative development after implantation of ceramic components closely, we still believe that ceramics in total hip replacement in young and active patients are indicated with good long term results.

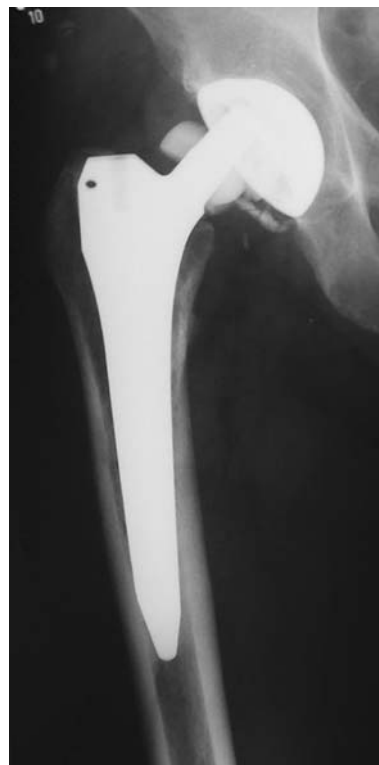
Fig. 1 Zweymueller type stem and cementless cup

Almost a month after a fall on his left side, the third patient presented himself at our outpatients' clinic. He recalled that immediately after the fall there was no pain in his right hip which received a total cementless hip replacement a year ago. The pain started several days later. In this patient, the inlay of the acetabular cup was due to the scratches exchanged (see Fig. 1).

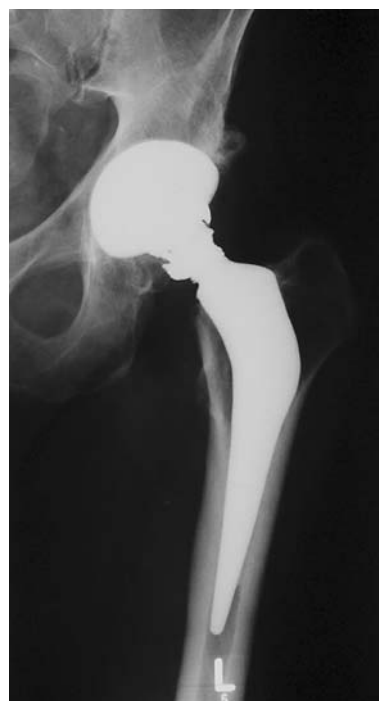
Fig. 2 Anatomical adapted stem and a cementless cup with a ceramic inlay. Typical signs of debris around the neck after fracture of the ceramic head

Two years after his total hip replacement, patient four fell on slippery ground on his left hip which was replaced 28 months ago. Though he did not feel any pain he heard and felt an ongoing crepitation in his operated hip while moving the lower left extremity. The X-ray and the CT-scan showed the fracture of the femoral head. Even though no signs of destruction and scratches were found intraoperatively, it was decided to change the inlay. Since all particles of the fractured ceramic head were sufficiently removed, the surgeon decided to implant a ceramic head and ceramic inlay (See Figs. 2, 4, 5, 6).

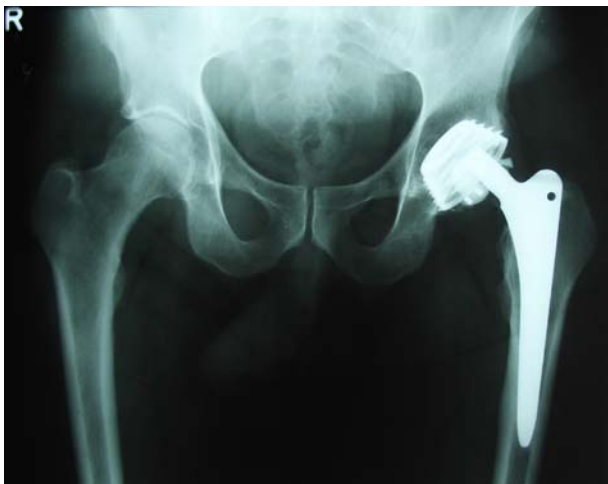
**Fig. 3** PPF type stem

Patient one presented himself in our outpatients' clinic and reported of a sudden pain without any trauma 4 days ago. Three years ago, a cementless hip prosthesis with a ceramic head and polyethylene cup was implanted. The x-ray showed a fracture of the femoral head. During the revision surgery the inlay of the acetabular cup did not show any signs of wear and scratches so that the surgeon decided not to change the inlay (see Fig. 3).

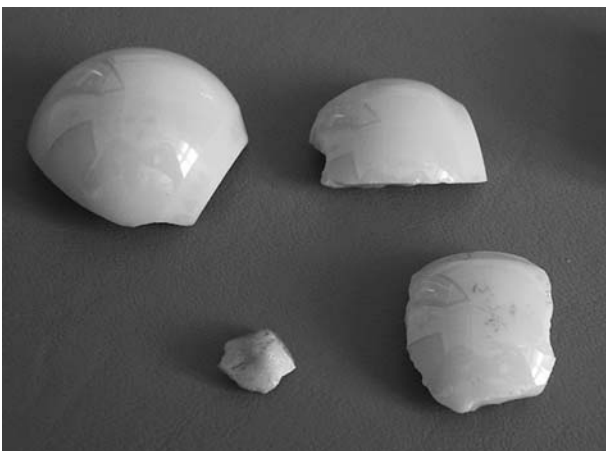
Fig. 6 Fractured ceramic head
