# Complete polyethylene wear-through and secondary breakage of the expansion cup in a ceramic-polyethylene total hip arthroplasty

Massimo Mariconda · Alessandro Silvestro ·  
Gelsomina Mansueto · Domenico Marinò

Received: 15 December 2008 / Published online: 26 February 2009  
© Springer-Verlag 2009

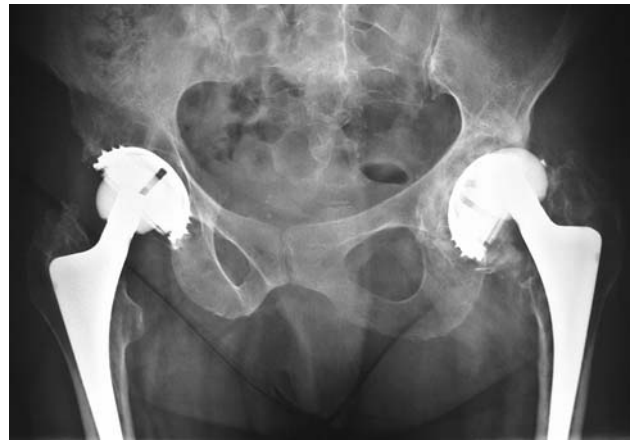
**Fig. 1** Anteroposterior standard radiograph of the pelvis. Radiographs taken before the revision surgery show correct placement of the right total hip arthroplasty, with an inclination of the acetabular component of  $44^\circ$ . Superior dislocation of the left total hip arthroplasty with an inclination of the expansion cup of  $60^\circ$  and extensive osteolysis of the acetabulum

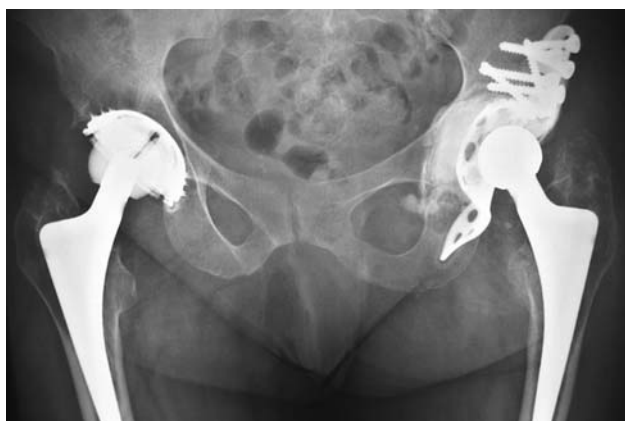
**Fig. 4** Anteroposterior standard radiograph of the pelvis obtained 2 years after revision surgery shows correct position of both the acetabular reinforcement cage and cup

At the two-year follow-up, the patient reported that she had returned to her previous level of activity. She walked without support and had complete and painless range of motion in her left hip; the Harris Hip Score was 85. The position of both the acetabular cage and cup were correct and no signs of loosening or migration were observed in the radiographs (Fig. 4).
