# Extreme rainfall-induced lahars and dike breaching, 30 November 2006, Mayon Volcano, Philippines

**Abstract** On 29–30 November 2006, heavy rains from Supertyphoon Durian remobilized volcanic debris on the southern and eastern slopes of Mount Mayon, generating major lahars that caused severe loss of life and property in downstream communities. The nearby Legaspi City weather station recorded 495.8 mm of rainfall over 1.5 days at rates as high as 47.5 mm/h, far exceeding the initiation threshold for Mayon lahars. For about 18 h, floods and lahars from the intense and prolonged rainfall overtopped river bends,

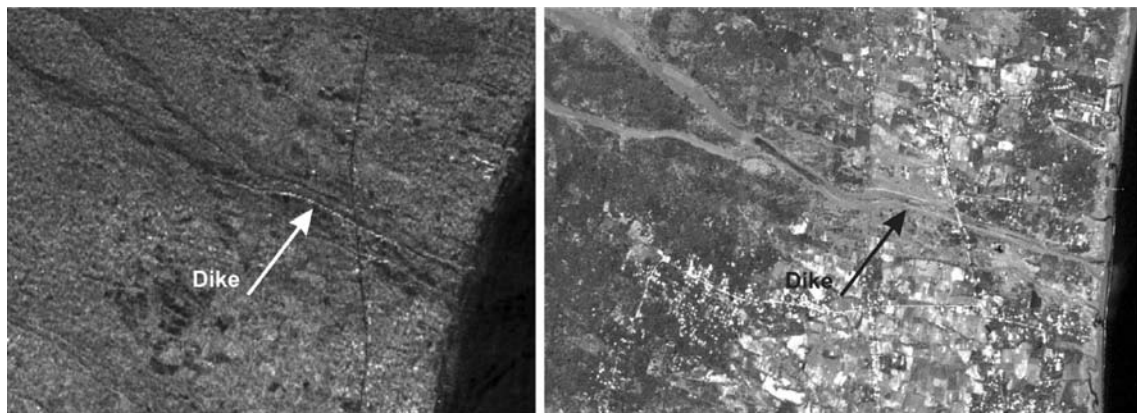
**Fig. 3** Concrete dikes appear as light-colored linear features on both radar (a) and optical (b) images

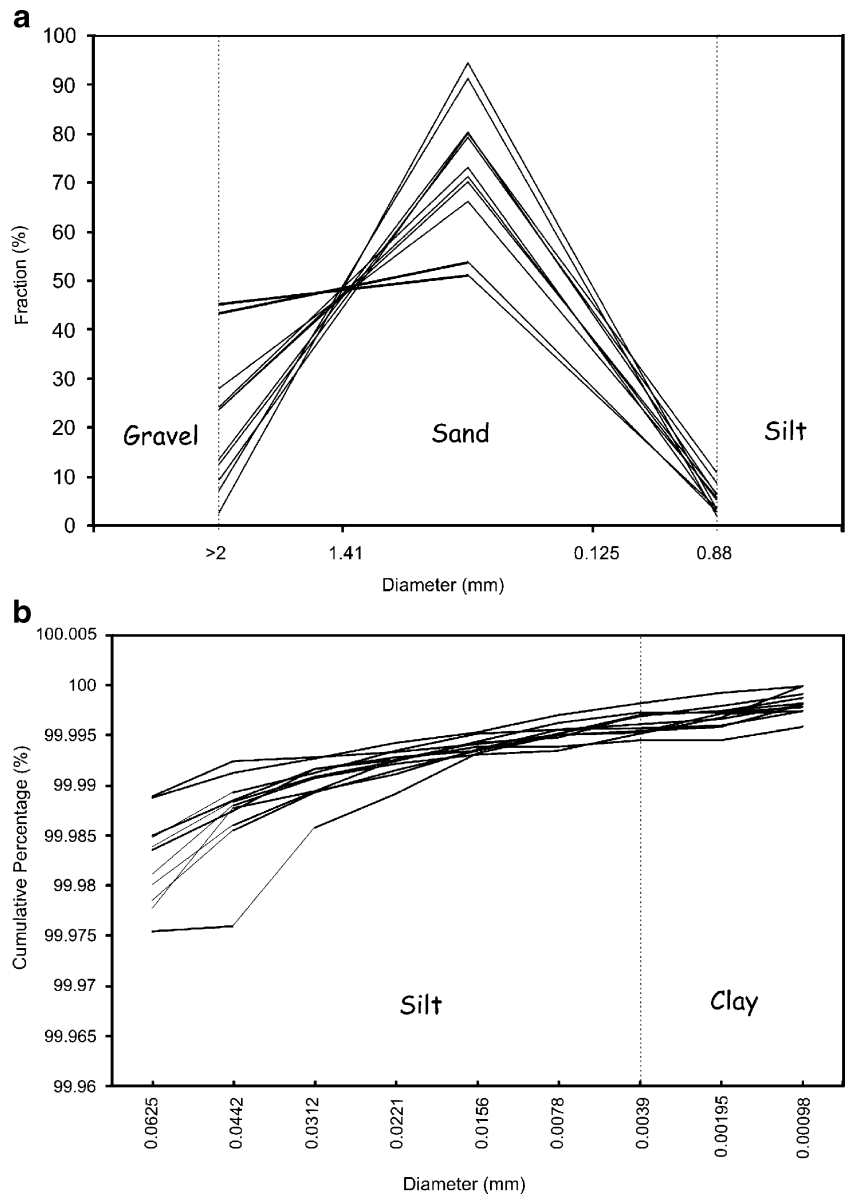
**Fig. 6** Granulometry of 11 Typhoon Durian lahar samples from the eastern and southern flanks of Mt. Mayon. **a** Gravel, sand and silt + clay fractions; **b** cumulative distributions of silt and clay fractions. Sample locations are plotted in Fig. 2

Deposits of the second type consist mainly of coarse to very coarse sand without large clasts and minor silt and sand fraction of 1.9 to 8.53 wt.% (Fig. 6a, b). They are massive or very crudely bedded, and are interpreted to have been deposited by hyperconcentrated flows. In the remotely sensed imageries, the debris-flow deposits correspond to the fan-shaped structures, whereas hyperconcentrated-flow deposits extend beyond the lahar fans and occur in distal portions of the channels.

Percentages of fine fractions are important regulators of lahar flow (Hampton 1975; Middleton and Hampton 1976; Qian et al. 1980; Costa 1984; Pierson and Costa 1987). Figure 6a shows that there is little clay-sized material in the lahars at Mayon, contributing to their non-cohesiveness. Clay fractions are randomly distributed in both debris-flow and hyperconcentrated-flow deposits.

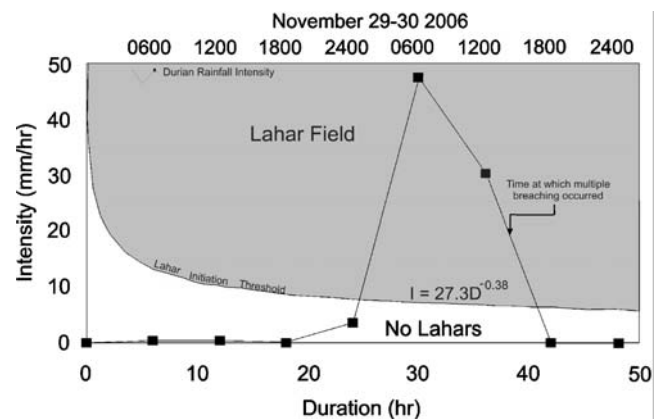
**Fig. 10** Rainfall intensity-duration threshold for the generation of Mayon lahars (after Rodolfo and Arguden 1991), and the 6-h average intensities and duration during Typhoon Durian

$$I = 27.3D^{-0.38}$$

where *I* is intensity and *D* the duration of rainfall. Compared to the worldwide intensity threshold values for debris flow generation (Balducci 2007), the triggering intensity for Mayon lahars is higher due to the coarse, granular, and very porous volcanoclastic surface material, which also renders the lahar-generating role of antecedent rain relatively insignificant (Rodolfo and Arguden 1991).

Plotted against the graph of the average intensity computed from the rainfall record of 29–30 November 2006 (Fig. 10), the equation shows that lahars probably started forming early on the morning of 30 November 2006 and were continuously generated until the early afternoon of 30 November 2006. Although it may be argued that the relationship of rainfall intensity and duration with lahar initiation threshold values is not linear from the time of an eruption but instead approximates a power law relation (Van Westen and Daag 2005), the rainfall intensity values from the evening of 29 November 2006 to noon of 30 November 2006 plot far in excess of the minimum threshold determined by the equation of Rodolfo and Arguden (1991).

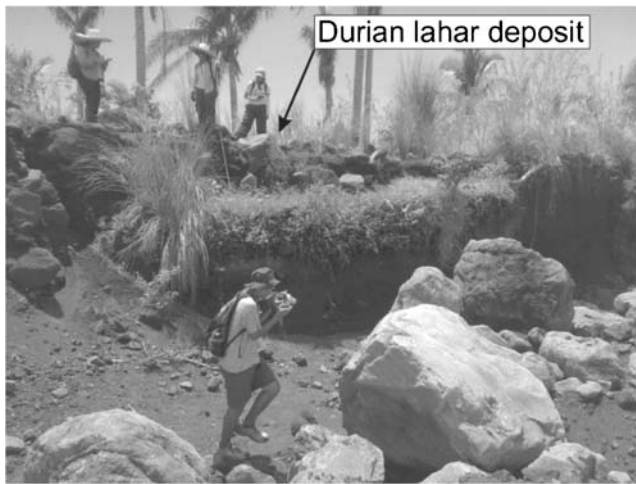
**Fig. 12** Eroded river bank along the outer bend of Basud channel, and overbank lahar deposits

This same kind of lahar erosion along the inside bend of the river downstream occurred in Basud (Fig. 11f). On its upstream, boulders had begun to erode the outside bend portion of the river channel (Fig. 12), depositing material on the river bank as far as 7 m away from its margin. Trunks of coconut trees were scarred up to 1.6 m above the 0.6 m-thick overbank lahar deposits, through which a 1-m wide and 0.5-m deep stream channel was cut outwards from the main channel. It is not known, however, if this channel was formed as a result of the overflow along the river bend or whether it had already existed.

The lahars initially were confined in river channels by dikes that were later breached during peak flow. Possibly, as at Mount Pinatubo, debris flows overtopped banks both on the inside and outside of channel bends (Figs. 11 and 12), first eroding the outer, unarmored back sides of dikes until they collapsed, and creating new pathways for the flows to cut through fields and overrun settlements. Inasmuch as the lahars inundated all the barangays virtually at the same time, peak flows, surges, and eventual dike breachings must also have occurred just before this period. Like the 1984 lahar events, the large
