Seismic risk of critical facilities in the Dominican Republic: case study of school buildings

Abstract

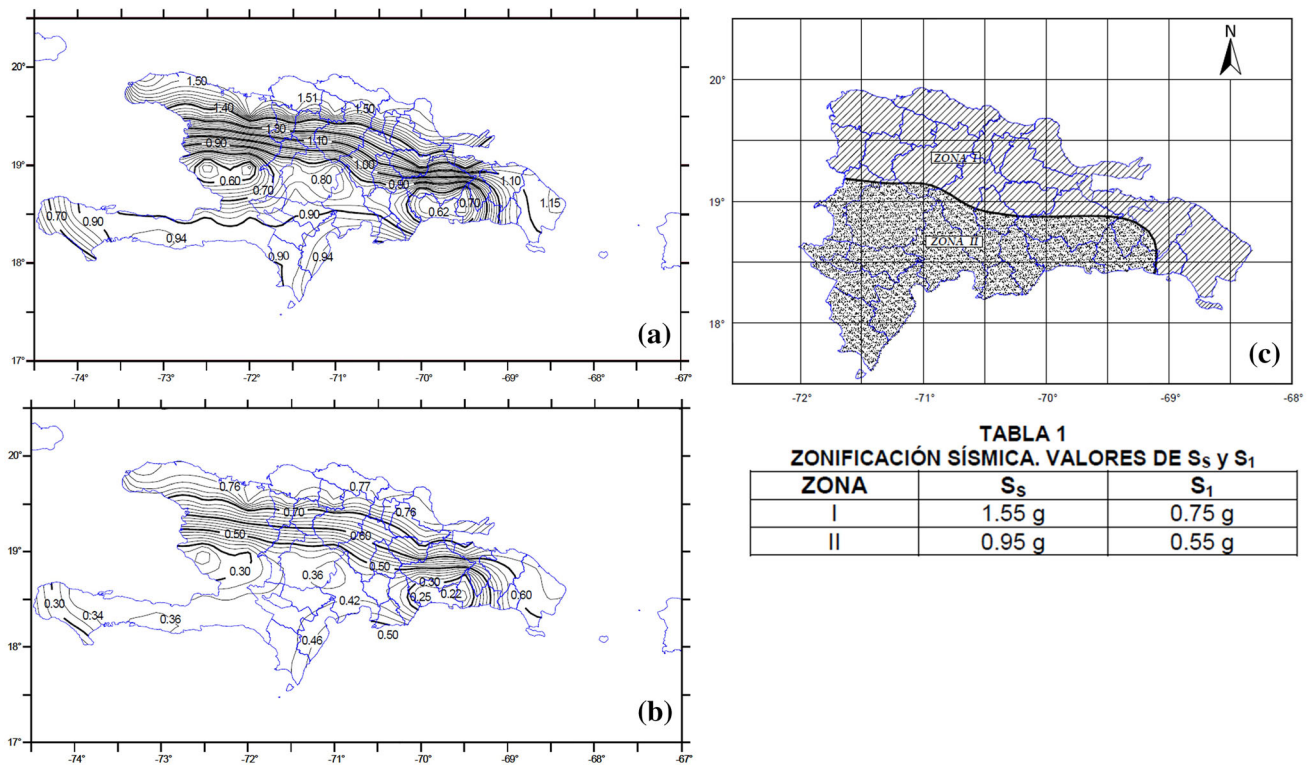
Fig. 5 Accelerations contour maps for a probability of exceedance of 2% in 50 years, according to the Dominican Republic 2011 seismic provisions. **a** Short period (S_s), **b** long period (S_1), and **c** seismic zoning. Adapted from MOPC (2011)

The regulation for the seismic analysis and design of structures (MOPC 2011) is basically an adaptation of the ASCE7-05 code (ASCE 2005) of the USA. For the purposes of the regulation, the Dominican Republic is divided into two zones, according to their reference spectral

seismic acceleration levels *S_s*, for a return period of 2475 years, with a probability of exceeding 2% in 50 years. Alternatively, for design purposes, the use of spectral iso-acceleration maps is allowed for short periods (*S_s*) and long periods (*S₁*), as shown in Fig. 5. The code also provides accelerations contour maps for both 2% and 10% probabilities of exceedance in 50 years. The expressions that define the elastic design spectrum are shown in Fig. 6. In the figure, *F_a* and *F_v* are the site coefficients, which depend on the site classification. Likewise, *U* represents the use of the structure, means while *R_d* is the energy dissipation factor that is a function of the structural system. It is important to mention that the current seismic code is not intended for the evaluation of existing structures; thus, the evaluation of the seismic risk of as-built schools may become controversial, especially for the estimation of the hazard levels.

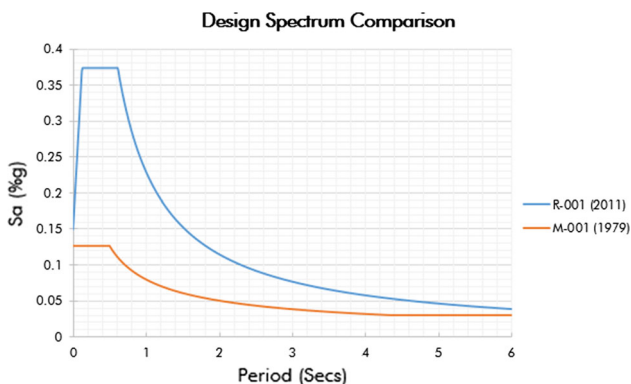
Fig. 7 Design spectrum comparison for the San Cristobal Province

The comparison of the design spectra by both the 1979 and 2011 codes for a concrete frame school structure located in the San Cristóbal Province is shown in Fig. 7. Considering that, as first estimate, the fundamental period for a reinforced concrete (RC) frame structure can be evaluated as 0.1 *N*, where *N* is the number of levels of the structure, for a typical school building of three levels, the seismic forces obtained from the 1979 code could underestimate such load in 61% (Table 2). Thus, it is necessary that school buildings designed with the former provisional regulations need to be assessed in order to determine the degree of vulnerability that such structures pose.

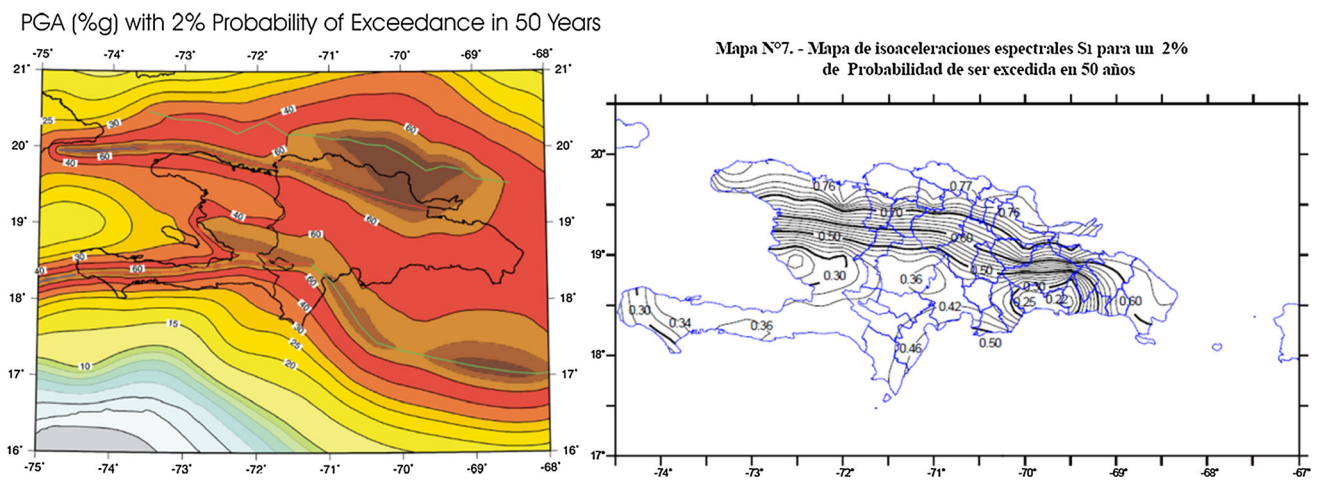
Fig. 9 Comparison between the contour accelerations of the seismic hazard maps developed by Frankel et al. (2011) and the long-period spectral accelerations (S_1) indicated in the R-001 seismic code, for the 2% probability of exceedance in 50 years

developed by Frankel et al. (2011). The comparison for the case of the long-period spectral acceleration is shown in Fig. 9. It is observed that the current seismic code has higher accelerations around the northern fault (northwest and northeast of the Dominican Republic). However, outside this region, the acceleration contour proposed by Frankel et al. (2011) shows higher accelerations. The same conclusions apply for the case of the short-period spectral acceleration (Fig. 10).

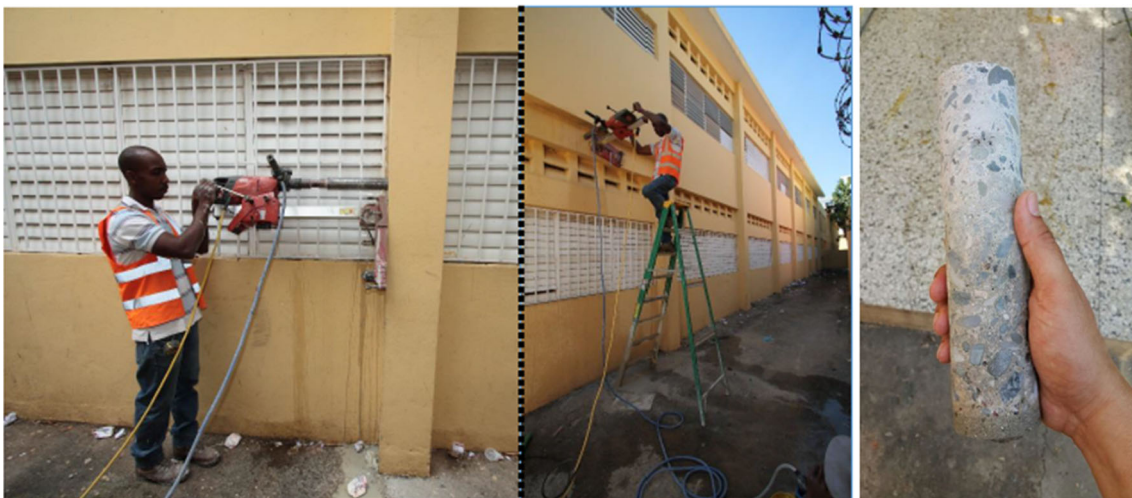
Fig. 15 Concrete core extraction

(three in beams and three in columns), in structural elements that resulted with higher load demand according to a preliminary structural analysis. The concrete core extraction process is shown in Fig. 15. The concrete test results for the beams and columns are shown in Tables 3 and 4, respectively. It is noteworthy to mention that three samples were extracted for the beams; however, the stress obtained from one of the tests was only 55 kg/cm^2 (5 MPa), which is clearly an outlier and thus was discarded.

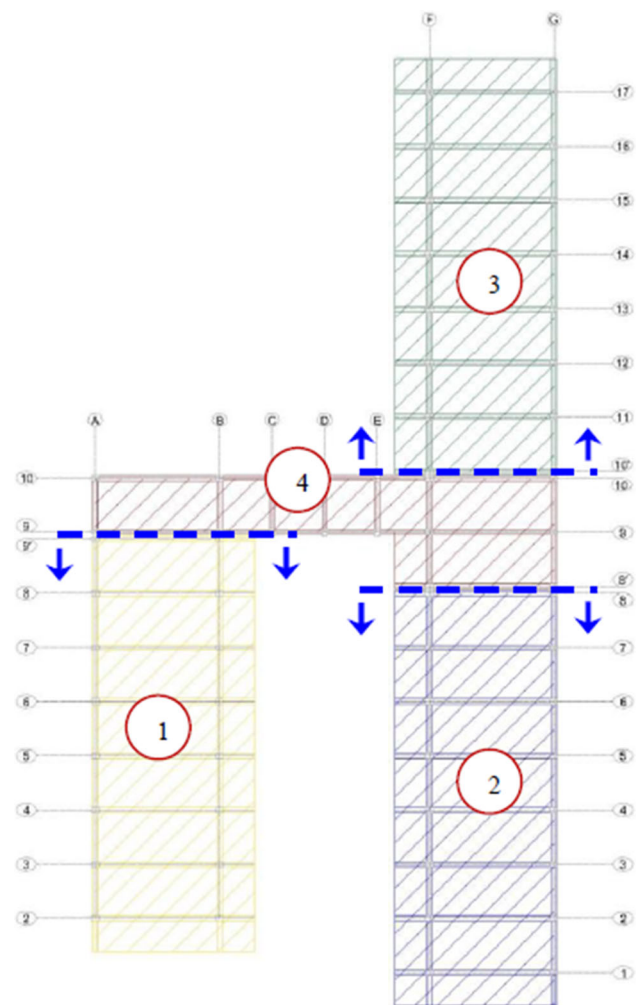
Fig. 18 Suggested construction joint

identified that the structures are separated by construction joints, however, the slab was cast in place continuously, which makes it behave as one body instead of four.

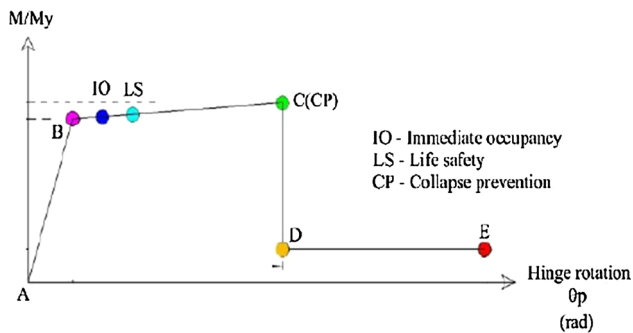
Fig. 20 Plastic hinge model for flexural member

To evaluate the performance of the proposed modified structure, a nonlinear static analysis (pushover) was carried out. The properties of the plastic hinges for the beams and columns were defined according to the recommendations of the standard ASCE7-05 (ASCE 2005). The behavior of the plastic hinges (Fig. 20) was evaluated at the performance point of the structure, in terms of the rotations limits established by the ATC-40 (Applied Technology Council 1996) for buildings with special occupation. To these buildings corresponds an immediate occupancy (IO) level.
