Response and Stability of Underground Structures in Rock Mass during Earthquakes

Ömer Aydan · Yoshimi Ohta · Melih Geniş ·
Naohiko Tokashiki · K. Ohkubo

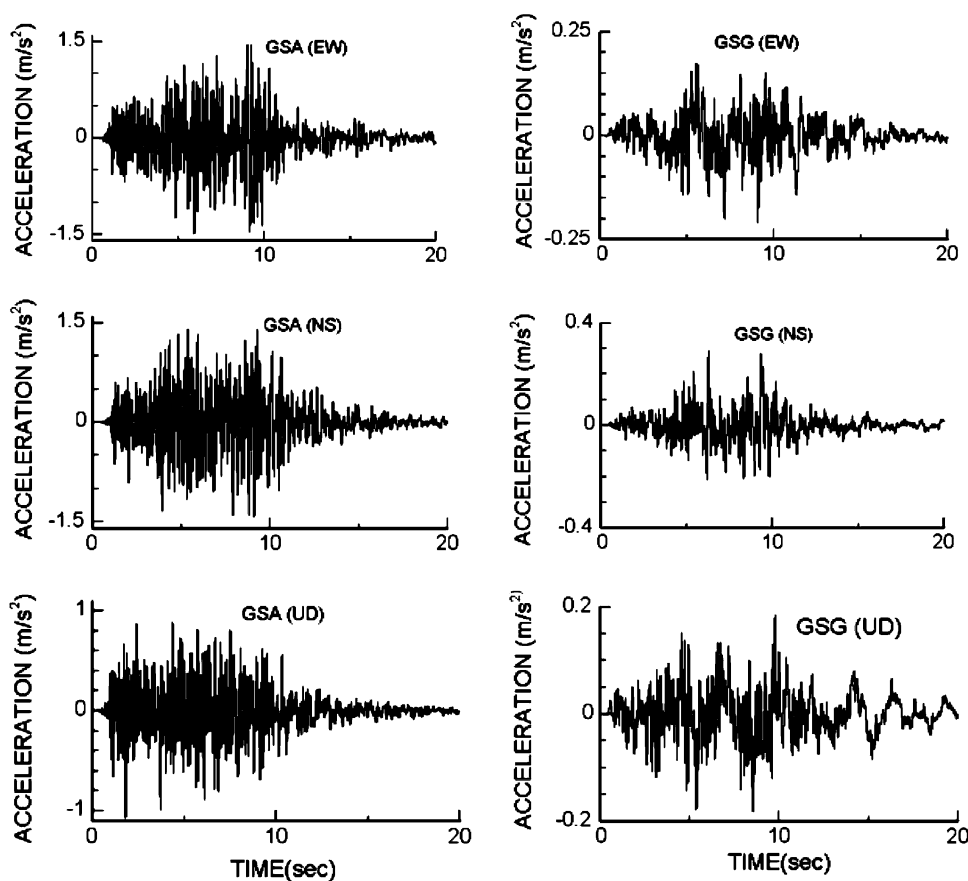
Fig. 1 Acceleration records at GSA and GSG strong motion stations (from Aydan et al. 2009c, strong motion records from Italian Strong Motion Network, RAN)

Figure 1 shows the acceleration records measured on the ground surface (GSA) and underground (GSG) during the 2009 Mw 6.3 L'Aquila earthquake. The GSA station is at Assergi and the GSG station is located in an underground gallery of Gran Sasso Underground Physics Laboratory of Italy. Both stations are founded on Eocene limestone with a shear wave velocity of 1 km/s. Although the epicentral distances and ground conditions are almost the same, the acceleration at ground surface is amplified almost 6.4 times that in the underground gallery.

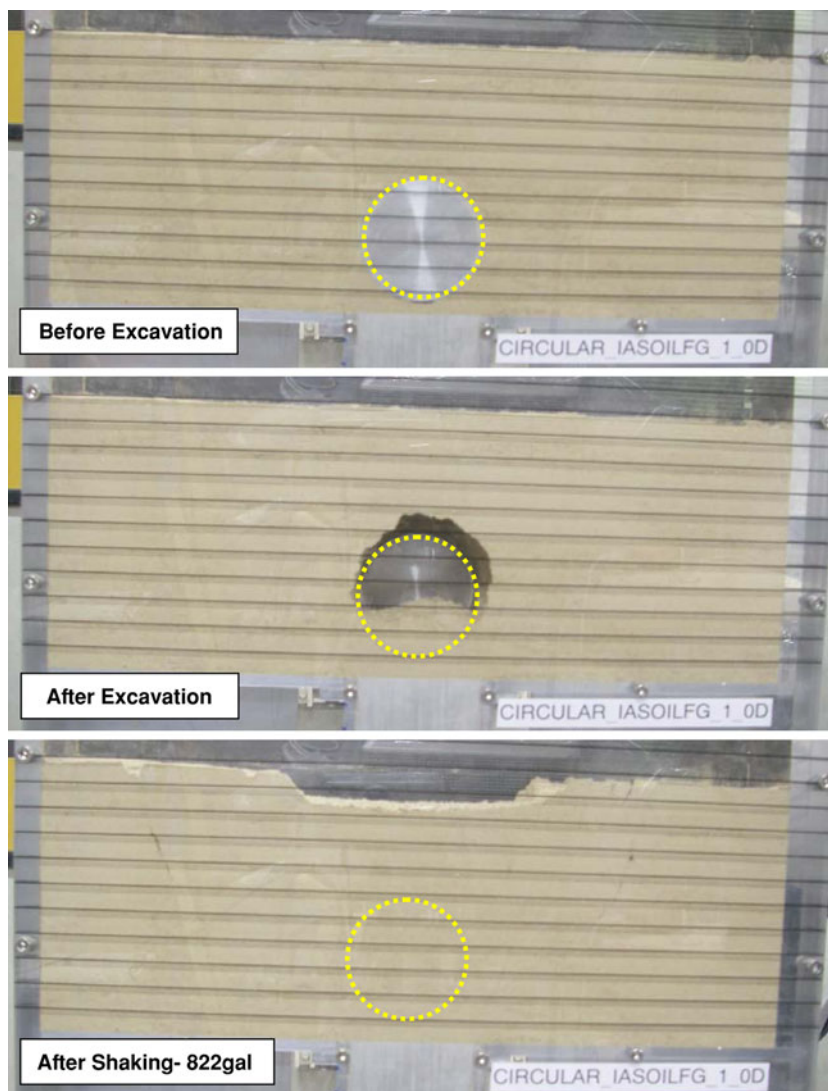
Fig. 3 Views of a model tunnel before and after excavation and shaking ($H/D = 1.0$)

may completely fail during earthquakes as seen in Figs. 3, 4, 5, 6, 7 and 8. There are also many reports of such case histories in literature (i.e., Wang et al. 2001; Aydan and Kawamoto, 2004; Aydan et al. 2009b, 2009c; Karaca et al. 1995). The authors studied the stability of shallow underground openings under both static and dynamic conditions (Aydan et al. 1994; Genis and Aydan 2002). The model tests (see also Fig. 6) revealed that there were two or three regions potentially unstable (denoted regions I, II and III) in the close vicinity of shallow underground openings as illustrated in Fig. 9. Aydan et al. (1994) derived the following condition for the horizontal seismic coefficient (α_H) to initiate the sliding of a region along a discontinuity set emanating from the opening for a shallow underground opening as illustrated in Fig. 9:

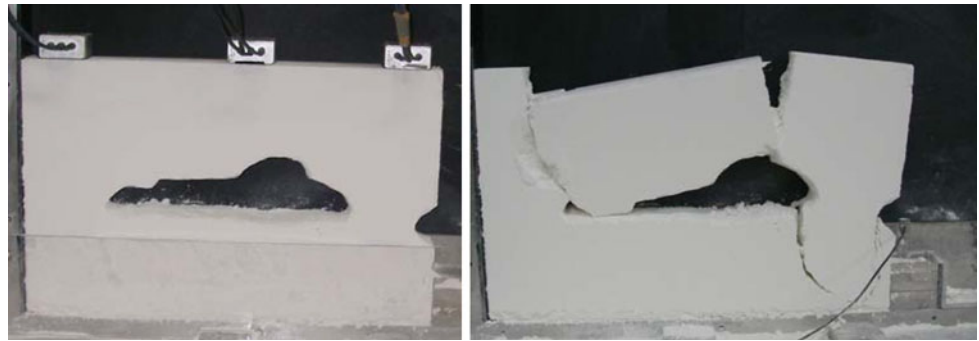
Fig. 5 Views of model test on the karstic cave beneath the Gushikawa Castle remains

Natural caves may sometimes be of great concern and their actual configuration would be different from those used in rock engineering structures. Figure 5 shows a shaking model experiment in relation to the effects of karstic caves beneath the Gushikawa castle remains in Okinawa Island.

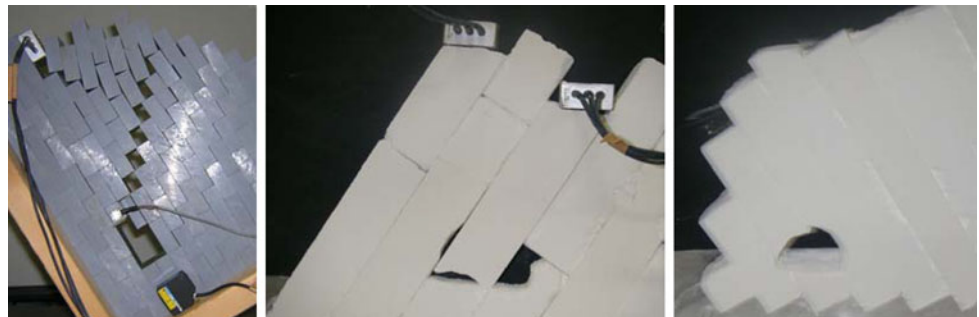
Fig. 6 Views of some model tests in discontinuous rock mass models

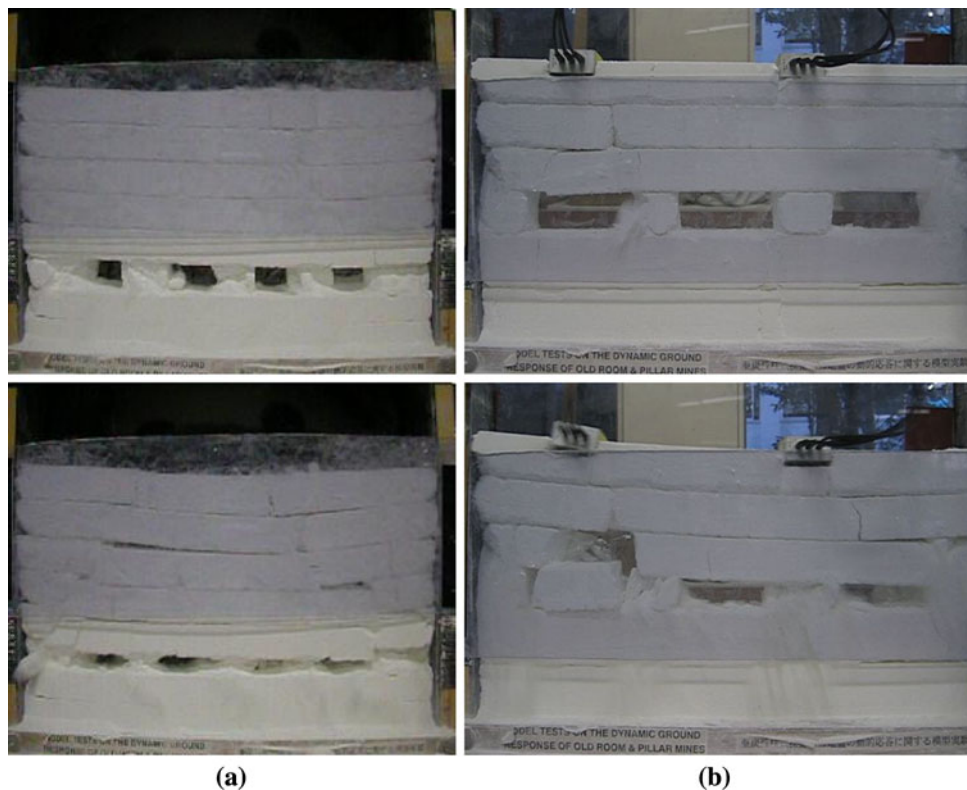
Fig. 7 Some views of models of abandoned lignite mines during shaking table tests.
a Compressive failure of pillars.
b Bending failure of roof layers

overburden height (H) to the seam height (h), and the total area (A_t) supported to the pillar area (A_p), were systematically varied. The model was fixed on a uniaxial shaking table apparatus and was shook. When the overburden ratio (H/h) was high, the failure was due to the compression failure of pillars for the excavation ratio (A_t/A_p) of 2 (Fig. 7a), while the failure was due to the failure of the roof layers for the excavation ratio (A_t/A_p) of 3 as seen in Fig. 7b.

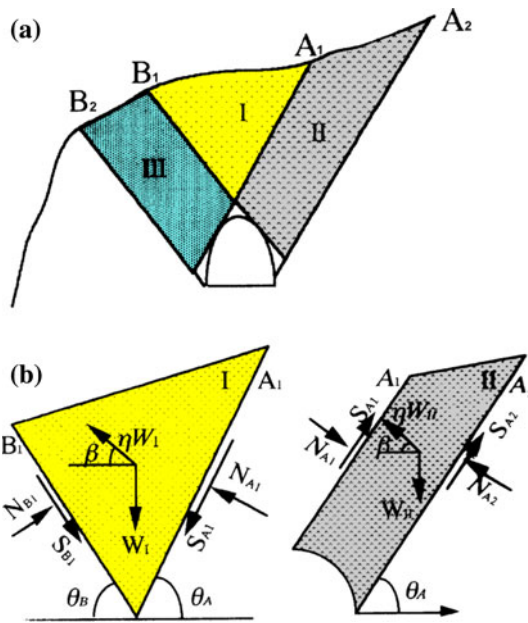
Fig. 9 Illustration of mechanical model for stability analysis of shallow underground openings (Aydan et al. 1994)

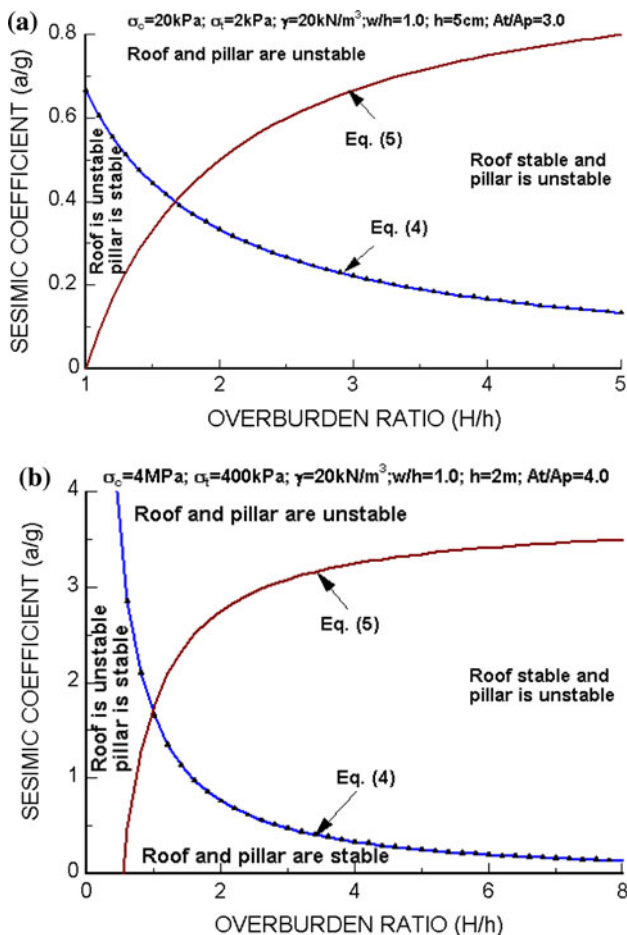
Fig. 11 Seismic stability charts for abandoned mines

The horizontal seismic coefficient at the collapse of the pillar may be obtained for the condition that the maximum compressive stress obtained from Eqs. 3 and 4 is the same. In Fig. 11, H and h stand for overburden height and pillar height, respectively. Model tests on room and pillar mines on shaking table indicated that the roof layers also fail by bending. Therefore, the load condition under horizontal shaking is assumed to consist of gravitational load inducing the bending stresses and the linearly varying axial stress along the roof axis from tension to compression due to horizontal shaking. On the basis of this assumption, the horizontal seismic coefficient at the time of roof layer failure by bending is obtained as follows:

where t and σ_t are the thickness and tensile strength of the roof layer, respectively. Figure 11 shows a computed

diagram of the relations between overburden ratio and seismic coefficient of various failure modes for the chosen parameters shown in the same figure in relation to experiments shown in Fig. 7. As noted from the figure, there are four different regions in the diagram, namely, region 1: roof layer and pillar are stable; region 2: roof layer is stable, while pillar is unstable; region 3: roof layer is unstable and pillar is stable; region 4: roof layer and pillar are both unstable. These results indicate that the shallow mines are prone to roof failure while the deeper mines are prone to pillar failure for actual strong ground motions during earthquakes.

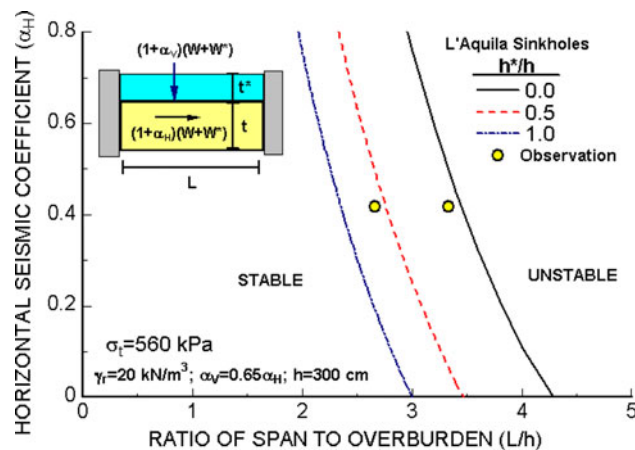
Fig. 12 Comparison of computational results with observational results

We applied this approach to the sinkholes caused by the 2009 L’Aquila earthquake (Aydan et al. 2009c). The computational results are shown together with the

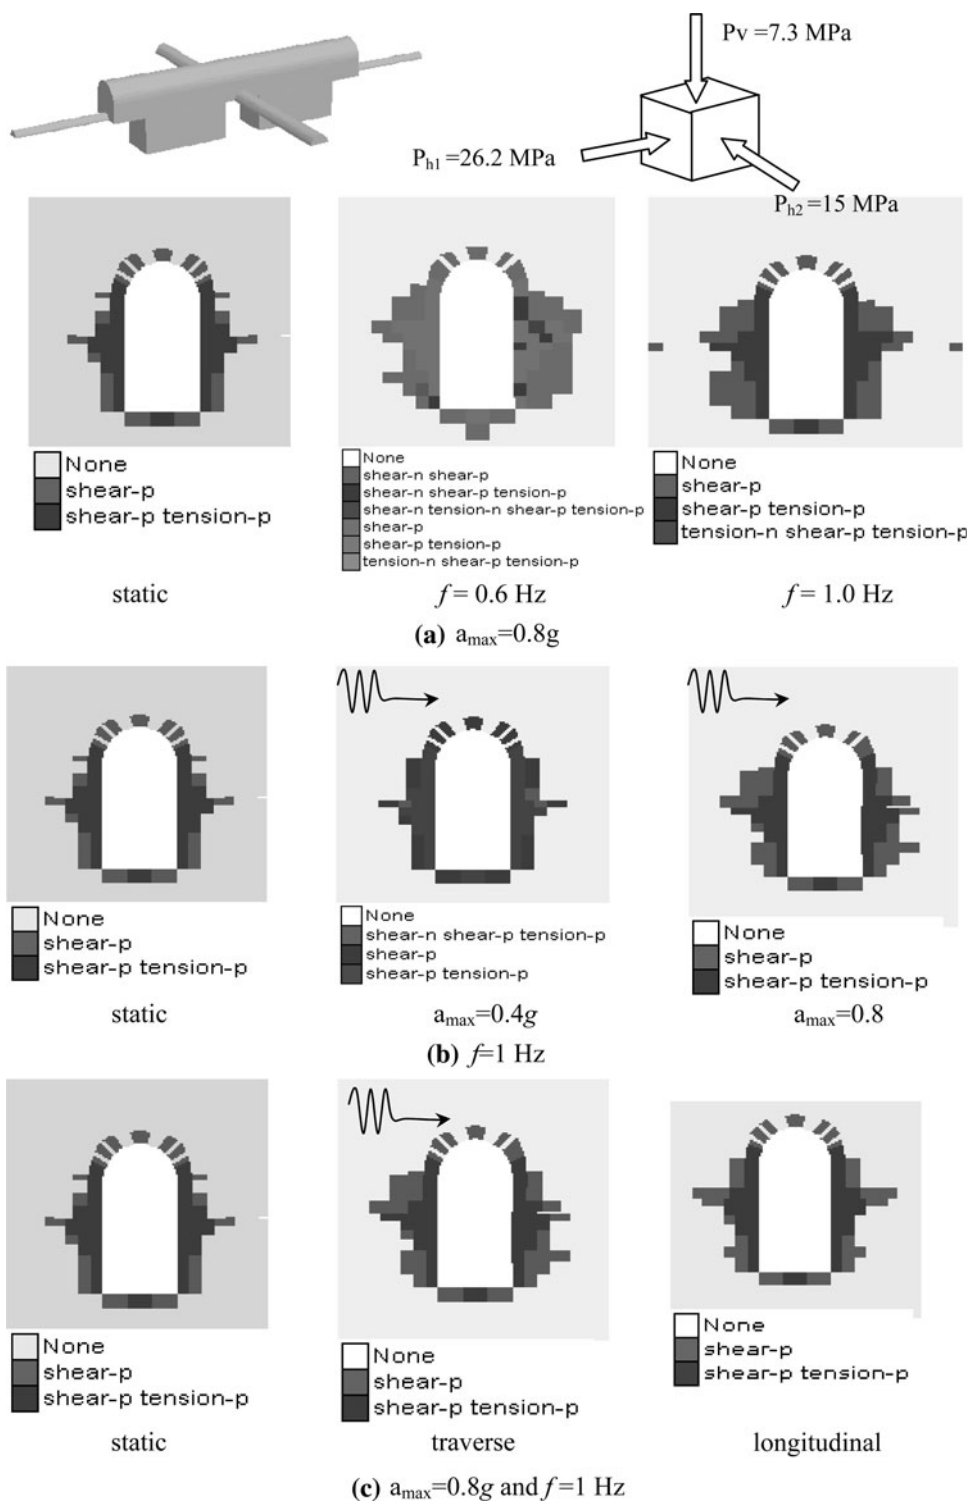
Fig. 14 Yield zone formation of underground powerhouse for different cases of input ground motions (arranged from Genis and Aydan, 2007)

Genis and Aydan (2007) carried out a series of numerical studies for the static and dynamic stability assessments of a large underground opening for a hydroelectric powerhouse. The cavern is made of granite under high initial stress condition and approximately 550 m below the ground surface. The area in 1891 experienced the largest inland earthquake in Japan. In the numerical analyses, the amplitude, frequency content and propagation direction of waves were varied (Fig. 14). Numerical analyses indicated that yield zone formation is frequency and amplitude dependent. Furthermore, the direction of wave propagation

also has a large influence on the yield zone formation around the cavern. When maximum ground acceleration exceeds 0.6–0.7 g, it results in the increase of plastic zones around the opening. Thus, there will be no additional yield zone around the cavern if the maximum ground acceleration is less than these threshold values.

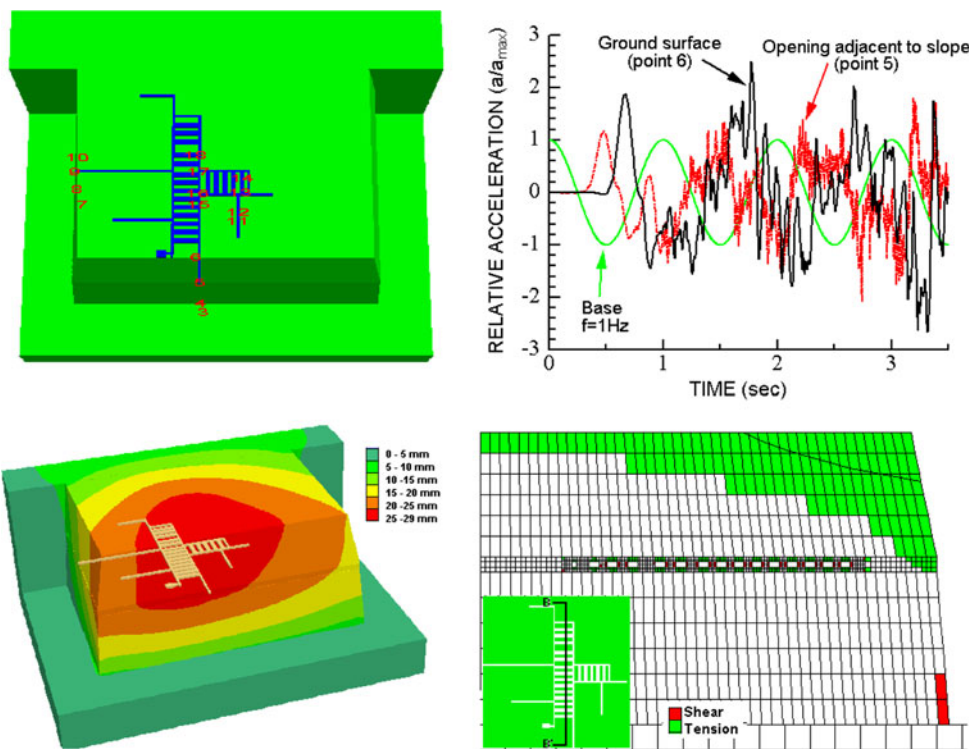
Fig. 15 Displacement response and yield zone around Bukittinggi underground shelter (arranged from Aydan and Genis 2008b)

The elastoplastic dynamic response of an underground shelter in Bukittinggi (Indonesia), which was excavated from very soft rock in 1942 and experienced the M6.8 Singkarak earthquake in 2007, was chosen as an actual example and its dynamic response and stability were analyzed (Aydan and Genis 2008b). There was no acceleration record in the vicinity of the underground shelter. However, the inferred maximum ground acceleration was about 0.3 g as shown by Aydan (2007). Therefore, sinusoidal waves with frequencies of 0.3, 1 and 3 Hz and amplitude of 0.3 g were applied horizontally to the base of the model. Figure 15 shows a three-dimensional perspective view of the underground shelter, acceleration responses at selected positions where some seismic damage were actually observed and displacement and yield zone distributions after the ground shaking disappeared. Although the analyses are limited to simple waveforms, the results can explain possible causes of the damage and its variation in the underground shelter.

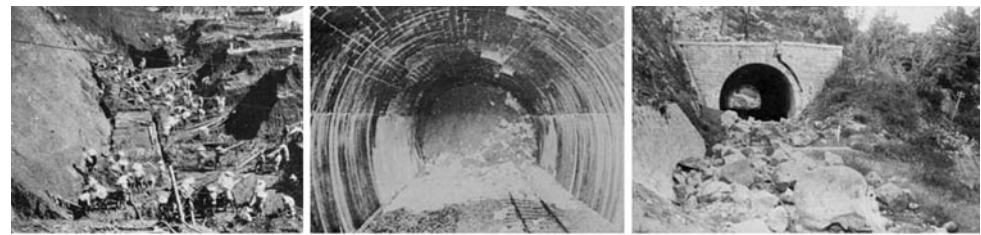
Fig. 16 Examples of damaged tunnels by the 1923 Kanto earthquake (JSCE Archive)

(a) Yose Tunnel

(b) Nenokamiyama Tunnel

(c) Fudousan Tunnel

1. shaking-induced damage (Figs. 16, 17, 18, 19, 20);
2. portal damage (Fig. 21) and
3. permanent ground deformations-induced damage (Figs. 22, 23).

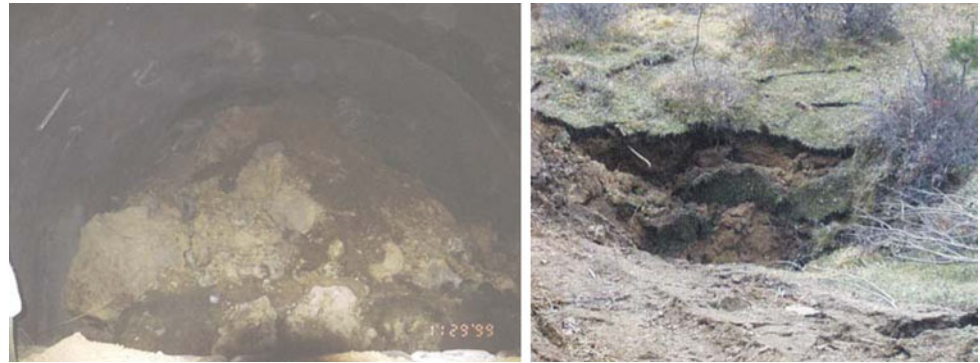
Fig. 17 Views of the collapsed section of Bolu tunnel and its surface depression

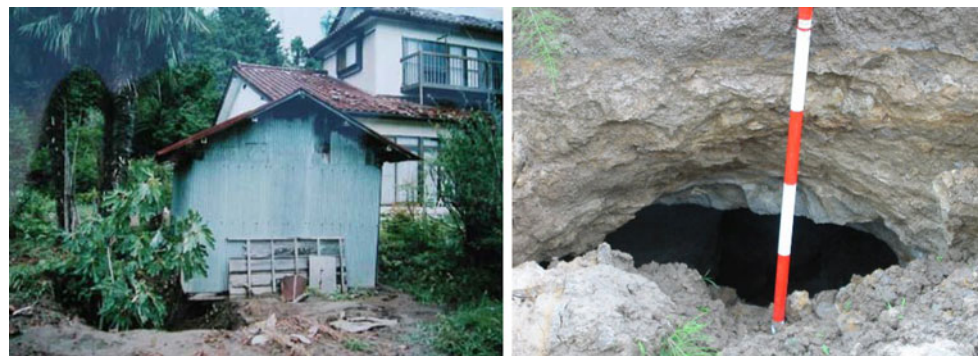
Fig. 18 Caving at Yamoto abandoned mine (from Aydan and Kawamoto 2004)

Many collapses were observed in the abandoned mine area of Yamoto town due to the 2003 Miyagi-Hokubu earthquake (Aydan and Kawamoto 2004). However, there is no available approach to consider the effect of earthquakes on the stability of abandoned room and pillar mines. Although appropriate consideration would require the solution of the equation of motion, Aydan et al. (2006) proposed a simple approach based on the seismic coefficient approach for the seismic design of structures in earthquake engineering (Fig. 10). When the pillar is in full contact with overburden layers, the stress on a pillar may be given as follows

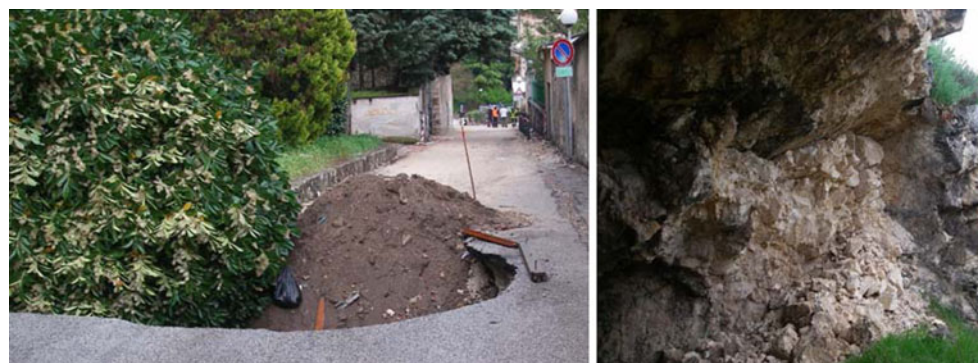
Fig. 19 Sinkholes in L'Aquila (from Aydan et al. 2009c)

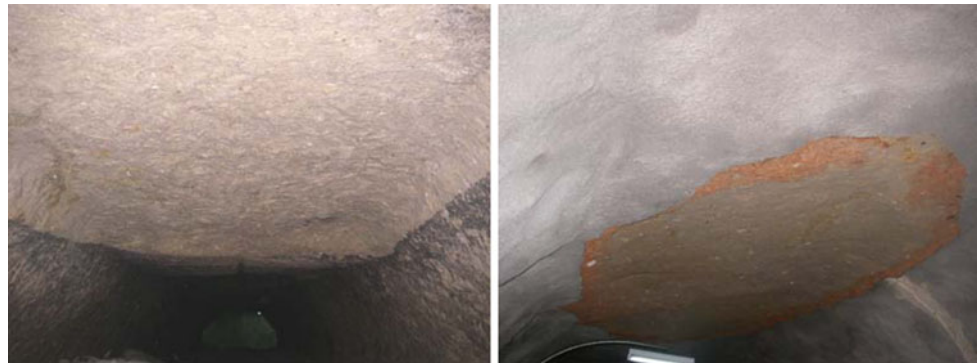
Fig. 20 Spalling from the roof in Bukittinggi underground shelter by the 2007 Singkarak earthquake

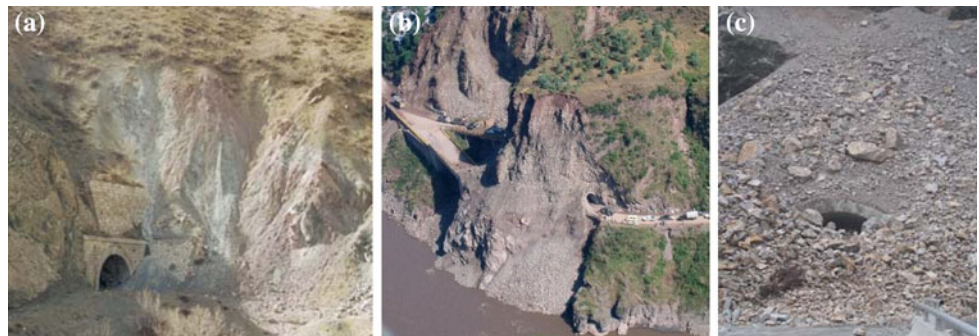
Fig. 21 Examples of damaged portals of tunnels. **a** 1992 Erzincan. **b** 2005 Kashmir. **c** 2008 Wenchuan

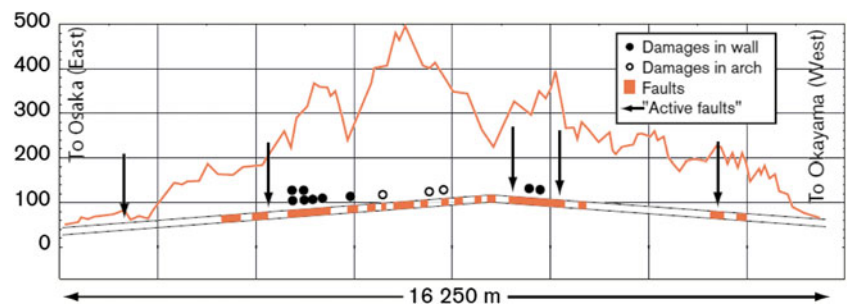
Fig. 22 Damage at the Rokko tunnel by the 1995 Kobe earthquake (from Asakura and Sato 1998)

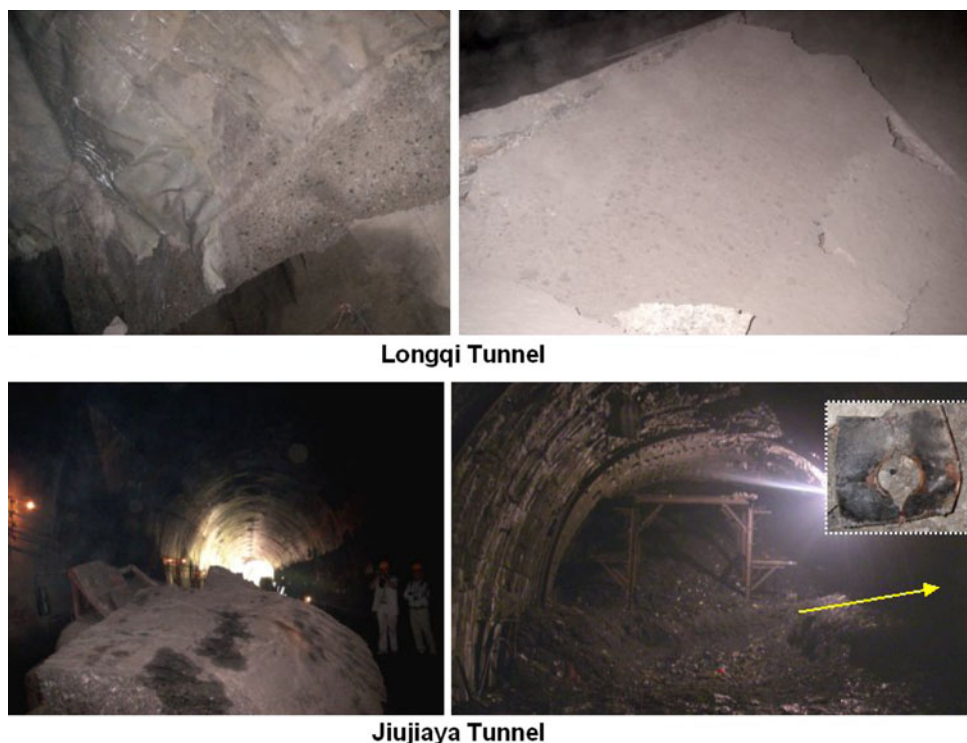
Fig. 23 Views of earthquake damage at Longqi (Longxi) and Jiujiaya tunnels

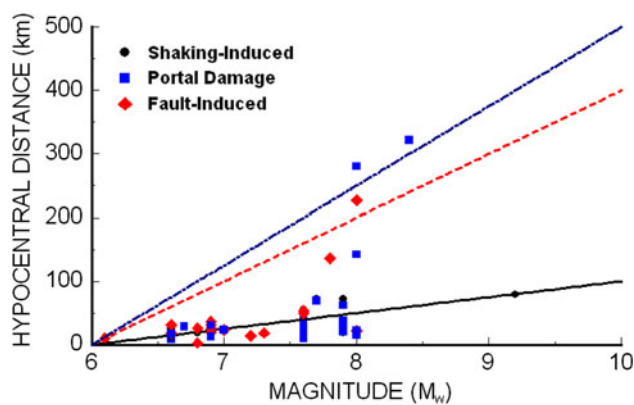
Fig. 24 Empirical relations between magnitude and limiting damage distance

hypocenter depth, relative slip), distances from epicenter and the earthquake fault surface trace (extrapolated surface trace when earthquake fault does not appear on the ground surface), geometry of tunnel, overburden, lining thickness, rock bolt density, rock unit and damage level index (DLI) defined in Table 2. Case histories are plotted in Fig. 24 with different symbols depending on the damage mode, the moment magnitude (M_w) of the earthquake and hypocentral distance (R) of the underground structure. As expected, the hypocentral distance of the damaged underground structures increases as the magnitude of the earthquake becomes larger. Furthermore, the limiting relations for fault-induced and ground shaking-induced damage on tunnels would be different. The available case history data also imply that there is no damage to underground openings by earthquakes when the magnitude is less than 6.

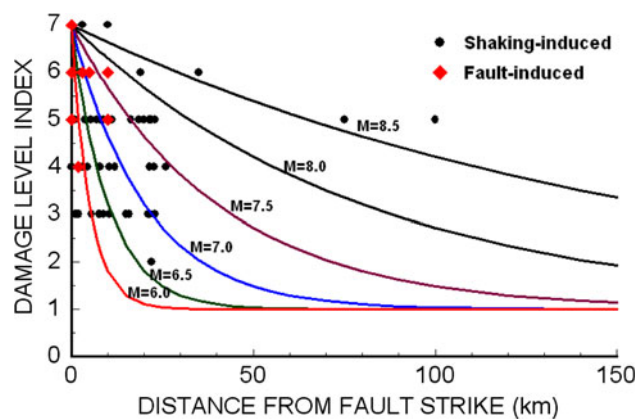
**Fig. 25** Relation between distance (R_f) from surface trace of the fault and damage level index (DLI)

Figure 25 shows the re-plotted data shown in Fig. 24 as a function of distance (R_f) from the surface trace or extrapolated surface trace of the earthquake fault. The vertical axis is the damage level index, the minimum and maximum values of which are 1 and 7, respectively. When the tunnel response is purely elastic, the damage level is assigned as 1. The functional form for the damage level index of underground openings subjected to earthquakes may be given in the following form:

It should be noted that the value of $Ae^{-V_s/B}$ must not be greater than 6 in view of the maximum value of the DLI. The authors plotted Eq. 10 in Fig. 25 for different magnitudes by assuming that $\theta = 90^\circ$ and fixing the value of $Ae^{-V_s/B}$ to 6 with $D = 0.5$ and $E = 2.5$. As noted from Fig. 25, the chosen function can closely estimate the observed damage level index of underground openings subjected to earthquakes. Nevertheless, the authors also feel the necessity of including a function related to the relative slip of the fault in Eq. 10.
