In Situ Observation of Rock Spalling in the Deep Tunnels of the China Jinping Underground Laboratory (2400 m Depth)

Abstract

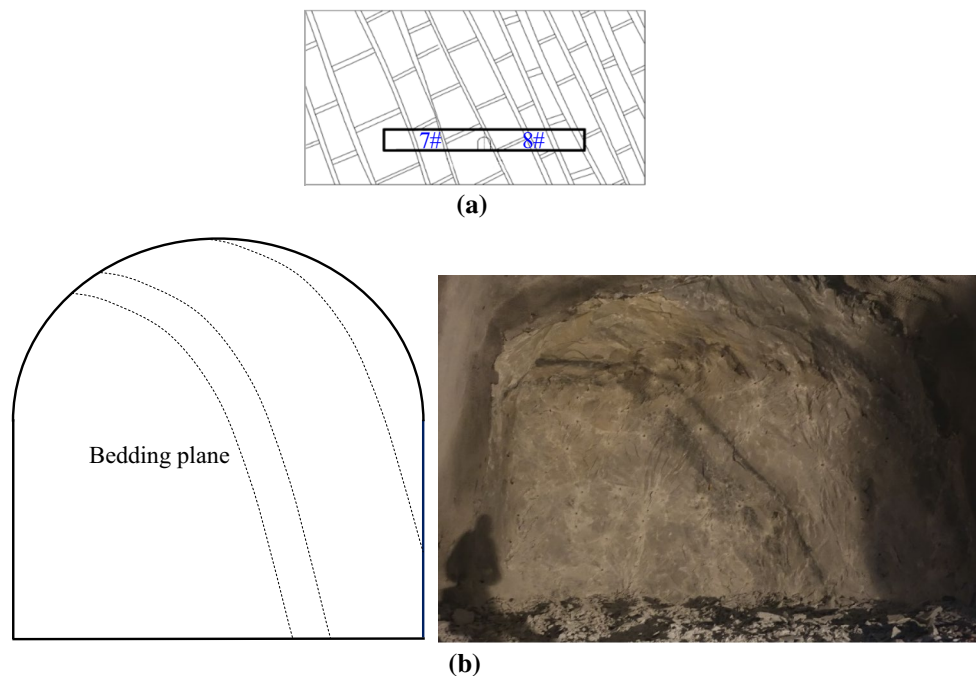
Fig. 2 Vertical geological cross section at China Jinping Underground Laboratory Phase II: **a** overall vertical geological cross section along the tunnel axis of 7# and 8# Labs and **b** longitudinal diagram: chainage $0 + 026$ of 7# Lab

white stripes. The dip angle of the bedding planes is 64° , and the dip direction of the bedding plane is $N94^\circ E$, which means the bedding plane intersects the tunnel axes with a big separative angle, as shown in Fig. 2. The main mineral composition of the rocks in different colours varies somewhat, consisting of dolomite and calcite, as shown in Table 1. A more detailed description of geological conditions can be found elsewhere (Feng et al. 2016).

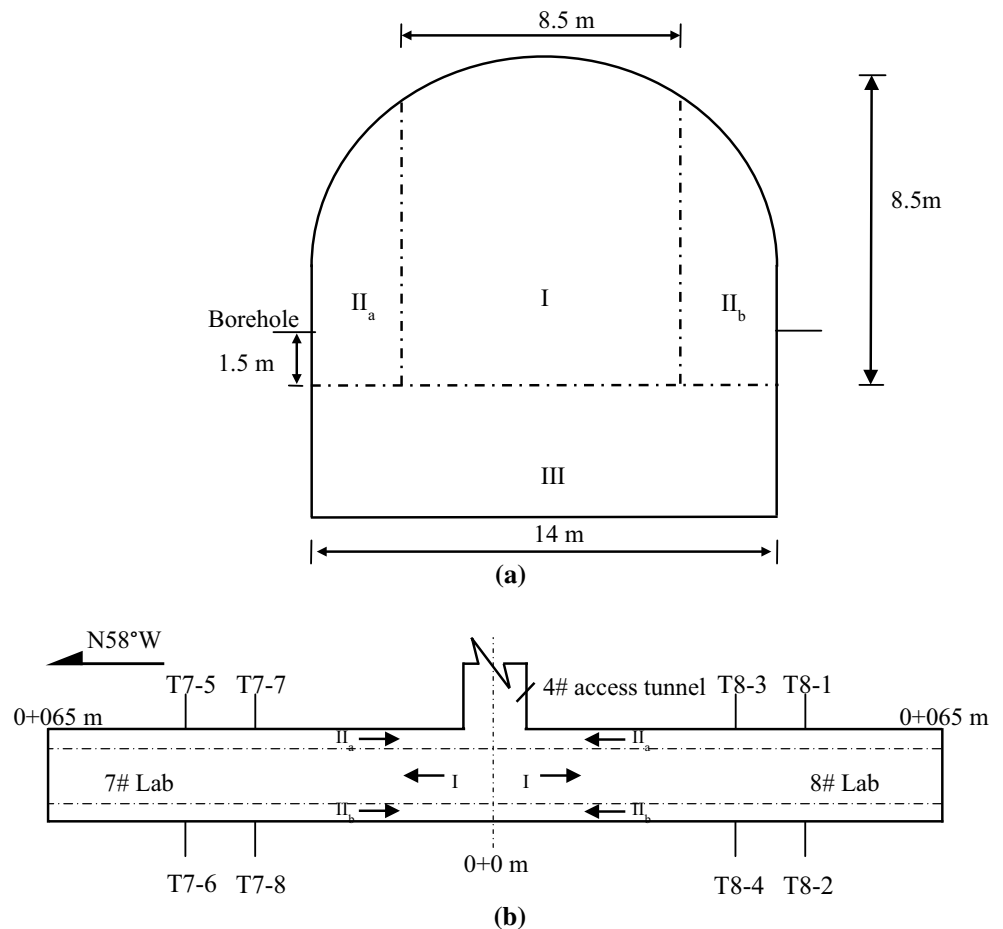
Fig. 3 Excavation sequence and borehole layout in the 7# and 8# Labs. **a** Cross section and excavation zones of 7# and 8# Labs. Step I: top-heading, step II: side wall in the upper layer, step III: middle groove and side wall in the bottom bench. **b** Plan view and excavation direction of each zone for 7# and 8# Labs. T7-5, T7-6, T7-7, T7-8, T8-1, T8-2, T8-3, T8-4 are boreholes used for digital borehole camera testing. The direction of excavation was described in (b); step I was excavated firstly from the centreline of the 4# access tunnel to the end of each laboratory; step II began from the end of each laboratory to the centreline of the 4# access tunnel; II_a was the slashing excavation of the north-eastern side, and II_b was the slashing excavation of the south-western side; step III went from the centreline of the 4# access tunnel to the end of each laboratory

To observe the spalling in the surrounding rocks, boreholes were drilled in both sidewalls of each laboratory at chainage $0 + 035$ and chainage $0 + 045$ when the excavation

Several boreholes were drilled on sidewalls of final tunnel (Fig. 3), to research rock spalling around the final sidewall tunnel. The digital borehole camera results indicated that rock slabs are almost parallel to the sidewall, some of them having small changes in orientation (Fig. 12). However, the number of slabs and depth of rock spalling varied with location (Table 3), and the thicknesses of the slabs generally increased from the tunnel surface to the interior of the rock mass (Fig. 13). It can be seen that depth of spalling is about 0.9, 0.8, 1.0, 0.9, and 0.5 m in boreholes T7-5, T7-6, T7-7, T8-1, and T8-3, respectively. Rock spalling in boreholes T7-6, T7-7, and T8-1 is the most developed. The spalling strike in the sidewall of tunnel occurred parallel to the tunnel axis. Moreover, the slabs are alternately thick and thin and gradually thickened towards the interior of the surrounding

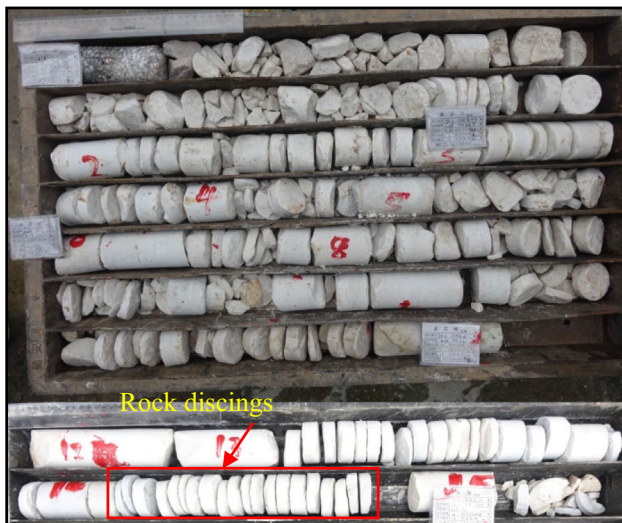
Fig. 4 Rock discing at borehole T8-2 in the south-western sidewall of 8# Lab, at chainage 0 + 045

of the pilot tunnel and slashing excavation were finished, respectively, to allow digital borehole camera measurement. The boreholes are located 1.5 m above the bottom of the pilot tunnel. Rock discing is illustrated in Fig. 4. Rock spalling at the working faces of the slashing excavation, II_a and II_b , can be seen (Fig. 5).

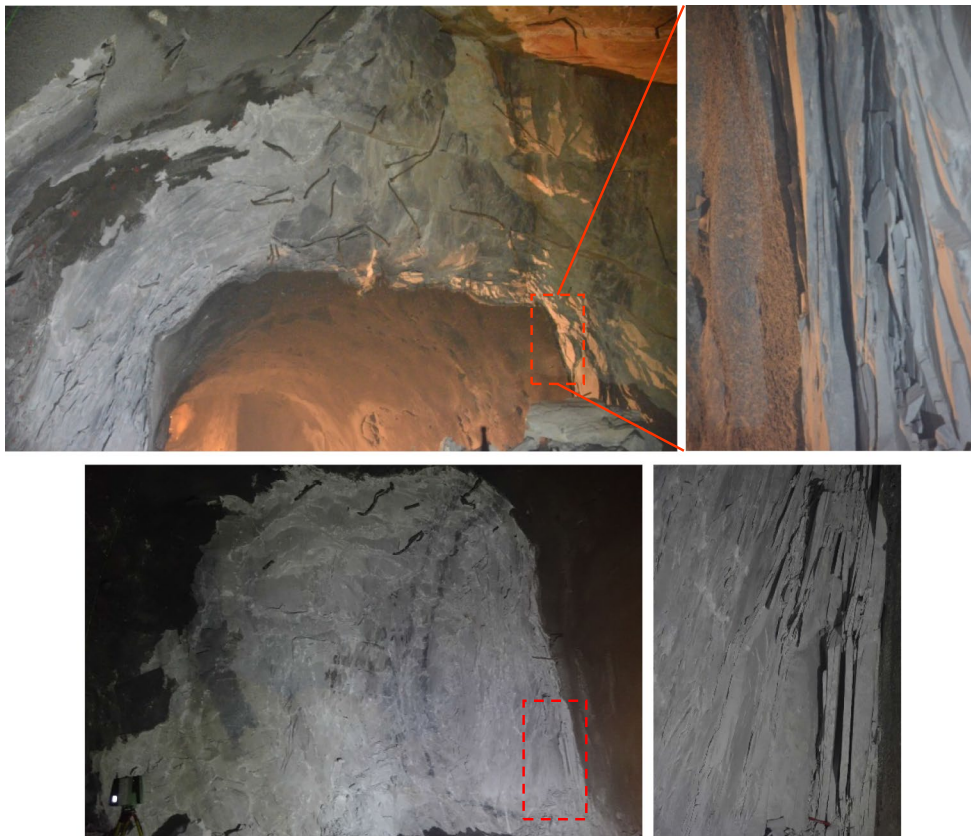
Fig. 5 Rock spalling occurred after slashing excavation of II_b and II_a at the 7# Lab

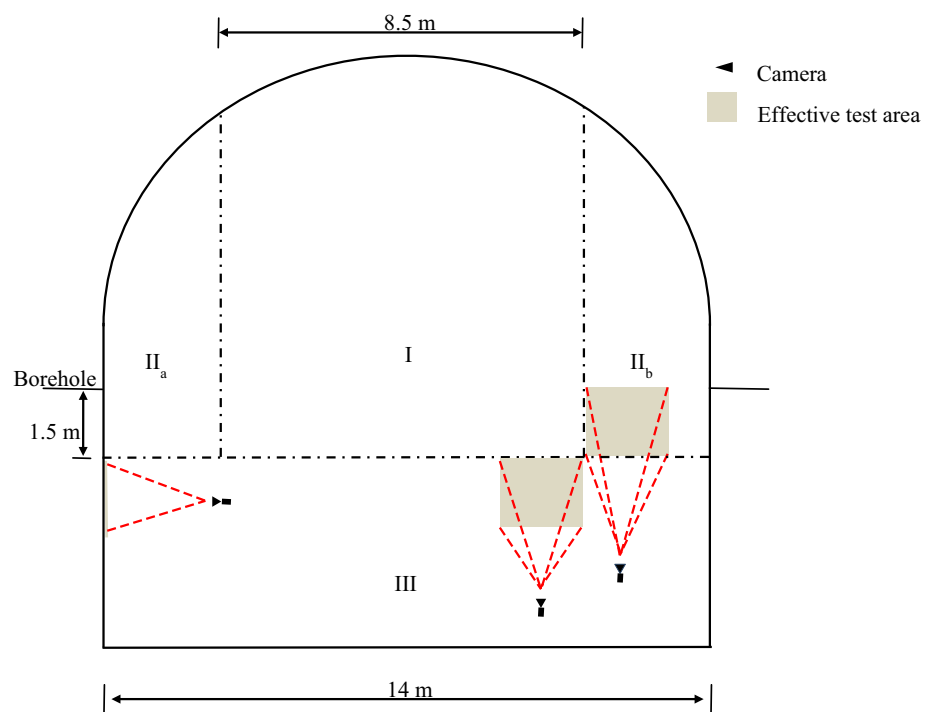
Fig. 6 Arrangement of photogrammetric survey points at 7# and 8# Labs

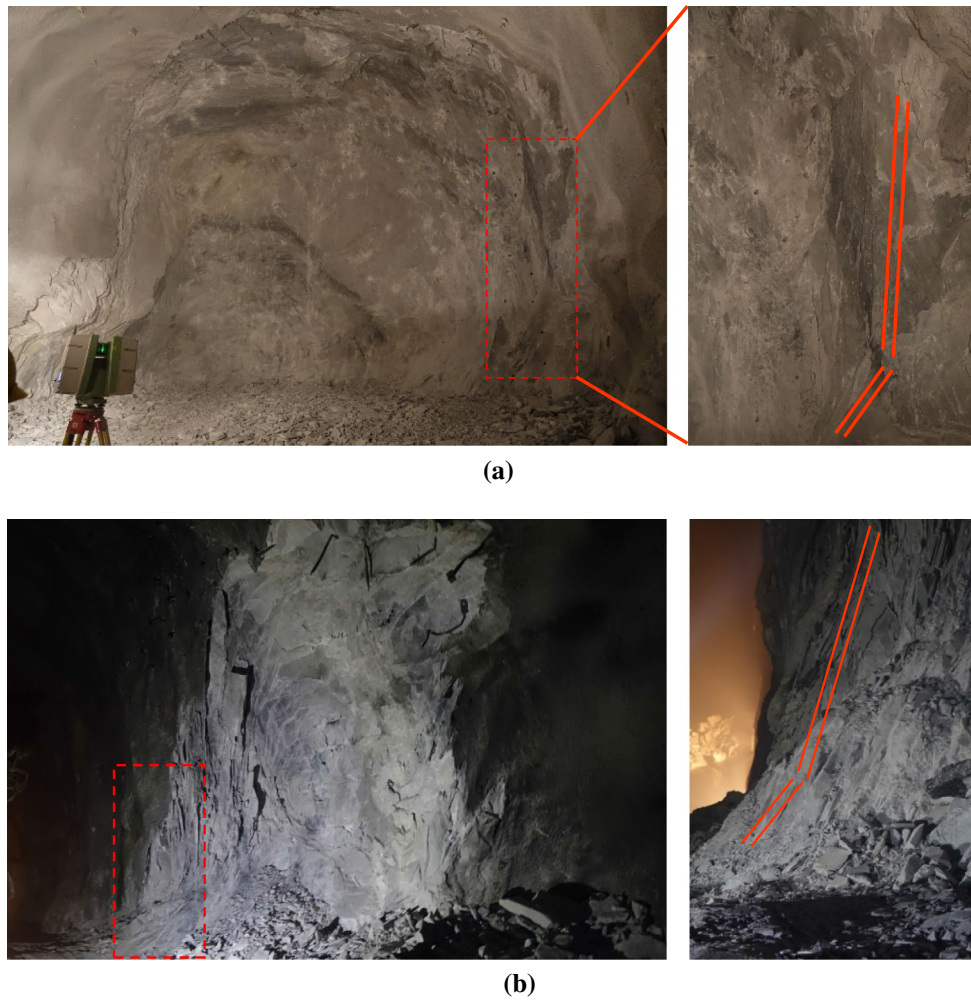
Fig. 8 **a** Rock spalling at north-eastern sidewall of the pilot tunnel of 7# Lab, at chainage 0 + 30. **b** Rock spalling of south-western sidewall of the pilot tunnel of 7# Lab at chainage 0 + 26 after excavation of the pilot tunnel

Figure 7 illustrates orientation of rock spalling observed at several typical working faces of intact rock mass zones. The results indicated that rock spalling mainly developed in the north-eastern sidewall of the pilot tunnel. By analysing the statistical distribution of slab surface orientations, it was concluded that: the inclinations of slabs approached 90°, and the surfaces of slabs intersected the sidewalls of the pilot tunnel at a shallow angle, lying approximately parallel to the sidewall of the pilot tunnel. However, the pattern of rock spalling at the floor corner of the pilot tunnel, where slab surfaces were turned to about 45°, is shown in Fig. 8.

By integrating Figs. 8, 12, and 17, the overall pattern of rock spalling observed after excavation of the pilot tunnel, slashing, and the bottom bench is shown in Fig. 18: it matched the principal stress direction predicted by numerical simulation (FLAC^{3D}) after the top-heading excavation based on in situ geo-stress test results (Fig. 18b).

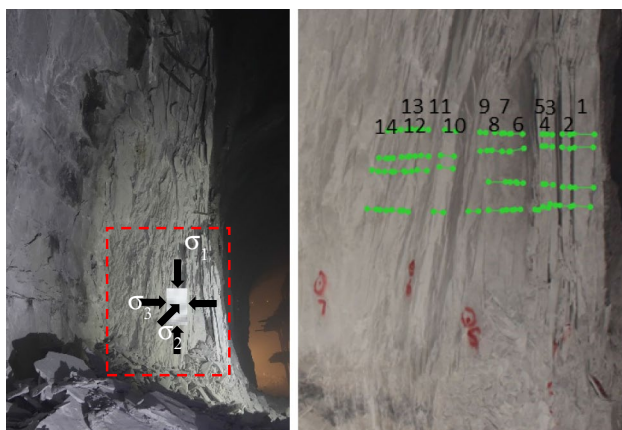
Fig. 9 Measurement of rock spalling at a typical working face of the slashing excavation

Slab thickness was directly measured from the reconstructed 3-d model. Rock spalling of sidewalls of the pilot tunnel after slashing excavation is shown in Fig. 9, and the slabs of different thicknesses were measured from the

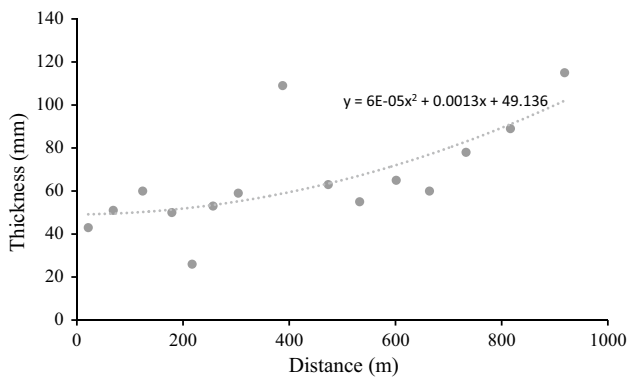
Fig. 10 Thickness distribution of slabs at 7# Lab observed after the slashing excavation

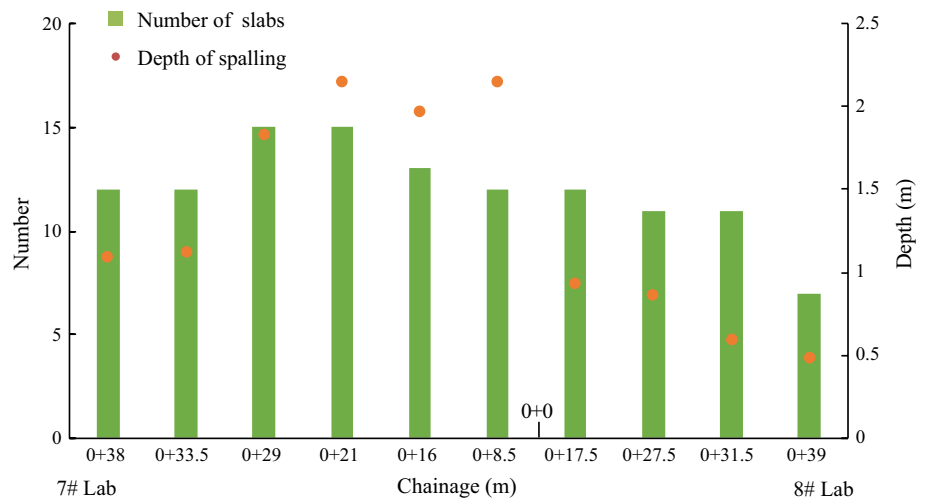
Fig. 11 Number of slabs and depth of rock spalling at typical north-eastern sidewall section of the pilot tunnels at 7# and 8# Labs along the direction of the tunnel axis

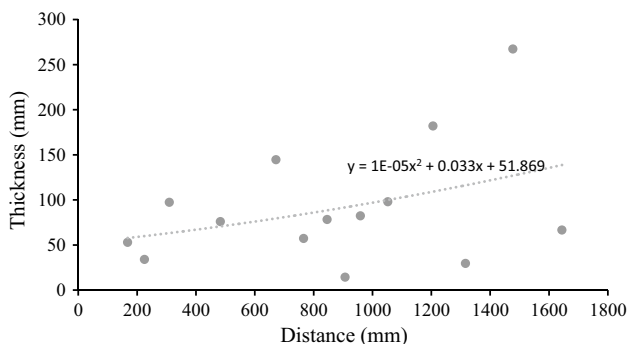
Fig. 13 Thickness of rock slabs at T8-1 borehole as seen by digital borehole camera. The distance indicates location from sidewall to inside rock mass at T8-1 borehole

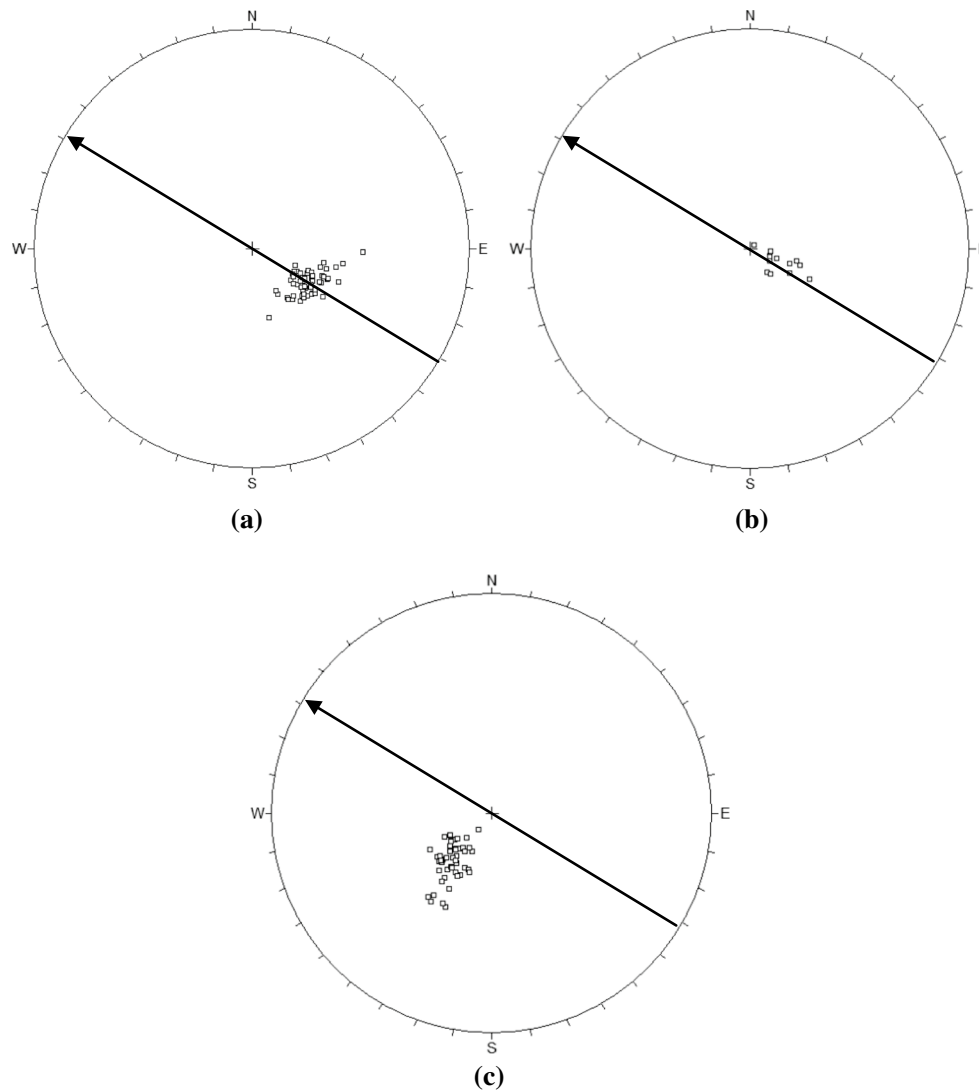
Fig. 14 Orientation of slab surfaces after excavation of the bottom bench at **a** the working face (chainage 0 + 037) near the north-eastern floor corner of the pilot tunnel, 8# Lab, **b** the working face (chainage

0 + 31) of the bottom bench, 8# Lab, and **c** the working face (chainage 0 + 32.5) near the south-western floor corner of the pilot tunnel, 7# Lab

The orientations of slab surfaces at the working face at corner of the pilot tunnel and bottom bench and the working face of bottom bench are illustrated in Fig. 14. The inclination of spalling in the interior of the surrounding rocks at the floor corner of the pilot tunnel, exposed after the excavation of the bottom bench, was small. The pole diagrams in Fig. 14b show that the slab surfaces at the working face of the bottom bench excavation were almost horizontal. Generally, the orientation of slab surfaces exposed after slashing excavation of the sidewalls presented the same trend with that at the floor corner of the pilot tunnel exposed after the excavation of the bottom bench, and the dip angle of such slabs significantly decreased in the floor corner of the pilot tunnel. This indicated that the spalling orientation was related to the disposition of the tunnels.

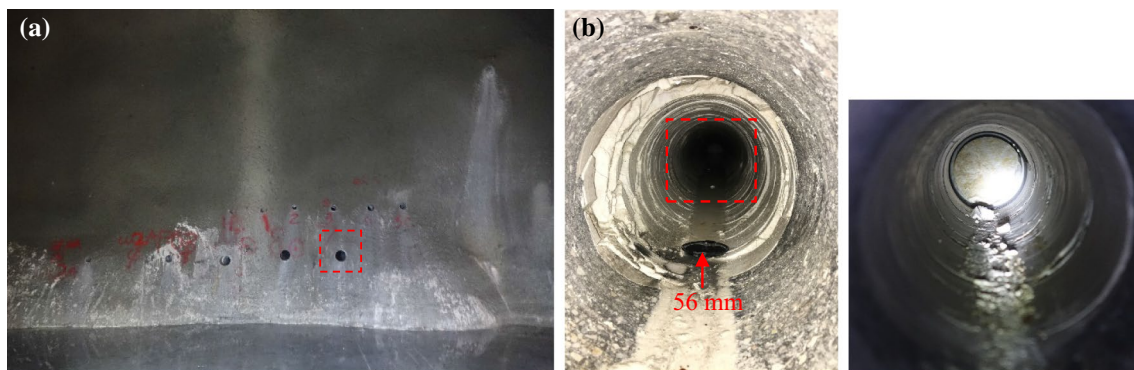
Fig. 16 **a** Boreholes and **b** nearly parallel cracks in the boreholes at the working face of the bottom bench of 7# Lab at chainage 0 + 65

The photograph taken from the borehole at the end of the bottom bench of the 7# Lab. indicated that there are several parallel cracks that propagated as a result of rock spalling from the sidewall (Fig. 16). The pattern of rock spalling at the sidewall of the pilot tunnel, in which the slabs at the middle are nearly parallel to the floor of the pilot tunnel, and pattern of rock spalling near the floor corner of the pilot tunnel, in which slab surfaces are turned to about 45°, are shown in Fig. 17, respectively.

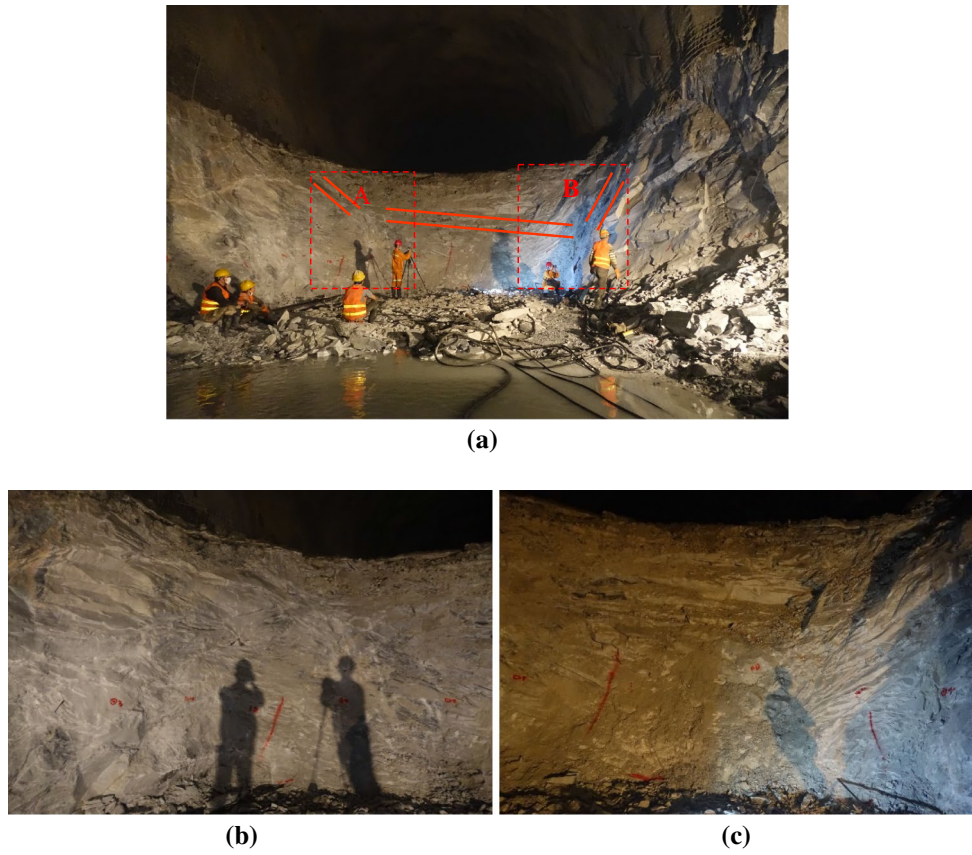
Fig. 17 **a** Rock spalling at working face of bench of 7# Lab at chainage 0 + 38. **b** Enlarged image of A in (a), **c** Enlarged image of B in (a)

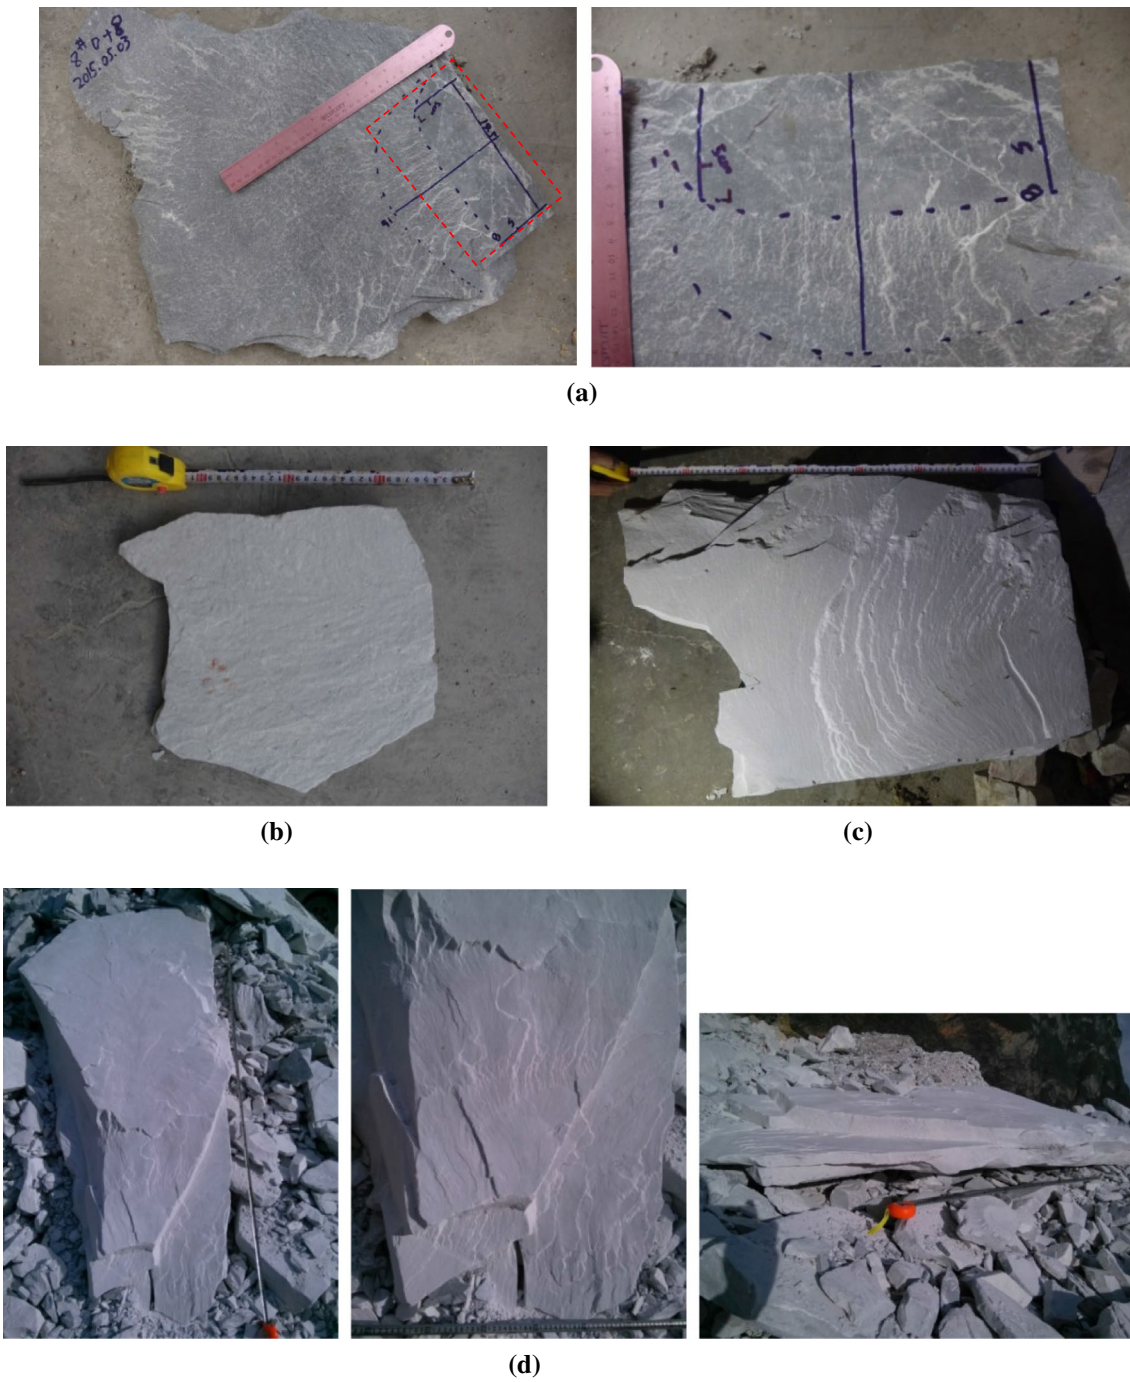
Fig. 19 Different types of fracture surfaces of slabs in intact marbles at 7# Lab and 8# Lab: **a** shell-shaped or feather-shaped concentric fracture surfaces, **b** flat fracture surfaces of a slab in two sides, **c** ripple-shaped fracture surface, and **d** combined-shape fracture surfaces

The shapes of fracture surfaces of slabs reflect the micro-crack characteristics (Pollard and Aydin 1988). The shapes of fracture surfaces observed in both tunnels are classified into four types, as shown in Fig. 19:

Type I Shell-shaped or feather-shaped concentric fracture surfaces (Fig. 19a). They have a flat centre and rib pattern distributed around the centre, forming an arcuate boundary line at the end of the rib patterns. The concentric feather pattern forms far away, even on the boundary of the slabs, in the rib patterns. The slabs are conchoidal on the whole.

Type II Flat shape (Fig. 19b). Slabs are straight and flat with linear patterns oriented in a certain direction.

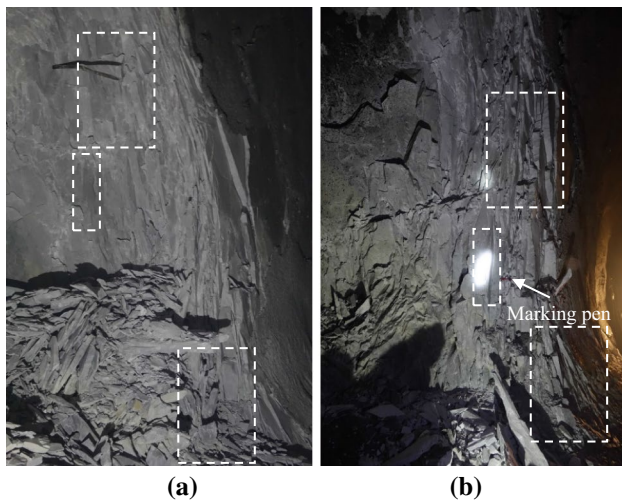
Fig. 20 Rock spalling at working face of the slashing excavation II_a (north-eastern sidewall of the pilot tunnel) of 7# Lab at chainage 0 + 33.5 observed **a** on the excavation day and **b** on the second day after excavation

Comparing rock spalling observed on the day of excavation with that of the second day, cracks were open and the orientation of the rock slabs changed thereafter (Figs. 20, 21, for example). The results indicated that time-dependent

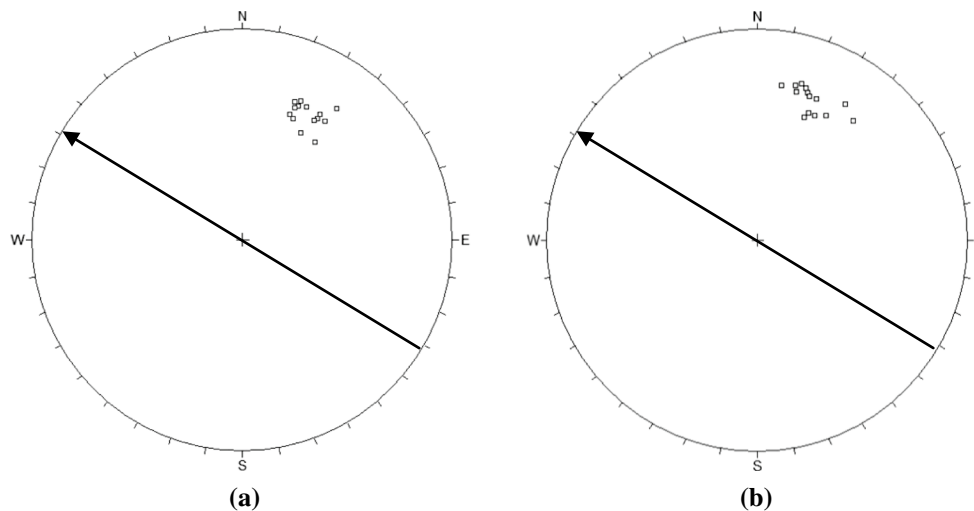
Fig. 21 Orientation of slabs at working face of slashing excavation (north-eastern sidewall of the pilot tunnel) of 8# Lab at chainage 0 + 14 observed **a** on the excavation day and **b** on the second day after excavation (obviously open and larger different angles of rock slabs)

3. The slabs were alternately thick and thin, and they gradually increased in thickness from the sidewall inwards.
4. Spalling in 7# and 8# Labs showed time-dependent behaviour under high stress. The longer the exposure time, the deeper the spalling (Fig. 11), and after excavation, the spalling still caused opening and extension of slabs to form new fractures (Fig. 21).

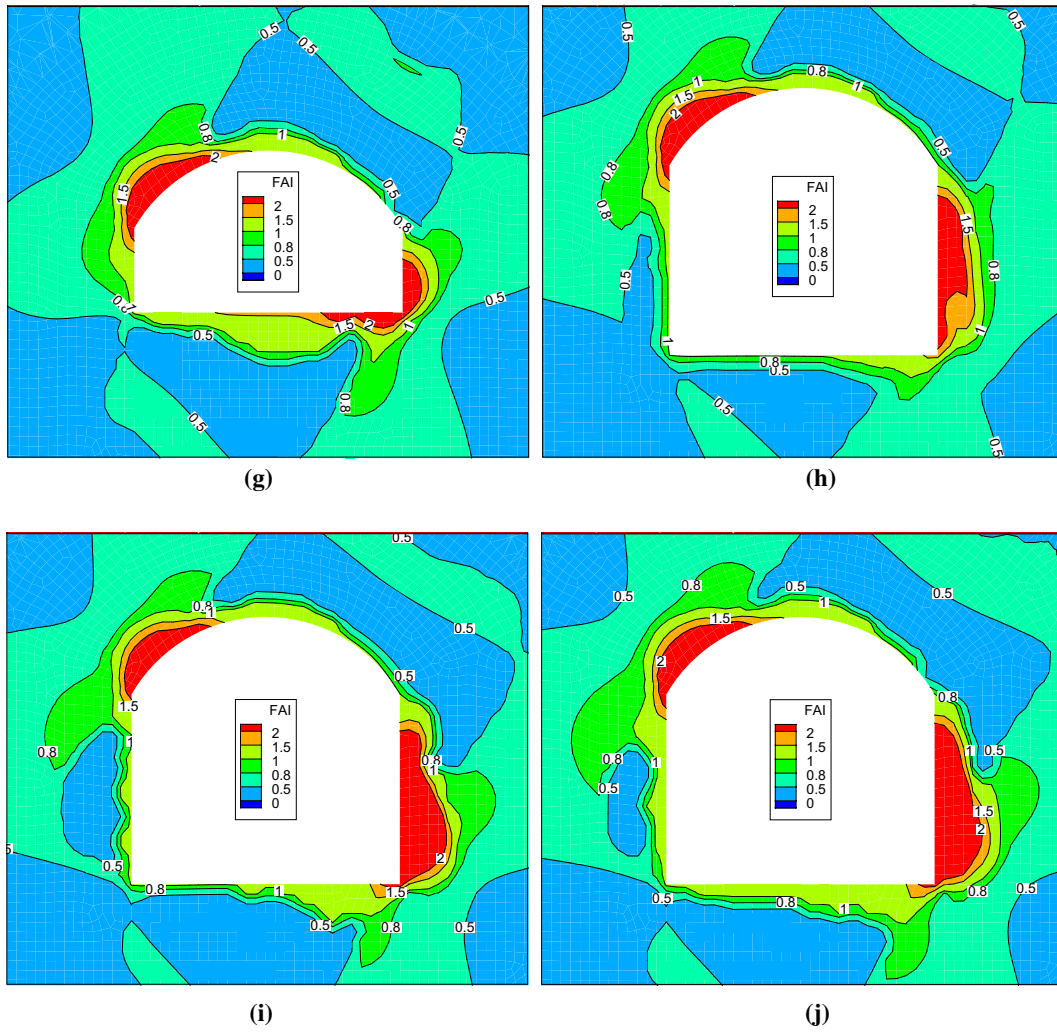
Fig. 23 Distribution of FAI in the surround rock of 7# Lab (The cross section at chainage 0 + 35 comprised the observation section) with **a** excavation working face of the pilot tunnel at chainage 0 + 036, **b** excavation working face of the pilot tunnel at chainage 0 + 040, **c** excavation working face of the pilot tunnel at chainage 0 + 045, **d** top-heading finished, **e** slashing excavation working face of the pilot

tunnel at chainage 0 + 034, **f** slashing excavation working face of the pilot tunnel at chainage 0 + 030, **g** slashing excavation finished, **h** excavation working face of the bottom bench at chainage 0 + 036, **i** excavation working face of the bottom bench at chainage 0 + 040, and **j** complete excavation of the bottom bench

According to the evolution process of calculated FAI during excavation of the pilot tunnel shown in Fig. 23a–d, the range and depth of rock spalling increased significantly at first and then slowed down with the working face going away from the observation section, as shown in Fig. 23a–c where the distances between working face and observation section are 1, 5, and 10 m, respectively. When the working face was more than 10 m away, spalling almost stopped, compared to the range and depth of spalling after the pilot tunnel excavation was completed (Fig. 23d). Therefore, in a certain range, the closer to the 4# access tunnel, that means the farther the distance from working face which stood at the end of the labs after excavation of pilot tunnel, the deeper the spalling developed. And then spalling depth remains constant if the distance was large enough. This is consistent with the observed results shown in Fig. 11. The same process can also be obtained during the slashing excavation, as seen in Fig. 23e–g, except that the sensitive distance from working face was 5 m which was less than that during excavation of the pilot tunnel. Similar characteristics could be found in bench excavation as shown in Fig. 23h–j, and the sensitive distance from working face of bench excavation was 5 m. Comparing Fig. 23d with Fig. 23g, the depth of spalling after the pilot tunnel excavation was deeper than that after the sidewall slashing excavation. This is mainly because cross section of the pilot tunnel (8.5 m in width) was larger than that of the sidewall slashing excavation (2.75 m in width) and was subjected to more significant unloading and consequently deeper spalling. That was why the depth of rock spalling after the pilot tunnel excavation

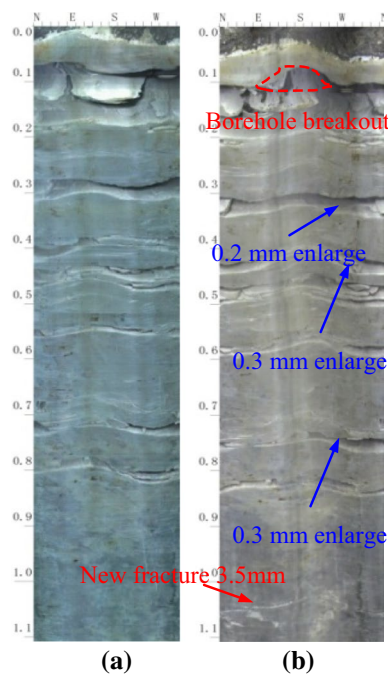
Fig. 24 Digital borehole camera images **a** after slashing excavation and **b** after the bottom bench excavation of T7-6

(photogrammetric result, Fig. 4) was deeper than that after the slashing excavation (borehole camera result, Fig. 24a).

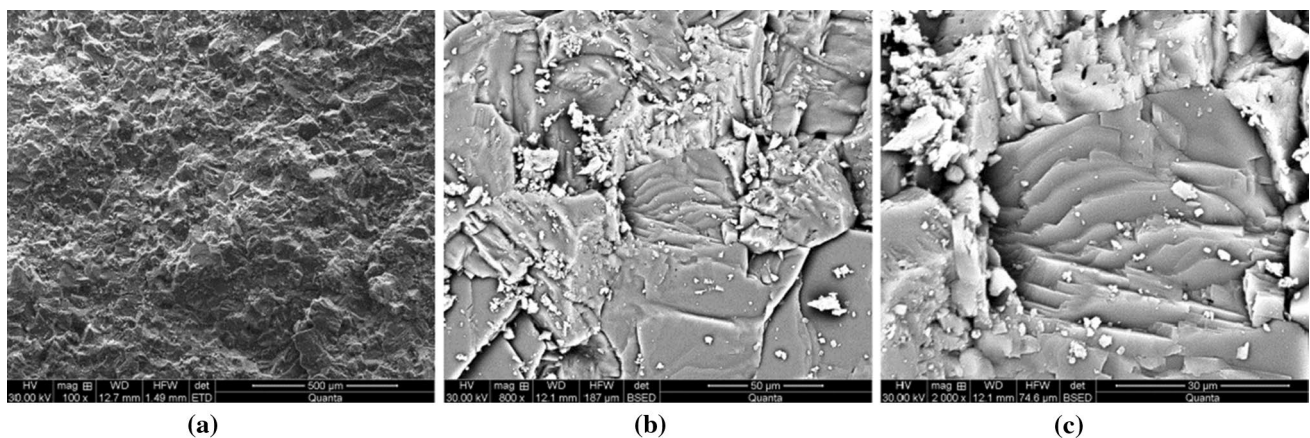
Fig. 25 Micrographs of slabs at the north-eastern sidewall tunnel surface of the pilot tunnel of 7# Lab at chainage 0 + 024. **a** Magnification ×100, **b** magnification ×800, **c** magnification ×2000

Slabs produced by in situ spalling were sampled, and SEM investigation was carried out. Typical micro-fracture images of slabs were acquired. Figure 25 shows the micrographs of slabs at the tunnel surface, Fig. 26 shows micrographs of the inner slabs of surrounding rock, and Fig. 27 shows micrographs of

seen in Fig. 25 and more intergranular failures seen in Fig. 26. The shear damage might have been caused by principal stress rotation (Eberhardt 2001), and we could see some parallel scratches in those slabs at the floor corner of the pilot tunnel (Fig. 27).

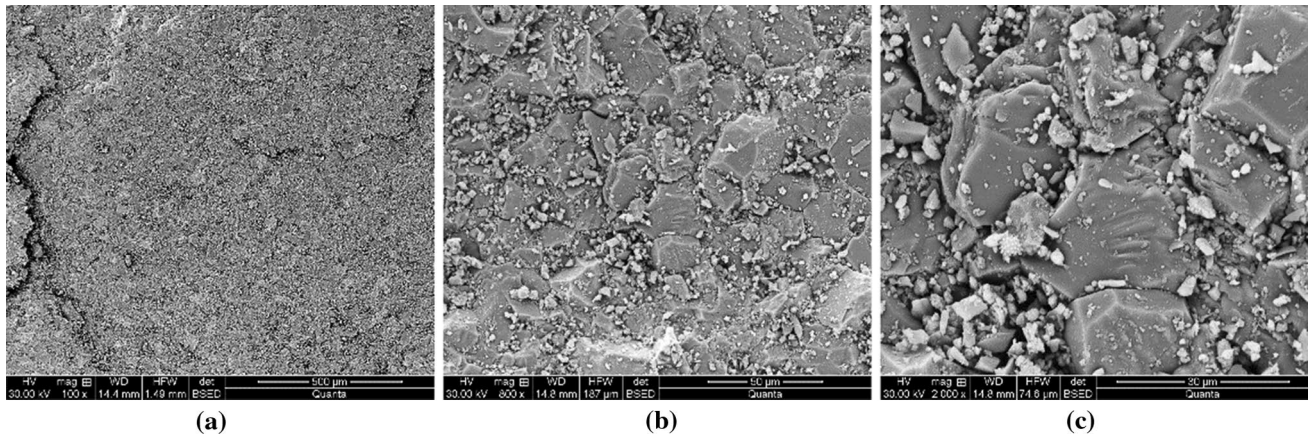
Fig. 26 Micrographs of slabs at the north-eastern sidewall inner of surrounding rock of the pilot tunnel of 7# Lab at chainage 0 + 024. **a** Magnification $\times 100$, **b** magnification $\times 800$, **c** magnification $\times 2000$

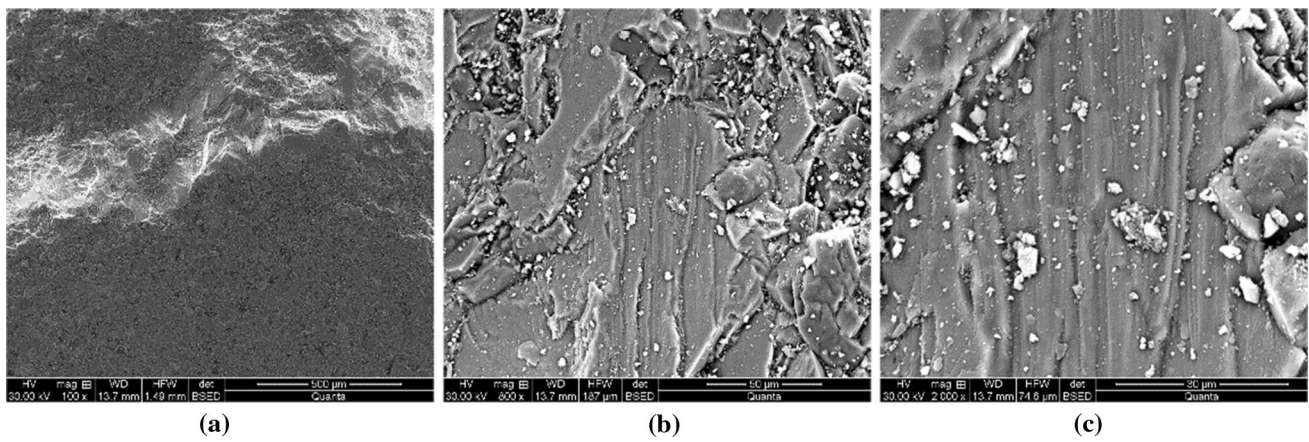
Fig. 27 Micrographs of slabs at the north-eastern floor corner of the pilot tunnel of 7# Lab at chainage 0 + 024. **a** Magnification $\times 100$, **b** magnification $\times 800$, **c** magnification $\times 2000$

5. Spalling was dominated by tension, with shear failures arising in local areas. The spalling mechanism can mainly be explained by intergranular fractures, with a mixture of intergranular and transgranular fractures present. There were more transgranular fractures at tunnel surfaces undergoing brittle failure (Fig. 25) and more intergranular fractures at the inner surrounding rock (Fig. 26) upon ductile failure: shear failure may have occurred at the floor corner (Fig. 27).

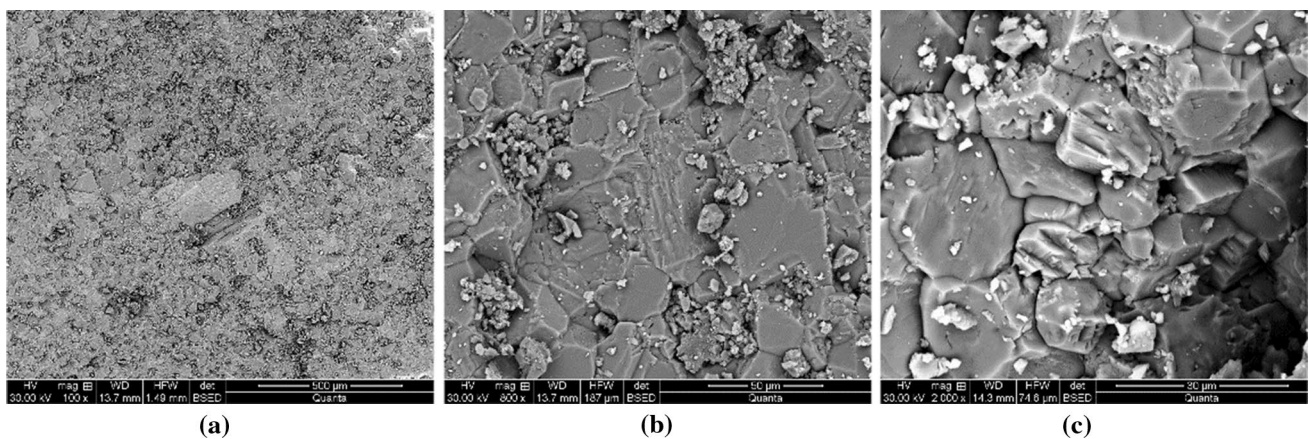
Fig. 28 Micrographs of marble samples without spalling. **a** Magnification $\times 100$, **b** magnification $\times 800$, **c** magnification $\times 2000$

slabs at the floor corner of the pilot tunnel. Figure 28 shows the SEM result for a rock sample without spalling but from the same place. By observing the three images of slabs magnified 100 times, the grain contours could be seen clearly. The overall fracture of slabs was generally found to take the form of intergranular fractures. By combining the images magnified 800 and 2000 times, it was found that the fracture of the specimens exhibited fluctuations in step-wise forms. It was obvious that intergranular and transgranular fractures increased in slabs compared with unstressed samples. The intergranular fractures were the dominant form of slabs, accompanied by a mixture
