The anatomy of non-carious cervical lesions

C. Walter · E. Kress · H. Götz · K. Taylor ·
I. Willershausen · A. Zampelis

Received: 24 September 2012 / Accepted: 28 February 2013 / Published online: 15 March 2013
© Springer-Verlag Berlin Heidelberg 2013

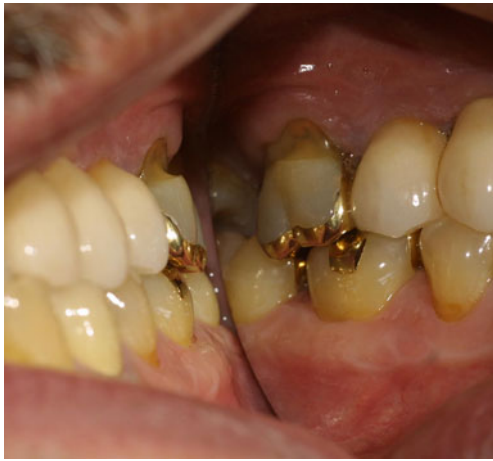
Fig. 1 Non-carious cervical lesion at a molar at the cementum–enamel junction

The term “non-carious cervical lesion” (NCCL) describes the loss of hard dental tissue at the cemento-enamel junction (CEJ) without caries decay (Fig. 1). According to Eccles, the dental hard tissue loss is separated into three classes [1] (Table 1).

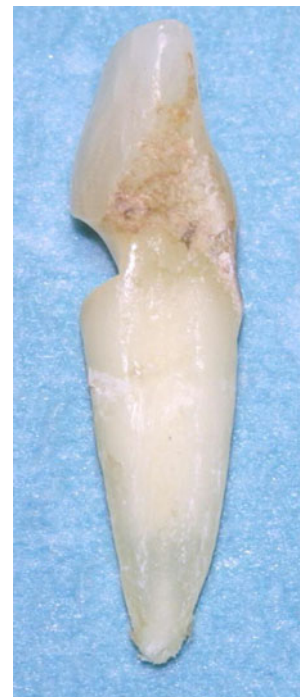
Fig. 2 Wedge-shaped lesion with a concave coronal-shaped surface and an apical convex-shaped surface of the defect

Two very distinct shapes of NCCL can be observed: a wedge-shaped (Fig. 2) and a saucer-shaped lesion (Fig. 3). Next to those, mixed shaped lesions can be observed. It can be speculated that different mechanisms or their combinations may form the basis of the different shaped lesions.

The apical and the coronal surfaces of the wedge-shaped lesion can have several forms: convex, concave and straight (Fig. 2). The five detected combinations are summarised in Table 3.
