E. A. Meshida

Highway failure over talc–tremolite schist terrain: a case study of the Ife to Ilesha highway, South Western Nigeria

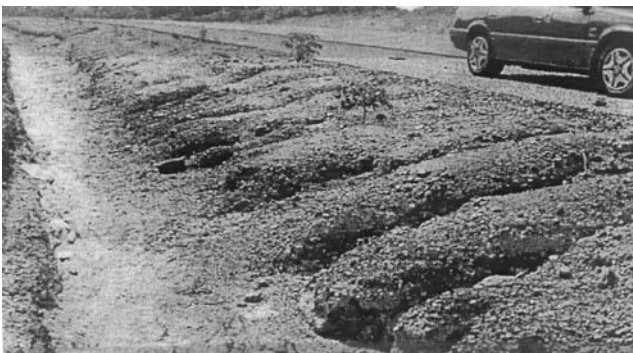
Fig. 2 Erosional rills created in the poorly compacted verge area along the highway

In Nigeria, the term 'laterite' is often used to imply an excellent soil material which will give rise to few construction problems. As a consequence of this, the recently completed dual highway between Ife and Ilesha (Fig. 1) failed within days of being opened to traffic. Many stretches of the highway have been rendered unstable by massive down-warping of the entire pavement and potholes of 1–2 m across frequently occur (Fig. 2). Also common is the separation of the asphalt finish from the base course

(Fig. 3) and verges are constantly being eroded by rainfall (Fig. 4).

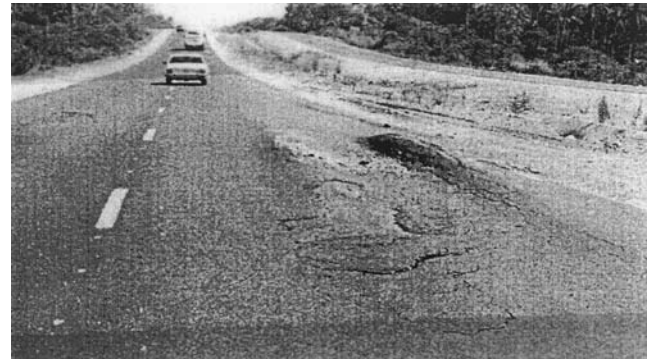
Fig. 3 Typical failure of asphalt finish by localized subsidence and distortion

The compacted fills crumbled and subsided en-masse such that in many cases filling and compaction had to be repeated along the failed stretches. Where the asphalt layers had already been placed, it was necessary to re-excavate these and undertake remedial compaction before re-surfacing.

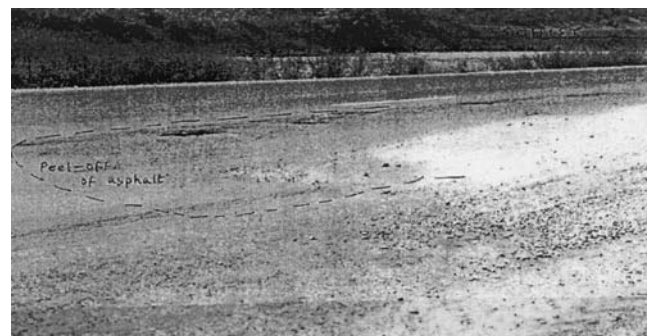
Fig. 4 Typical separation/peel-off of asphalt finish

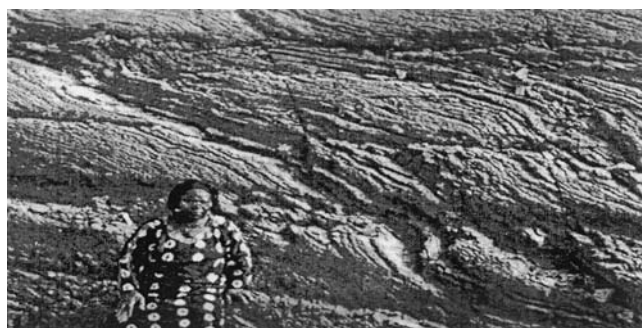
Fig. 6 Schistose structure along cuts typical of the deposits seen in the road cuttings

The study area is part of the schist belt of Western Nigeria (Fig. 5) and comprises mainly schist and amphibolite. Some NE–SW ridges occur where quartzites are present trending approximately NE/SW while a more gentle topography is found on the schists and amphibolites. Prominent schistosity is present over the 28 km of the new road at sub-grade level; Fig. 6 shows an example of schists exposed in one of the road cuttings.
