# Resolving serious seepage through karstified limestone at the Mujib Dam, Jordan

**Abstract** The 67 m high Mujib Dam (Jordan) was built between 1999 and 2003 in Cretaceous limestone with intercalated marls in the middle of the section. Initial investigations indicated only moderate permeability, hence prior to impoundment a normal grouting program was undertaken extending to 50 m in depth. Initially, little seepage was observed when the lower section of the reservoir was filled. After a dry summer, heavy rainfall filled the reservoir overnight to its maximum water level (194 m a.s.l.). A sudden seepage began downstream of the right abutment, which reached 140 l/s by morning, increasing to up to 240 l/s during the following 2 weeks. Although a second grouting program reduced the seepage to some 3 l/s of highly mineralized water, there were concerns as to the adequacy of the Phase 1 grouting. A detailed analysis of the testing and grouting results indicated that the hydraulic pressures created by the sudden increase of water in the reservoir had washed out the natural infill which had previously sealed karstic voids.

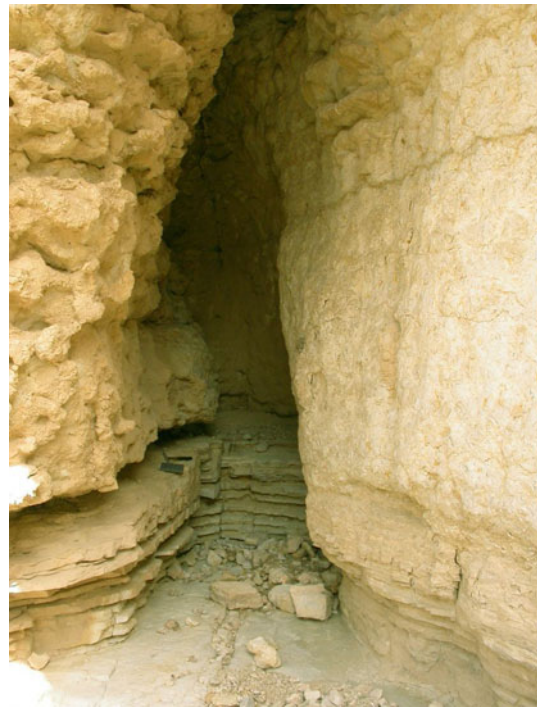
**Fig. 2** Karst cave, developed on a fissure on the right slope, above maximum storage level. Note difference in karstification on each side, within the same rock

Table 1 shows the various stages of grouting. It can be seen that despite the reduced spacing of the holes, some high takes still occurred in the later series, probably due to features such as that seen in Fig. 2.

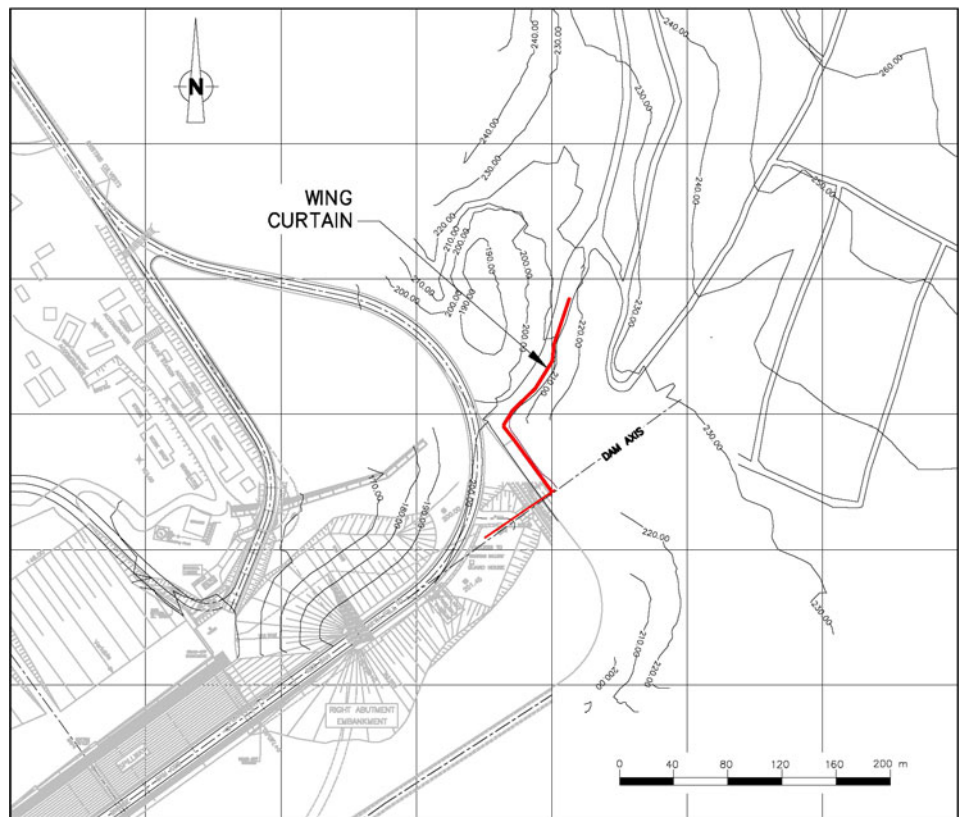
**Fig. 3** Layout—right part of dam and abutment. Cut-off-wing course is indicated red

In an early phase of the project, the rock of the dam foundation appeared to be effectively impervious. However, as limestone is always prone to karstification, a grout curtain was installed (Fig. 3), extending to a maximum depth of 50 m. The permeability tests yielded low Lugeon values and the grout takes were small except at the left abutment. Substantial karstification was not recognized.

This part of the curtain was drilled and grouted in an open air section until the fan of Phase 1, then in a somewhat odd configuration along the cut slope in the D/S direction and further in a right bend uphill (see Fig. 3). This configuration was necessary in view of the topography. A straight extension would have required the excavation of a gallery,

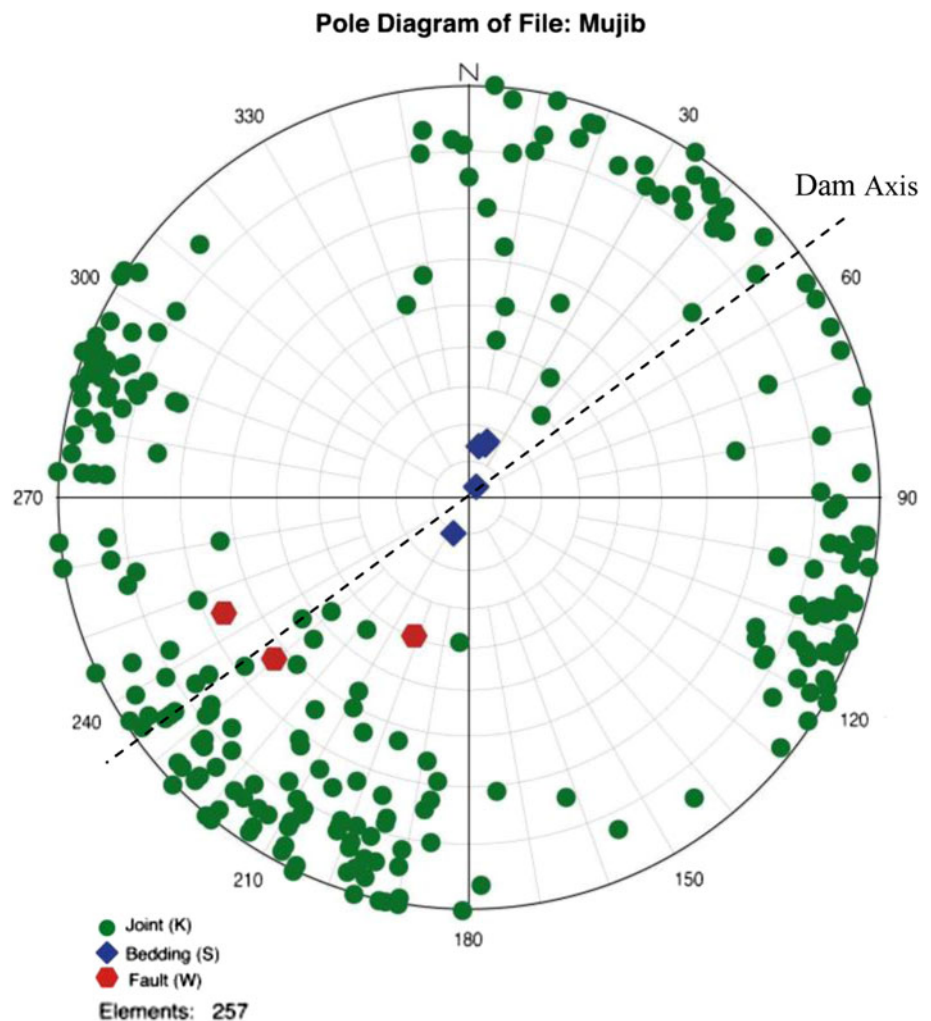
**Fig. 4** Density of joints at Mujib damsite. *Bold line* indicates dam axis

Curtain grouting was undertaken through inclined boreholes, as mapping revealed a predominance of near vertical joints (Fig. 4). Holes were drilled from the

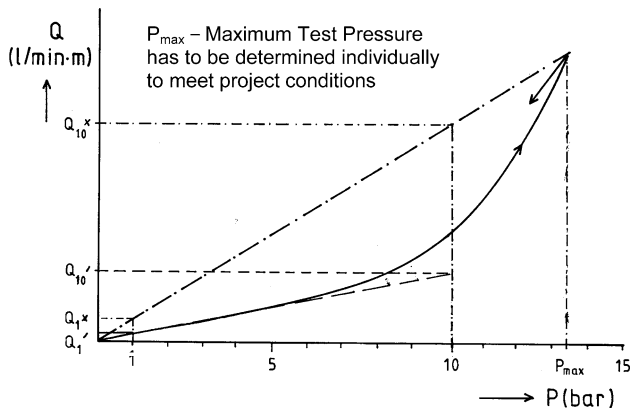
**Fig. 5** Definition of WPT parameters  $Q_{10}'$  (original permeability) and  $Q_{10}^*$  (artificial permeability)

Water Pressure Tests (WPT) were carried out in the P, T, Q and CH holes, but not in the S holes. In general, before reaching the reference pressure of the Lugeon criterion of 10 bar, open joints may be dilated or latent planes may be hydrofractured; it is not known whether the Lugeon value reflects the original permeability or is affected by such dilation or fracturing. In order to distinguish between the original and the possibly enlarged permeability, the WPT results are given as  $Q_{10}'$  and  $Q_{10}^*$  values (Fig. 5), where  $Q_{10}'$  gives the original permeability and  $Q_{10}^*$  takes into account dilation or erosion of infillings or hydrofracturing (Ewert 1996b). The statistical evaluation of the results shown in Figs. 6 and 7 indicates:

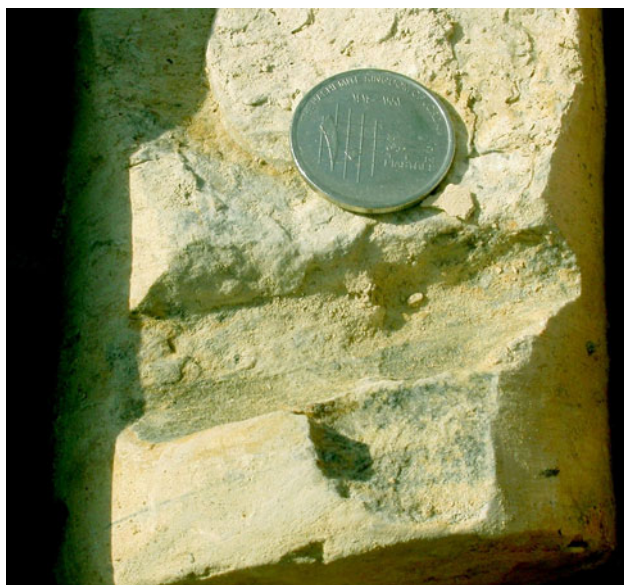
**Fig. 10** Linear karst channel in NX core, Wing Section, right abutment

This section encountered voids which had either originally been open or had been cleared of debris during the sudden filling of the reservoir. Figure 10 shows a linear karst channel. Such a feature can only be grouted when directly intercepted. Both wing sections had typical grout takes, as shown in Figs. 11, 12:

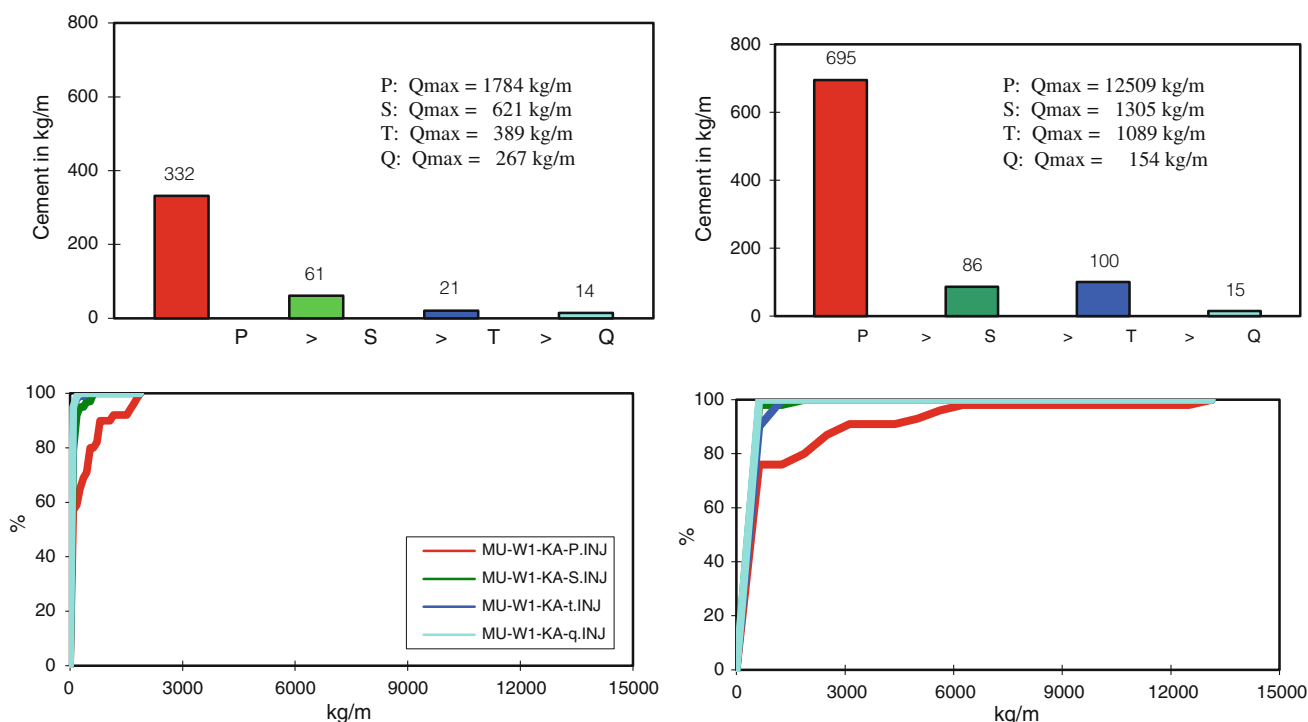
**Fig. 11** Mean values and frequency distribution of grout takes in Sections W1 (left) and W2 (right), Phase-2

- The majority of the grout holes encountered tight rock; about 60 % in Wing-Section 1 and 75 % in Wing-Section 2.
- The groutable voids were relatively large, but as they had generally been filled during the P-series, the take in subsequent series was relatively small.
- Especially in Wing-Section 2, however, the rock had longer and wider karstic joints, many of which had not been grouted during the P-series. As a consequence they took significant quantities in the S-series and even in the tertiary holes.
- The depth distribution indicates that the open voids were restricted to the upper 35 m below ground surface (165–180 m a.s.l.).
- The significant grout takes injected at low pressure had clearly entered open cavities rather than any caused by the fracturing of discontinuities.

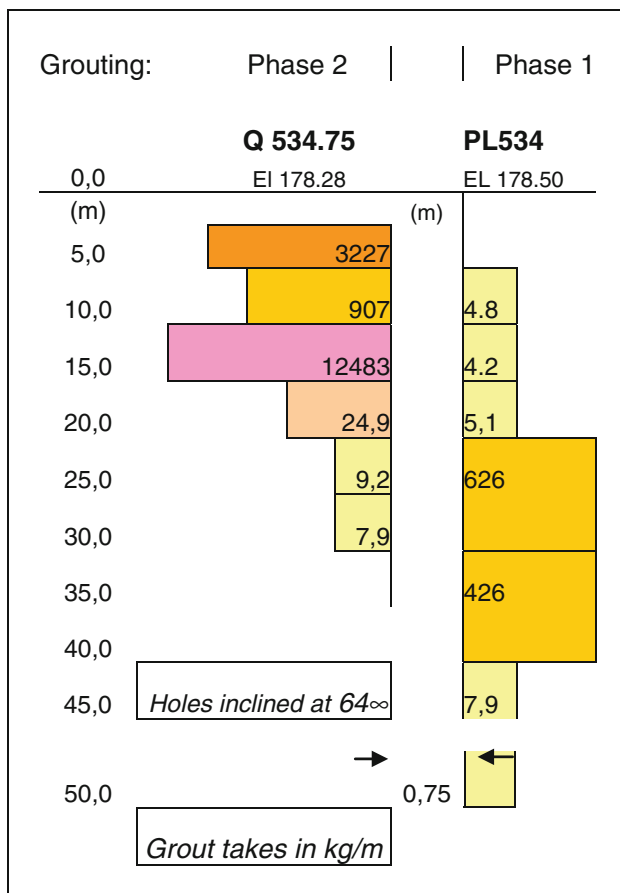
**Fig. 14** Originally plugged channels absorbed large grout quantities in adjacent hole (75 cm distance) after erosion of infillings

Figure 14 compares the grout takes in PL 534 and Q 534.75, within 0.75 m of each other, for the two phases of grouting. It is possible that the large grout takes in Q 534.75 in Phase 2 are the consequence of the erosion of infill from the intercepted karst channels (Fig. 13). Alternatively, a karstic fissure may have been completely filled with sediment, but the apparent or real cohesion of this material may have been strong enough to withstand the initial low water pressures. As the pressures increased, however, the material was gradually pushed towards the open end until the entire plug was removed (retrograde erosion). Depending on the length of the infilled section, both processes may be relatively quick or take place over many months or even longer, especially if the joint had been infilled with gypsum, as observed at Mujib. In contrast to the Caspe Dam in Spain (Manquero Piqueras et al. 2012), however, at Mujib Dam gypsum was of minor importance; the gypsum filled joints occurring only within the uppermost meters of the reservoir where the water pressure gradient and impounding time are lowest.

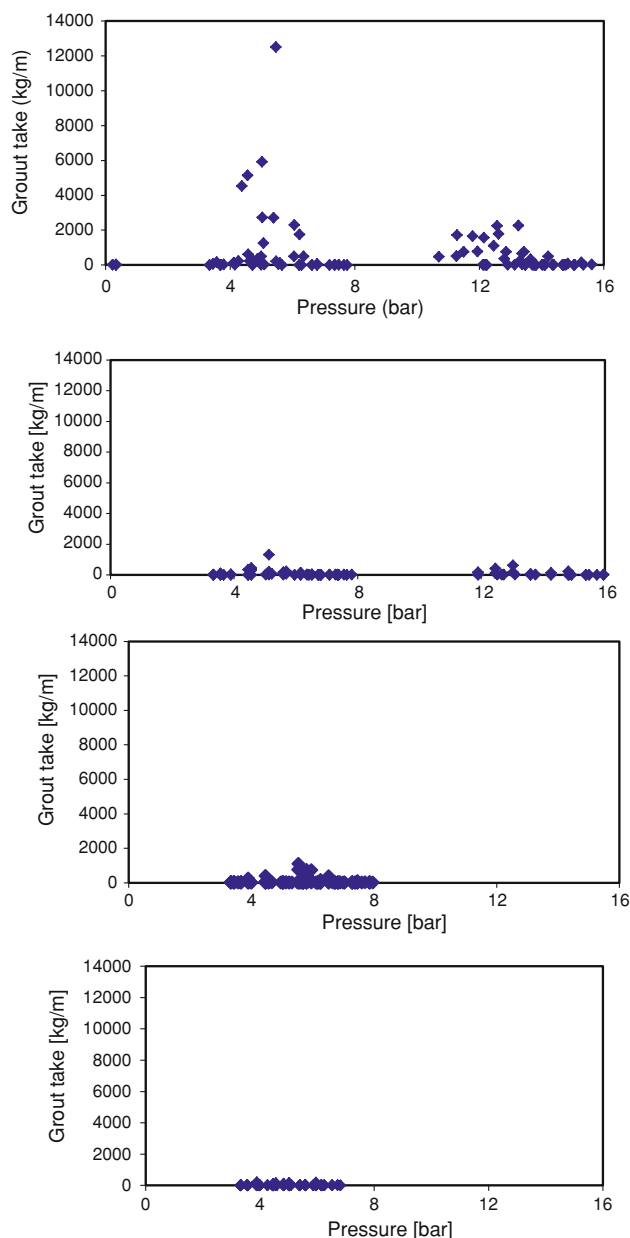
**Fig. 16** Relationship between grouting pressure and grout takes obtained in Series P–S–T–Q (from *top* to *bottom*), Sections W1 and W2 together, Phase 2

The possibility that Phase 1 grouting was inadequate as a consequence of low grouting pressures was considered (Ewert 2005). Grouting of open voids begins at low pressure. After some time the pressure starts rising since the void is getting filled. By contrast, if voids are lacking or quite narrow the grouting pressure rises from the beginning. Supposed latent discontinuities intersect the hole, hydrofracturing occurs as soon as the grouting pressure—if increased that much—exceeds the tensile strength of the latent plane. The fissure pressured open is then filled with grout. Figures 15 and 16 suggest that refilling of hydrofractured planes did not happen: the large grout takes in Phase 1 took place at low to moderate pressures (3–13 bar), and in Phase 2 at even lower pressures (3–6 bar).
