# TBM tunneling in marble rock masses with high in situ stress and large groundwater inflow: a case study in China

**Abstract** Two of four headrace tunnels in the Jinping II hydropower project were constructed using tunnel boring machines (TMBs). The geology along the tunnel alignment is dominantly massive to highly fractured marble and the maximum overburden depth is 2,525 m. The paper discusses the problems encountered during the TBM tunneling, including instability of the tunnel wall and face induced by high in situ stresses, high-pressure groundwater inflows and excessive cutter and cutterhead damage. Measures taken to overcome these problems involved modifications to both the machines and the mode of operation as well as changes to the support parameters.

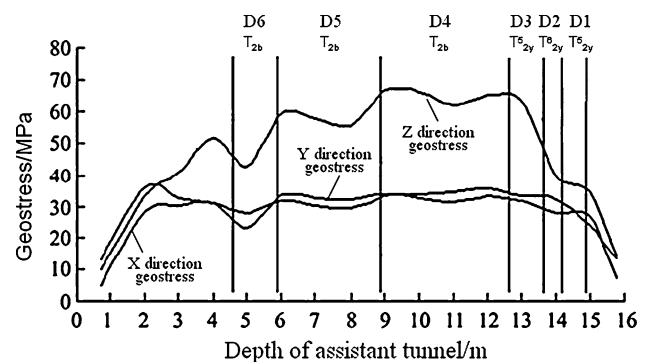
**Fig. 3** Initial in situ stress along the tunnel alignment

In situ stress measurements in the project region show stress not only increases with burial depth (to a maximum of 42 MPa) but changes from horizontal to vertical from 600 to 3,000 m depth. The maximum in situ stress obtained from the survey reached 42.11 MPa. The regression curve of in situ stress along the auxiliary tunnel alignment is shown in the Fig. 3.

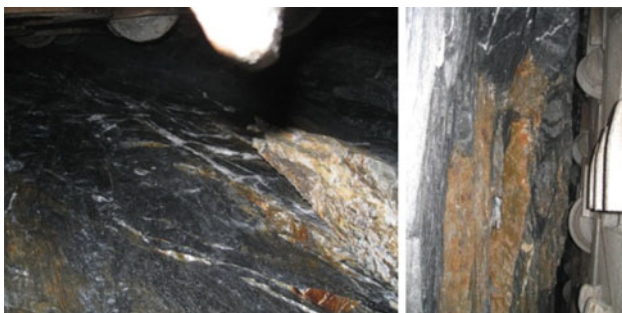
Fig. 5 Tunnel face at CH.15161.03 m in headrace tunnel 3 (medium layer rock mass)

Slabbing and collapse occurred at the tunnel face in areas where the rock layers were thin to medium (Fig. 5). The high in situ stress induces slabbing which facilitates rock breakage by the TBM cutters, but can result in instability when the cutter is too close to the slabbing surface (Fig. 6). In this case, the muck includes both normal rock chips and rock slabs (Fig. 7).

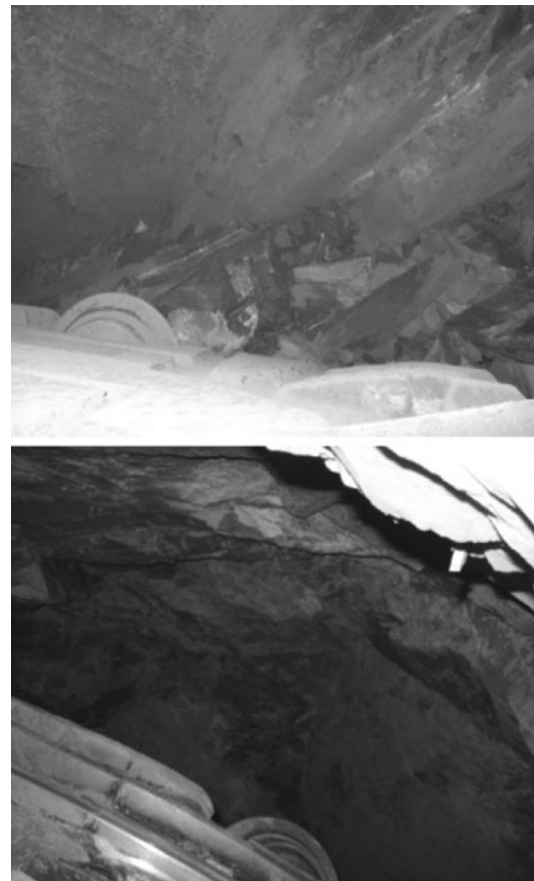
Fig. 6 Examples of tunnel face collapse

Tunnel face collapse occurred where the marble was in thin bands dipping at high angles. In view of the high in situ stresses, tensile fractures were created. The consequential tunnel face collapse increased the torque of the TBM and, rather than advancing the tunnel, much of the machine effort was taken in removing the blocks (rather than chips) which fell in front of the cutterhead. To avoid jamming the TBM, the thrust and RPM had to be decreased in an attempt to reduce the impact of the rock blocks on the cutters and cutterhead.

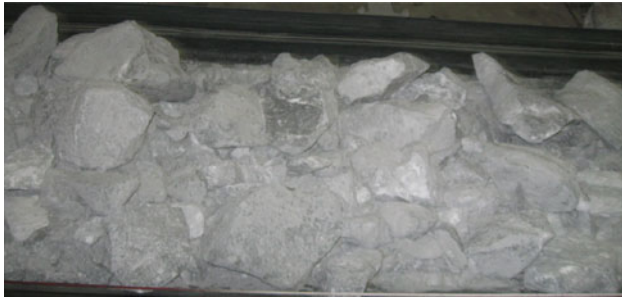
**Fig. 7** Chips and big rock blocks

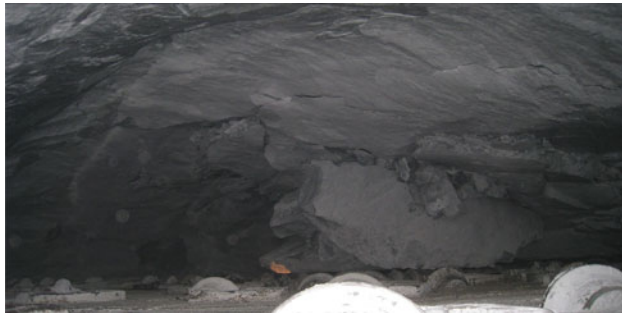
**Fig. 8** Large block (2 × 2 × 4 m) ahead of cutterhead

The third failure type is the most unfavorable for TBM operations. In this case, the rock masses are composed of medium to thick or very thick layers of marble and there are large discontinuity surfaces, such as faults and large joints. Intense or very intense rock bursts accompanied by slabbing result in large rock blocks reaching the TBM cutters and cutter-head, and the creation of an arch-shaped tunnel face. The largest rock block found in the tunnel face mapping was 2 m wide × 2 m high × 4 m long (Fig. 8). Such large blocks frequently jammed the cutter-head

causing abnormal damage. In addition, the penetration rate had to be decreased in order to clear away the rock blocks falling from the tunnel face.

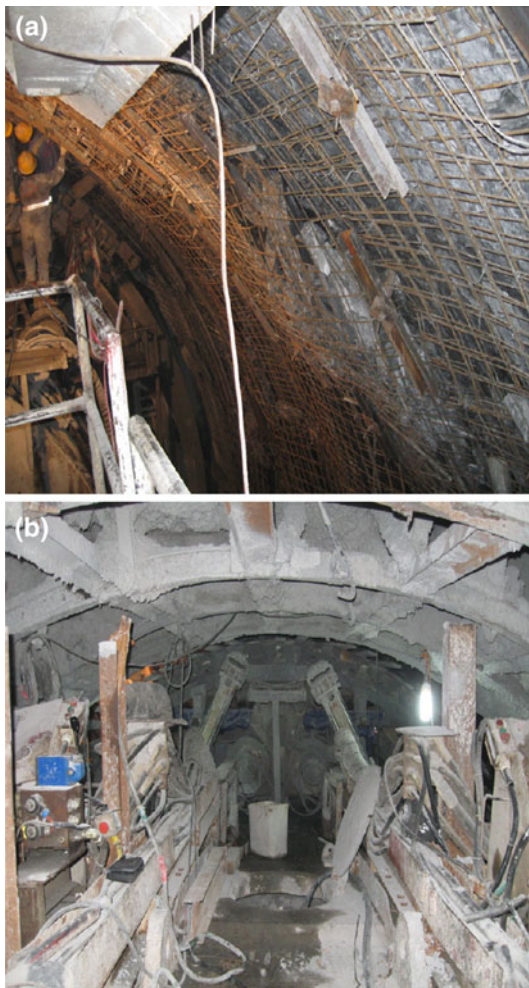
**Fig. 10** a Support at unstable section b steel arch and structural support at rockburst section

additional support using steel arches, anchors and shotcrete (Fig. 10); while these were being installed TBM operations had to be suspended, significantly affecting the overall advance rate.

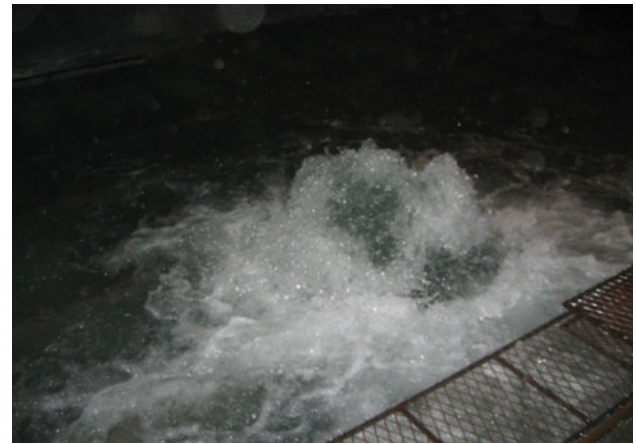
Fig. 14 Groundwater inflow at CH.11240 m in headrace tunnel 3

During the TBM excavation, two large water inflows were encountered in headrace tunnel 3: 1.4 m<sup>3</sup>/s at CH. 13791.61 and 1.8 m<sup>3</sup>/s at CH.11240 (Fig. 14). It took almost a month and 2 weeks, respectively, to solve the problems of damage to the TBM equipment. Plugging and drainage was very difficult and time-taking, significantly reducing the rate of advance.

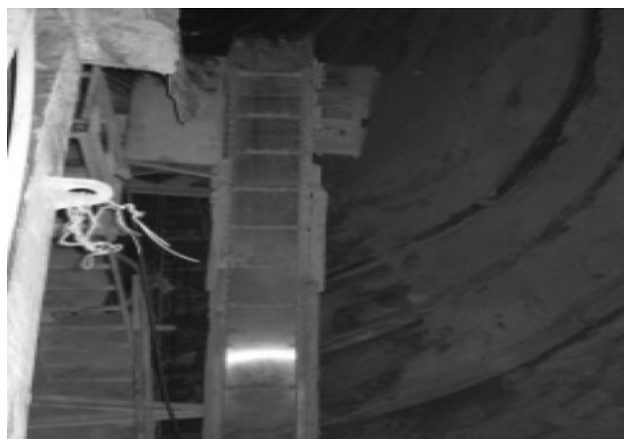
**Fig. 16** Accessorial belt conveyor machine installed in TBM of headrace tunnel 1

- (i) In order to overcome the problem of large blocks damaging the machine, a steel plate was welded to the muck scoop and additional teeth cutters installed.
- (ii) The size of the gripper plates was increased by 28.6 %, such that the impact of the grippers was reduced and the gripper stability increased.
- (iii) To improve the support installation, a finger-type shield was placed behind the cutterhead. This was reinforced by two layers with a steel mesh between, and enhanced both the strength of the finger shield and the safety of workers (Fig. 15). These modifications and an increase in the work space improved the progress.
- (iv) Attempts made to improve the conveyor belt system (Fig. 16) were largely unsuccessful due to the small width of the accessorial belt and the small dipper teeth.
