# Effect of wastewater on building foundation in karst travertine areas in Antalya, Turkey

**Abstract** This paper reports the site investigations (geological, geophysical and geotechnical) for the construction of a block of five buildings, with nine storeys each, in the Muratpasa District, Antalya. The base rocks consist of travertines that have been affected by domestic and industrial liquid wastes that were injected directly into the travertine plateau through septic holes prior to 2000. Therefore, the travertine rocks have poor engineering properties, such as high deformability and insufficient strength. This causes problems in the construction of engineered structures, and detailed investigations were required to determine the potential risk to the foundations of the buildings, and what measures would be required to mitigate those risks. In this study, the effects of injected wastewaters on the mass and material properties of travertine rocks, as well as overall reinforcement of the foundation, were investigated. Further investigations for foundations were recommended and implemented.

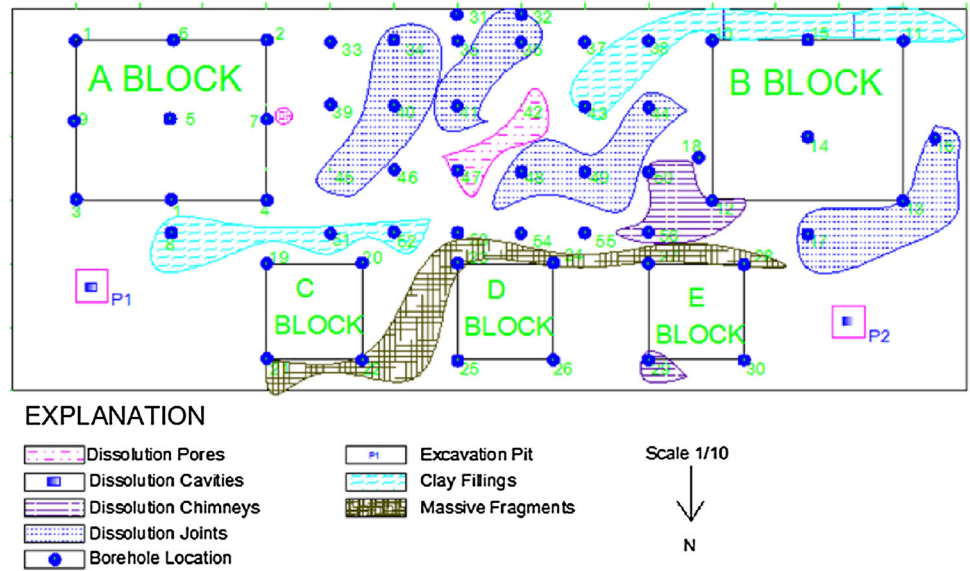
**Fig. 2** Location of the boreholes and of the karst structures identified close to the level of foundation

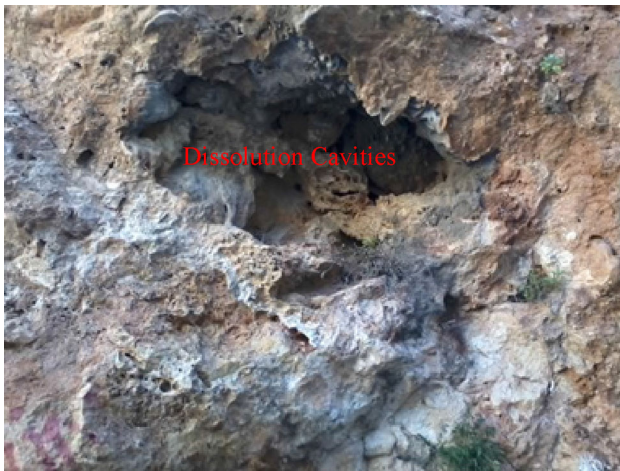
**Fig. 3** The dissolution cavities in the travertine rock near the E block

The dissolution cavities in the travertine showed variable dimensions and geometry, and are frequently linked to other dissolution structures (Fig. 3).

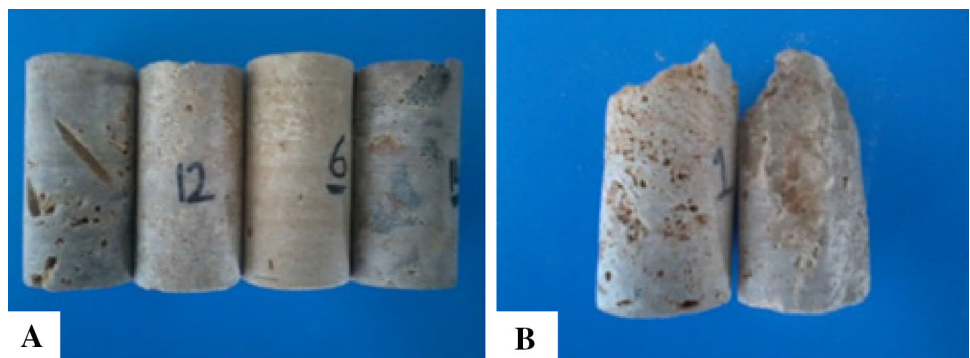
**Fig. 4** A rock core specimen. a Before and b after mechanical test

The effect of wastewater on travertine materials was investigated in the laboratory because of the karst structures found on site. The wastewater came from the residential units and industries that are connected to the septic holes for discharge. These septic holes allow the wastewater to percolate downwards through cracks in the underlying travertine over several years. Physical and mechanical properties of three types of travertines were determined. Chemical weathering due to changing pH values in sewage water had a negative impact on the strength of the rock (Singh et al. 1999; Asta et al. 2010). For this purpose, laboratory study was conducted on the massive, weak and spongy travertine samples (Fig. 4).

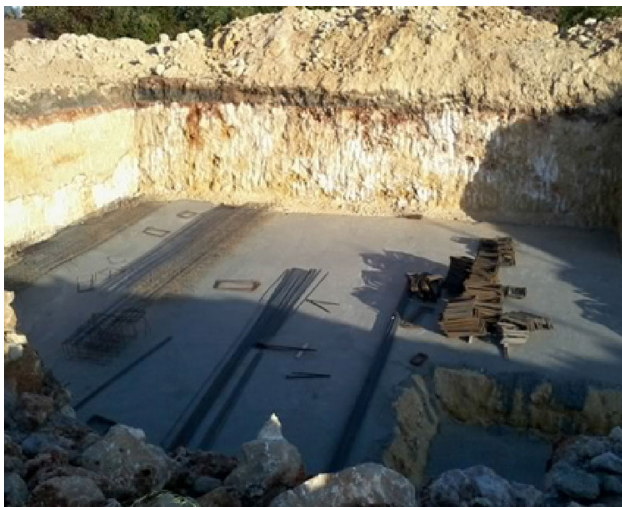
**Fig. 5** Foundation level filled with concrete (view from E block foundation)

Before the placement of the regularization concrete, all the soils were removed by cleaning the pores with a jet of water, to allow identification of the karst structures. In the karst structures filled with soils, cleaning was performed, at least 1 m below the lowest foundation level, and the volume was filled with concrete (Fig. 5).

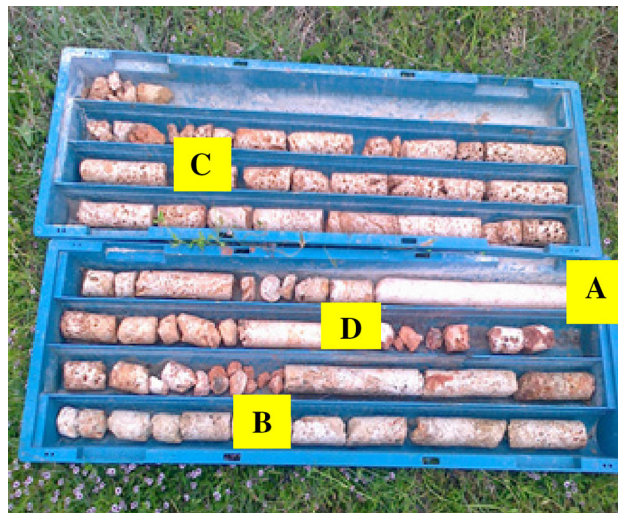
**Fig. 6** A view of core box belonging to BH-7. **a** Massive travertine, **b** moderately weak travertine, **c** spongy travertine, **d** dissolution pore section

Since the performance of the pile is dependent on the bond between the grout and the competent rock (Fig. 6), the integrity of the grouted bond zone in karst is of primary importance. Site-specific installation techniques must be selected with this in mind. This is achieved principally by the optimal selection of drilling and grouting techniques.
