# A preliminary study on the conservation and polishing performance of Sanliurfa limestones as a traditional building material

**Abstract** Sanliurfa limestones have been used as building materials from antiquity to current day (e.g., Gobeklitepe temple B.P. 14,000, Bazda underground quarries B.P. 3000, Harran castle B.P. 3000, etc.). These antique structures are listed within the United Nations Educational, Scientific and Cultural Organization (UNESCO)'s World Heritage List. However, the stones were used in these structures without any protection, and atmospheric conditions (precipitation, acid rain, temperature changes, etc.) cause damage to these stones over time, such as strength loss, abrasion, and discoloring. The damage can lead to the collapse of precious historical structures, or may require costly restoration. In this study, Sanliurfa limestone was investigated with respect to conservation using polish insulation (polysiloxane, lithium silicate, and varnish), appearance performance by polishing, and potential usage in the marble industry. The results revealed that conservatives could maintain up to 92 % of the unconfined compressive strength (UCS) of the natural stone an

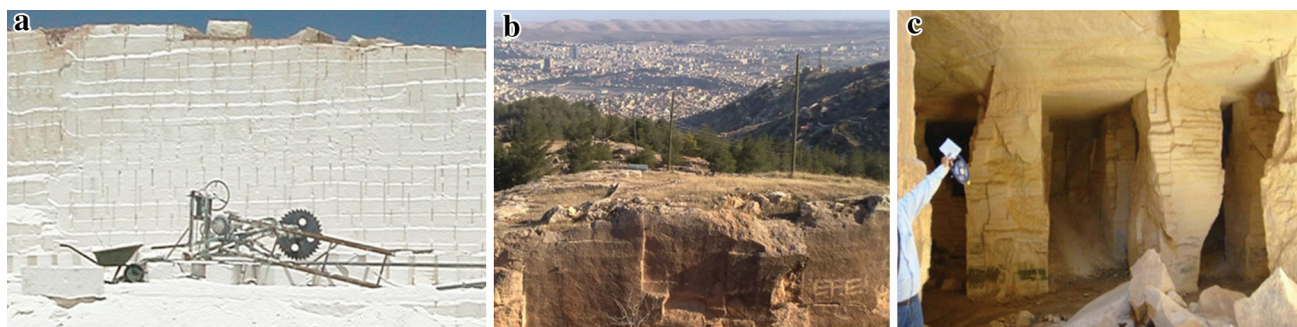
**Fig. 2** Photographs of (a) new, (b) ancient open air, and (c) ancient underground quarries

SLS can easily be cut with a hand-held saw or a rock-cutting machine, and therefore is suitable for building masonry walls. The processing of the SLS can be adversely affected by the presence of contaminants such as argillaceous, chalk, and chert within the SLS. Samples of stones used for construction have been obtained from new quarries (Fig. 2a), ancient open pits (Fig. 2b), and ancient underground quarries (Fig. 2c). There are more than 300 small underground caverns and quarries in Sanliurfa. Some of these are located down to a depth 10 m below the surface, and they sometimes have up to four levels. Most of the self-supported caverns are used during the hot summer season as a places for food storage (Fig. 2b) as well as

barns for animals (Fig. 2c). The physico-thermal properties of the SLS are tabulated in Table 2. The rather high porosity (around 17 %) must be noticed.

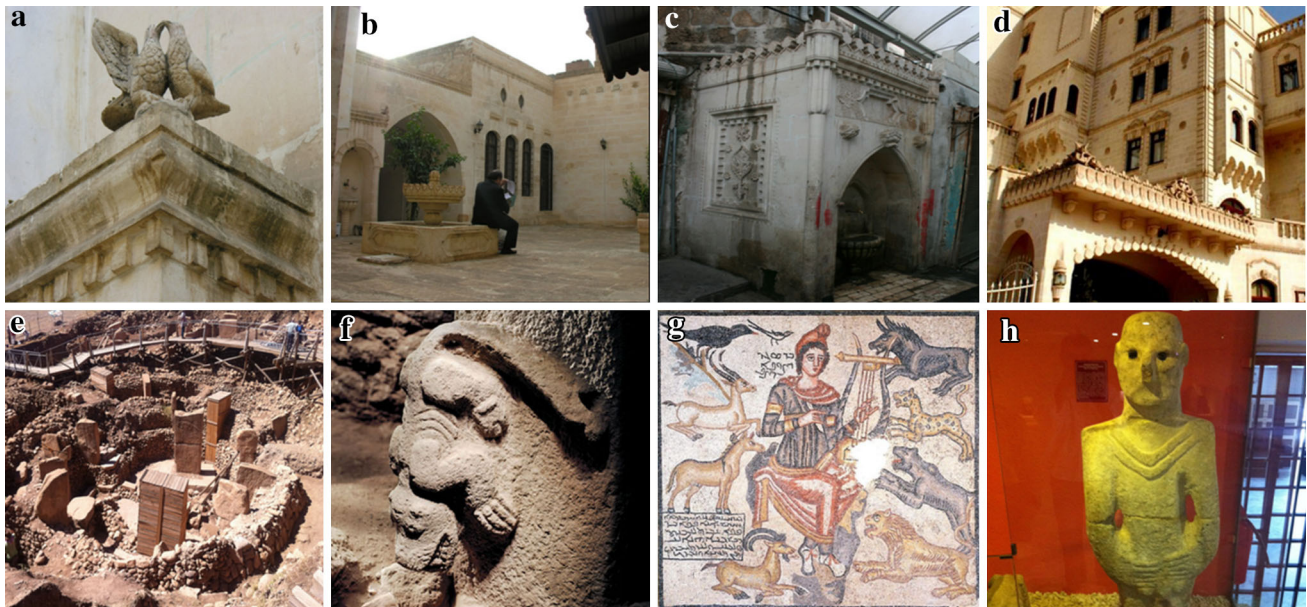
**Fig. 3** Examples of uses of SLS for (a) decoration, (b) construction, (c) fountain, (d) external cladding, (e) temple, (f) stone relief sculpture, (g) mosaic, and (h) statue**Table 3** Rock mass classifications of the SLS

Prior to the use of reinforced concrete structures, SLS was the main building material for decoration (Fig. 3a), major construction (Fig. 3b), fountain construction (Fig. 3c) and external cladding (Fig. 3d). Furthermore, SLS was used in the area for art by stone craftsmen, e.g., see Gobeklitepe (Fig. 3e), the oldest antic temple discovered (14,000 years B.P.), stone relief sculptures and catacombs in Gobeklitepe (Fig. 3f), Orpheus (Fig. 3g) mosaic (1820 years B.P.), and Balikligol (Fig. 3h) the first and the oldest full-sized human statue discovered (13,500 years B.P.). The rock mass classifications of the SLS are tabulated in Table 3.

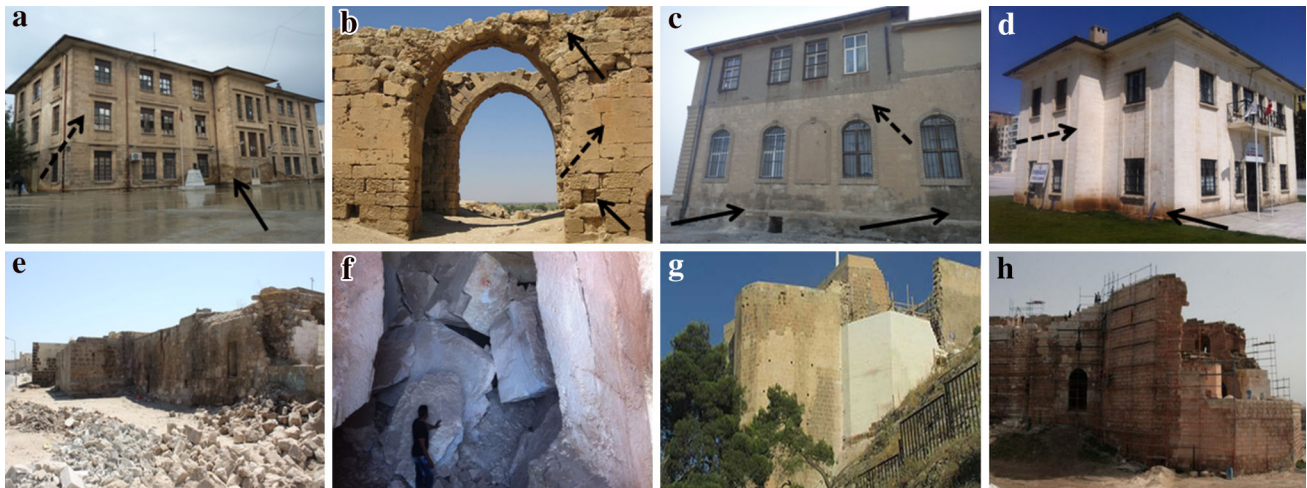
**Fig. 4** Photographic evidence of (a–d) stone erosion that occurred on the roofs and in the bases of the masonry walls, (e–f) the structural damage, and (g–h) incompatible restorations

In addition to accessibility and ease of quarrying, SLS has good isolation and strength properties. However, SLS tends to absorb water and as seen from the historical structures, major stone erosion occurs in the roof and base of the masonry walls. The decomposition of materials occurs due to precipitation for the roofs of the masonry walls, and due to surface runoff for the bases. The best-preserved stones are observed in the middle parts of the walls (Fig. 4a–d). The mechanical properties of the SLS are tabulated in Table 4.

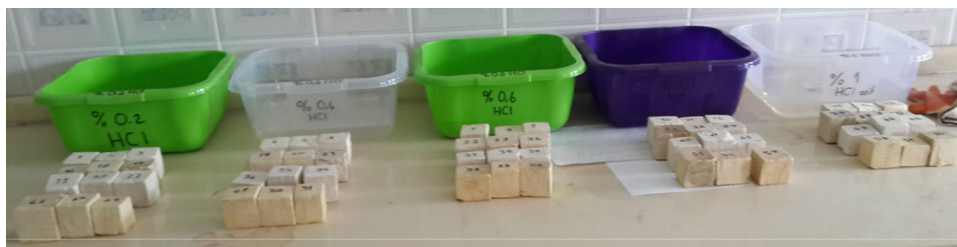
**Fig. 5** Natural and treated samples for HCl acid tests

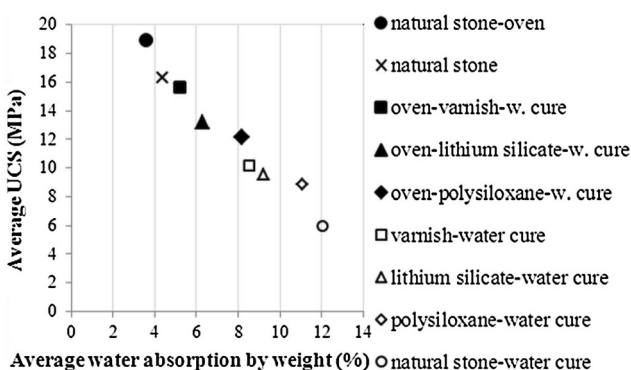
Fig. 9 Average UCS values of the samples versus average water absorption by weight percentages

The adverse effects of water absorption level and the positive effects of polishing and pre-drying processes on the UCS of SLS are collectively shown in Fig. 9. The UCS was inversely correlated to water absorption for the samples that were tested, with the UCS decreasing with increasing water absorption. As seen in Figs. 8 and 9, the dried natural stone (natural stone-oven) samples with the minimum water absorption percent by weight provided the maximum UCS value. In contrast, the saturated natural stone (natural stone-water immersed) samples that had the maximum water absorption percent by weight provided the minimum UCS value. Figures 8 and 9 also indicate that the polishing process could increase the UCS of the SLS, because the polishes decreased the water absorption levels of the SLS samples to varying degrees. In this regard, the maximum and the minimum conservation action was provided by varnish and polysiloxane, respectively. In addition, the pre-drying process before polishing increased the UCS, and decreased the water absorption potential of SLS. The maximum UCS values (i.e., the closest to the UCS values of natural stone samples) were obtained for the pre-dried and then the treated SLS samples. As stated by Sariisik and Sariisik (2011) and Dreesen and Duser (2004), the stones with low porosities were less affected by environmental factors. The polishes likely penetrated the dry

stone surface well, forming a watertight, protective film and reducing water absorption potential.
