Assessment of complex rock slope stability at Xiari, southwestern China

Abstract Detailed engineering geological studies and stability assessments were carried out on Xiari rock slope in southwestern China. Geomorphic analysis of digital elevation models, detailed structural field mapping and boreholes data indicate that the slope has a poor rock mass quality and complex deformation mechanism. The necessary rock mass parameters were determined by means of slope mass rating (SMR), geomechanic classification system (Q) and geological strength index (GSI). Slope stability analyses were performed by means of kinematic, limit equilibrium and numerical modeling techniques. Analyses results indicate that slope stability is mainly controlled by the discontinuities. The combination of discontinuities and topography makes the slope susceptible for a large landslide. The major potential mode of slope failure is planar failure. Planar failure has a higher probability in comparison to wedge failure, while wedge failure contributes towards a more severe hazard, like the landslide in part A of the study area. Numerical analysis results indicate a catastrophic landslide in the future, with a volu

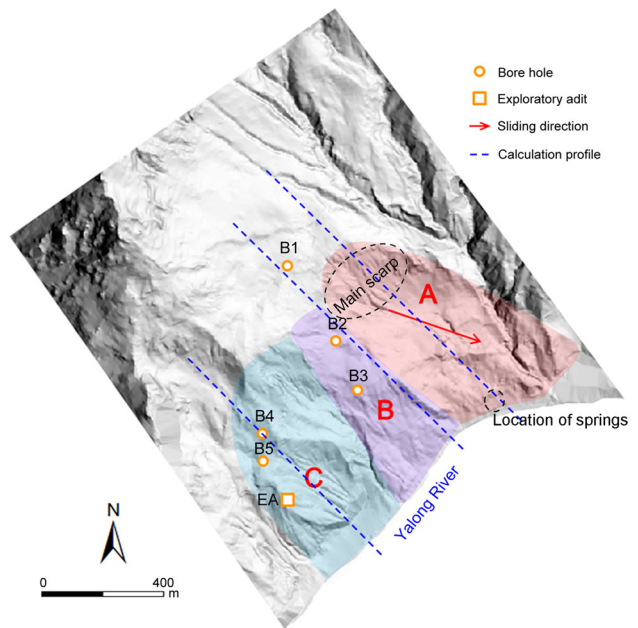
Fig. 3 Digital elevation model of Xiari slope: A, B and C are the three subareas discussed in this paper; B1–B5 are the locations of bore holes; EA is the location of the exploratory adit; the three dotted lines are the profile sections for stability analysis

Xiari unstable rock slope is located on the northern slope of Yalong River Valley. The height of the unstable slope is about 750 m, with an elevation of 2350 m at the foot of the slope. The whole slope orientation is about N140°/40°. A digital elevation model was constructed based on a contour map of 1:5000 scale with a contour interval of 5.0 m (Fig. 3). It can be seen that Xiari slope is situated just between two large gullies, where the upstream gully is deeper and steeper. The upper part of the slope is covered by debris deposit and has a gentle slope angle of less than 25°. The lower terrain of the slope is steep (about 40°) with exposed bedrock. According to the topography and deformation characteristics, we divided the lower part of the slope into three subareas. The upstream part, subarea A, includes a landslide of unknown age. The landslide shows a structurally controlled failure mode. The landslide slipped towards the outlet of upstream gully. The main scarp of the landslide is steep with exposed bedrock. At the top of the

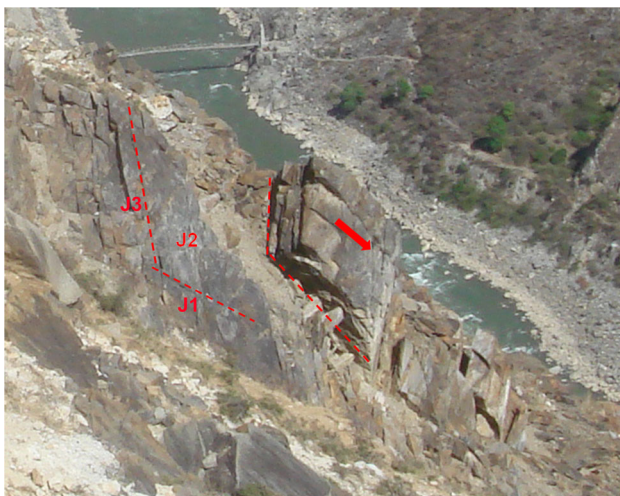
Fig. 4 Loose rock blocks observed in subarea B

slope, subarea B, is mostly covered by the collapsed deposit. The bedrock exposed here is fractured. Some freestanding blocks split by discontinuities were observed in this area (Fig. 4). The downstream part, subarea C, is convex with a cliff-like toe. This part shows a different deformation pattern. Rock avalanche deposit was found near the toe of the subarea C (Fig. 5). Between the subareas B and C, an erosional gully has developed.

Field observations indicated that the mode of existing failures and deformation of the slope are strongly influenced by the combination of different joint sets. The basal failure surface of the landslide in subarea A was observed to be developed along J_1 , where J_2 and J_3 served as lateral and rear separate structures. Unstable toppled blocks in subarea B were also delimited by the combination of joint sets J_1 , J_2 and J_3 (Fig. 4).

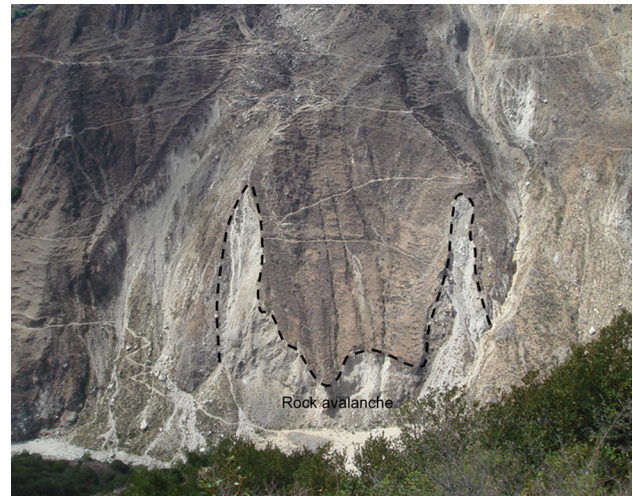
Fig. 5 Rock avalanche at the toe of subarea C

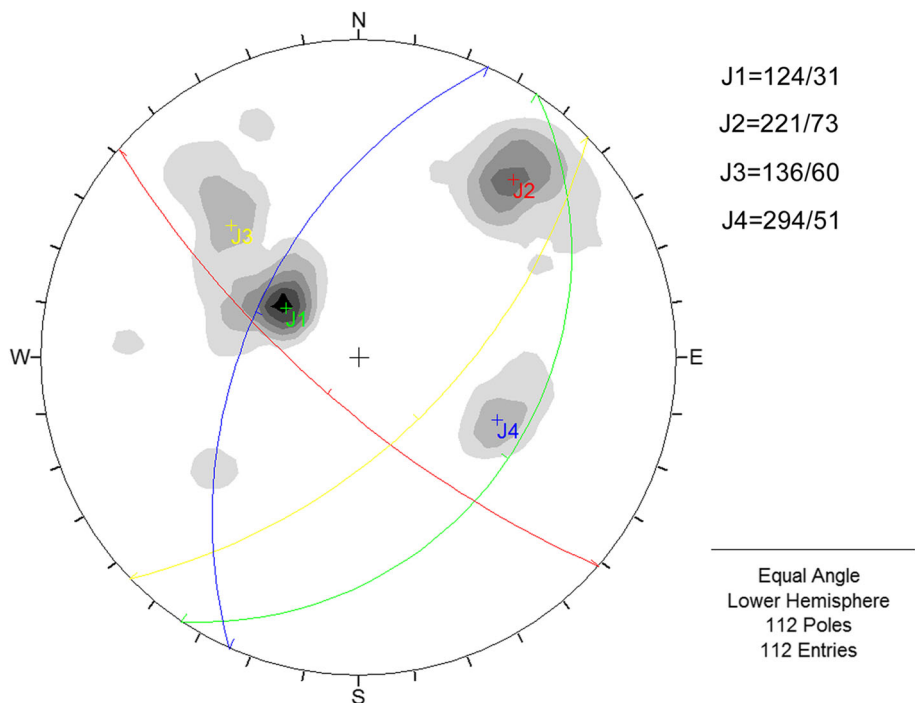
Fig. 6 Density stereo plot of the discontinuities data collected from field and the derived mean surfaces for the major discontinuity sets

Most part of the slope surface is covered by debris deposit. Discontinuity planes at 112 different locations were measured, mostly in the subarea C. The poles of these discontinuities were plotted, contoured and four major joint sets were derived on equal-area stereographic projection plot (Fig. 6). The orientation of these joints, which were given as dip direction and dip angle in degrees, are N124°/31° (J_1), N221°/73° (J_2), N136°/60° (J_3) and N294°/51° (J_4). The spacing of joint sets J_1 to J_3 ranges between 0.1 and 0.5 m. Joint set J_4 runs parallel to the bedding plane with spacing varying from 0.2 to 0.6 m. The discontinuities are moderately to highly persistent, and the joints walls are smooth and undulating in metamorphic sandstone and rough in granite according to the International Society for Rock Mechanics (ISRM) (1981). The volumetric joint count was estimated to be 30 using the empirical relationship provided by Palmstrom (2005).

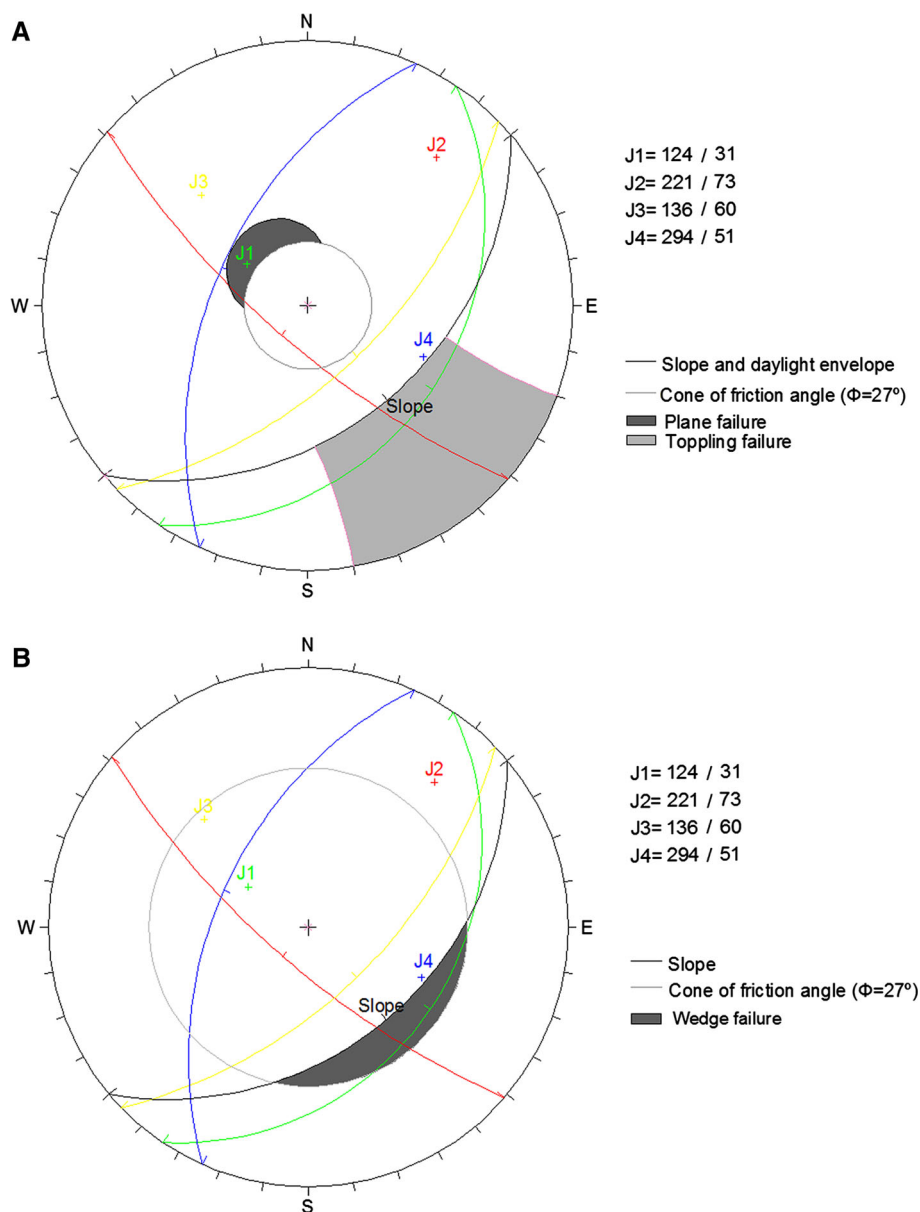
Fig. 7 Kinematic analysis for different modes of failures: **a** planar and toppling failure and **b** wedge failure

Kinematic analysis indicates that planar failure along J_1 is feasible in the study area (Fig. 7a). Although the mean orientation of joint set J_4 is out of the toppling failure envelope, there is a possibility of toppling failure along J_4 , taking into account the variability of orientation, especially in the place with steep slope angle. We did find some toppling failure at the toe of the slope where the slope angle is greater than 50°, but no field evidence of widespread toppling was observed at higher elevation of the slope. Toppling along the bedding plane may result in separation of J_3 and weakening of the strength of the rock mass at the toe, which then provide feasibility to planar failure along J_1 . Figure 7b highlights that the wedge failure is kinematically possible along the plunge of the intersection of J_1 and J_2 .

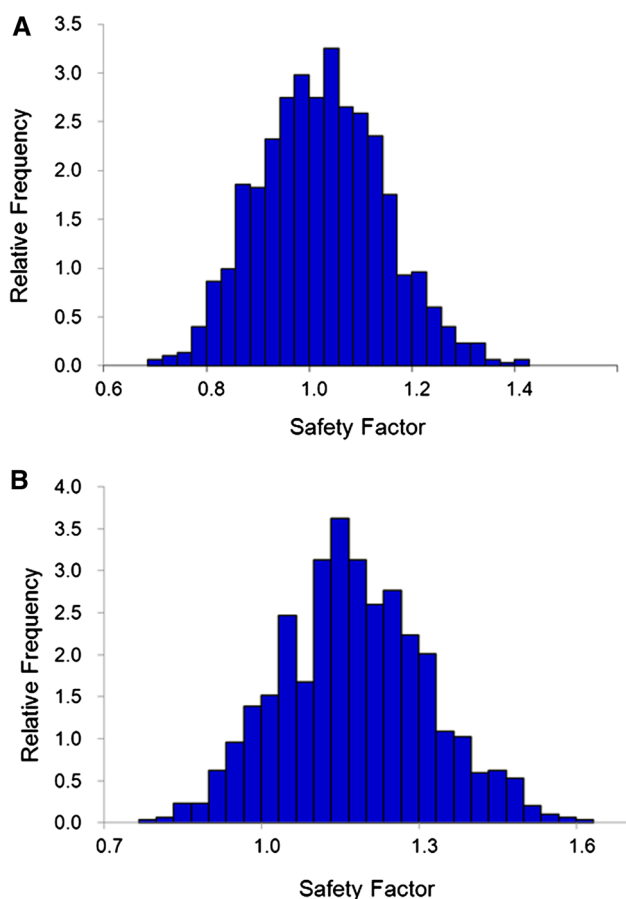
Fig. 8 Histogram of factor of safety for: **a** planar failure and **b** wedge failure calculated in probabilistic analysis

wedge failure. Probabilistic analyses gave similar results. The histogram of safety factors in Fig. 8 shows that the probability of instability is 43.1 % for planar failure along joint set J_1 . This value is much higher than the probability of wedge failure for the combination of J_1 and J_2 , which is only 10.7 %. Therefore, the planar failure along joint sets J_1 represents a frequent and common failure mechanism at Xiari slope. However, we must keep in mind that the calculated mean block volume of wedge failure, although has a very low possibility, reaches $4.7 \times 10^6 \text{ m}^3$, which is much larger than that of planar failure, $1.4 \times 10^4 \text{ m}^3$. This indicates that the wedge failure stands for a greater hazard.

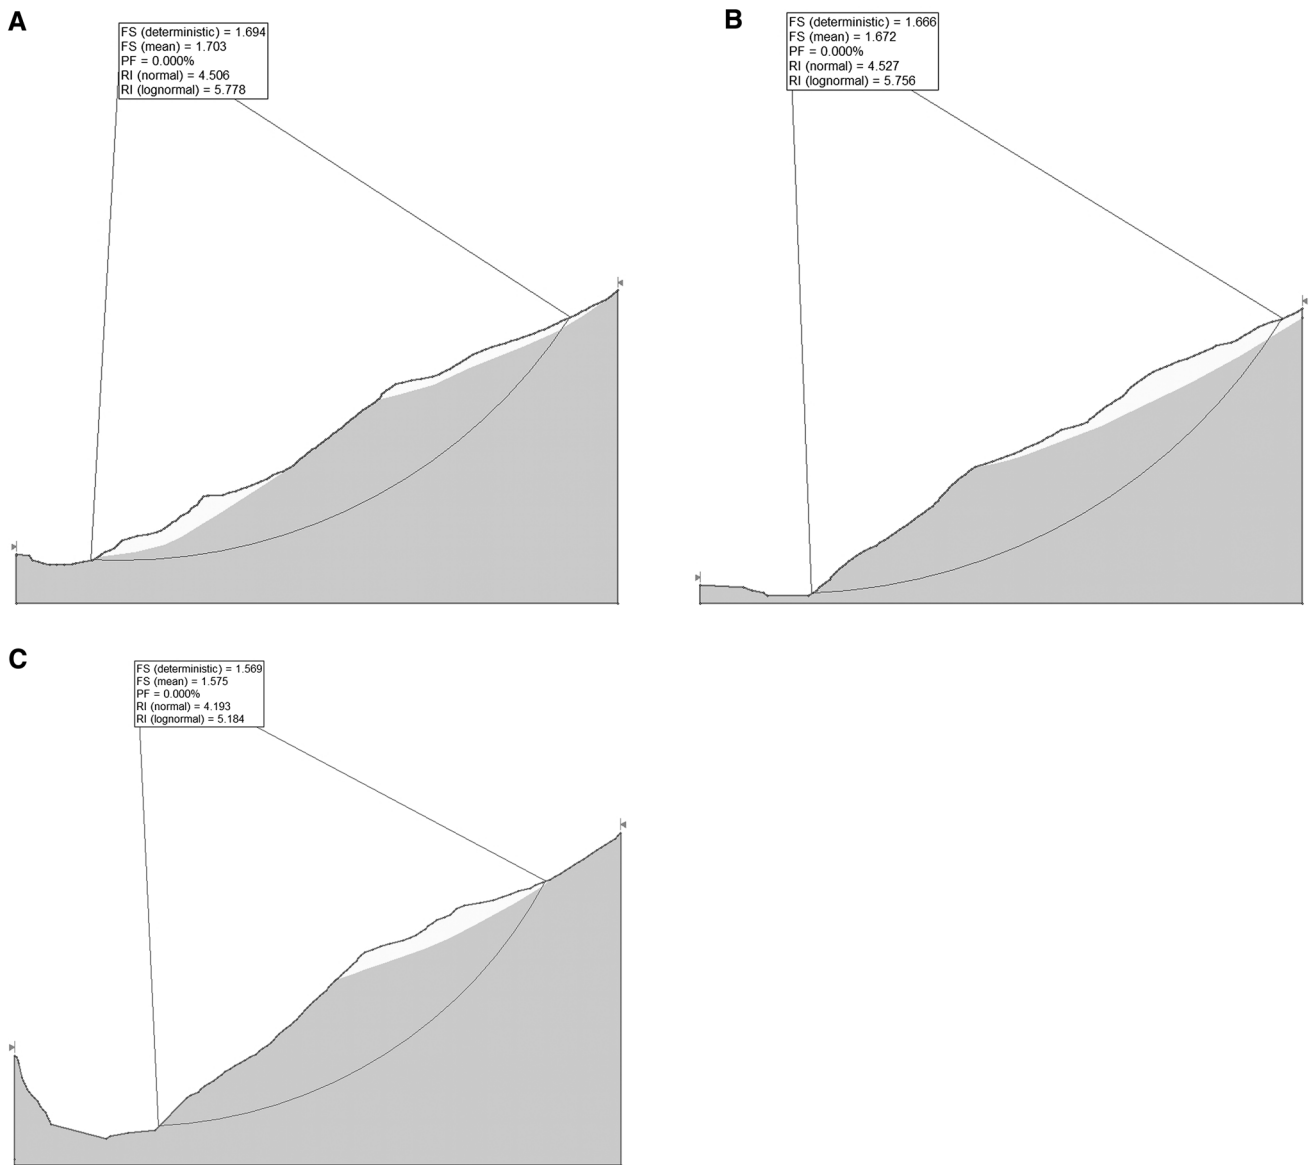
Fig. 9 Circular slip surface results of deterministic and probabilistic analyses for subareas **a** A, **b** B and **c** C using the Spencer method

of the mean values. The geometric models of the three subareas and the results determined by the Spencer method are shown in Fig. 9a–c. The results illustrate that all three subareas of the slope have deep-seated failure modes. The mean factor of safety ranges from 1.696 (Janbu Corrected method) to 1.705 (Bishop method) for subarea A, 1.672 (Spencer method) to 1.679 (Janbu Corrected method) for subarea B and 1.575 (Spencer method) to 1.577 (Bishop
