# Deformation and failure of a tunnel in the restraining bend of a strike–slip fault zone: an example from Hengshan Mountain, Shanxi Province, China

**Abstract** The Yanmenguan Tunnel runs through Hengshan Mountain in Shanxi Province, China. The mountain is mainly composed of metamorphic rock cut by a well-developed strike–slip fault system. As a result of the local geological setting, significant deformation and mud bursting occurred during excavation of the tunnel. In this paper, a representative 170-m-long section of the tunnel (from Sta. 118 K + 30.0 to Sta. 118 K + 200.0), which is located in the restraining bend area of the strike-slip fault system, is chosen as a case study to investigate the influence of such a fault on tunnel stability. The characteristics of strike-slip faults and asymmetrical pressure are then investigated, in conjunction with monitoring stress and displacement in the tunnel. The results of the analysis suggest that the strike-slip fault complicates the geological condition and decreases the quality of the rock masses. Different rock mass classifications for the surrounding rocks are the dominant factor causing asymmetrical pressure in the tunnel, which

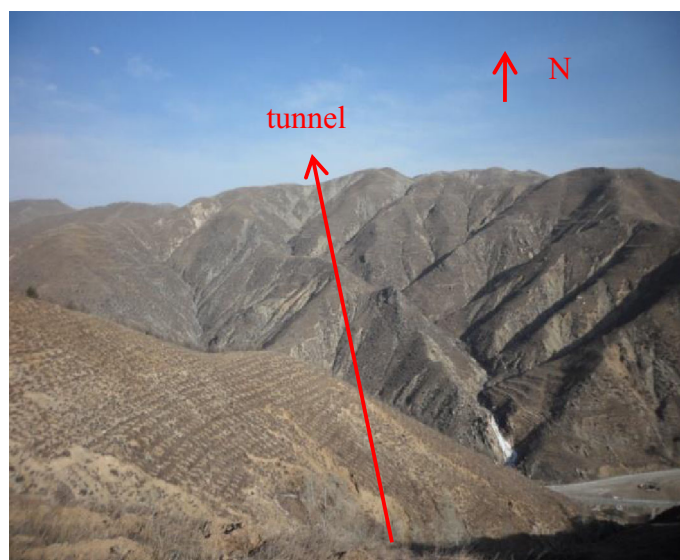
**Fig. 1** Geological map and location of the Yanmenguan Tunnel (*left*) and the landforms around the tunnel (*right*)

The Yanmenguan Tunnel in the western part of Hengshan Mountain carries a key section of the Datong–Yuncheng Expressway, which starts west of the village of Miaojiaoyao in Shanyin County and ends to the north of the village of Taiheling in Dai County (Dechao and Dejun 2015). Joints and gneissic schistosity are distributed widely in this area. Most of the structures were formed in the Lvliang period. The lithology of this area is mainly composed of granite, gneiss, and supracrustal rock (Fig. 2).

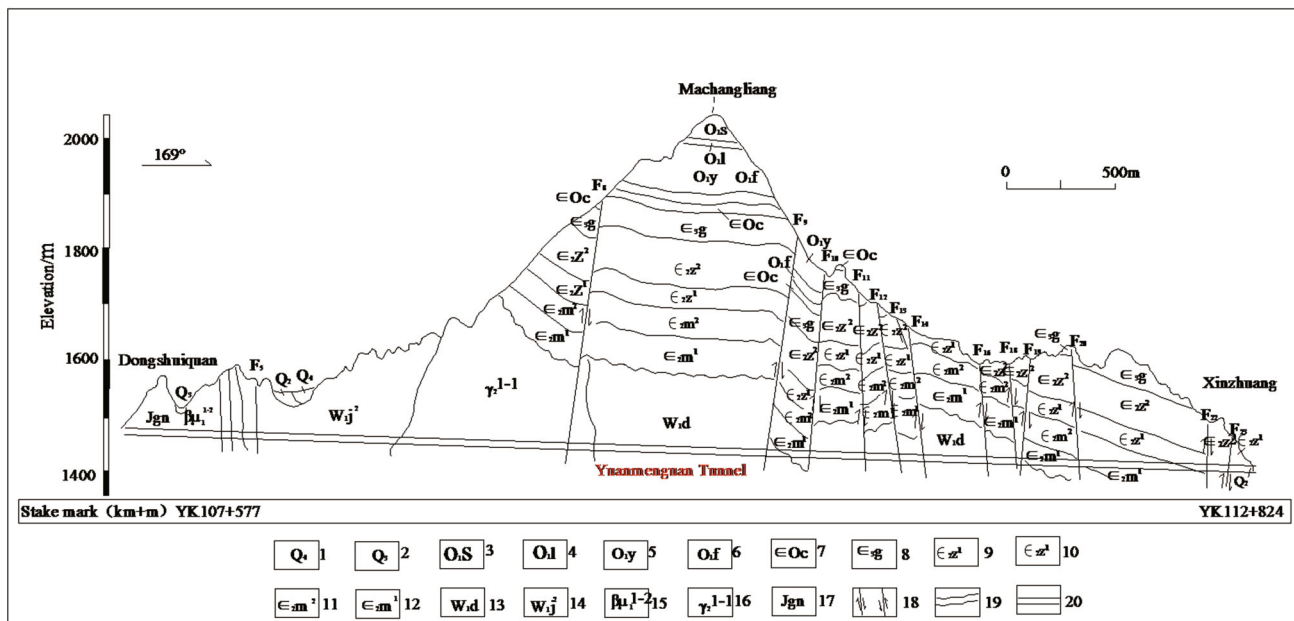
**Fig. 2** Schematic engineering geological profile along the axis of the Yanmenguan Tunnel. 1 Quaternary Holocene, 2 Quaternary Pleistocene, 3 Ordovician Sanshanzi group, 4 Ordovician Liangjiashan Group, 5 Ordovician Yeli Group, 6 Ordovician Fengshan Group, 7 Cambrian Ordovician Changshan Group, 8 Cambrian Gushan Group, 9 Cambrian Second: Zhangxia Group, 10 Cambrian First: Zhangxia

Group, 11 Cambrian Second: Mantou Group, 12 Cambrian First: Mantou Group, 13 Five-tai Dianfang Group, 14 Five-tai Jingangku Group, 15 Luliang late diabase dikes, 16 Luliang metamorphic granite, 17 Five-tai mid-plagioclase gneiss, 18 normal faults, reverse fault, 19 stratigraphic boundaries and unconformity boundary, 20 tunnel line

Yanmenguan Tunnel (Fig. 2), where is the central region of the strike-slip fault zone, show that asymmetrical pressure is the dominant factor influencing rock deformation here.

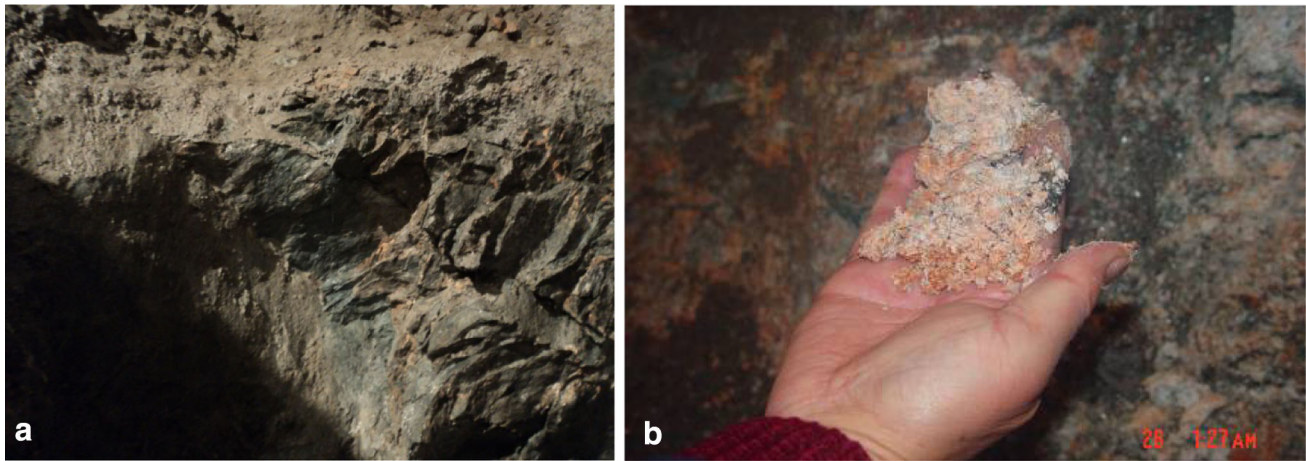
**Fig. 6** The surrounding rocks. **a** Biotite-bearing plagioclase amphibolites; **b** potassic granite

In the country rock on the right side of the tunnel, biotite-bearing plagioclase amphibolites are distributed widely (Fig. 6a). Dikes in the rock mass intersect with the tunnel axis at an angle of about  $45^\circ$ . Joints are well developed and several 3- to 5-cm-thick muddy intercalations are observed. Discontinuities are generally spaced from 30 to 60 cm apart. The uniaxial compressive strength of a samples of the rock has been measured at 51.95 MPa. According to the Chinese standard for the engineering classification of rock masses and code for rock and soil classification for railway engineering, the surrounding rock mass of the tunnel can be rated as III (from the Chinese

The left side of the survey section mainly consists of potassic granite with severely kaolinitized plagioclase. These rocks have extremely low strength and are cemented poorly, which means that they are easily softened by water (Fig. 6b). Some apparent interfacial shears, such as shearing along dikes and gneissic schistositys, occurred in the seam-filled and crushed rocks surrounding the tunnel. Two sets of discontinuities were developed and parts of them were kaolinitized. Again, based on the Chinese standard for engineering classification of rock masses and code for rock and soil classification for railway engineering, the surrounding rock masses on the left side of the survey section can be rated as V (from the Chinese national standard; the BQ of class V is less than 250, whereas the RMR is less than 40).

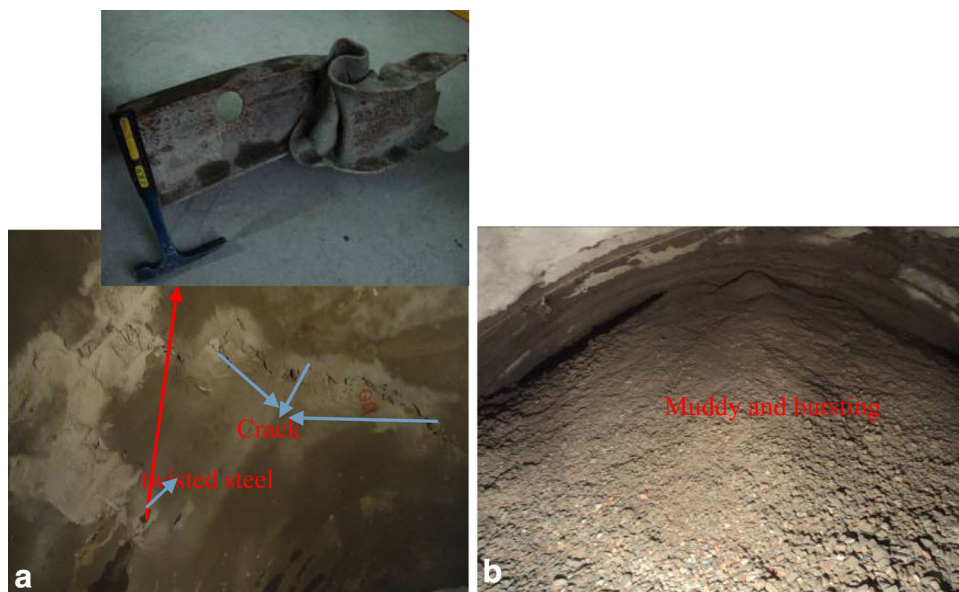
support on the left side of the tunnel is badly cracked (Fig. 7a). An altered design involving steel frames was then adopted. However, the frames became twisted (Fig. 7a), and the sprayed concrete became cracked and peeled. The tunnel wall thus moved into the tunnel, and a large-scale mud burst comprised mainly of granular potassic granite dike material and a fault gauge occurred in the arch wall of the left side (Fig. 7b).

**Fig. 7** Geo-hazards during tunnel opening. **a** Cracking and twisting of support wall; **b** large-scale muddy sand bursting at Sta. DK118 + 90.0

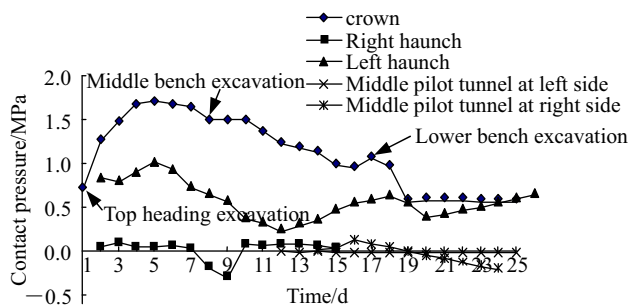
Fig. 9 Contact pressure between surrounding rock and initial lining

various monitoring locations, asymmetrical pressure is obviously inferred within the tunnel (Fig. 9). The contact pressure may even occasionally assume a negative value, which may result from the loose contact between the surrounding rocks and pressure gauges.

The results of the investigation showed that the surrounding rocks on the left side of the tunnel consist of crushed loose sand, and are subjected to severe kaolinitization; these rocks are easily softened by water and have no ability to support the tunnel. However, the surrounding rocks on the right side of the tunnel consist of relatively intact, blocky biotite-bearing plagioclase amphibolites. Therefore, the surrounding rocks can serve as the primary supporting structure, with relatively low stress pressure on the steel ribs. Based on different contact pressures at

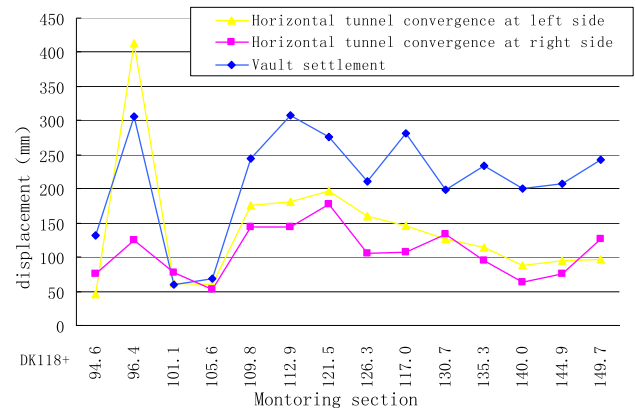
The results of monitoring tunnel convergence in the section from Sta. 118 K + 94.6 to Sta. 118 K + 150 are illustrated in Fig. 10. The value of crown settlement is greater than that of horizontal convergence, and the horizontal convergence on the left side is generally greater than that on the right side in most of the monitoring profiles, thereby indicating the significant influence of asymmetrical pressure on tunnel convergence. The monitoring profile from Sta. 118 K + 96.0 shows that horizontal convergence on the left and right sides is 412.52 and 124.18 mm, respectively, while the crown settlement is 306.66 mm. Measurements from all other monitoring profiles also show that the value of the crown settlement is smaller than those of the horizontal convergence on the left side of the tunnel. The monitoring results in the middle section of the

Fig. 10 Monitoring results of deformation in study section

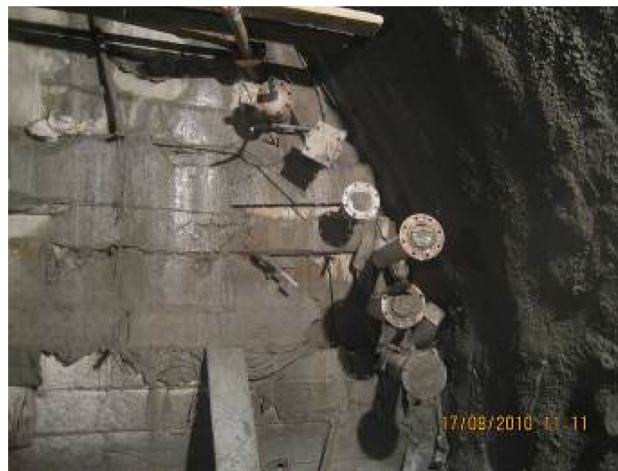
**Fig. 11** Advanced long pipe-shed grouting

stability of surrounding rocks. In the Yanmenguan Tunnel, both flexible and rigid linings were used to strengthen hard and soft rock masses, respectively. Based on the results of monitoring stress and displacement, such measures were employed in the section from Sta. 118 K + 90.0 to Sta. 118 K + 97.8 to replace the center arch. Simultaneously, the surrounding rock masses were reinforced by advanced grouting (Fig. 11).

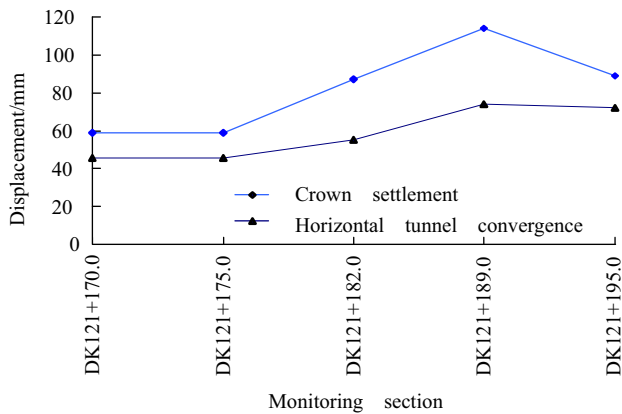
**Fig. 12** Deformation of wall rocks after altering construction techniques

In the section from Sta. 118 K + 0.0 to Sta. 118 K + 100.0, various types of geologic instabilities at different locations need to be considered carefully to avoid disaster. Considering the poor geological condition of the surrounding rock masses in the section from Sta. 118 K + 30 to Sta. 118 K + 97.5, the classification of the rocks were modified to V from its original III. A composite-lining designed for rock masses with a classification of V was therefore installed, the resurrection sliding could be effectively suppressed by H-beam arch frame supporting

structure. In addition, the top-heading-and-bench method that keeps a reserve of core soil was adopted; additionally, the driving distance is cautiously controlled. The initial lining composed of a steel I20b H-beam with a spacing of 60 cm was used to support the tunnel. At the same time, C25 concrete was sprayed with the thickness of 27 cm. The tunnel convergence under the modified construction techniques is illustrated in Fig. 12. Note that the tunnel deformation becomes much smaller than that observed under the original construction method. The crown settlement is 6–11 cm, which is significantly smaller than that before (30 cm), and the tunnel convergence in the horizontal direction decreases to the range of 5–8 cm from the previous value of 56 cm. By increasing the lining strength, tunnel cracking and steel rib twisting are greatly reduced in the tunnel, which indicates the rationality and applicability of the modified control techniques.
