Use of multi-source remote sensing images to describe the sudden Shanshucao landslide in the Three Gorges Reservoir, China

The primary objective of this research is to better understand the movement characteristics and patterns of a sudden landslide that occurred in the Three Gorges Reservoir, China (the Sept. 2, 2014 Shanshucao landslide) by using three periods of multi-source remote sensing images in combination with a field survey. A georeferenced, aerophotographic orthomosaic and corresponding 1:2000 topographic map of the pre-landslide area was referenced to rectify the micro-unmanned aerial vehicle (UAV) based orthomosaic, digital surface model (DSM) and Google Earth satellite image of the post-landslide area. By using orthomosaics of the post-landslide area, especially the very high spatial resolution micro-UAV based orthomosaic, the landslide boundaries were accurately delineated. By comparing the images of the area both pre- and post-landslide, three landslide subzones were identified, and two boundaries between the three subareas were divided more precisely than in previous studies. Based on the digital elevation model (DEM) of the pre-landslide area and DSM of the post-

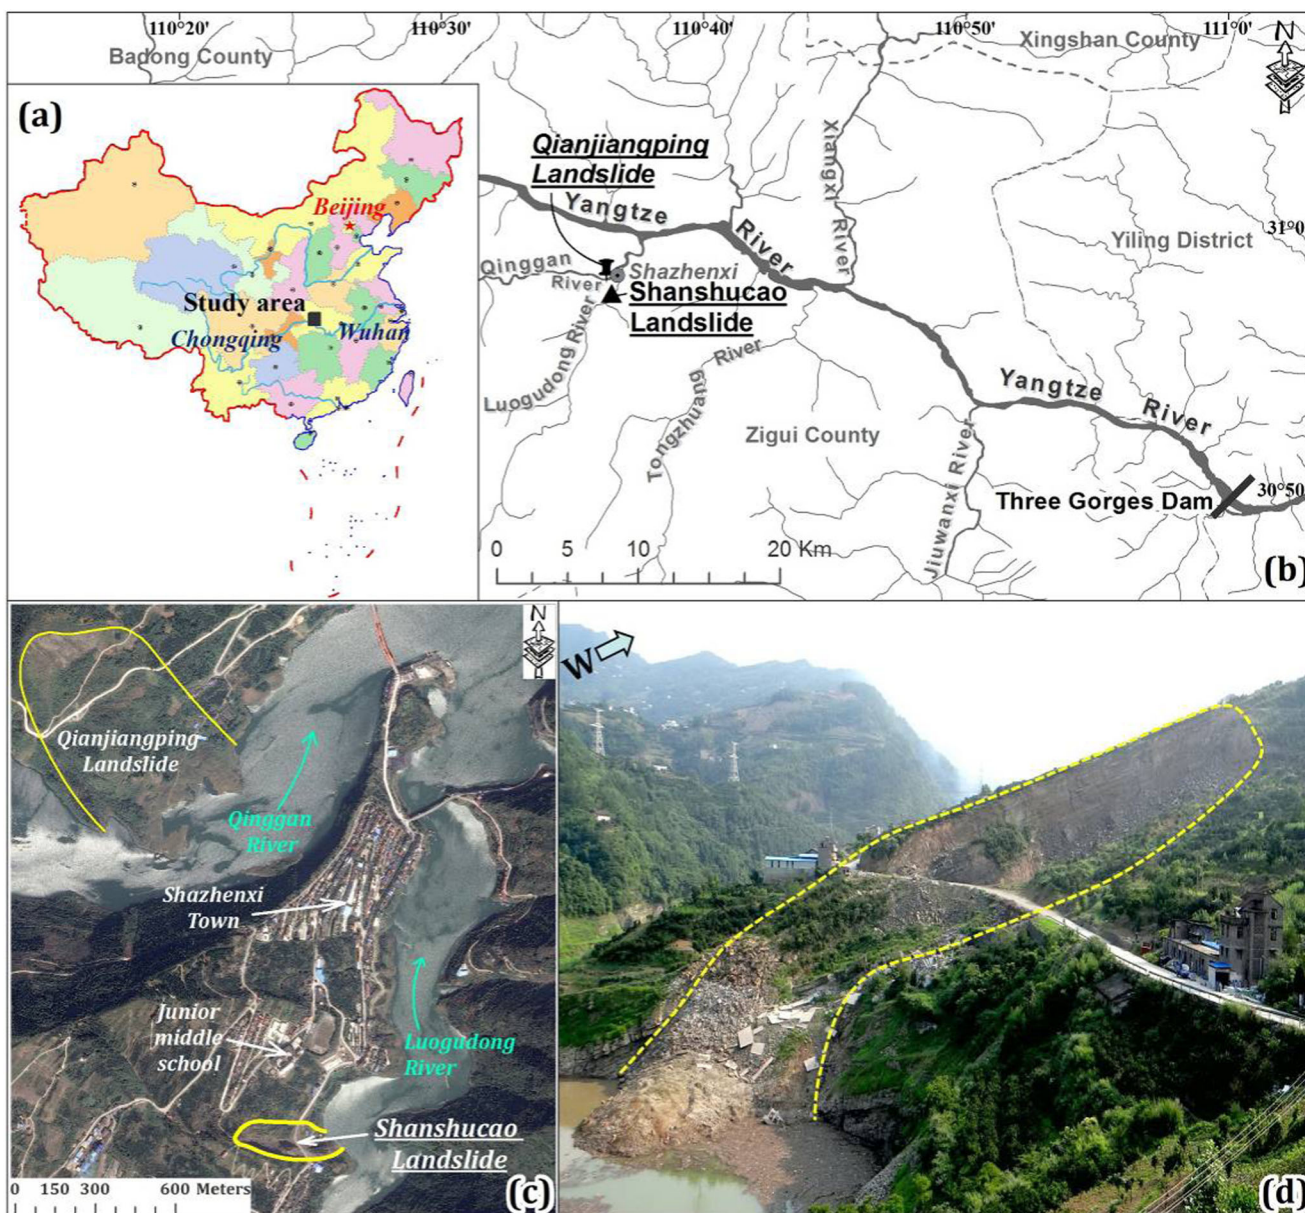
Fig. 1 Location and general overview of the Shanshucao landslide. **a** Location in China; **b** location in the Three Gorges Reservoir; **c** location in the town of Shazhenxi; and **d** general view of the southern rocky part of the failed landslide

houses, pressure pipes, an impounding forebay, and a 5-story dormitory were destroyed (Fig. 1 d). In addition, 160 m of national highway (G348) was interrupted, and an area of approximately 0.2 million m² of citrus trees was seriously damaged (Huang et al. 2015; Xu et al. 2015). Fortunately, there were no fatalities in this event because the local residents reported clues of slope deformation in a timely manner; then, the landslide specialists and governmental officials made a prompt collaborative decision to evacuate all relevant personnel before the failure occurred (Huang et al. 2015).

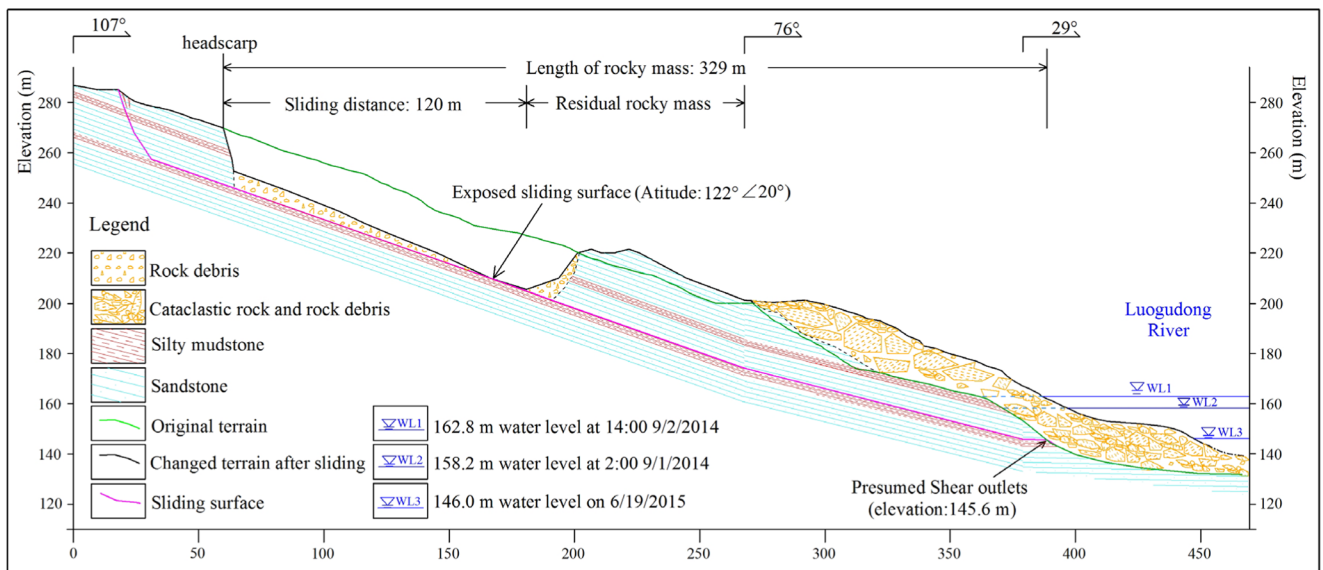
Fig. 3 The longitudinal section sketch (line 1–1' in Fig. 2) of the main rocky part of the Shanshucao landslide

Lithologically, the combination of the thick layered sandstones with interbedded thin to medium layered, silty mudstones could be observed on the scarp (Fig. 7b, c). Obviously, the soft silty mudstones were broken because of their weak anti-weathering ability, but the hard sandstones were the complete opposite. Moreover, the sliding surfaces formed easily along the interface between the upper sandstones and lower silty mudstones, e.g., both the lower bedding surface and upper bedding surface in Fig. 7 were sliding surfaces (Fig. 3).

The main rock sliding zone (I in Fig. 13 b, c) moved significantly over a long distance, which resulted in a deep trough on the real surface and many broken rocks covered on the sliding surface (Figs. 3, 7). Accordingly, a residual rocky mass was left in the eastern area and was divided into two parts because of the re-excavation of the G348 highway; the western part became isolated, broken rocky cones with some living trees on top, the eastern part became a broken rock sliding mass with fan-shaped cracks on the back, and there was an obvious sliding tongue in the front riverbed.

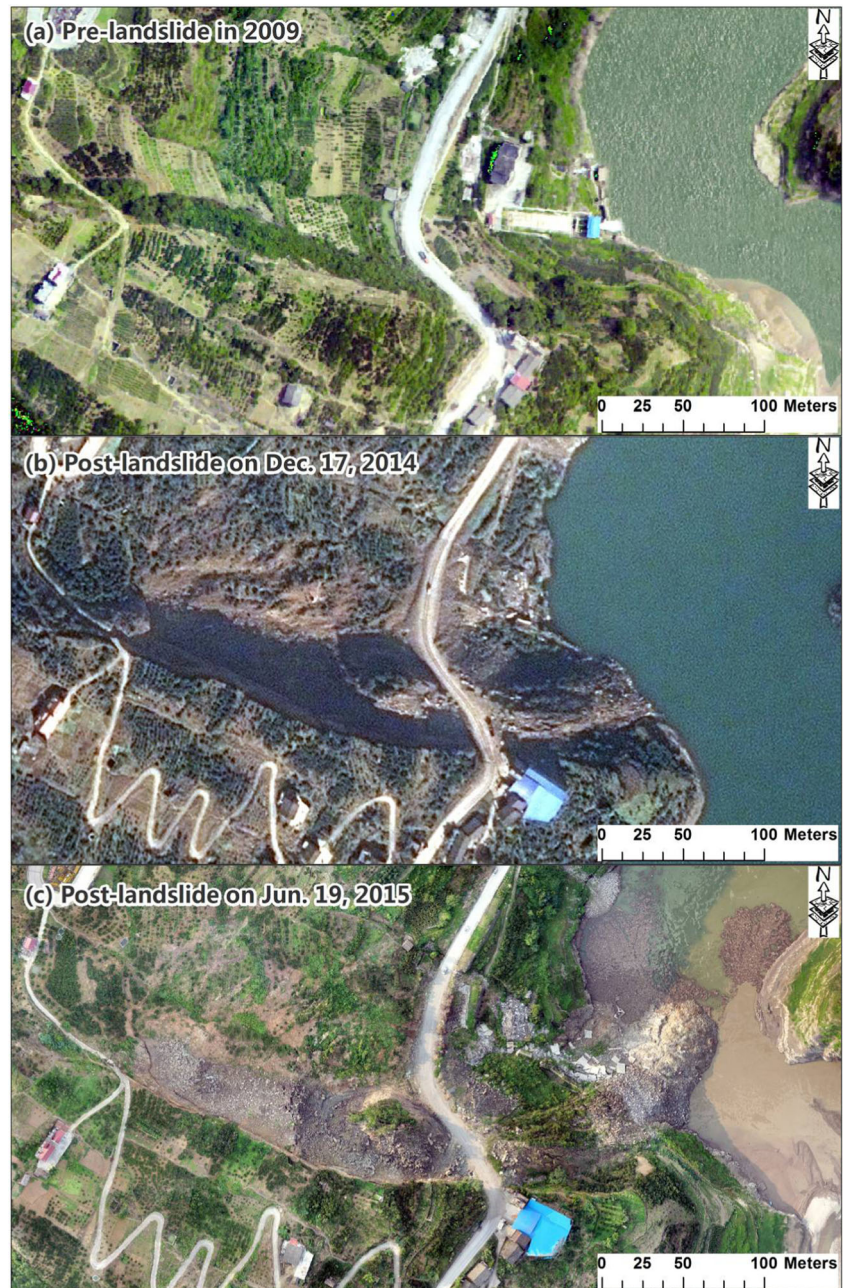
Fig. 4 Three periods of multi-source remote sensing images of the Shanshucao landslide. **a** aerophotographic orthomosaic of the pre-landslide area in 2009; **b** satellite image of the post-landslide area on Dec. 17, 2014, which was obtained from Google Earth; and **c** micro-UAV based orthomosaic of the post-landslide area on June 19, 2015

To understand the sudden movement characteristics and patterns of the Shanshucao landslide, three periods (one pre-landslide and two post-landslide) of high-resolution images and terrain data were collected (Table 1, Fig. 4) as follows:

(1) Georeferenced, aerophotographic orthomosaic with an approximately 20 cm ground sampling distance (GSD) (Fig. 4 a) and corresponding 2009 1:2000 topographic map. These unique image and terrain data of the pre-

(2) Georeferenced satellite image with an approximate 1 m GSD for Dec. 17, 2014, which was obtained from Google Earth (Fig. 4b). Although the image had a relatively low spatial resolution and relatively high shading, it differed significantly from the other images with respect to texture and color. This image could more accurately reflect the surface features (especially the sliding soil mass) of the post-landslide area, because the image was captured in winter after only three months, and the

- (3) Georeferenced orthomosaic (Fig. 4c) and digital surface model (DSM) with 3.6 cm GSD, which was captured by a micro-UAV system (Fig. 5) on June 19, 2015, and generated by photogrammetry (Westoby et al. 2012;

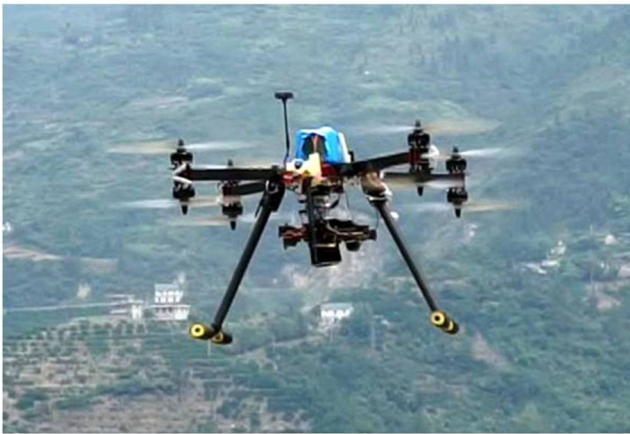
Fig. 5 The micro-UAV that was used to capture photos and generate georeferenced orthomosaic and DSM of the post-landslide area on June 19, 2015

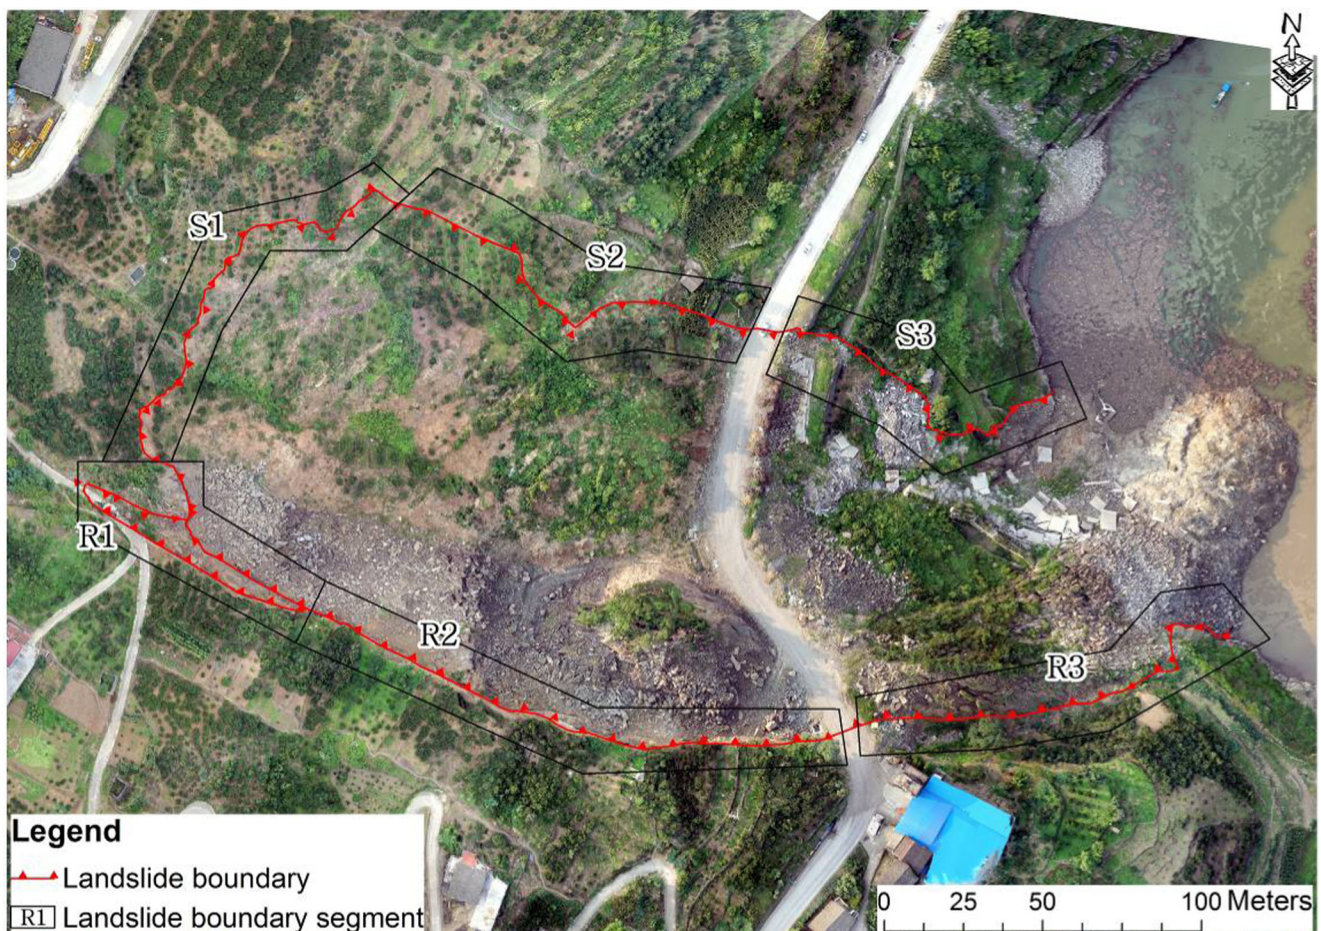
Fig. 6 Boundary of the Shanshucao landslide; the base map is the micro-UAV based orthomosaic from June 19, 2015

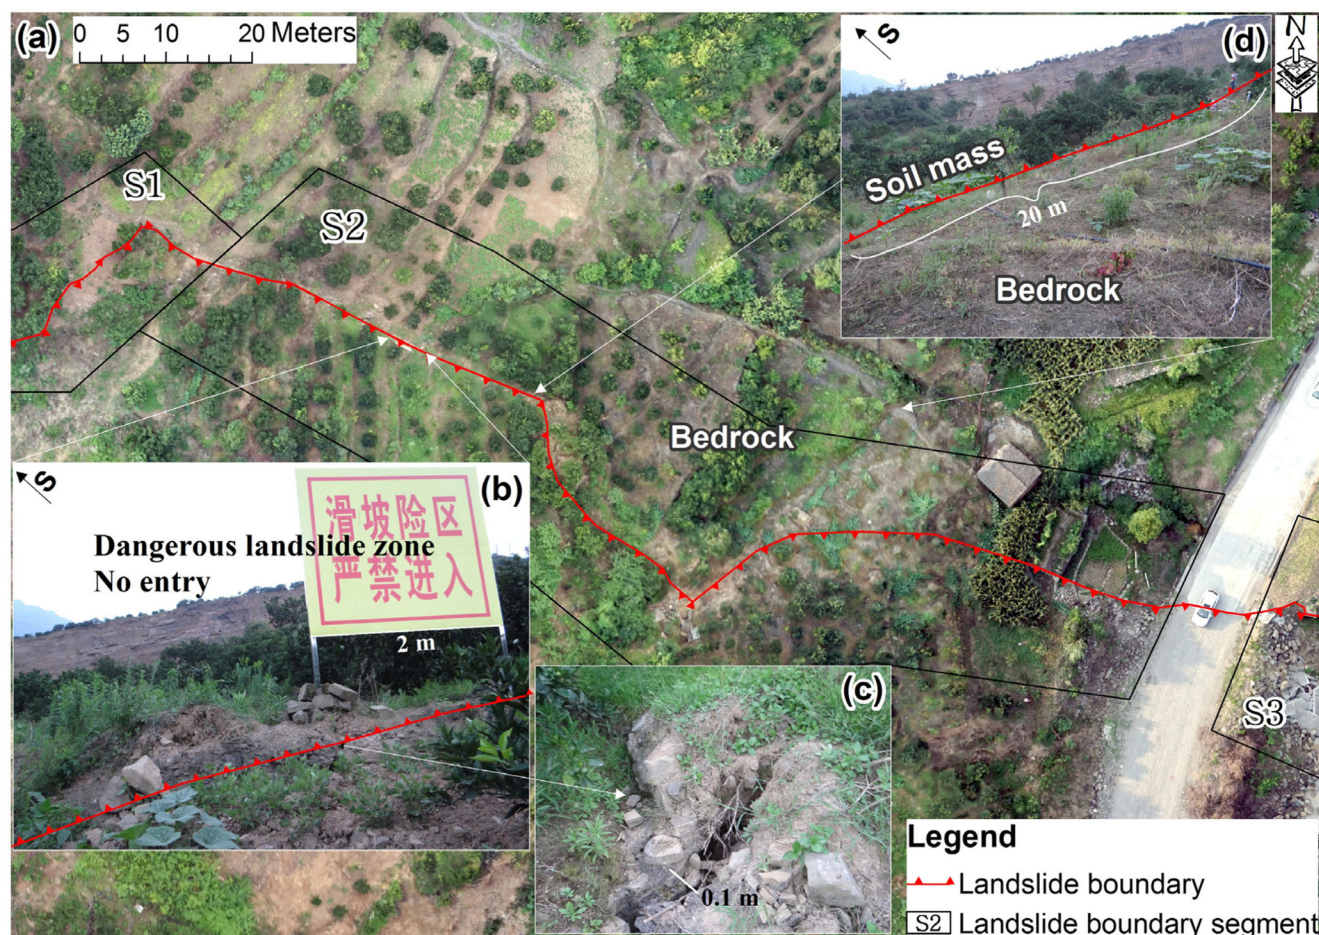
It was difficult to identify this part of the boundary based only on the orthomosaic because no obvious material collapse or lateral scarp could be found. By means of a field survey, the boundary was delineated. In contrast to the soil headscarp, bedrock could be found on the outside of the soil mass (Fig. 11a). The upper part of the boundary was formed by a straight crack (Fig. 11a, b). Even more interesting, the crack was not sheared but was tensional (Fig. 11b, c), which meant that this part might not have slid along the main direction, but instead,

Fig. 11 Features of segment S2 (in Fig. 6) of the Shanshucao landslide boundary; the base map is the micro-UAV based orthomosaic from June 19, 2015. **a** Overall view of S2; **b** straight crack boundary of the upper part; **c** tensional crack boundary; and **d** hindered boundary with bedrock in the lower part

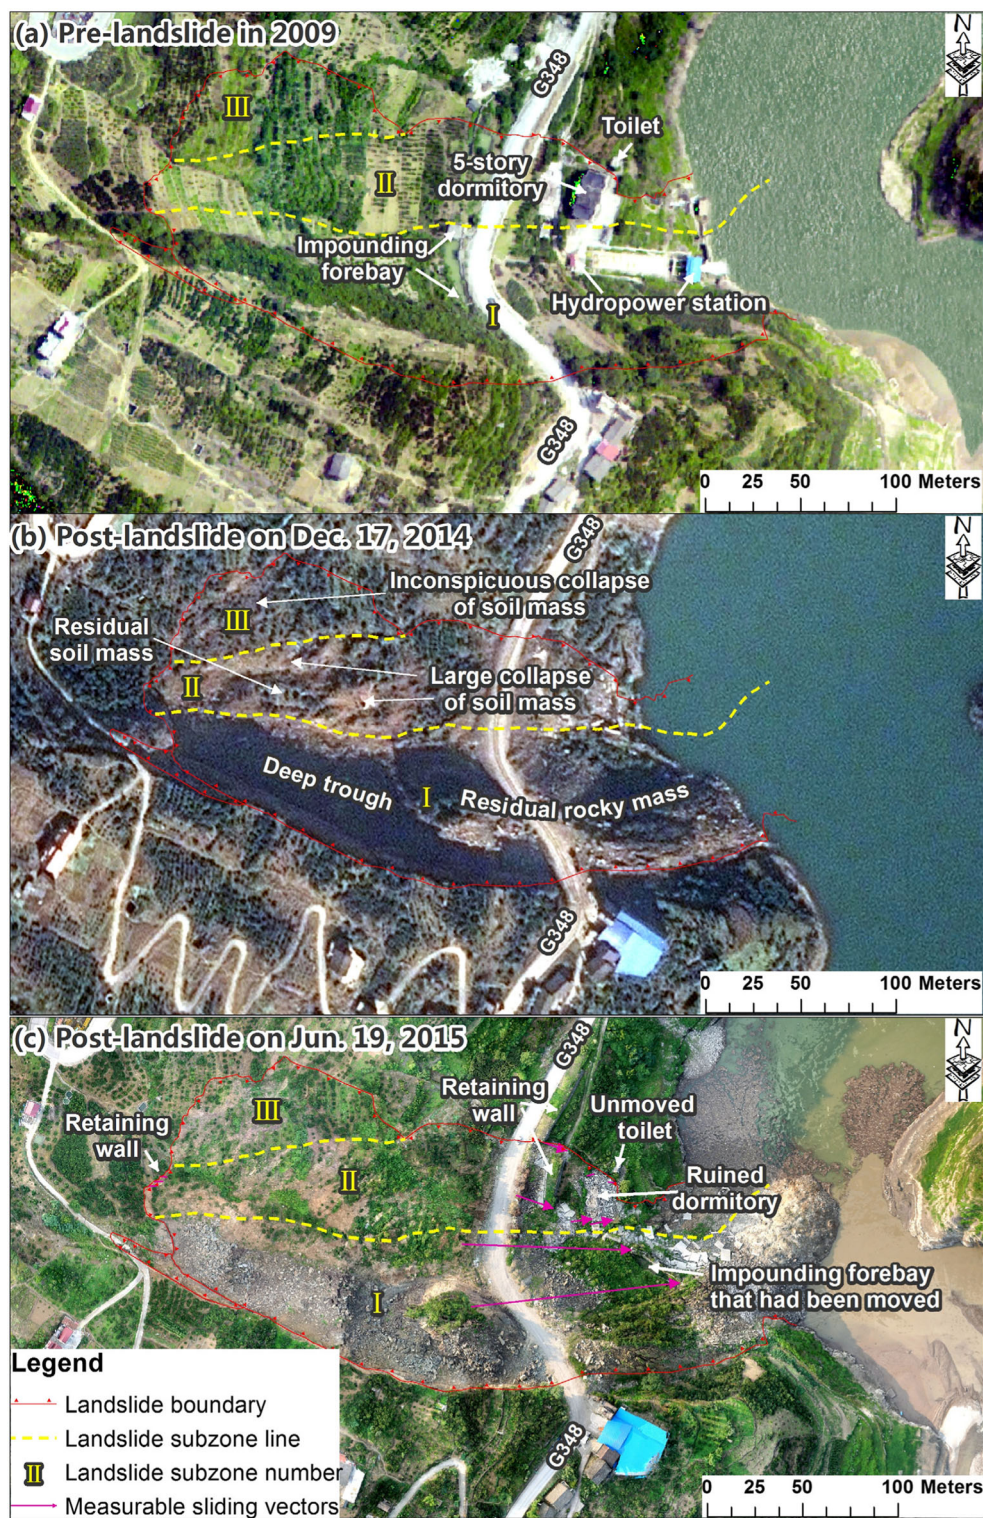
(Fig. 13): the main rock sliding zone (I), the main tractive soil sliding zone (II), and the secondary tractive soil sliding zone (III). This differs from other studies (Huang et al. 2015; Xu et al. 2015).

According to the difference in materials and measurable sliding vectors, the boundary was delineated between zones I and II. In the western part of G348, a disturbed loose soil mass could be easily identified in zone II (Fig. 13 b). In the eastern part of G348, the impounding forebay moved 89–110 m along a 92–83° direction, while the retaining wall of G348 moved 14–21 m along a 110° direction, and the 5-story dormitory moved 4–12 m along a 77–96° direction; the

obvious difference meant that these objects lay in different zones (Fig. 13a, c). Moreover, in the satellite image of Dec. 17, 2014 obtained from Google Earth, the collapse of two large soil masses and a residual soil mass could be observed in the western part of G348 (Fig. 13b), which implied strong traction in zone II with the movement of zone I.

Fig. 13 Three subzones of the Shanshucao landslide. **a** aerophotographic orthomosaic of the pre-landslide area in 2009; **b** satellite image of the post-landslide area on Dec. 17, 2014, which was obtained from Google Earth; and **c** micro-UAV based orthomosaic of the post-landslide area on June 19, 2015

- (1) In zone I, the northern end of the concrete wall of the impounding forebay moved 89 m/92° (distance/azimuth) and the southern end moved 110 m/83° (the impounding forebay could be clearly distinguished on Fig. 13a at pre-landslide and on Fig. 13c at post-landslide). This implied the residual broken rocky cones should be the head part of the main rock sliding mass; therefore, the sliding distance of zone I was approximately 110 m. With respect to the sliding direction, the western part above the original impounding forebay slid along an average direction of 106°; the middle part, where the original impounding forebay extended to the river bank, showed the characteristics of forward extrusion, which extended from more than 90° to less than 80° under the bank block. In addition, when the sliding mass moved through the bank, the movement direction changed to 45°, and the eastern part formed a sliding tongue on the riverbed.

masses was observed on both sides with a residual soil mass in the middle (Fig. 13 b).

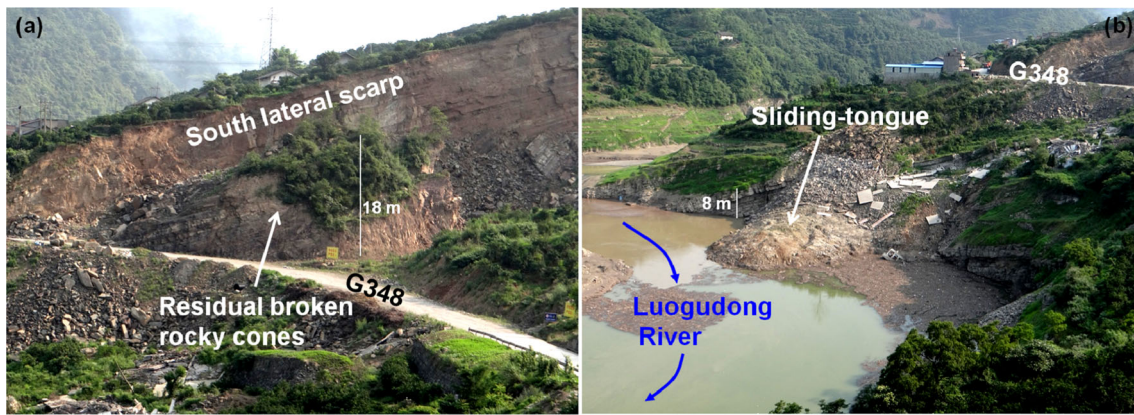
distance and deepest sliding surface. Moreover, the rear section of the rocky sliding mass was reshaped into isolated, broken rocky cones because of re-excavation of the G348 highway (Fig. 15a), and a typical sliding tongue was formed on the front riverbed (Fig. 15b).

Fig. 15 Photos of the rear and front parts of the southern rocky sliding mass. **a** The residual broken rocky cones above G348 and **b** sliding tongue on the front riverbed

Figure 15a shows that the residual broken rocky mass and the southern lateral scarp were in complete agreement with the original sediments and occurrence, which indicated that the rocky sliding was a typical translational movement, and this has been recognized in Huang et al. (2015), Wang and Yi (2015), and Xu et al. (2015). Therefore, if some true sliding surfaces could be found in the landslide body, the accurate shear outlet altitude could be deduced by the position and the unchangeable occurrence of the sliding surface. Fortunately, one such exposed smooth sliding surface with an area of approximately 10 m^2 was found in the rock debris accumulation (Fig. 19); the lithology was silty mudstone, and the dip direction and dip angle were $122^\circ/20^\circ$. Accordingly, based on the terrain of the area pre- and post-landslide and the exposed sliding surface, the longitudinal section sketch of the rocky sliding mass could be concluded as presented in Fig. 3. The altitude of shear outlets was 145.6 m, which is consistent with the result reported in Xu et al. (2015), while the 180 m reported by Huang et al. (2015) is an obvious error.

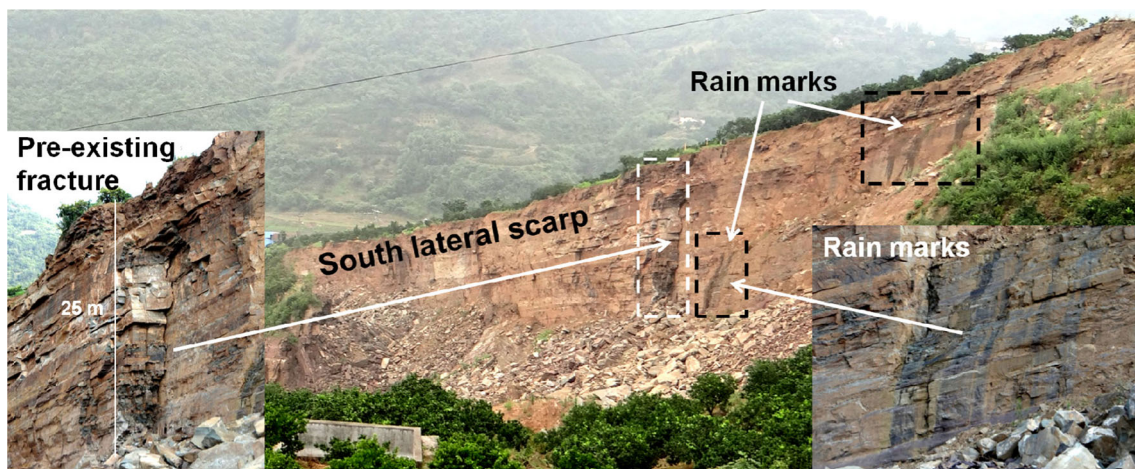
Fig. 18 The rain marks and residual crack on the south lateral scarp

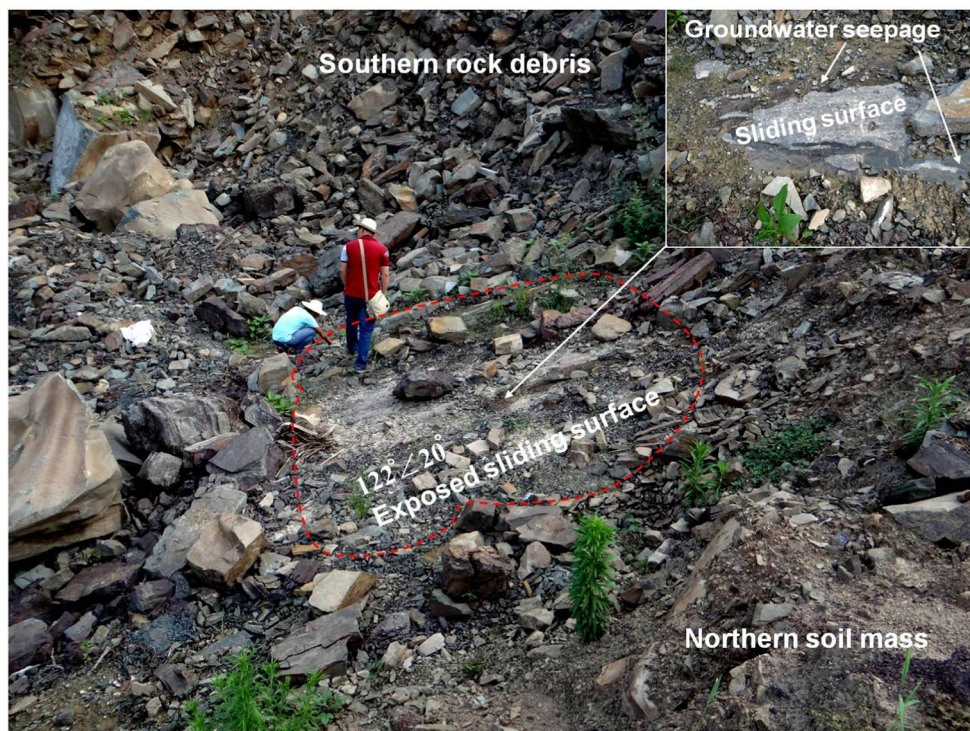
Fig. 19 The exposed sliding surface of the rocky landslide

On the other hand, according to the field survey, a slight amount of groundwater seepage was observed at the position where the exposed sliding surface was in contact with the overlying rock debris (Fig. 19). As the level of the original groundwater was low on the slope, the observed groundwater could only originate from the rainwater that infiltrated into the sliding mass and then flowed along the sliding surface. Therefore, two sets of tectonic fractures that pre-existed and were extremely developed provided many channels for rainfall infiltration (similar to the rain marks on the southern lateral scarp in Fig. 18), and the mudstone layers became the confining bed. The sliding surface became the impervious base of the channel through which the infiltrated groundwater flowed into the river. Under conditions of continuous heavy rain, a large amount of rainwater infiltrated into the landslide mass along two sets of tectonic fractures. Additionally, the groundwater discharged very slowly along the pelitic sliding surface, a large thrust was generated in the vertical fractures (i.e., the headscarp and southern lateral scarp after the sliding), and uplift pressure was generated above the sliding surface; both of these processes became the primary forces that triggered the sliding. In addition, the sliding surface formed by the mudstone was softened by the groundwater over a long period, which led to a considerable decrease in the shear strength (Stark et al. 2005; Xu et al. 2015) and then further aggravated the sliding. In summary, we believe, with reservations, that rainfall was the key trigger of the rocky sliding. To clarify the mechanism of the Shanshucao landslide, numerical simulation analysis of the rainfall impact, increase in river water, and leakage of tunnel pipelines is currently underway.
