Investigation of a methane flare during the excavation of the Silvan irrigation tunnel, Turkey

Abstract

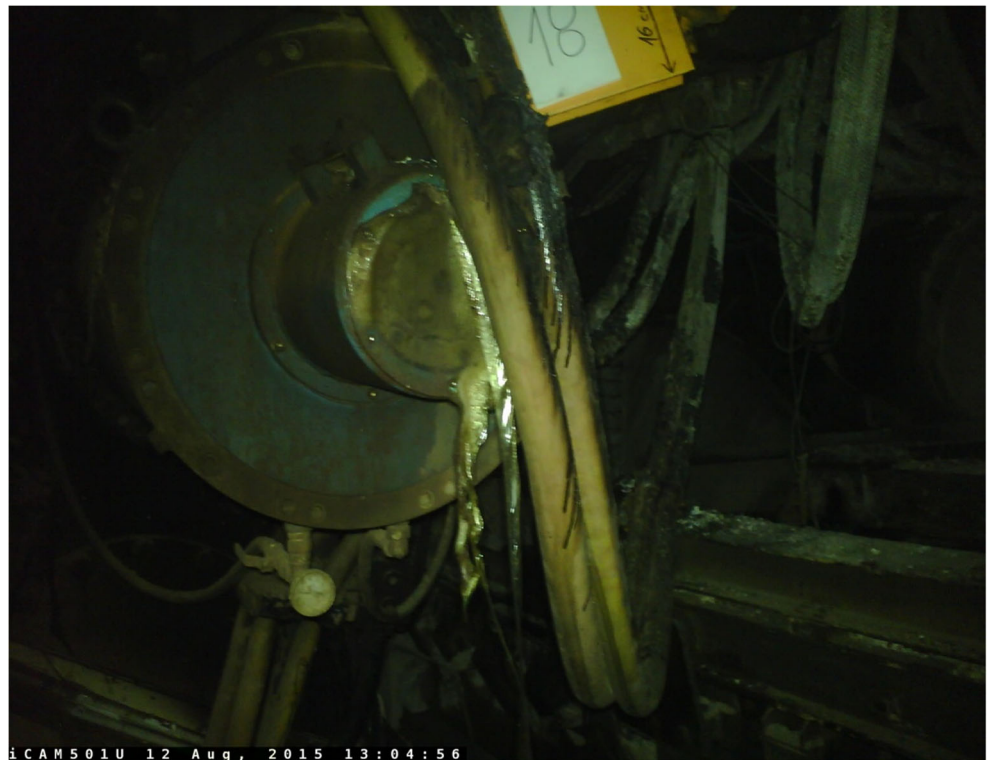
The main units of the TBM, such as telescopic shield pistons, hydraulic connections, cutterhead engines, the sensor camera close to the cutterhead and electrical wiring, were all badly damaged by the methane flare. The cutterhead unit was unusable and could not be repaired without the risk of igniting gas that continued to enter the excavations (Fig. 7). This unit was therefore left underground.

Fig. 7 The state of the cutterhead motor after the methane flare

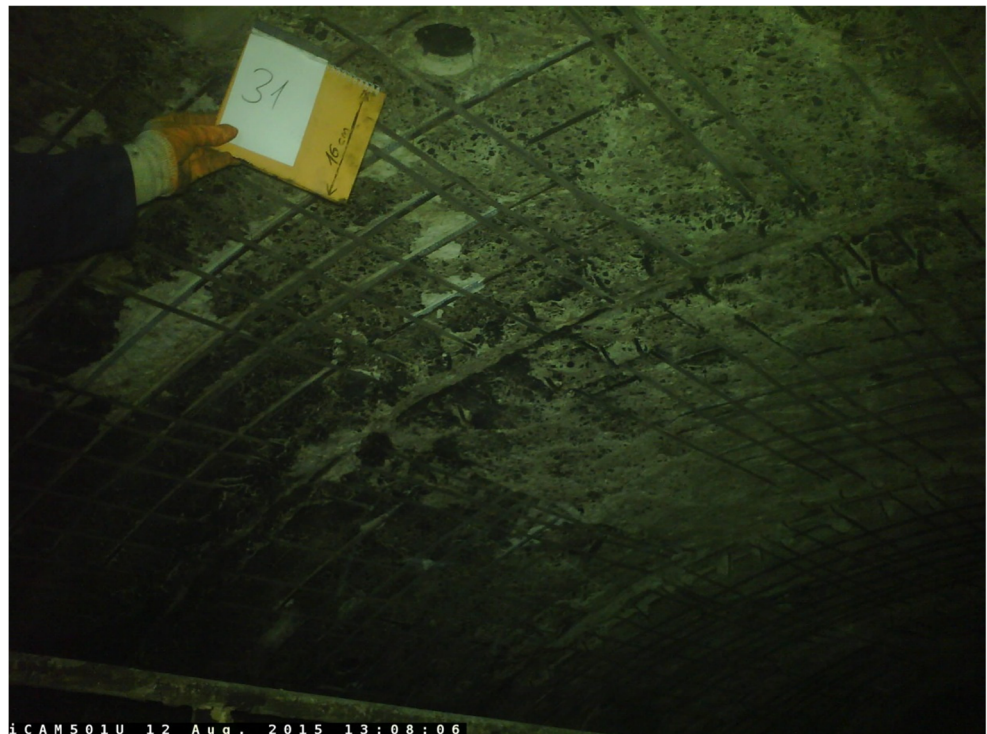
Superficial damage caused by the high temperature resulted in spalling to parts of the concrete segments as far as 48.50 m from the excavation face, revealing the reinforcement (Fig. 8). At this time the methane concentration was well above the acceptable limits and, therefore, a number of occupational health and safety measures were taken. These included uninterrupted 24-h air flow provided by three blower fans (90 kW, 20 m³/s) located at the tunnel entrance. A generator system that would provide automatic back-up power in the case of a power cut was installed to ensure the uninterrupted operation of the fans. Due to the leakage and resistance, only

Fig. 8 Spalling of concrete and exposed reinforcement due to heat damage in the roof of the tunnel
