Slope stability analysis of mine waste dumps at a mine site in Southeastern Nigeria

Abstract

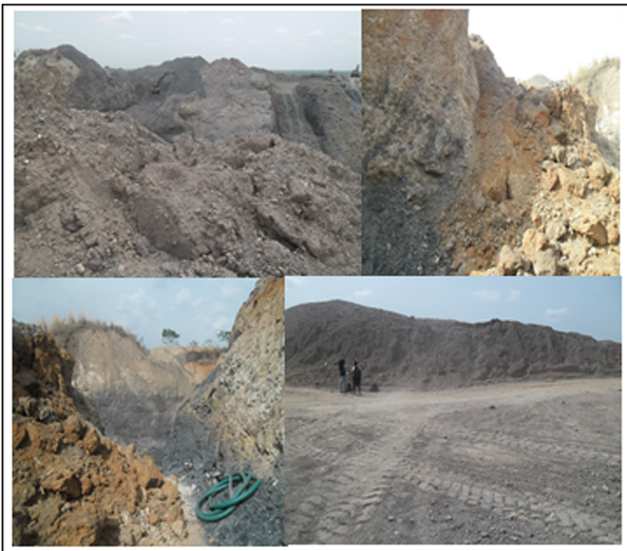
Fig. 1 Indiscriminate dumping in the mines

The study area (Enyigba and Ameri Mines) has Pb-Zn mineral deposits that are locally mined by the old open-pit mining method, and mine tailings are indiscriminately dumped internally within the areas (Fig. 1) in close proximity to the mines. The tailings are composed of ore and gangue minerals which when weathered release those composing heavy metals into the soil (Ezeh and Anike 2009). The tailing dump-sites are scattered within the localities, which cover an area of approximately 80 km² and are strategically located at about 14 km from Abakaliki (capital city of Ebonyi State, Nigeria) along the Abakaliki—Afikpo expressway (Igwe et al. 2012a, b). The surface topography has been greatly distorted, and there is severe environmental degradation.

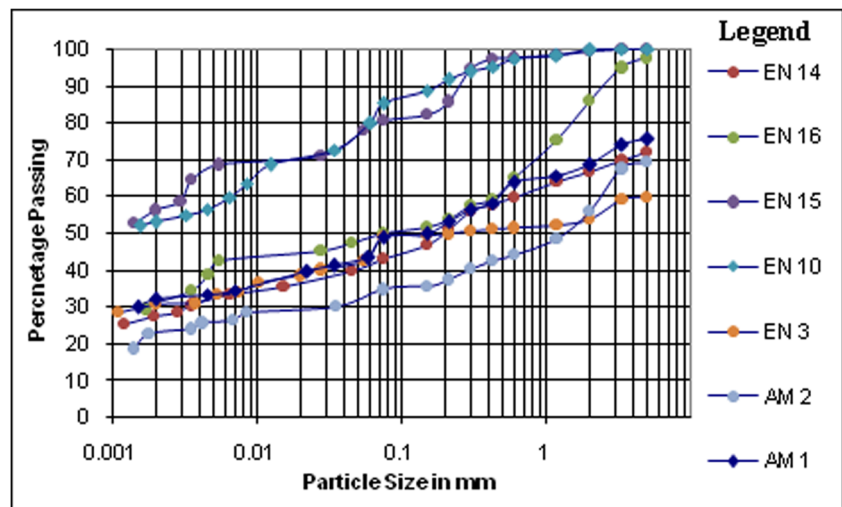
Fig. 5 Particle size distribution curve

Results obtained from this test are presented in Table 1. The particle size distribution revealed that the slope material comprises gravel ranging from 1.42 to 30.13%, sand ranging between 15.94 and 33.34%, silt ranging from 9.75 to 26.87% and clay ranging from 32.1 to 56.25%. This implies that clay dominates the slope materials. The high amounts of clay in the slope material at the mine sites also have strong implications

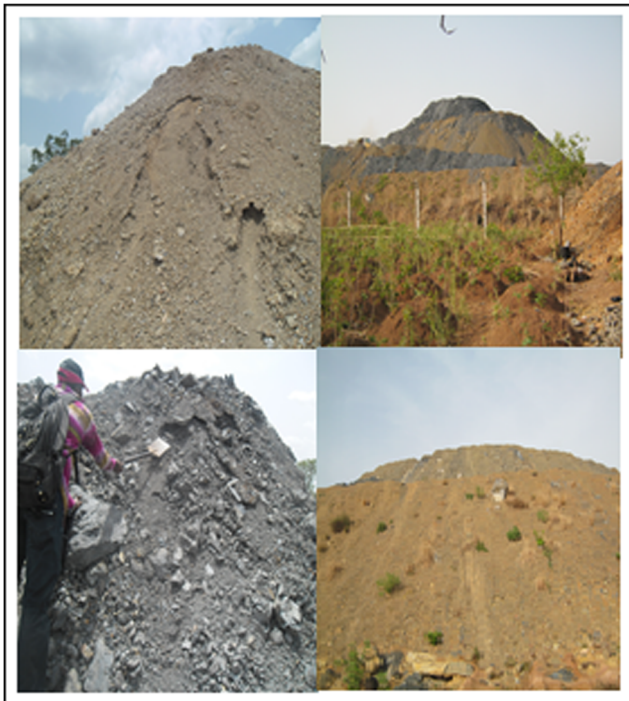
**Fig. 6** Conical hills of the dump at the mine site

Evidence of sliding surfaces and minor landslides were seen on the tailings (Fig. 6). Field observations showed that the landslides were more evident on the old tailings compared to the new ones and consist of mainly translational slides. Mud cracks were seen on the natural ground which is evidence of very fine clay materials in the area.

Most slopes were observed to be concave in curvature (Fig. 6), and from the field measurements, slope angles of the individual slopes ranged from 30 to 60° . The steep concave nature of the slopes and the inherent weakness (erosion) as observed at the two mine sites have important implications on the slope stability. Most landslide events have normally been reported to occur on concave slopes ranging between 36 and 58 slope angles (Mugagga 2011; Mugagga et al. 2011). A spatial correlation between landslide occurrence and topographical concavity has been noted by Mugagga (2011). Igwe (2015a) also reported that positive correlation exists between frequency of landslide and slope angle and noted that landslides occur more on slopes with angles greater than 30° but less than 40° . Thus, slope geometry could be one of the causes of the sliding surfaces as shown in Fig. 6, since it presents moderate to high slope angles.

sliding mass agree with the findings of other authors such as Maduka et al. 2016, who also noted that slope failures with these magnitudes of sliding masses could be described as intermediate to high landslide. The new mine dumps would likely undergo shallower landslides with slip surfaces ranging between 11 and 14 m when compared to the depth of 12–17 m of the old mine dumps (Figs. 14 and 13 respectively). These values and other disparities in failure parameters as seen in Figs. 13 and 14 could be as a result of differences in their level of compaction and cohesion. The friability of the new tailing dumps could be the reason for the shallow landslides observed in Fig. 6.

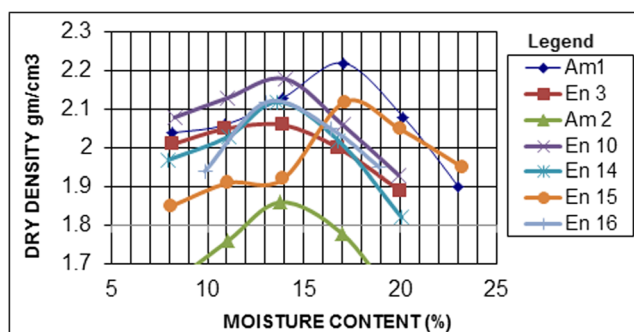
Fig. 8 Compaction curves of the samples

Figure 8 shows maximum dry density curves for the samples. It explains the maximum compaction of the soil at optimum water content and dry density. The compaction result showed that the soil optimum moisture content (OMC) ranges between 13.45 and 17.05%, while the maximum dry density (MDD) ranges from 1.86 to 2.22 g/cm^3 (Table 3). The curves represent that of low to medium plastic clays, which agrees with the consistency limits. At high water content, energy has little effect on the compacted density of a clay soil because the water is incompressible and takes the applied force without densifying the soil. Invariably, moderate OMC and moderate to high MDD suggest an intermediate to high density material.

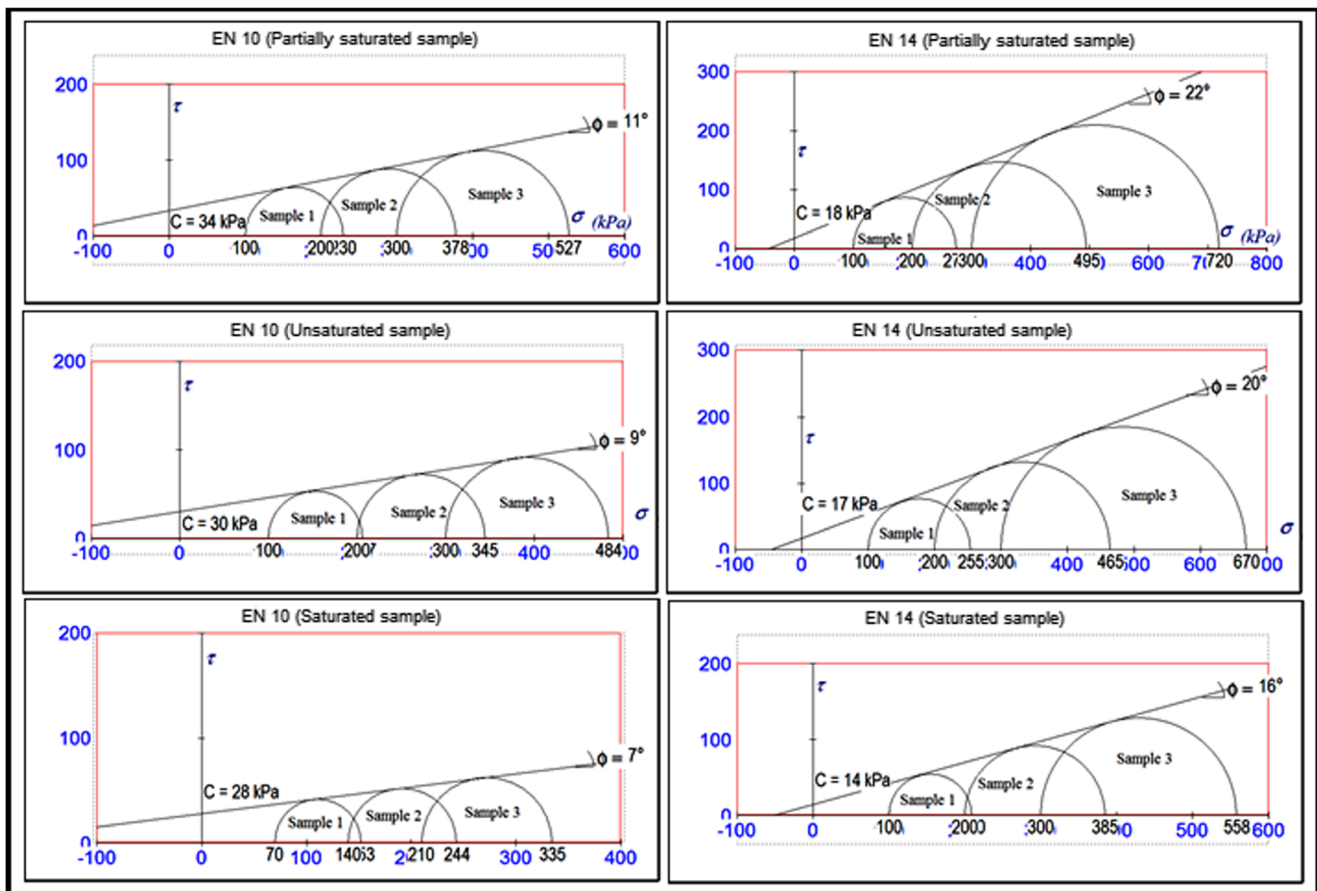
Fig. 9 Failure envelop showing strength parameters

This is one of the key tests in establishing the stability of a slope material as it indicates cohesion and angle of internal friction of the material. Gupta and Paul (2016) clearly stated that slope stability is ultimately determined by two factors; the slope geometry and the strength of the materials on it. The range of the angle of internal friction and cohesion are 8–37° and 13–34 kN/m² respectively (Table 3). These results implied low-moderate values of cohesion and low values of internal friction angle for AM1, EN3, EN10, EN 15 and EN 16 (Table 3). Some of the samples' failure envelopes are shown in Fig. 9.

It was observed that AM 2 is the least cohesive and has the highest angle of internal friction. This confirms the cohesionless nature (low clay content and plasticity) of the material. The low shear strength of AM 2 could be a result of the presence of expansive minerals. Blyth and de Feritas (1984) postulated that the strength of any rock or soil where permeability prevents the draining of water in the voids would be reduced by any increase in hydrostatic pore pressure that develops within them as observed in Fig. 9. Water-infiltration weakens slopes and induces failure by reducing suction and strength (Crosta and Frattini 2008; Igwe and Fukuoka 2014;

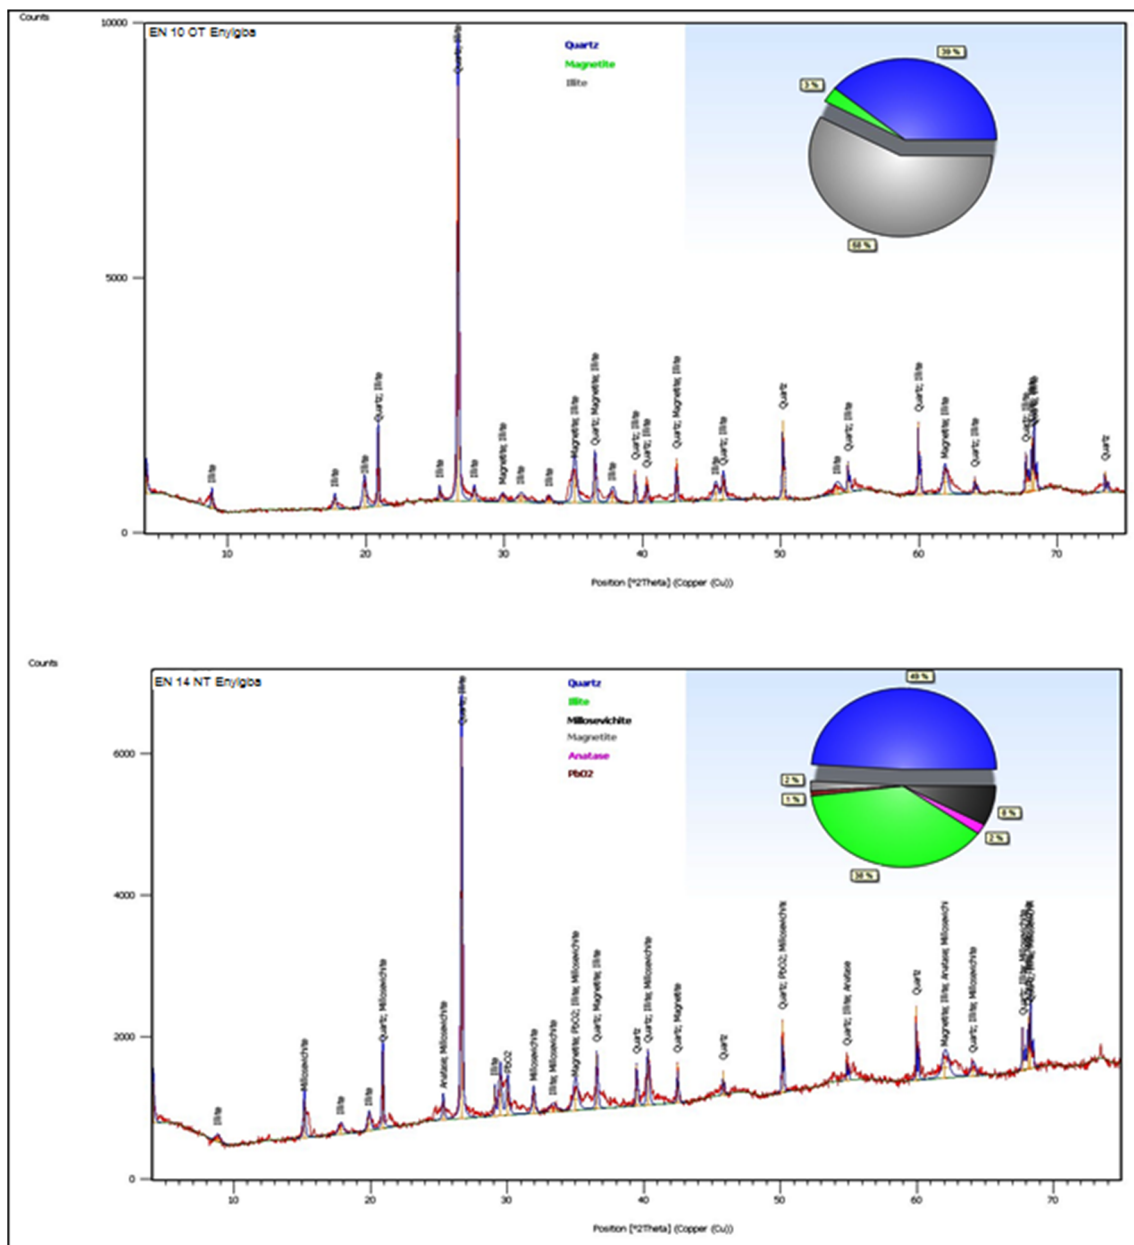
Fig. 10 XRD showing the mineral components of the samples

The XRD result showing the minerals present in soil is given in Fig. 10. The presence of illite indicates plasticity of the soil due to its swelling ability. There is evidence of the shrink-swell ability of the soils in the form of voids or desiccation cracks within the site (Fig. 11). The presence of clay minerals could give more plasticity to the soil, which is one of the most important causes of slope failure (Behera et al. 2016). Previous authors (Kitutu et al. 2009; Ohlmacher 2000; Yalcin 2007) have observed the role of dominant plastic clay minerals in landslide occurrence owing to their low shear strength and high swelling potential.

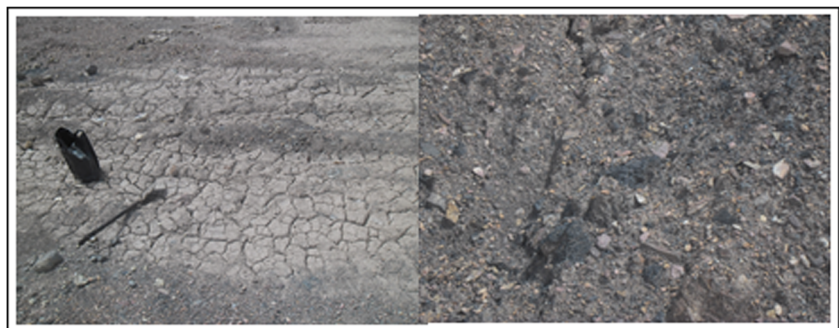
Fig. 11 Evidence of smectite minerals, soil plasticity and flooding

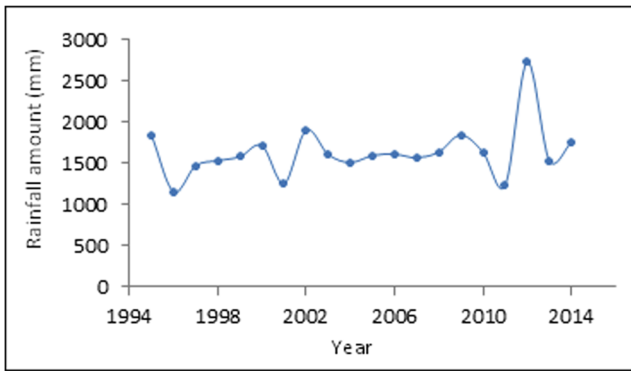
Fig. 12 Rainfall data of the study area

the area (Fig. 12), it is evident that the study area has very high cumulative annual rainfall that could be as high as 1200 mm and sometimes up to 2500 mm. This high rainfall pattern could be detrimental to the stability of the tailing dump slopes. High rainfall may result in high infiltration and seepage through the dump slope, and thus increase pore pressure within the tailing dumps which thereby undermines the shear strength of the materials (Verma et al. 2013). The decrease in shear strength could initiate movement in the tailing dump slope along weak planes (Behera et al. 2016). As the erratic increase in rainfall continues, there will be a need to make adequate preparations for stabilization works in order to prevent the occurrence of landslides.

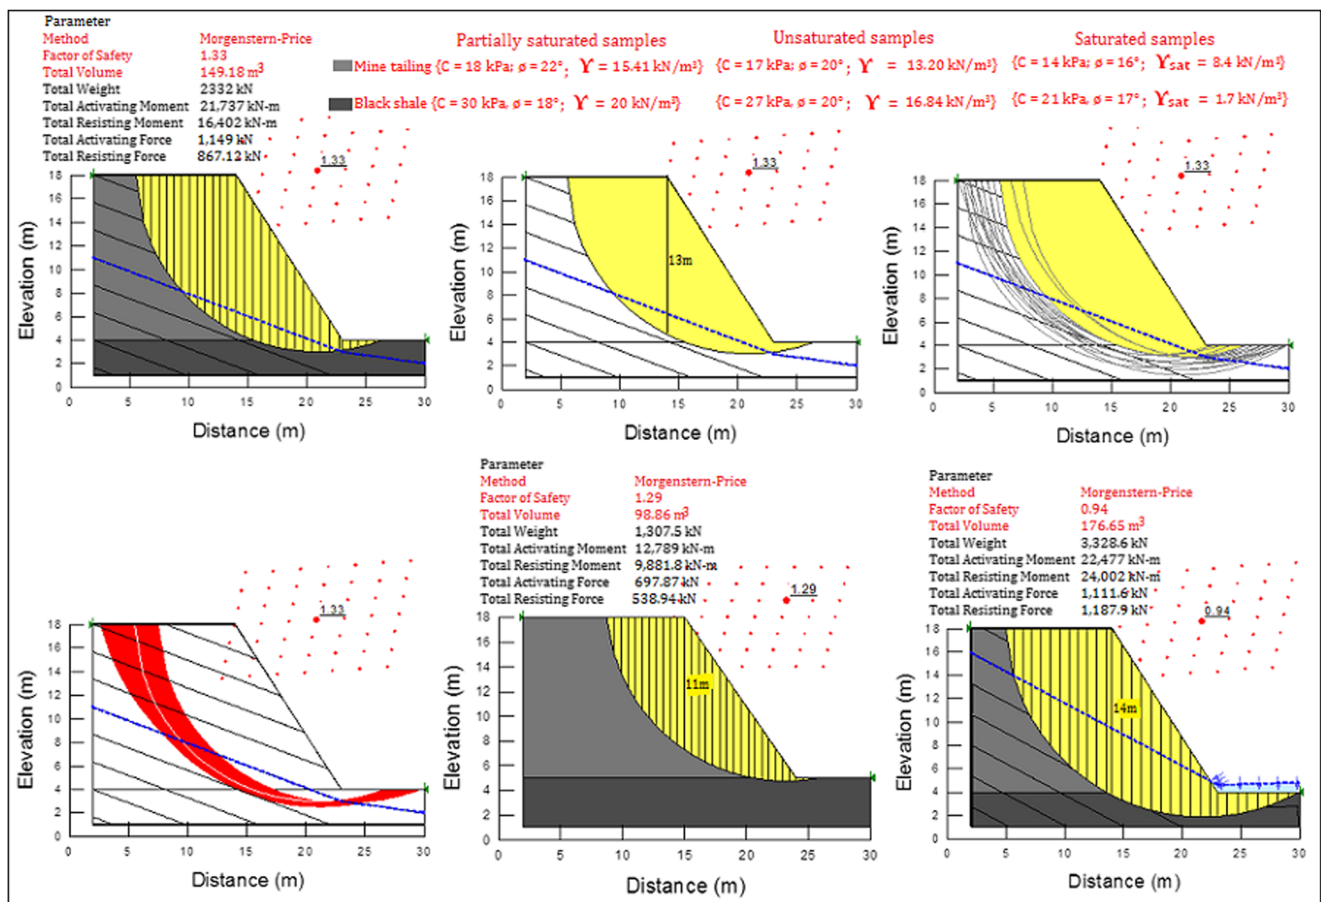
Fig. 14 New mine tailing slope stability model

Stability analyses of several slopes of the Enyigba mine dumps were evaluated, and their factor of safety (FS) computed. Figures 13 and 14 are the stability analysis of slopes EN10 and EN14, and the computed FS were 1.27 and 1.33, suggesting fairly stable slopes (Figs. 13a and 14a). The FS of the other slopes analysed ranges from 1.00 to 1.30, implying critically to fairly stable slopes (Table 4). These factors of safety were recorded at the onset of the rainy season. At this time of the year, the slope materials could be partially saturated, with little water in the dumps. A back analysis performed on the samples to represent the unsaturated state of the slopes in the dry season showed FS of 1.10 and 1.29 (Figs. 13e and 14e), which is a reduction in the stability of the slopes. The higher FS recorded at the start of the rainy season could be as a result of the shear strength mobilized by the tailings due to suction.

stable. This fall in FS was also observed on the new mine tailing slope, where the FS dropped to 0.94 (Fig. 14f).

It is important to note that water in and around the slopes could increase the volume of the sliding materials. The sliding masses increased from 156 m^3 to 292 m^3 and 99 m^3 to 176 m^3 as water content increased within the slopes at the old and new tailing dumps as seen in Figs. 13 and 14. These increases in

Several trial slip surfaces were analysed on the modeled slopes (Fig. 13c and 14c) to produce a safety map for each. A safety map reflects a zone of potential failure in which the factors of safety of the trial slip surfaces are similar. Although the FS for the trial slip surfaces range from 1.27 to 1.75 for the old tailing dump and 1.33 to 1.44 for the new dump, the safety zone ranges between $FS = 1.27\text{--}1.32$ and $1.33\text{--}1.38$ for the old and new tailing dumps respectively. The safe zones are the area covered by the red band (Figs. 13d and 14d), and all the factors of safety within the region indicated a fairly good stability. It is important, however, to state that even slopes with $FS > 1$ are conditionally stable (Mugagga et al. 2011). This could be the appropriate description of allegedly stable slopes because slope failure often occurs as a result of localized

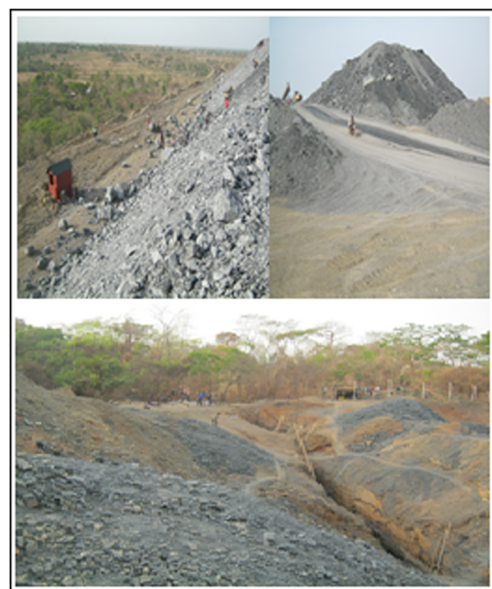
Fig. 15 The dangerous closeness of the tailings to the mines

within the mine sites. Therefore, stabilization of the slope is needful, particularly on slopes in proximity to the mining pits (Fig. 15), though only shallow landslides are evident on the
