A case study of a rainfall-induced landslide involving weak interlayer and its treatment using the siphon drainage method

Abstract

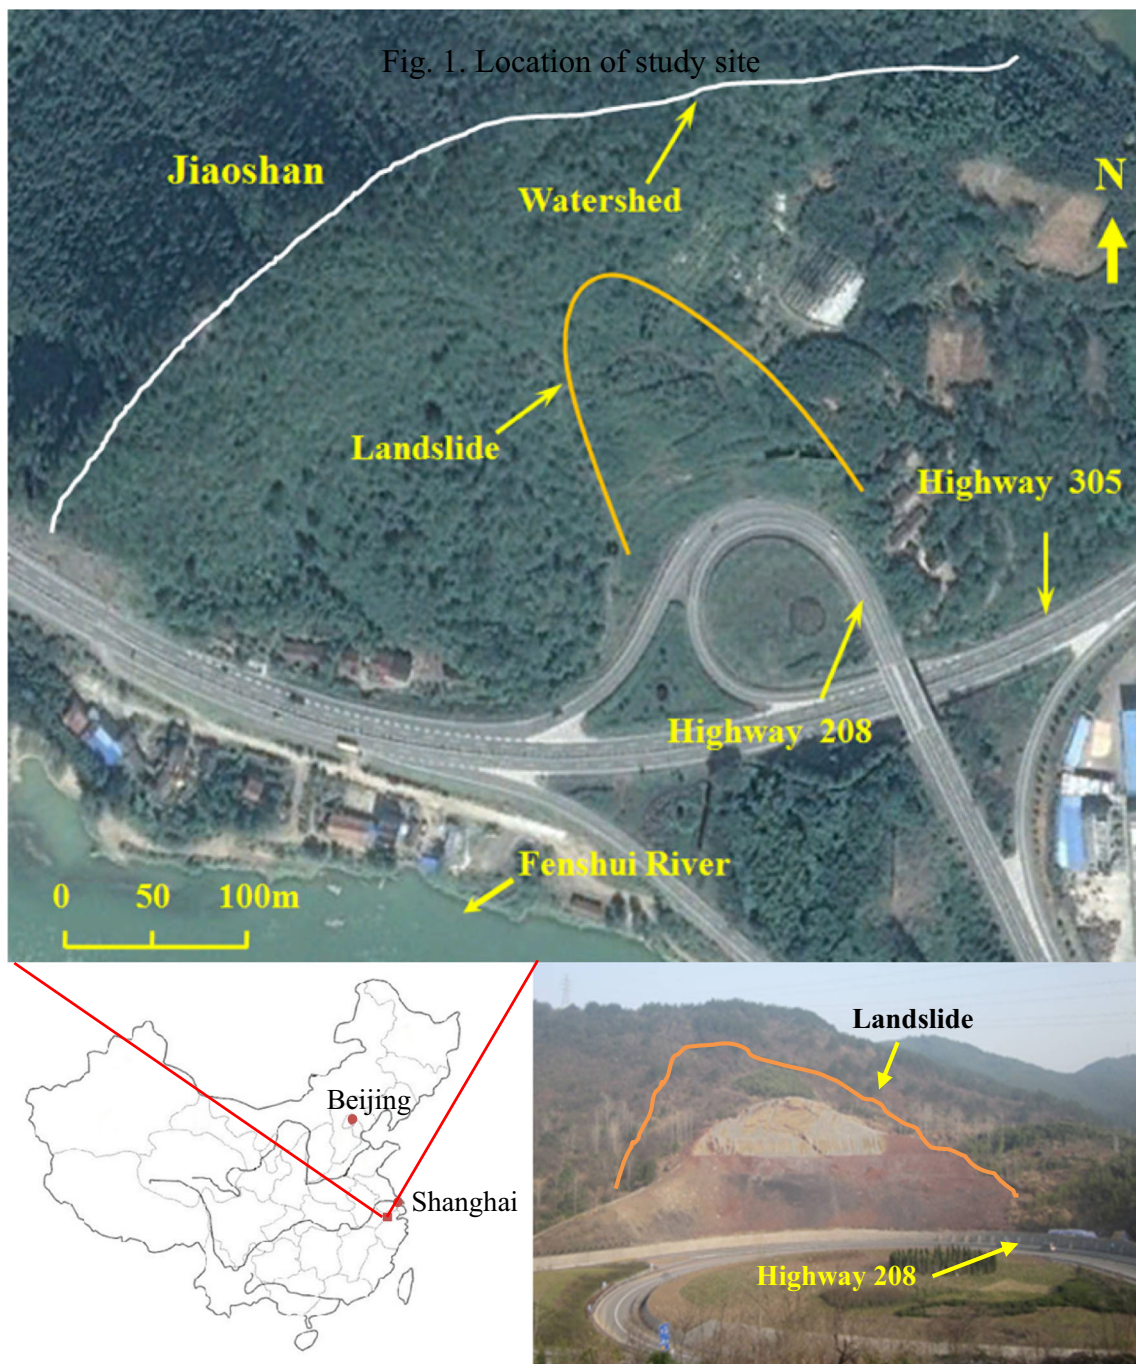
Fig. 1 Location of study area

The Houpucun landslide is located in Tonglu County, Zhejiang Province of China, which is excavated due to the construction of an interchange ramp of Highway 208, as shown in Fig. 1. The peak elevation of the nearby Jiaoshan Mountain is approximately 166.8 m. The original gradient of the terrain is approximately 25 to 40° above the elevation of 100 m and is approximately 15 to 25° below 100 m. Because of the construction of the Highway 208, the slope is currently cut into approximately 30 to 40° at the toe.

The construction of Highway 208 completed in December 2004, and the slope shape at that time is shown in the photo at the lower right corner of Fig. 1. At the beginning of 2005, the slope experienced creep deformation affected by rainfall. The sliding produced multiple tension cracks on the slope surface, and some cracks exhibited an increasing tendency. Some countermeasures, including cutting down the slope and building intercepting and drainage ditches, were then put in place. Unfortunately, in 2011, the slope was subjected to persistent rainfall and showed a tendency toward accelerated sliding and stability deterioration, producing local uplift on the leading edge and obvious tensile deformation on the trailing edge. In July of 2014, according to field observation, small scale toppling, faulting and fracturing occurred in the previously built retaining wall and intercepting ditch, as shown in Fig. 3a.

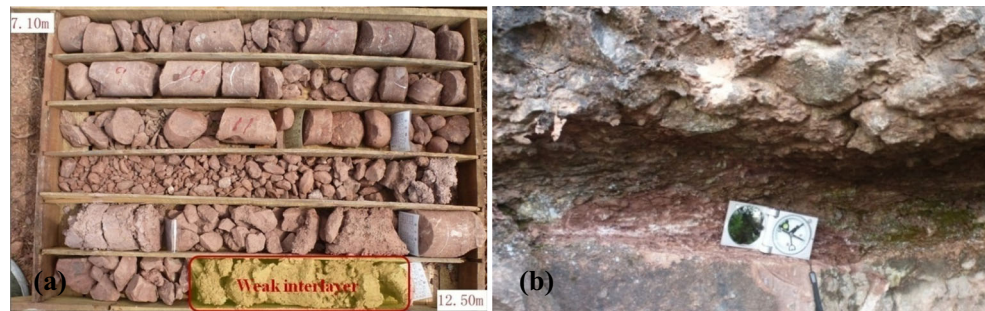
Fig. 2 The weak interlayer exposed by drill core and outcrops: **a** weak interlayer in the conglomerates and **b** tuffaceous siltstone

(P_{1q}), conglomerates, tuffaceous siltstone and welded tuff of the Jurassic Laocun Formation (J_{3l}), and eluvial gravel interbedded with clay of Quaternary Holocene (Q₄). As revealed by borehole data, the conglomerates and tuffaceous siltstone in the study area are intercalated with weak layers. These weak layers are generally lenticular and discontinuous; most are approximately 0.1 to 4.0 m in thickness. The lengths of these layers are approximately 5 to 50 m. According to the drill core (Fig. 2a), the weak interlayer in conglomerate presents cataclastic state with some gravels (diameter of 0.5 to 2 cm), while original rock is black shale with purple tuffaceous siltstone and muddy cementation. The interlayer in tuffaceous sandstone is relatively thin, with fine particles and low strength (Fig. 2b). The results of laboratory tests show that the mechanical strength of the weak interlayer is very different between the saturated and natural state.

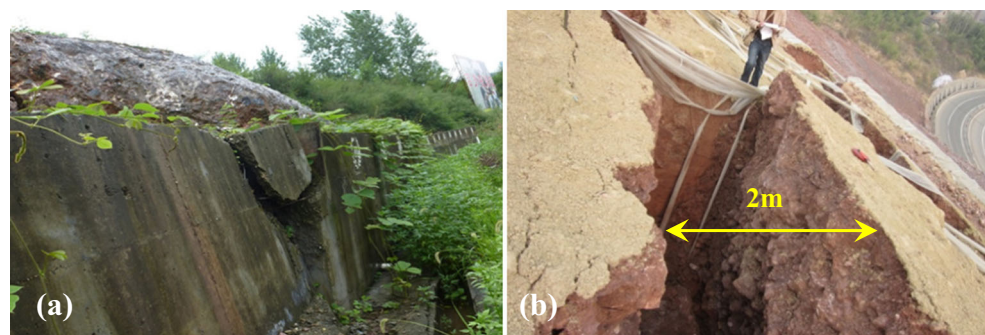
Fig. 3 **a** Local fracture on the concrete retaining wall; **b** characteristics of the deep tension crack

After several slip deformations, a series of tension cracks developed on the slope surface between the elevation of 50 m and 110 m, with lateral distribution in a range of 100 m. Field investigation shows that the total number of cracks on the slope surface reached 24, and these cracks are mostly between 20 and 40 m in length and approximately 0.3 to 2 m in width. Most of the cracks are vertical, and their shapes are mainly arc-shaped in the plane. The deepest crack is located in the front of the slope, at an elevation of about 70 m, and is a tensile crack of approximately 1 to 2 m in width with a maximum

visible depth of approximately 8 m. This crack cut off the overlying conglomerate, as shown in Fig. 3b.

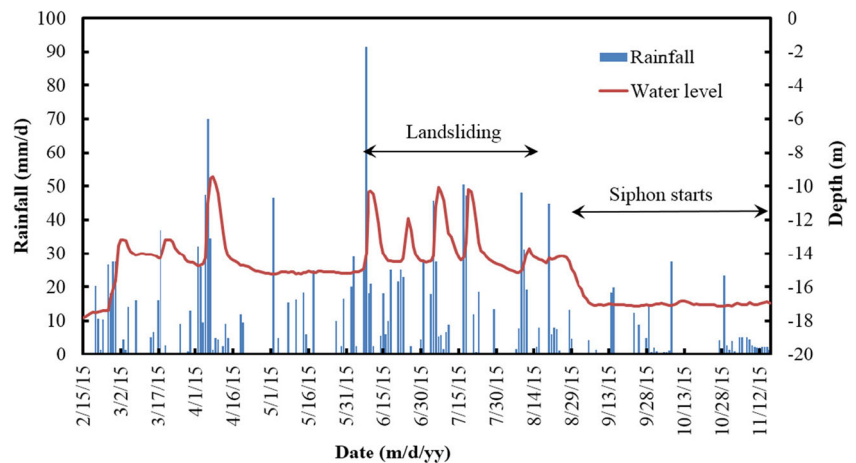
Fig. 5 Variation of the monitored hydraulic head in BH3 and rainfall data

Figure 5 shows the variation of monitored hydraulic head in BH3 and the corresponding rainfall data. The hydraulic head was expressed in terms of total head with the reference datum set at ground level of the borehole. As shown in Fig. 5, the rainfall is mainly distributed in mid of April to the end of August. The peak rainfall of a single day occurred on June 8th, reaching 91.5 mm. Afterwards, the rainfall decreased gradually from September to November. The groundwater in the study area was sensitive to rainfall. With a gradual increase in rainfall in February, the hydraulic head persistently rose from approximately -17 m and was maintained at approximately -14 m, and then it fluctuated rapidly along with the change in rainfall intensity. However, the hydraulic head was still able to maintain a high level despite the rainfall decrease at the end of August, which indicates that the groundwater in the study area has a

characteristic of rapid recharge from rainfall and poor discharge capacity.

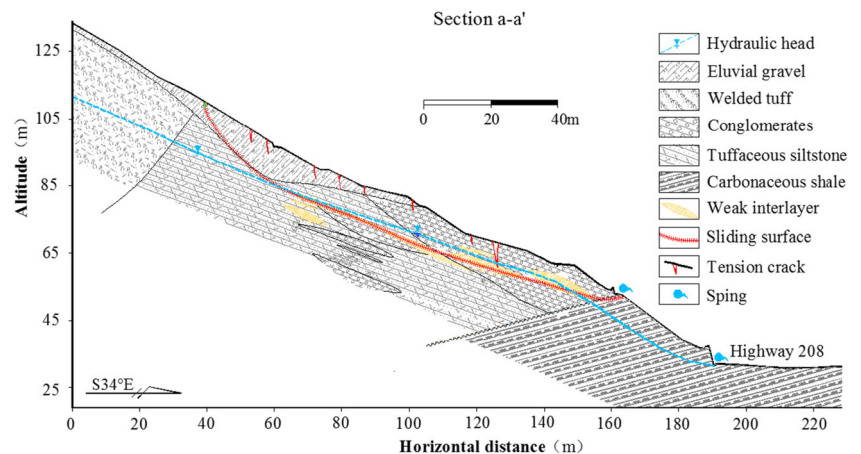
Fig. 7 The lithological profile of Houpuacun landslide (cross section a-a' in Fig. 4)

(2) the wide distribution of tension cracks on the slope surface. Among them, the weak interlayer is the internal factor of the landslide. A large number of vertical tension cracks provide favorable conditions for rainfall infiltration, which is an external factor inducing the slope deformation. The lithological profile of the main deformation area of the slope (i.e., the cross section a-a' in Fig. 4) is shown in Fig. 7, in which the weak interlayer in the slope basically formed a potential sliding zone and the dense distribution of tension cracks can be seen.

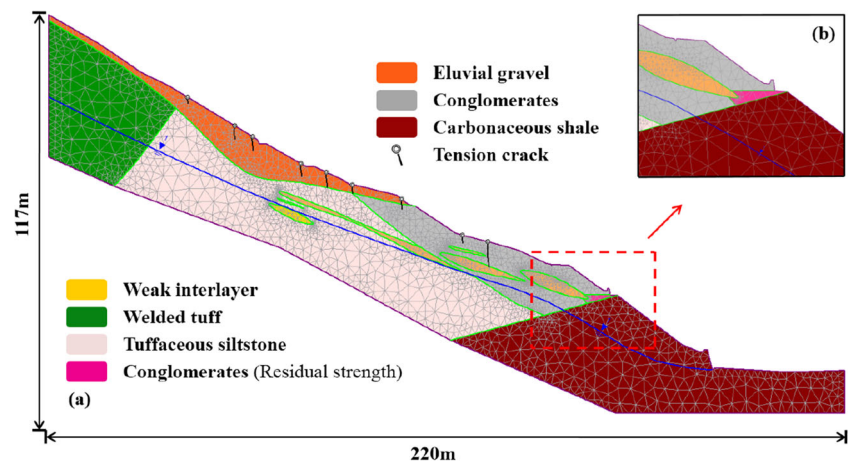
Fig. 8 **a** Model of the numerical simulation (Scenario 1); **b** a part of conglomerate is set as residual strength values

To quantitatively evaluate the influence of the weak interlayer and the tension crack on the slope stability, a series of numerical simulations are carried out. The numerical model is developed using the finite element code Phase2 (www.roscience.com), which is 220 m in length and 170 m in height, as shown in Fig. 8a. The model is discretized by

Taking into account the early deformation and sliding failure of the landslide, the strength parameters of rock mass near the shear outlet are set as residual strength values. Some scholars proposed estimation methods of the residual strength and the deformation parameters of rock mass (Cai et al. 2007; Peng et al. 2014). In these studies, the residual cohesion of the rock mass was usually set to zero. Therefore, in this numerical simulation, a part of the conglomerate, near the landslide shear outlets, is set to only provide a friction angle for its shear strength (Fig. 8b).

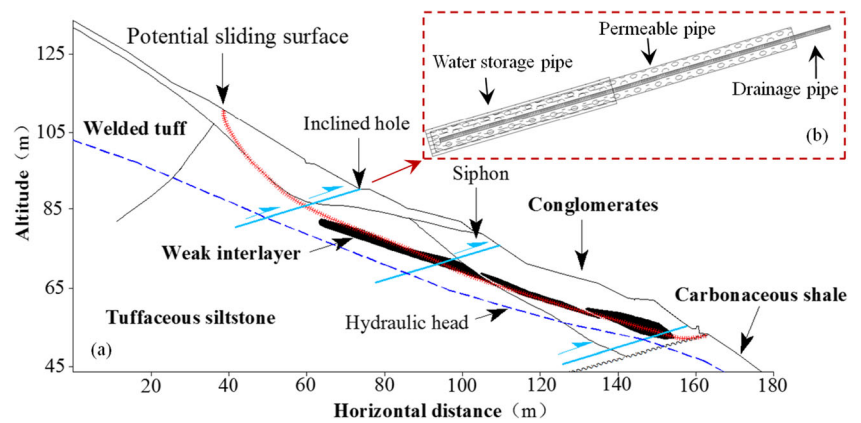
Fig. 10 a Location of the siphon drainage hole in the Houpuacun landslide (a-a'); **b** tectonic diagram of a drainage pipe, permeable pipe and water storage pipe

For the Houpucun landslide, based on the investigation of the catchment area, the rainfall intensity, groundwater level and its descending requirement in the study area, three rows of inclined boreholes for siphon drainage are created along the slope at elevations of 55 m, 75 m and 90 m, respectively, as shown in Fig. 10a. The total number of siphon boreholes is 80,

among which 20 are at 55 m elevation and spacing 5 m, 40 are at 75 m elevation and spacing 3 m, and 20 are at 90 m elevation and spacing 3 m. The siphon drainage pipe, permeable pipe and water storage pipe are arranged in the specified form and placed into the borehole, as shown in Fig. 10b. The depth of the siphon drainage borehole is 40 m, and the downward drilling angle is 17° (Fig. 11a). After the construction of the siphon system is completed, the drainage pipes are buried under the slope surface (Fig. 11b). Four drainage pipes with diameter 4 mm are arranged in each siphon hole, and a high pressure sprayer is used for reverse water injection to start the siphon. All of the siphon pipes are pulled down along the slope surface from the orifice to the concrete retaining wall near Highway 208, and the groundwater is discharged into a water collecting pool.

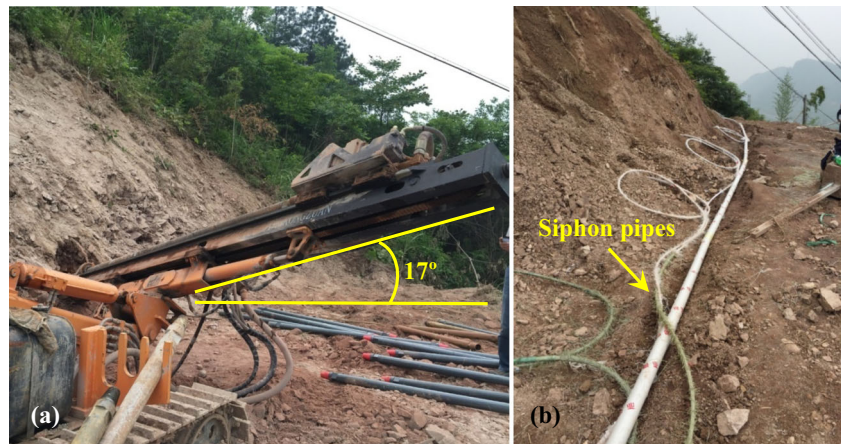
Fig. 11 **a** Construction of the drainage borehole using the drilling rig; **b** siphon drainage pipes buried under the slope surface

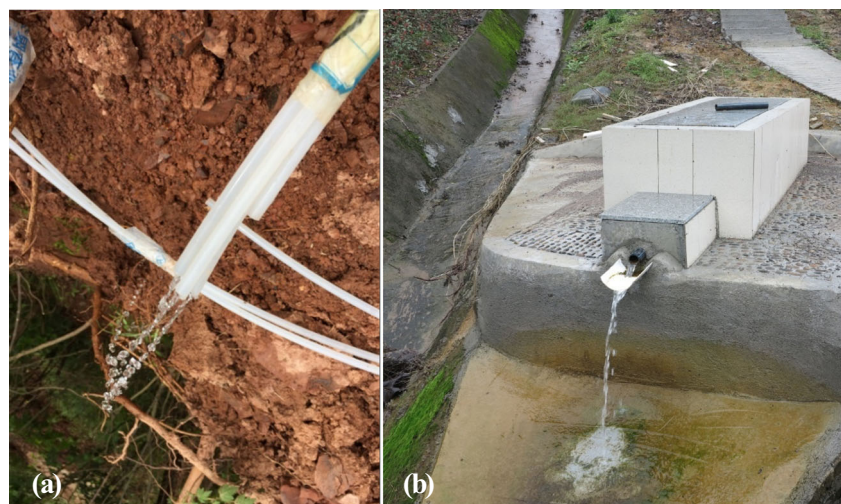
Fig. 12 **a** Groundwater drained by siphon pipes; **b** water collecting pool at the foot of the Houpucun landslide

Figure 12a shows the groundwater drained by the siphon pipes, and Fig. 12b shows the water collecting pool at the foot of the Houpucun landslide in which a triangular weir is used to

monitor the total water yield. Because of the powerful water delivery capacity of the siphon, the actual drainage efficiency depends on the velocity of groundwater infiltrating into the borehole. The fractured rock mass and the tension cracks on the slope surface in the study area provide convenient conditions for the infiltration; thus, the rainfall can be quickly discharged through the siphon drainage pipes. From the monitoring data, the flow is relatively stable and can reach about 13 m³/day currently. Therefore, the hydraulic head also returns to a deep position. According to the monitored data, the groundwater level in BH3 drops to approximately -17 m, which is about -14 m before drainage. The displacement monitoring data indicate that the slope restores stability after the siphon drainage works. These results demonstrate that the siphon drainage method effectively achieved the desired stability goal for the case in hand.
