Physical model experiments for shallow failure in rainfall-triggered loess slope, Northwest China

Abstract

Keywords Loess slope · Rainfall-induced landslide · Physical model experiment · Pore-water pressure

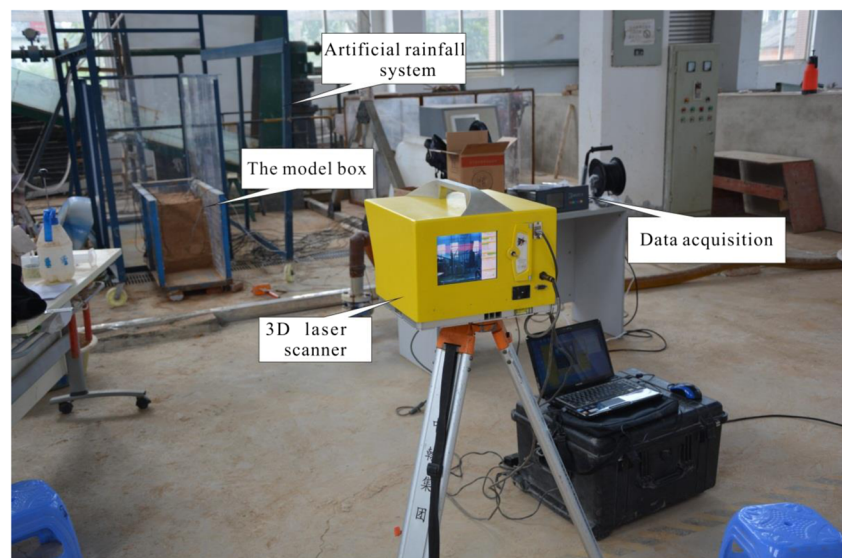
Fig. 1 The layout of experiments

Three groups of physical model experiments were conducted in Chengdu University of Technology, China. The length \times width \times height of the model box used in experiments is 1.2 m \times 0.4 m \times 0.6 m, and the volume is 0.288 m³. The layout of experiments is shown in Fig. 1.

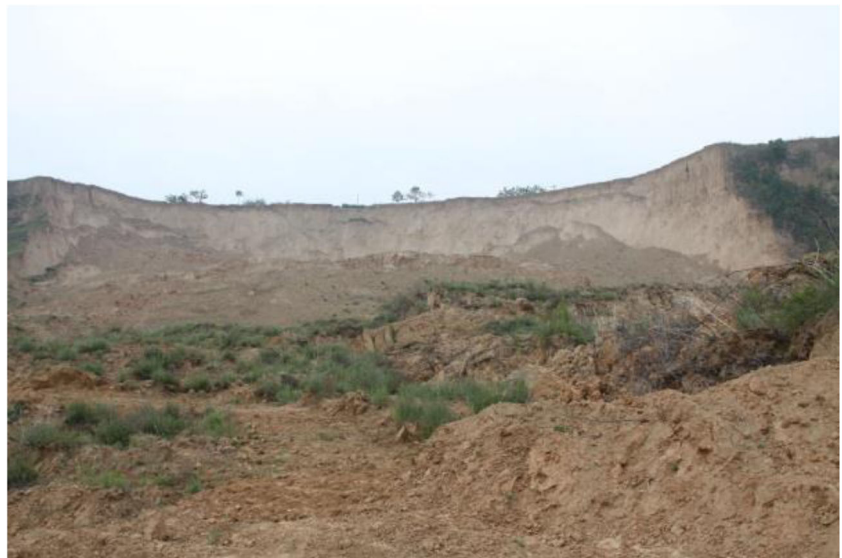
Fig. 2 A typical loess landslide at Jingyang, China

The loess sample used in experiments was collected from the south Jingyang Plateau, China, with a large amount of shallow loess landslides here (Fig. 2). For the indoor physical model experiments, loess sample was crushed by a hammer and passed through a 5 mm screen. The physical parameters of the loess are shown in Table 1. The distribution curve of the loess is shown in Fig. 3, and the soil water retention curve can be seen in Fig. 4.

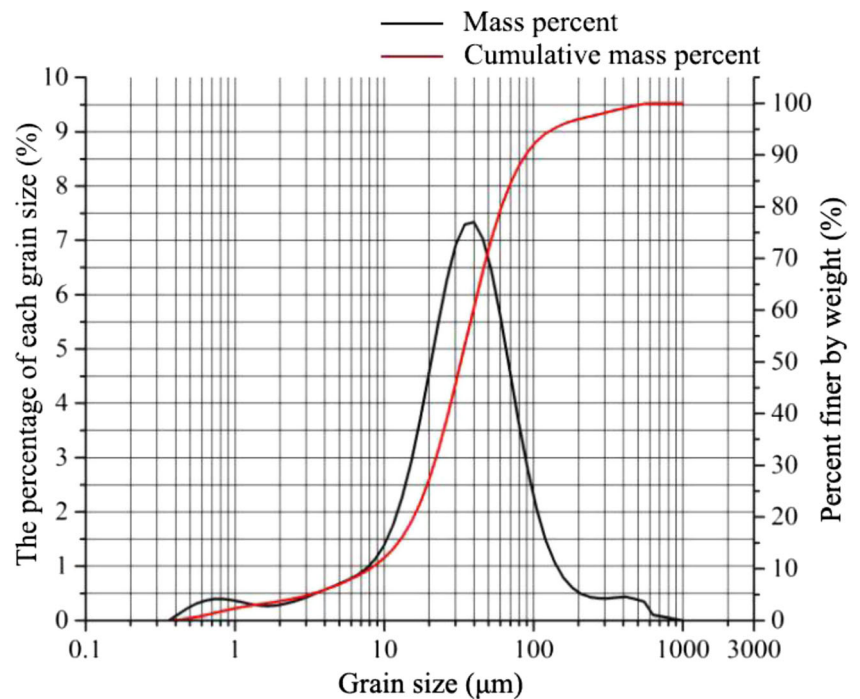
Fig. 3 Particle distribution curve of the loess

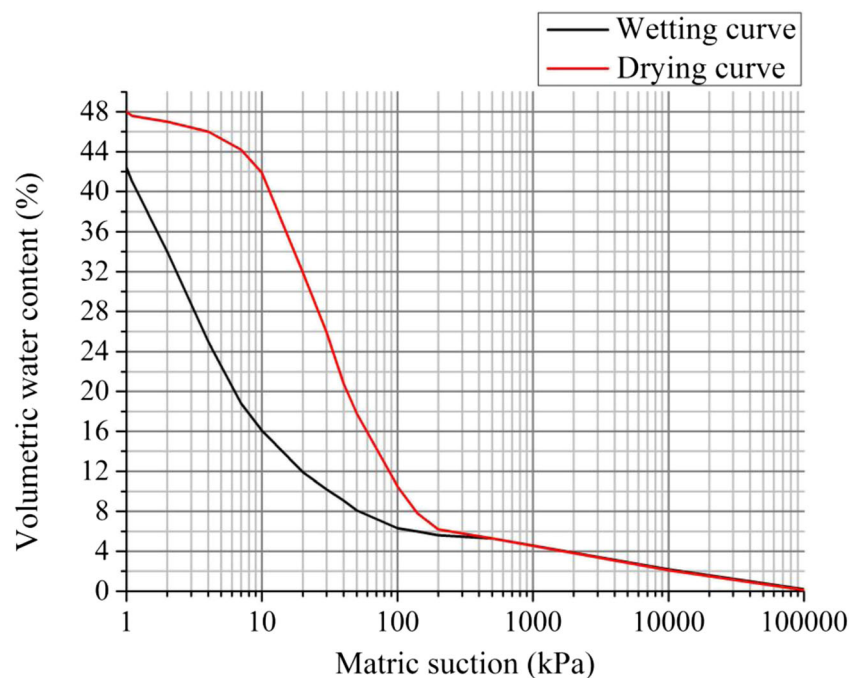
Fig. 4 Soil water retention curve

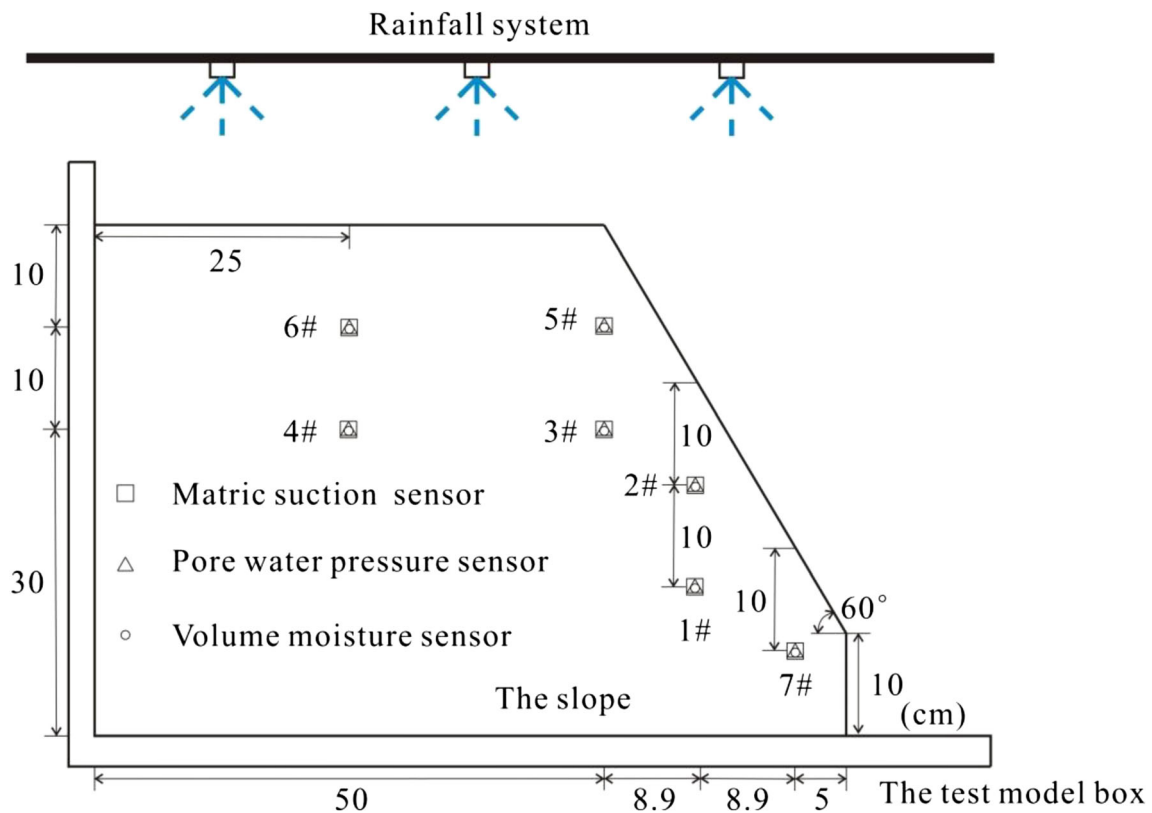
Fig. 6 Experimental section of loess slope with continuous heavy rainfall

For continuous and intermittent heavy rainfall experiments of the loess slope, the location of sensors buried in the slope and size of the slope are shown in Fig. 6.

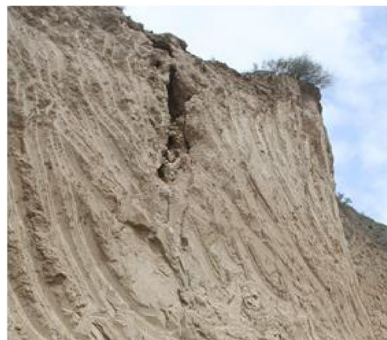
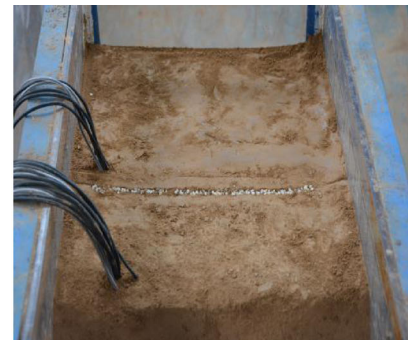
Fig. 7 The prototype slope and the model slope

(a) The prototype slope

(b) The model slope

the trailing edge of the slope were filled with gravels and debris, as a result, the vertical joint in model slope was full of quartz sands. The model slope is shown in Fig. 7b, and Fig. 8 shows the experimental section of the slope.

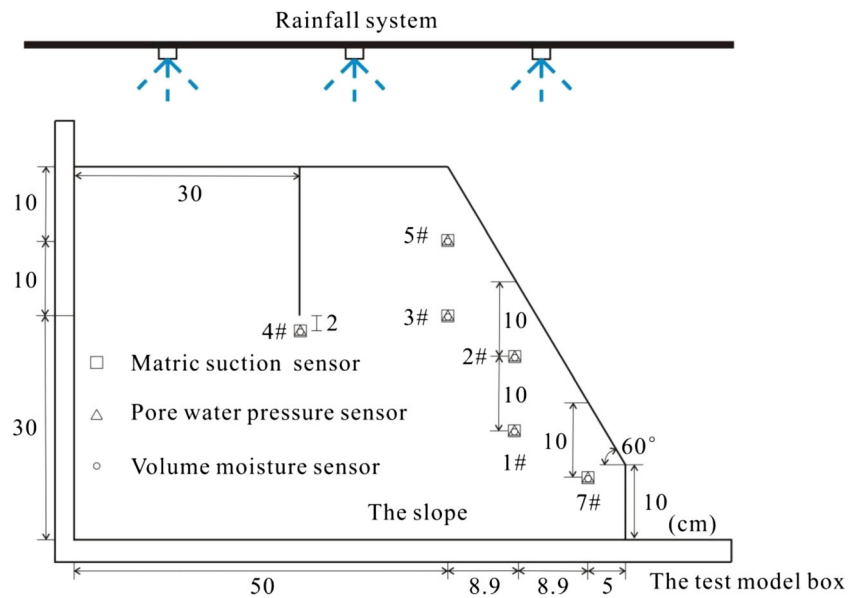
Fig. 8 Experimental section of slope containing a vertical joint with continuous heavy rainfall

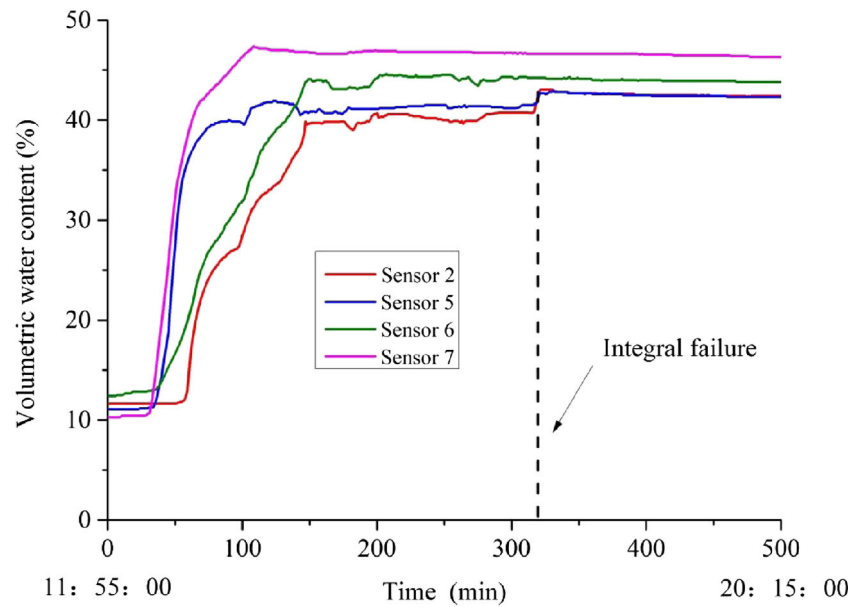
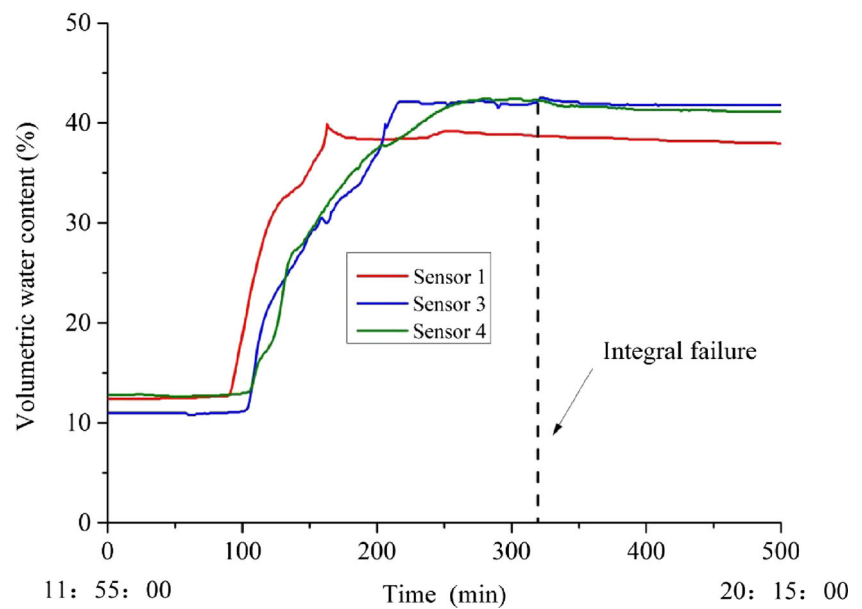
Fig. 10 Reading changes in volume moisture sensors of the loess slope with continuous heavy rainfall

(a) Changes in volumetric water content of sensors 2, 5, 6 and 7

(b) Changes in volumetric water content of sensors 1, 3 and 4

Figure 9 shows the process of deformation and failure of loess slope with continuous heavy rainfall. From the changing sensor readings (Figs. 10, 11, and 12), the sequence of seepage velocity from large to small was: toe of slope, trailing edge of the slope and middle slope, under the condition of heavy rainfall. Among the volumetric moisture sensors 2, 5, 6, and 7 buried at 10 cm depths, readings of sensor 7 buried at the foot of the slope rose rapidly at the beginning, and then increased gently for a period until it was stable. Notably, there was no obvious change in the readings when landslide failure occurred.

As for the moisture content sensors (Fig. 10a), sensor 5 is located below the slope shoulder, the rainwater on the trailing edge flows through the shoulder, causing erosion. The No. 2 sensor is located below the slope, and the water is easy to runoff. Compared with sensor 2, the water

content of sensor 5 began to increase earlier. After 2 h and 21 min, the soil becomes basically saturated, and then the water content remained basically unchanged. After 5 h and 20 min, moisture content of sensors 2 and 5 suddenly increased. At this time, the slope slid, then rainfall stops, and the water content decreases slowly. Reading of sensor 2 increases largest among the sensor groups because it was close to the front edge of slip surface when the slope slid.

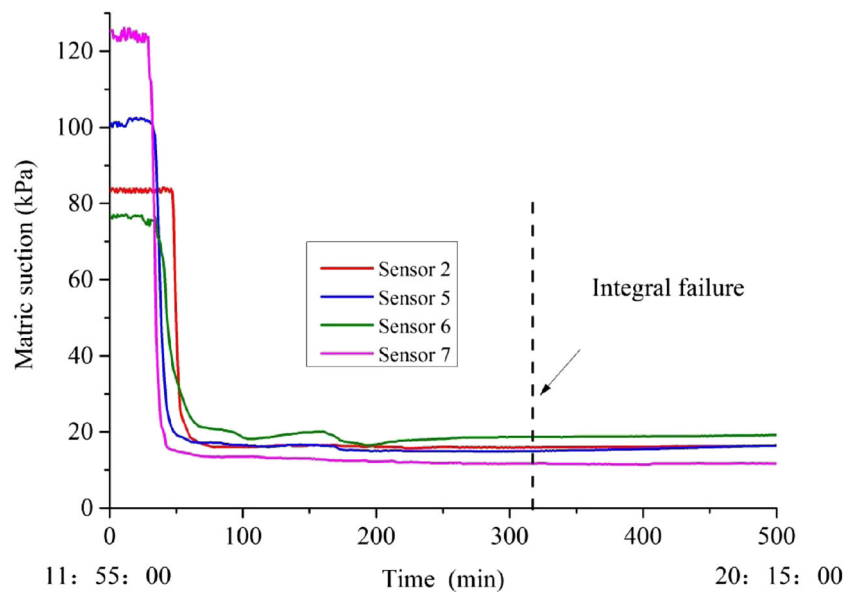
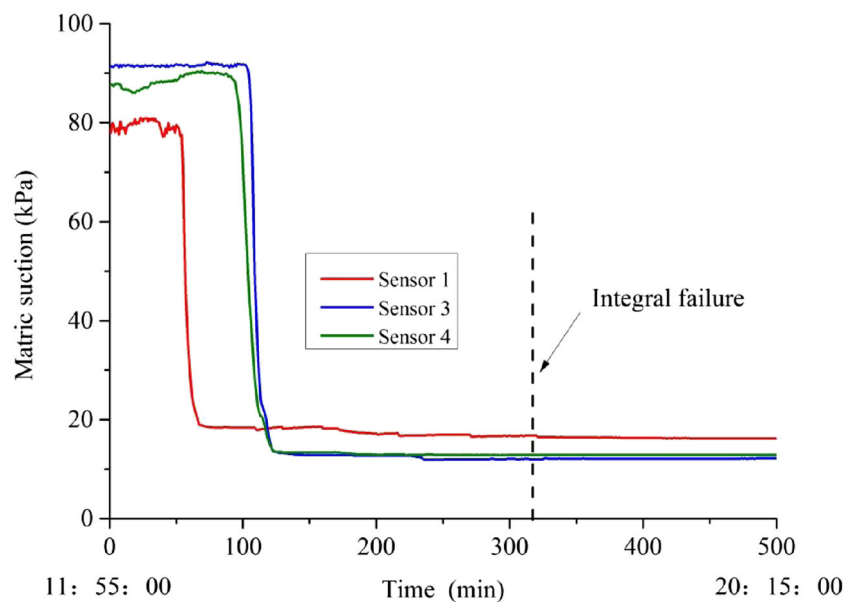
Fig. 11 Reading changes in matric suction sensors of the loess slope with continuous heavy rainfall

(a) Changes in matric suction of sensors 2, 5, 6 and 7

(b) Changes in matric suction of sensors 1, 3 and 4

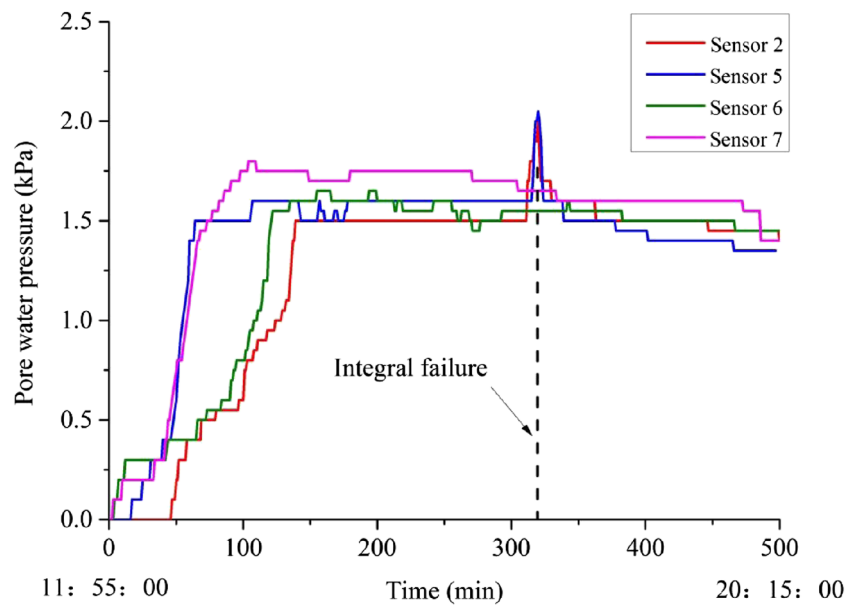
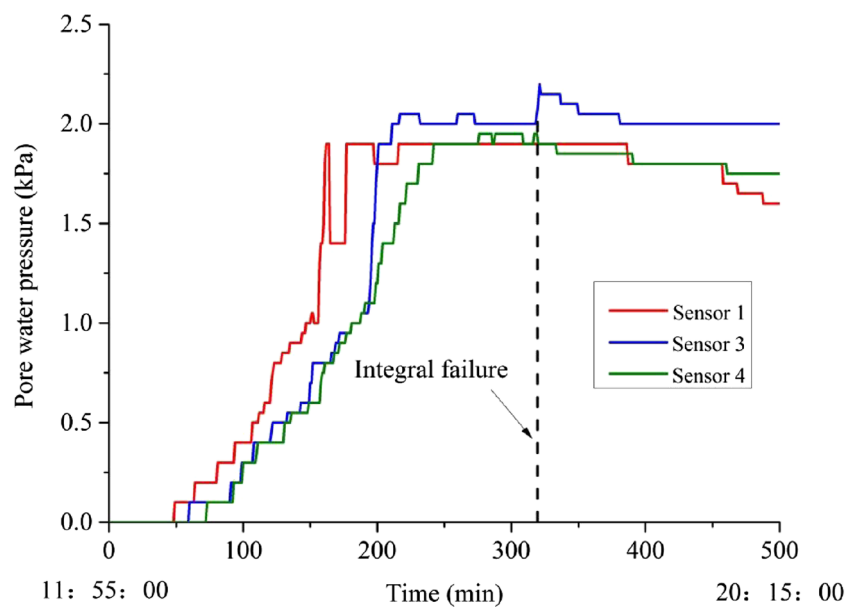
Fig. 12 Reading changes in pore water pressure sensors of the loess slope with continuous heavy rainfall

(a) Changes in pore water pressure of sensors 2, 5, 6 and 7

(b) Changes in pore water pressure of sensors 1, 3 and 4

As for the pore-water pressure sensor, due to the rainwater infiltration, the sensors 5 and 2 began to increase at 17 min and 47 min respectively, and stabilized at 1.6 kPa (1 h, 47 min) and 1.5 kPa (2 h and 20 min) respectively.

At 5 h and 20 min, the pore-water pressure suddenly increases, which is a main factor inducing the slope sliding. The increment of sensor 2 is largest because the position of soil particle changed due to shearing. The pore-water pressure near the sliding surface suddenly increases, which creates the excess pore-water pressure. The sliding distance of point 2 located at the landslide front is largest, and the shearing speed is the largest. Therefore, the excess pore-water pressure is also relatively high. The change in pore-water pressure is not consistent with the water content, because the pore-water pressure sensor and the moisture content sensor are at different positions.

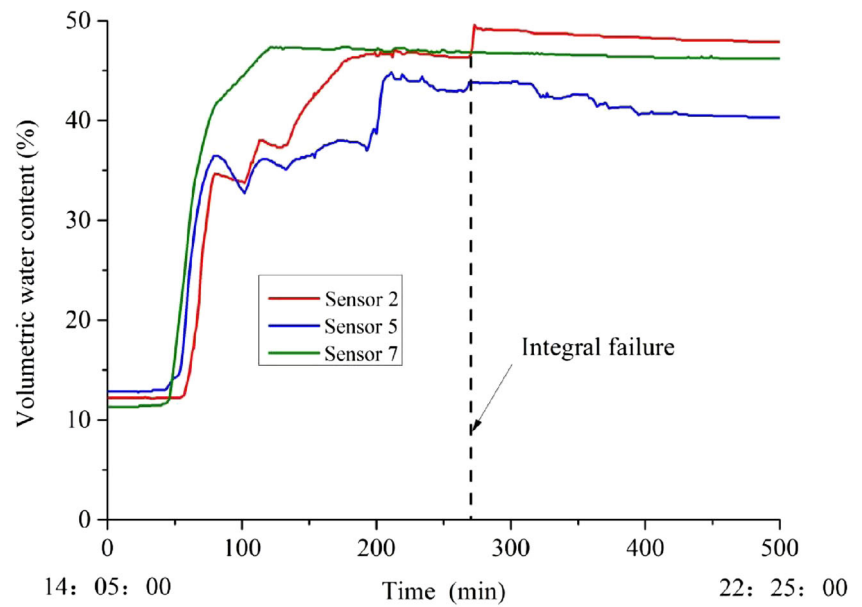
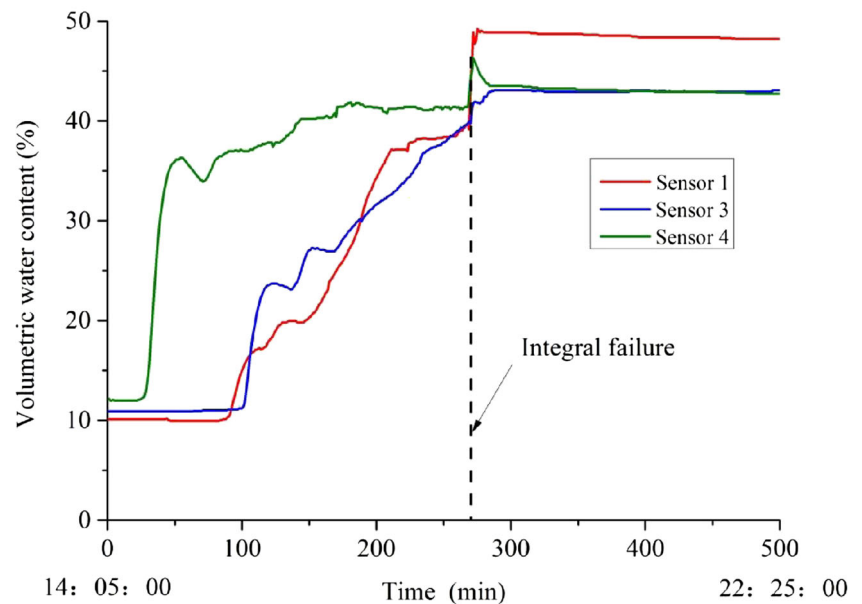
Fig. 14 Reading changes in volumetric moisture sensors of the loess slope with a vertical joint

(a) Changes in volumetric water content of sensors 2, 5 and 7

(b) Changes in volumetric water content of sensors 1, 3 and 4

As for the volumetric water content of sensors, sensor 5 is located below the shoulder, the rainwater on the trailing edge flows through the shoulder, causing erosion. Sensor 2 is located below the slope, and water runoff is easy. Therefore, compared with sensor 2, sensor 5 began to increase earlier. After 3 h and 24 min, the loess became basically saturated, and the water content remained basically unchanged. The moisture content of sensor 2 began to obviously increase. The readings of sensor 2 and sensor 5 suddenly increased at 4 h and 32 min, when the loess slope slid.

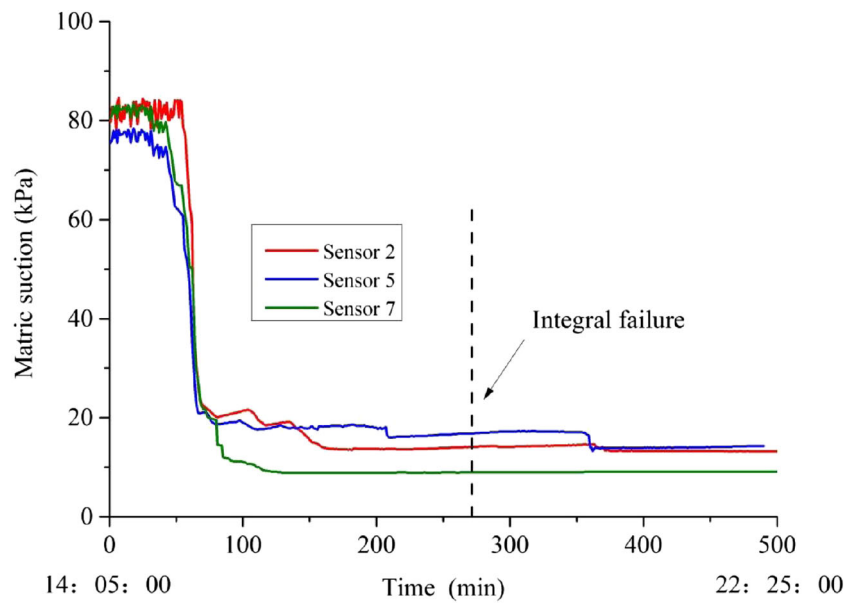
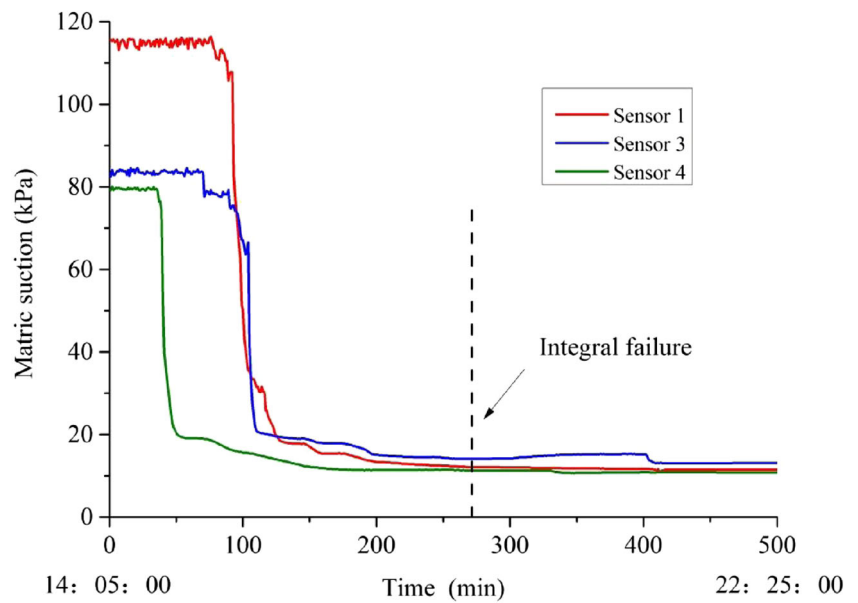
Fig. 15 Reading changes in matrix suction sensors of the loess slope with a vertical joint

(a) Changes in matrix suction of sensors 2, 5 and 7

(b) Changes in matrix suction of sensors 1, 3 and 4

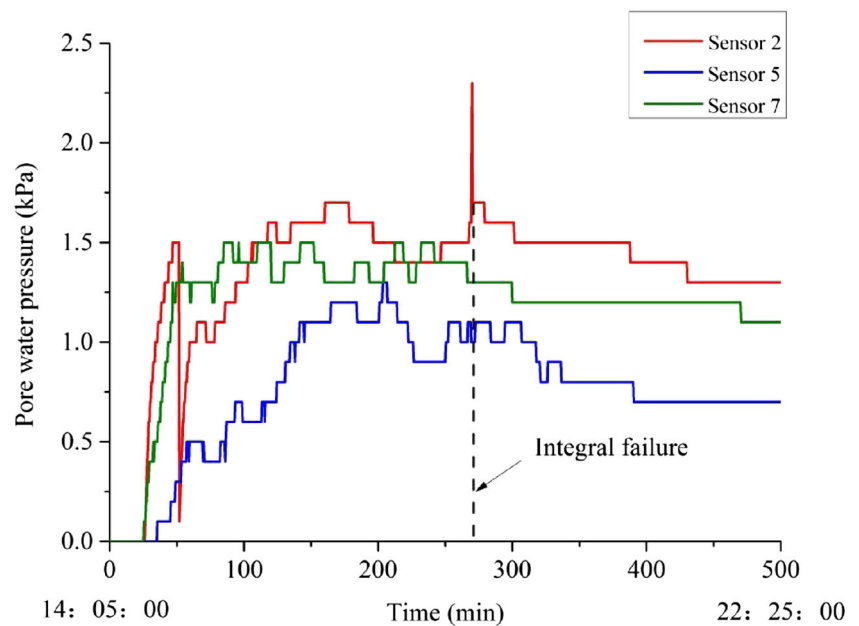
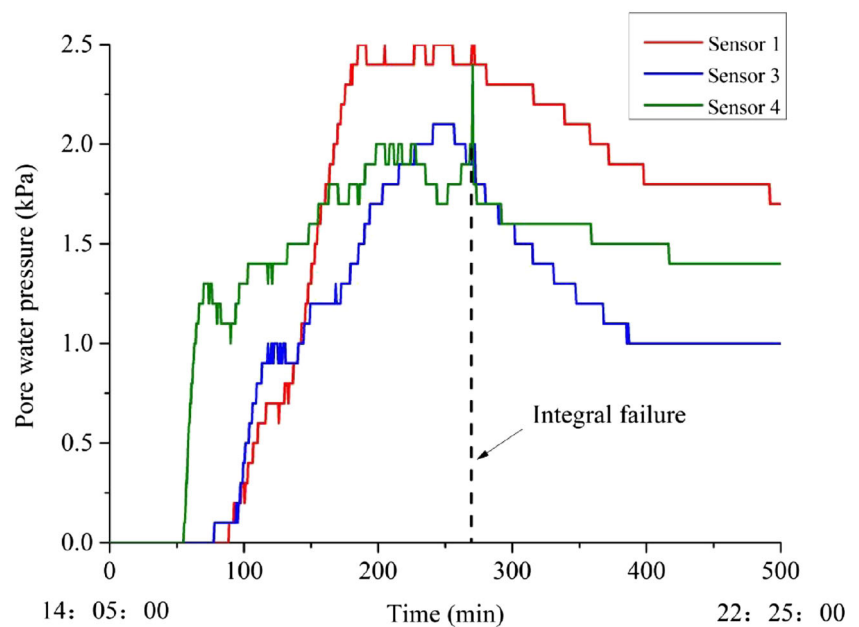
Fig. 16 Reading changes in pore water pressure sensors of the loess slope with a vertical joint

(a) Changes in pore water pressure of sensors 2, 5 and 7

(b) Changes in pore water pressure of sensors 1, 3 and 4

The change in pore-water pressure sensors was consistent with volumetric moisture sensors. Sensor 5 started to increase earlier than sensor 2, and then the pore-water pressure increased significantly. The pore-water pressure suddenly changed at 4 h and 32 min, and then the pore-water pressure gradually dissipated, which led to the landslide.

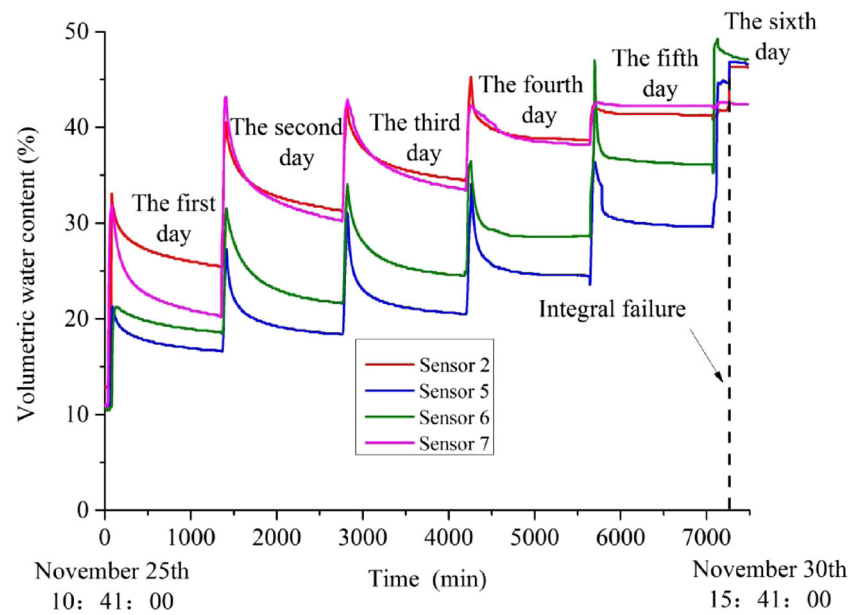
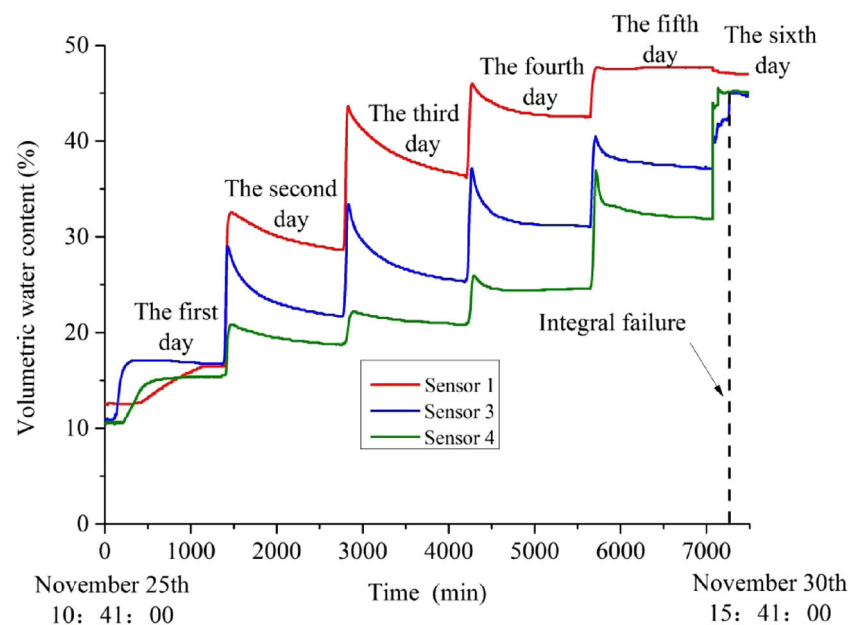
Fig. 17 Reading changes in volume moisture sensors of the loess slope with a intermittent heavy rainfall

(a) Changes in volumetric water content of sensors 2, 5, 6 and 7

(b) Changes in volumetric water content of sensors 1, 3 and 4

authors will not reiterate them here. From Figs. 17, 18, and 19, the authors found the seepage velocity from large to small was the same order as that of the loess slope with continuous heavy rainfall. Among the sensors 2, 5, 6, and 7 buried at 10 cm depths, readings of sensor 7 buried at

Volumetric water content sensor 5 is located under the shoulder of the slope, the water content starts to increase earlier, and increases significantly at 57 min. The rain continued the next 5 days with the same rainfall intensity. The difference between the maximum and minimum values of sensor reading

became smaller and smaller as the loess slope became gradually saturated. On the sixth day, water content increased to 44.6% and remained basically stable. When water content suddenly increased the landslide occurred.

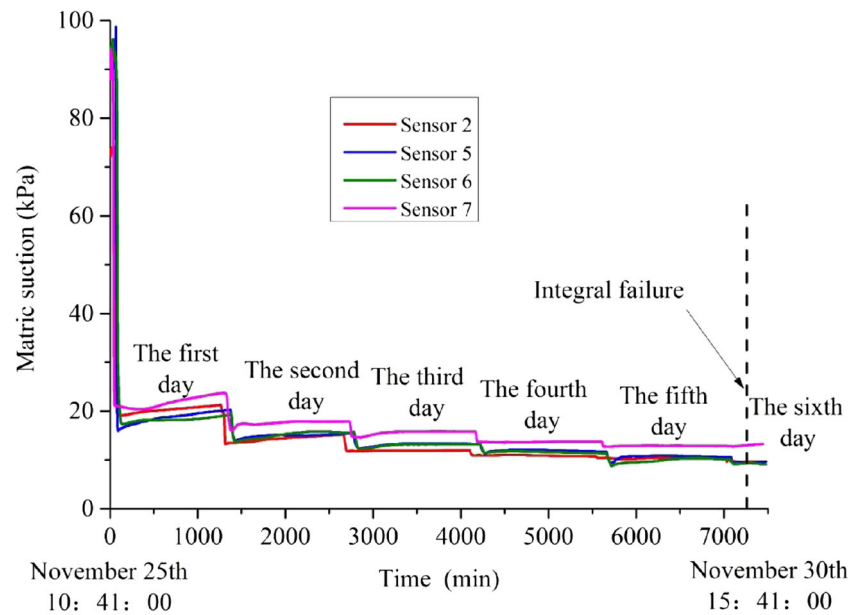
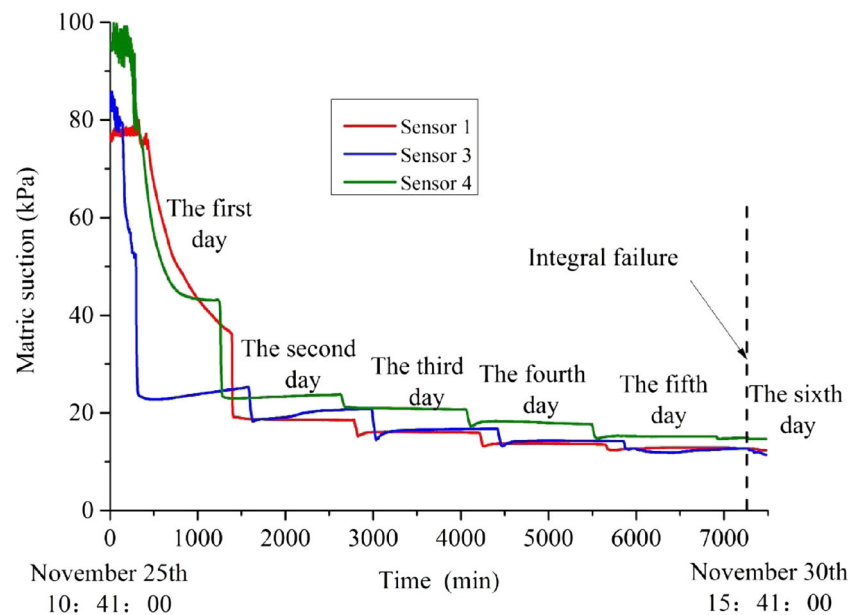
Fig. 18 Reading changes in matric suction sensors of the loess slope with a intermittent heavy rainfall

(a) Changes in matric suction of sensors 2, 5, 6 and 7

(b) Changes in matric suction of sensors 1, 3 and 4

slope failure happened. The order of the decreasing readings of matric suction sensors was consistent with that of the volumetric moisture sensors, and the difference is when the readings of matric suction sensors reached a certain value and increased slightly after the cessation of rain and decreased after the beginning of rainfall, but the rate of decrease waned gradually. The trend of the increasing readings of pore-water pressure sensors coincide with the trend of changing readings of volumetric water content sensors. When volumetric water content rose, it was accompanied by an increase in pore-water pressure, and

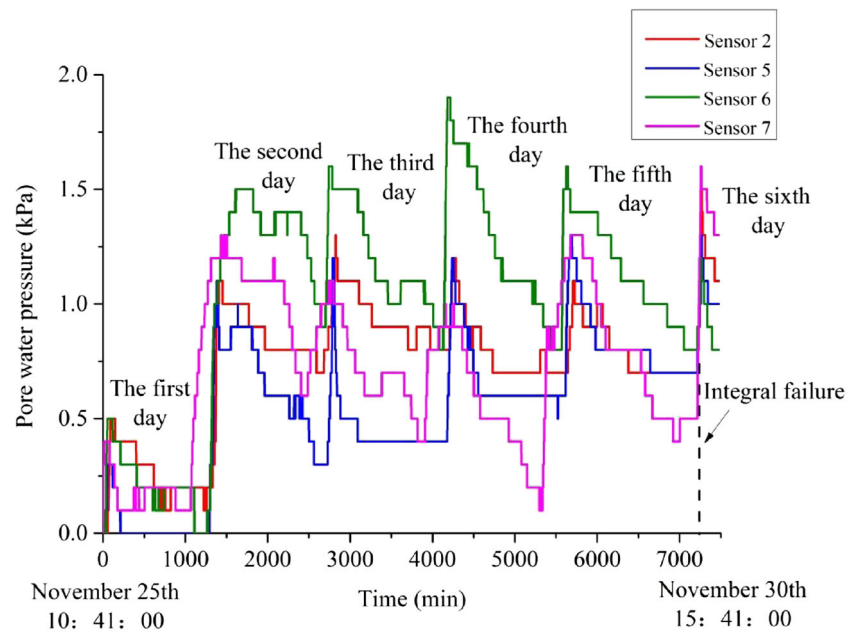
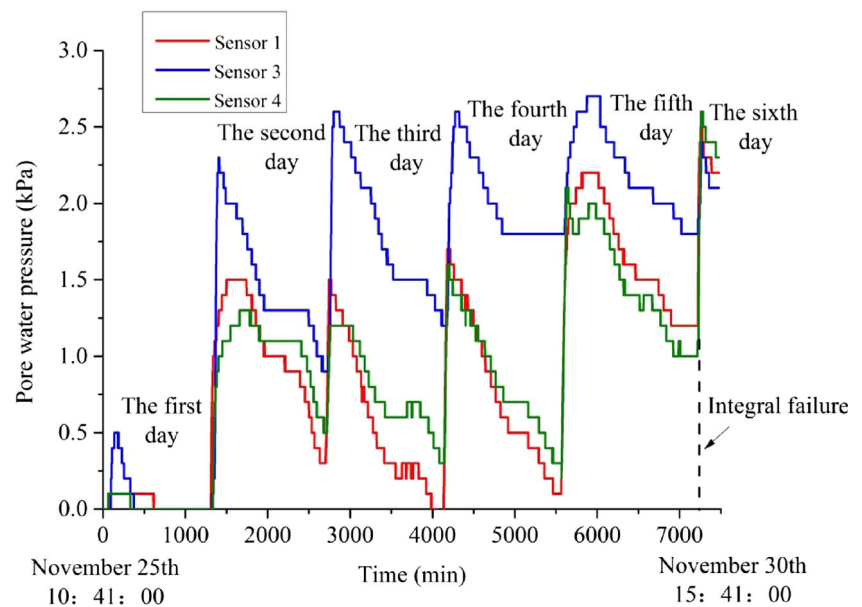
Fig. 19 Reading changes in pore water pressure sensors of the loess slope with a intermittent heavy rainfall

(a) Changes in pore-water pressure of sensors 2, 5, 6 and 7

(b) Changes in pore-water pressure of sensors 1, 3 and 4

Pore-water pressure sensor, sensor 5 began to increase at 36 min, and gradually decreased after reaching the peak value of 0.3 kPa. The change trend of pore-water pressure in the second, third, fourth, and fifth days was consistent with the change trend of volumetric moisture

content of sensor 5. On the sixth day, the pore-water pressure increased slightly, while the slope slid as a whole. Reading of sensor 2 began to increase after 57 min and reached 0.5 kPa. The change trend of pore-water pressure in the next 5 days was consistent with that in water content. Pore-water pressure suddenly increased, which is a main indicator of the loess slope sliding.
