Comparative analysis of rockmass characterization techniques for the stability prediction of road cut slopes along NH-44A, Mizoram, India

Abstract

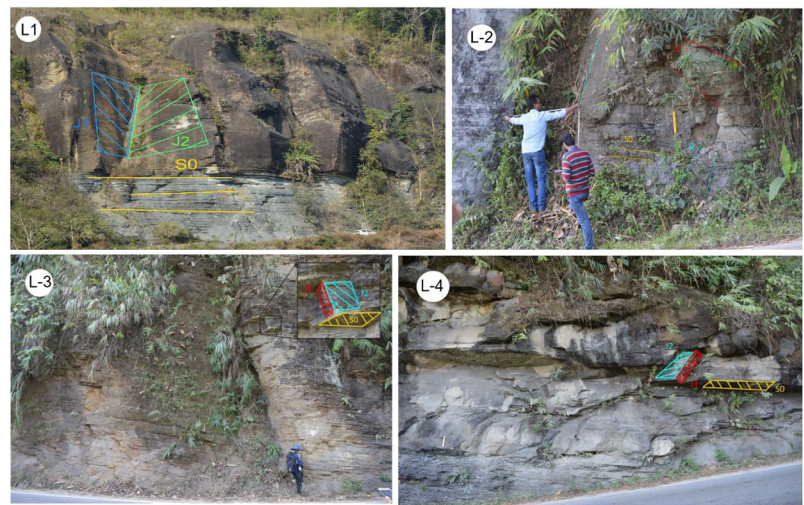
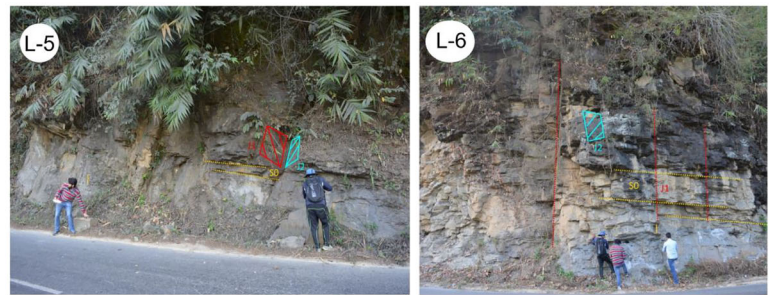
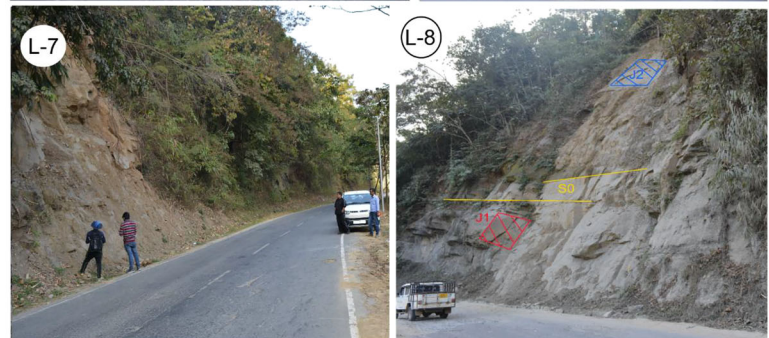
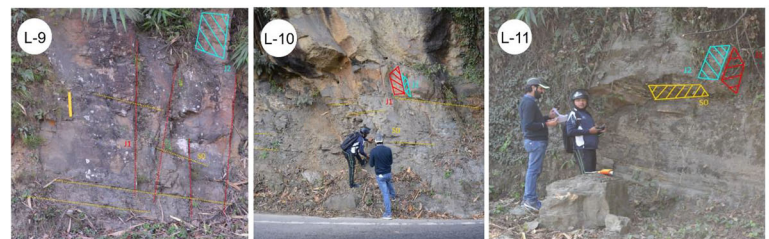
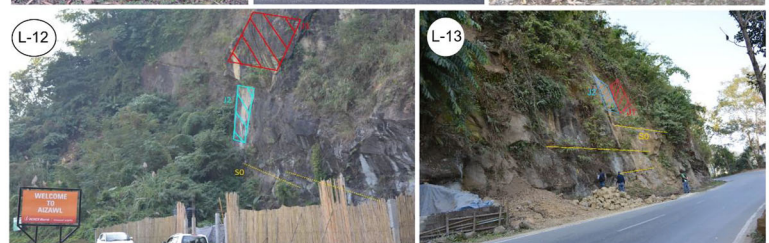
Fig. 2 Field photographs showing joint distribution and different mode of failure for (a) Lengpui region from slope L-1 to L-4; (b) Phunchawng region from slope L-5 to L-8; (c) Aizawl Zoo region from slope L-9 to L-13

In this study, thirteen slopes from three regions were studied, from the Airport to Aizawl city along NH-44A (Fig. 1). The three regions, namely Lengpui area, Phunchawng area and Aizawl Zoo area, comprise four slopes (L1-L4), four slopes (L5-L8) and five slopes (L9-L13) respectively (Table 1). Mostly sandstone-shale or siltstone-shale intercalation was observed in these regions. During the field survey, the height of two slopes, L-1 and L-12, were measured at 30 m and 31 m, respectively, and for the remaining slopes, the slope height varied from 5 m to 15 m in Lengpui, Phunchawng and Aizawl Zoo region. The site photographs of the slopes from the three regions are shown in Fig. 2.

photographs of slopes L-8, L-10 and L-11 (Fig. 2). The results of kinematic analysis support the modes of failure observed during the field survey.

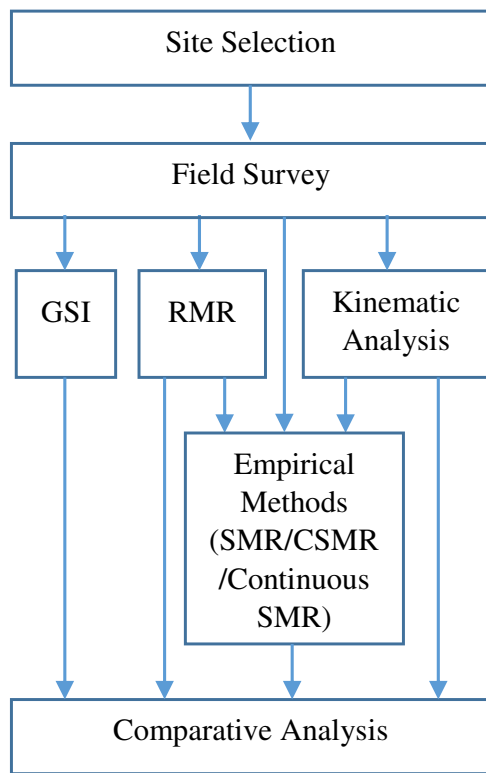
Fig. 3 Methodology used in the study

This paper focuses on the rockmass characterization of the road cut slopes using *RMR*, *GSI* and various *SMR* techniques. The methodology used in the study is shown in Fig. 3 as a flowchart.

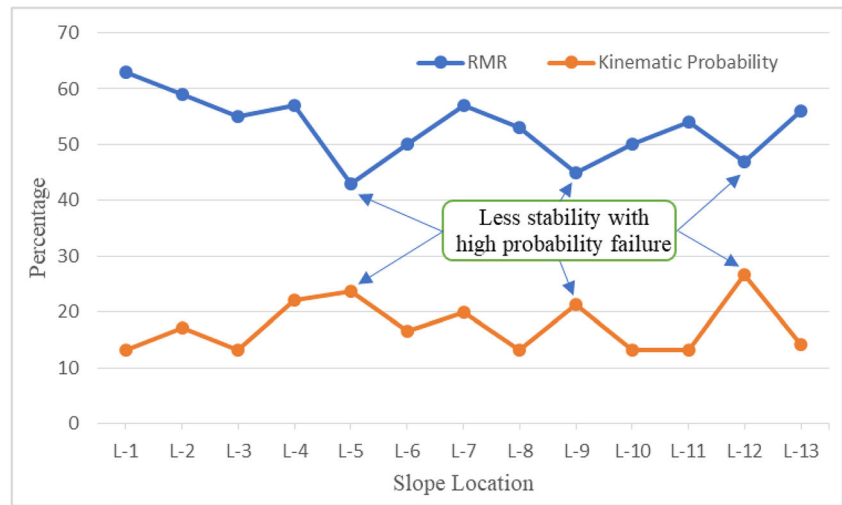
Fig. 6 Comparison between kinematic feasibility and basic rock mass rating

Kinematic feasibility was calculated by considering the average of all the critical percentage values for failure (i.e planar, wedge, flexural and direct topple failure) in the kinematic analysis (Table 4). Calculated values of kinematic feasibility for each slope were compared with basic *RMR* values (Fig. 6) to identify the relation

between them. The range of kinematic feasibility and rating of *RMR_b* varied from 13.33% to 26.67% and 43 to 63, respectively, for all the cut slopes along this highway. It was found that four slopes, L-4, L-5, L-9 and L-12, show the kinematic feasibility greater than 20%, out of which three slopes have *RMR_b* scores less than 50. L-4 is the only slope which has both high *RMR_b* and high kinematic feasibility. The comparison of these two parameters for the remaining nine slopes shows that these slopes have high *RMR_b* with low kinematic feasibility (Fig. 6). The comparative analysis of kinematic feasibility and *RMR_b* concluded that a slope with lower quality of rockmass may have a high kinematic feasibility.

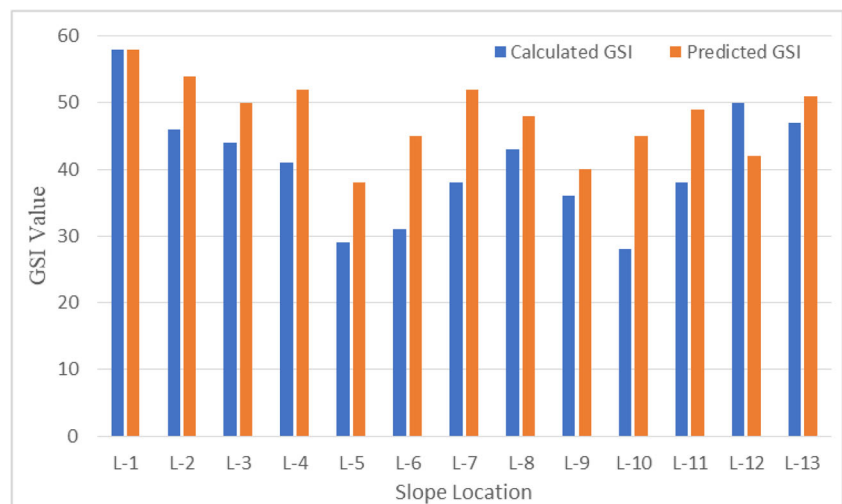
Fig. 7 Comparison between predicted *GSI* and calculated *GSI*

of *GSI* can also be predicted using the rating of basic *RMR* as given in Eq. 12 (Hoek and Brown 1997). We compared the predicted *GSI* value (GSI_P) and calculated *GSI* value (GSI_C) from the site investigation in Fig. 7. The value of GSI_C ranged from 28 to 58, whereas, for GSI_P , it ranged from 38 to 58. GSI_P was found to be the same as GSI_C for slope L-1, lower for slope L-12 and, for most of the slopes, it was higher than the GSI_C .

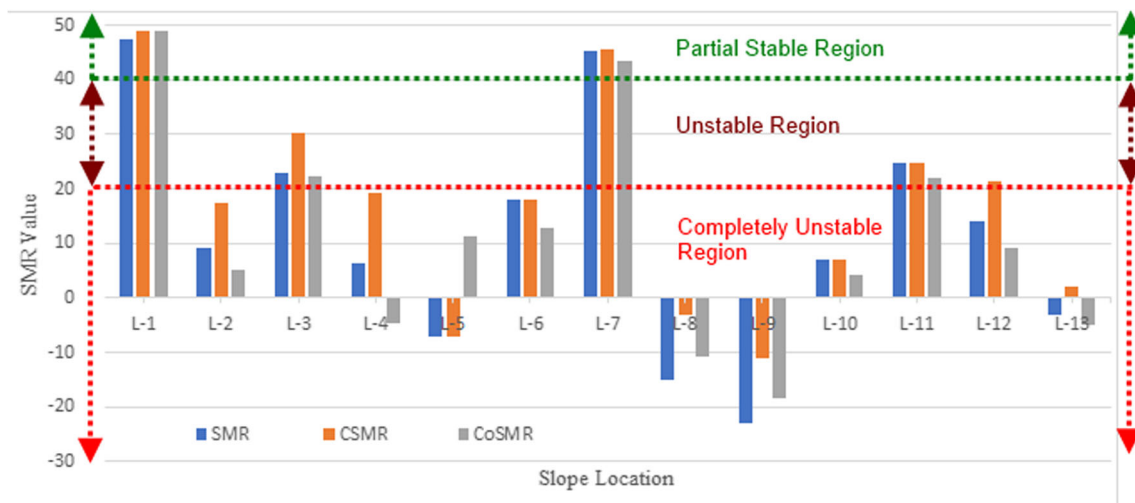
Fig. 8 Comparison between various *SMR* techniques (Original *SMR*, *CSMR* and *CoSMR*)

The various *SMR* techniques, i.e. discrete (Original *SMR* and Chinese *SMR*) and continuous *SMR*, were compared by considering the minimum calculated score from Table 5 to account for the maximum vulnerability for each slope (Fig. 8). In the comparative analysis, a distinguishable difference was observed between discrete *SMR* and continuous *SMR* for most of the slopes. The scores of both discrete *SMR* techniques (i.e. *SMR* and *CSMR*) show a slight difference, but their stability class was found to be the same for each slope, except L-12. For slope L-12, *SMR* represents class V whereas *CSMR* represents class IV. The slopes that fall under partially stable and unstable region show a slight difference between scores of *SMR*, *CSMR* and *CoSMR* techniques, whereas for the slopes of a completely unstable region, the difference is higher. The continuous *SMR* scores were found to be lower as compared to discrete *SMR* scores for most of the slopes, which indicates that the maximum vulnerable result was obtained from the continuous *SMR*. Although all three *SMR* techniques have different final scores, their stability class was the same for all the slopes, except L-12. For some of the slopes, both discrete

and continuous *SMR* show negative scores, especially in the case of wedge failure, as the joint orientations were very unfavourable. The slopes with negative scores represent class V of the Romana (1985) interpretation.
