# Characteristics and main causes of earth fissures in northeastern Beijing Plain, China

**Keywords** Earth fissures · Beijing · Preexisting fault · Paleochannel · Pumping

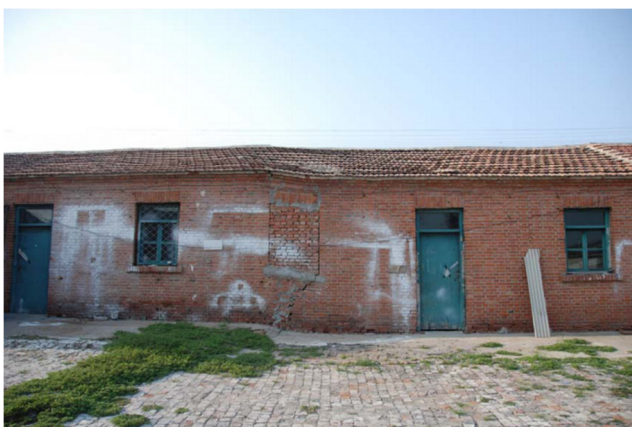
**Fig. 5** Damaged building and floor in Tugou village (derived from the Beijing Hydrogeological and Engineering Geological Survey 2007). Location is shown in Fig. 4. The lens is aimed at north, and the right side has subsided

fissures extension, more damages were discovered subsequently in Tangzitou orchard, Tugou village (Fig. 5), and Baxian villas (Fig. 6) by this institute (Beijing Hydrogeological and Engineering Geological Survey 2007, 2014). All structures in the Tugou village have been demolished and removed entirely, and several houses in the Baxian villas, including villa 0702, are still blocked for further demolition, from our reinvestigation.

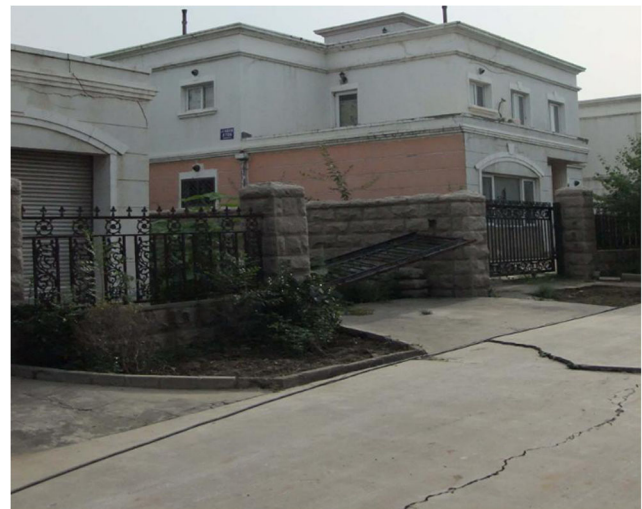
**Fig. 6** Damaged roads and Villa 0702 in the Baxian villas (derived from the Beijing Hydrogeological and Engineering Geological Survey 2014). Location is shown in Fig. 4. Southeastern side has subsided

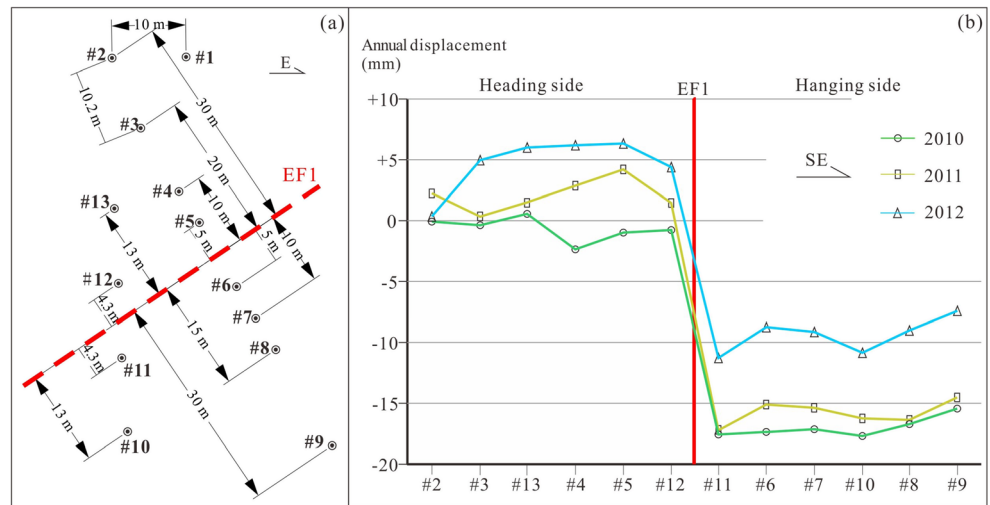
**Fig. 8** Layout and annual vertical displacement of the observation points (derived from the Beijing Hydrogeological and Engineering Geological Survey 2014). **a** Locations of all of the observation points. **b** Annual displacement of the twelve observation points in 2010, 2011, and 2012; “+” indicates uplift and “-” indicates subsidence

The Beijing Hydrogeological and Engineering Geological Survey (2014) set up an artificial observation network that adopted leveling in thirteen observation points to simultaneously detect the absolute vertical displacement on opposite sides of the EF1 fissures, monthly. The location of each point, relative to the EF1 fissure, is shown in Fig. 8a. From 2010 to 2012, twelve annual displacement data sets show increasing uplift on the footwall and decreasing subsidence on the hanging wall (Fig. 8b). This alleviated the land subsidence but extended the duration and deterioration of the earth fissure due to the entirely different displacement direction. The uplift of the footwall and the subsidence delay of the hanging wall may be related to the end of a drought that lasted for over 10 years and the resultant groundwater recovery, which started in 2011.

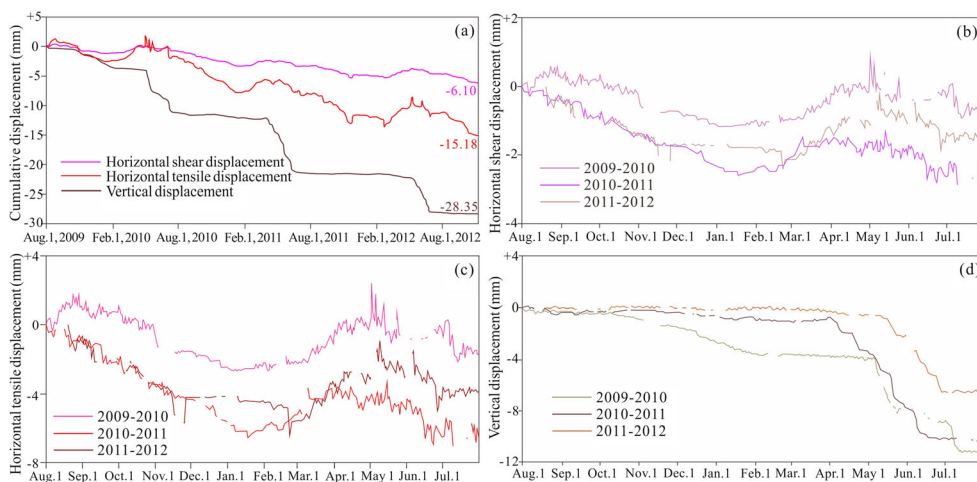
**Fig. 9** Relative displacement curves for the hanging wall in 2009–2012 (derived from Wang et al. 2013). **a** cumulative horizontal and vertical displacements in 3 years. For the horizontal shear displacement “+” indicates left-lateral and “-” indicates right-lateral, for the horizontal tensile

displacement “+” indicates compression and “-” indicates tension, and for the vertical displacement “+” indicates uplift and “-” indicates subsidence. **b** Annual horizontal shear displacement curves. **c** Annual horizontal tensile displacement curves. **d** Annual vertical displacement curves

According to Wang et al. (2013), the automatic monitoring system employed three displacement sensors on the hanging wall and one datum on the footwall to monitor the three-dimensional deformation of the EF1 fissure, which included recording data every half hour. Figure 9a shows that the subsidence occupied the first place, the opening followed, and the right-lateral shear is the least. The proportion of these three modes of cumulative displacement was 28.35: 15.18: 6.10, from August 1, 2009 to November 1, 2012. The fluctuation

in the horizontal displacement curves and the substantial decline in the vertical displacement curves indicate the dominant position of the subsidence. Figure 9b and Fig. 9c present similar variation tendencies, indicating that the hanging wall deformed horizontally along two basically fixed orientations, primarily south and occasionally north, based on the N70°E strike of the EF1 fissure in Xiwanglu village and the ratio between cumulative horizontal displacements. Figure 9d shows the delay in the land subsidence over the years, which is in agreement with the leveling observations (Fig. 8b). It also shows a sharp change from declines in April to June (or May to July) to almost constant levels in the other months. The conversion was not explained by Wang et al. (2013) but is speculated to be associated with heavy pumping of groundwater after winter ended in this paper.

In addition, in Fig. 9, horizontal compression and horizontal left-lateral shear, indicating a north-trending movement of the hanging wall of the EF1 fissures, occurred synchronously with each sharp vertical displacement, while the horizontal displacements returned as soon

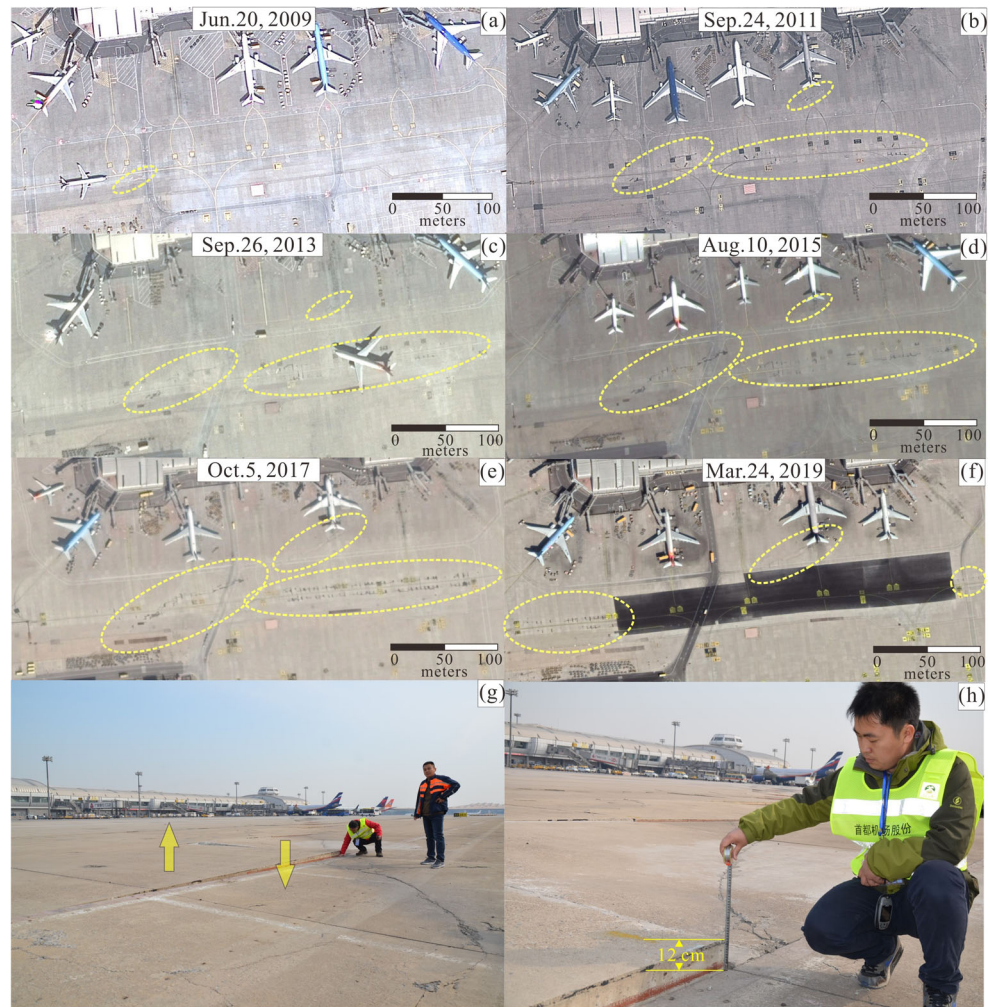
**Fig. 12** Cracked cement concrete slabs and subsided southeastern side in the BCIA. Fissures are 300-m long, 1~10-cm wide, and have 1~12-cm vertical dislocations. Location is shown in Fig. 10. **a~f** Pictures are based on Google Earth image. **g~h** Photos were taken on March 15, 2017

In 2017, we noticed the appearance of a large numbers of earth fissures at the Beijing Capital International Airport (BCIA), which were not reported before. According to the unpublished records from the airport, an unprecedented number of cracks and vertical offsets both occurred in the airstrips, taxiways, underground passages, aprons, Terminal 2, and Terminal 3. As a result, the infrastructure was damaged to a certain degree, and nearly 10% of the total airport area was affected. Satellite images (Figs. 12a–f) indicate that the fissures mainly emerged along a NE-SW trend in the concrete

near the Terminal 2, beginning in 2009. Figure 12f shows that repair and preventative efforts did not prevent the fissures from propagating. In our subsequent survey, for the first time, identical geological phenomena were discovered from the Air China hotel (Fig. 13) to the Wuyuan logistic park (Fig. 14). The Wuyuan logistic park is very close to the SHF (Fig. 2), and no fissures or damages have been observed or reported on the other side of this regional normal fault until now.

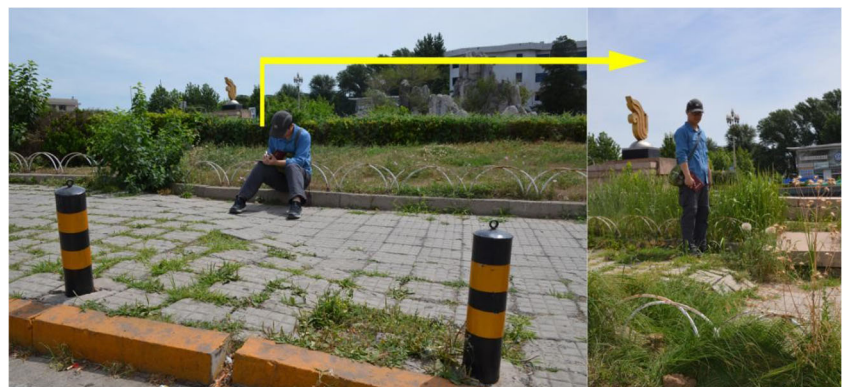
**Fig. 13** Damaged pavement in a garden of the Air China hotel. Photos were taken on June 8, 2018. Location is shown in Fig. 10. Twenty-five-meter-long earth fissures trending N40°E. Southeastern side has subsided 10~30 cm

In the northeastern Beijing plain, preexisting faults played a crucial role in the formation of the EF1 and EF2 fissures. The distribution and deformation patterns of the EF1 and EF2 fissures are consistent with segments of the HGF and SYF, respectively. The two faults have propagated upward into the shallow sediments, or even to the ground surface, which are shown in excavated trenches (Figs. 7 and 15) and geophysical prospecting profiles (Fig. 16). The deposits around the crack tips of these shallowly buried faults are fragile and sensitive; this explains why there is a lot of overlaps between the two groups of earth fissures and the preexisting faults in the horizontal direction. Second, the kinematic consistency between the preexisting faults and the earth fissures confirms the definite control action of the two normal faults. The dip-slip movements of the HGF and SYF were dominated by vertical displacements in the Quaternary period, which are identical to the monitoring results for the EF1 fissure shown in Fig. 9 and the damage pattern caused by the EF2 fissures shown in Fig. 13 and Fig. 14.

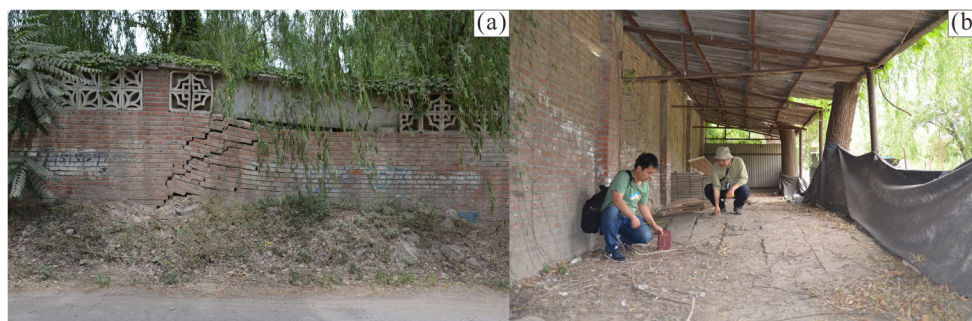
**Fig. 14** Damages in the Wuyuan logistic park. Photos were taken on June 2, 2017. Location is shown in Fig. 10. Three-hundred-meter-long earth fissures trending N30 °~40 °E in the Wuyuan logistic park. Southeastern side has subsided 10~20 cm. Differential subsidence and

earth fissure occurred starting in about 2010, based on interviews. **a** Damaged southern wall. **b** Damaged southern wall and subsided ground surface

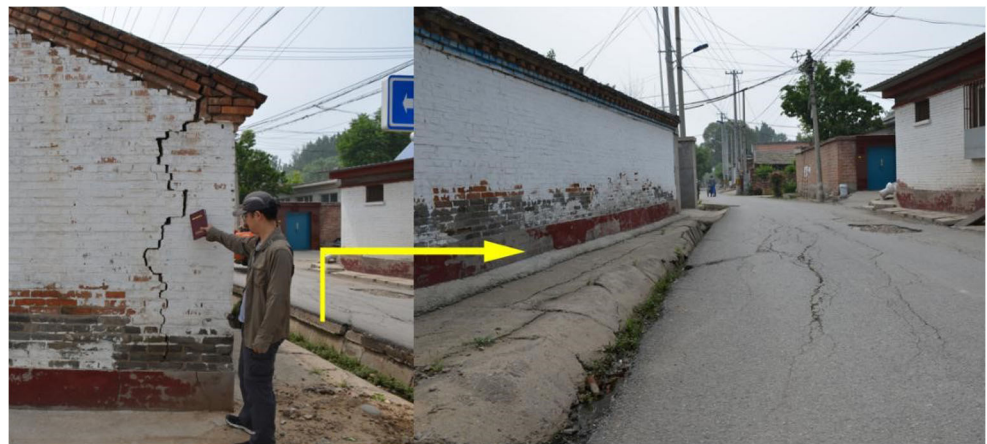
**Fig. 18** Cracked house and pavement, without a measurable vertical offset, in Beicai village. Photos were taken on May 16, 2018. Location is shown in Fig. 17. Fissures in the pavement, trending E-W, 10~20-m long

fissures (Fig. 18 and Fig. 19), which are almost perpendicular to each other in the horizontal direction (Fig. 17), cracked houses and infrastructures. Figure 19 shows an inverted “Y” type fissure formed along the weak planes between a wall and a dike by bending. The upper branch of the fissure caused the wall to tilt and the lower branch damaged a drain pipe.

Additionally, the formation pattern of earth fissures on the margins of paleochannels follows the bending model (Pacheco-Martínez et al. 2013; Xu et al. 2019). In the northeastern Beijing Plain, there are two basic layers consisting of a stiff layer, i.e., concrete and hardened fills, and a compressible layer, i.e., heterogeneous paleochannel deposits. As soon as uneven vertical deformation occurs in the compressible layer, the upper stiff layer bends and cracks above the voids due to the gravitational stress and additional stresses. This pattern is exhibited by the EF3 fissures (Figs. 18 and 19).

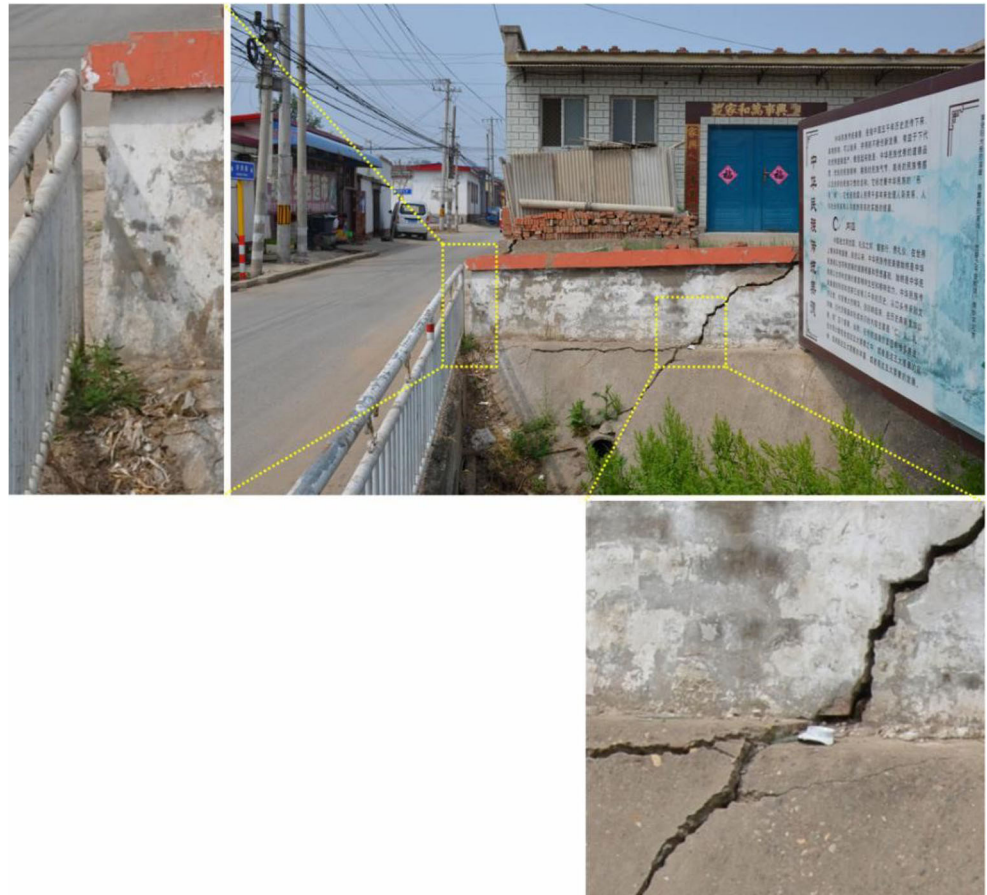
**Fig. 19** Cracked house, wall, and dike with small vertical offsets in Beicai village. Photos were taken on May 16, 2018. Location is shown in Fig. 17. Fissures trending N10°E mostly covered by new concrete pavement. Wall tilted inward by fissure propagation
