# Study of the slope deformation characteristics and landslide mechanisms under alternating excavation and rainfall disturbance

Xiang Yu<sup>1</sup> · Bin Gong<sup>1,2</sup> · Chun'an Tang<sup>1</sup>

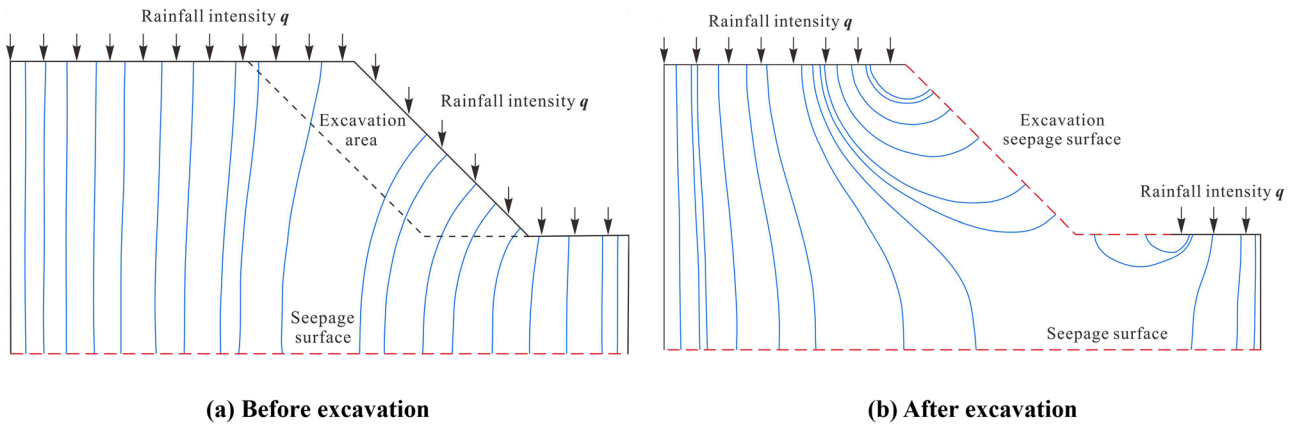
**Fig. 1** Schematic diagram of seepage path changes in unsaturated soil slope excavation simulation (blue lines in the figure are the seepage lines). (a) Before excavation. (b) After excavation

This section will explain the simulation difficulty of unsaturated slope excavation. Figure 1 shows the change in the seepage field of an unsaturated soil slope because of rainfall infiltration before and after excavation. Before excavation, the seepage surface is assumed to coincide with the bottom boundary, and rainfall intensity  $q$  is applied to the top boundary. The rainwater infiltrates from the top and seeps towards the bottom. After excavation, the infiltration boundary of the excavation area disappears, and the excavation–formed boundary becomes a new seepage surface. The rainwater near the excavation boundary seeps towards the new surface, while the rest still seeps towards the bottom. Thus, the seepage paths are changed by excavation.

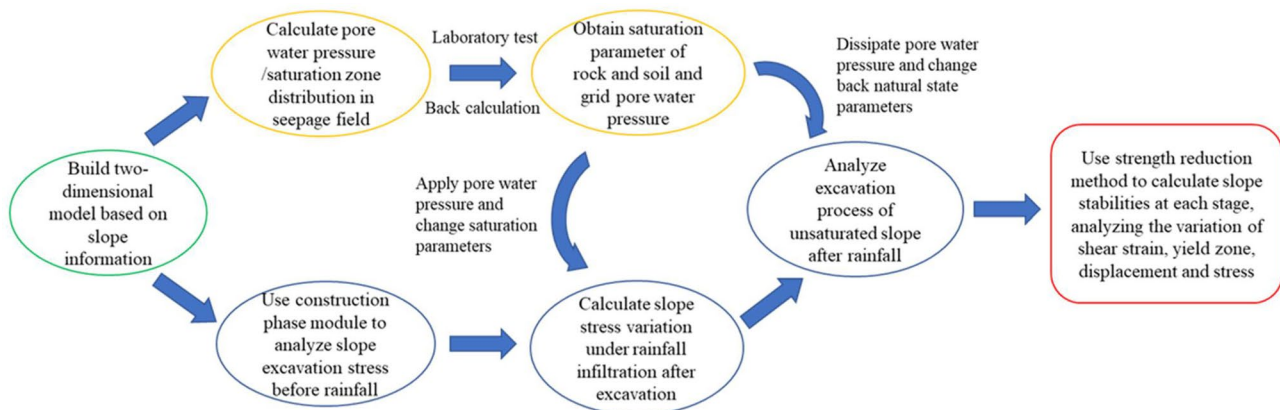
**Fig. 2** Slope stability simulation process under alternating excavation and rainfall

The change in the seepage field lags behind that in the stress field, which complicates the numerical calculation. However, in actual engineering, rainfall can only infiltrate into the shallow layers of slopes (Zhang et al. 2020). Pore water can completely dissipate within a few days under sun and wind exposure. If the residual pore water pressure dissipates before excavation, the slope can be restored to its natural state, and the stress of the elements that will be excavated can be determined. Therefore, the method of separate simulation and superposition analysis is proposed to analyse the slope stability under alternating excavation and rainfall. The detailed calculation process is shown in Fig. 2. The specific steps are as follows:

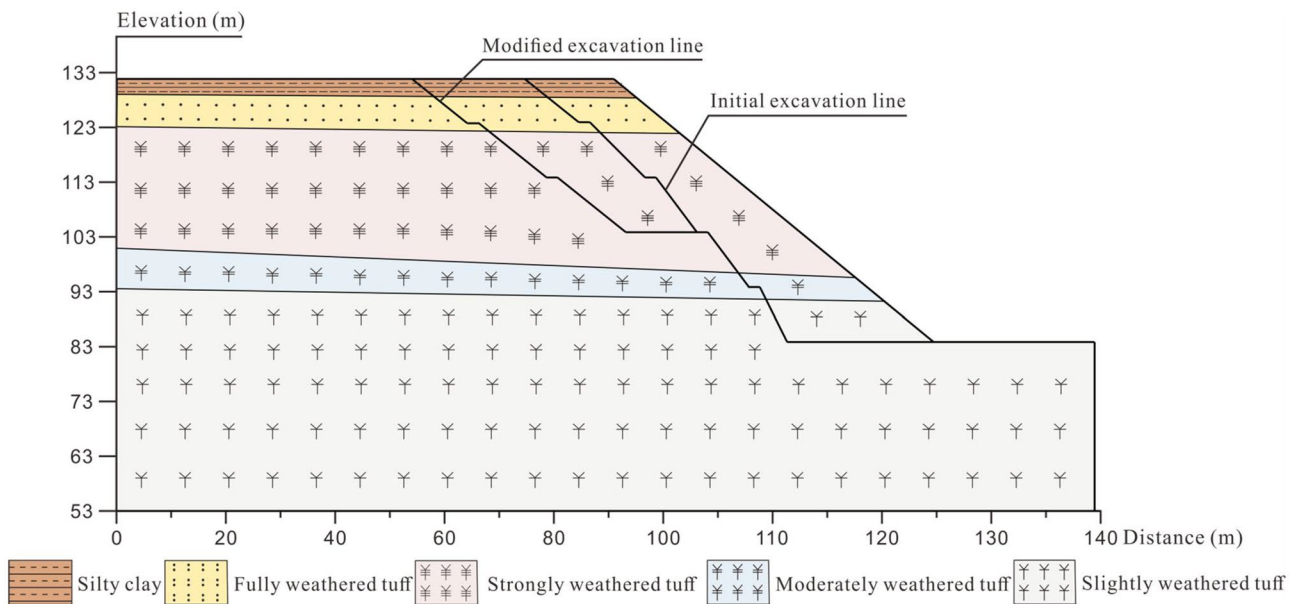
Fig. 3 Slope morphology and engineering geological conditions

summer. The groundwater is bedrock fissure water supplied by atmospheric precipitation. Due to the water absorption properties of the strongly weathered tuff at the upper part of the slope, it is difficult to find groundwater in the study area. The slope morphology and engineering geological conditions are shown in Fig. 3.

Based on the engineering geological section shown in Fig. 3, Midas-GTX software is used to establish a two-dimensional finite element model. Vertical sliding bearings are applied to the left and right boundaries, while fixed bearings are applied to the bottom boundary. The slope safety factor is calculated by the strength reduction method. Because the slope simulation is complicated under alternating excavation and rainfall conditions, the proposed method is used to simulate the excavation stress field and the rainfall seepage field separately. Then, the seepage field results are applied to the corresponding

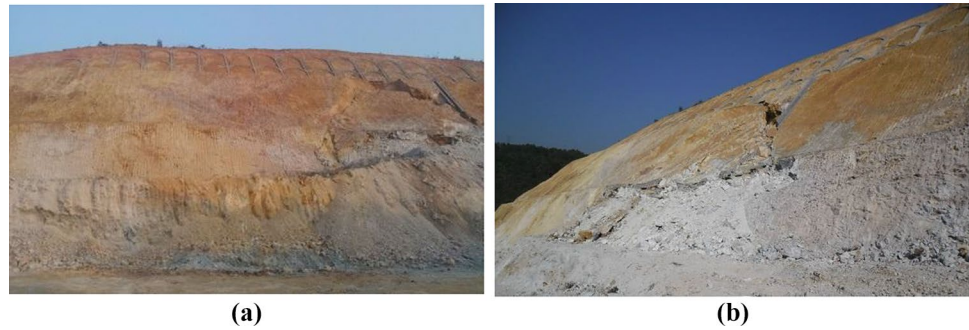
**Fig. 4** Status of the slope sliding area in January 2015

The on-site observations after the first rainfall event are shown in Fig. 4, and the slope safety factor is reduced from 1.05 to 1.02. The infiltration of rainwater produces a transient saturated zone in the shallow layers, as shown in Fig. 17. The shear strength and density of the rock and soil

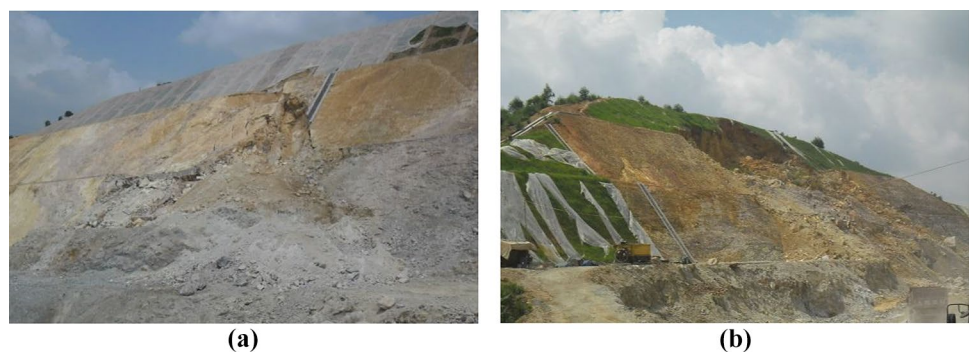
**Fig. 5** Development of the slope sliding area from May to June 2015

slopes. Similar to the fourth-level slope failure mechanism, the fifth-level slope was dragged and damaged by the lower sliding bodies. Finally, a sliding area that ran through the third- to fifth-level slopes formed in June 2015, as shown in Fig. 5b.

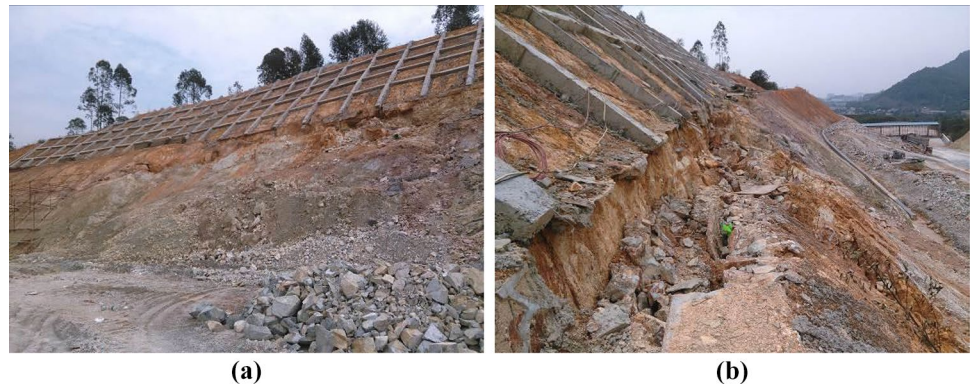
**Fig. 6** Status of the slide after the modified excavation in January 2016

In January 2016, heavy rainfall occurred again in the slope area. At this time, the excavated third- to fifth-level slopes had not yet been supported, and a slide occurred through the third- to fourth-level slopes, as shown in Fig. 6a. Slip surfaces and tension cracks were clearly observed at the toe of the fourth-level slope, as shown in Fig. 6b, and no further slope deformation has occurred since.

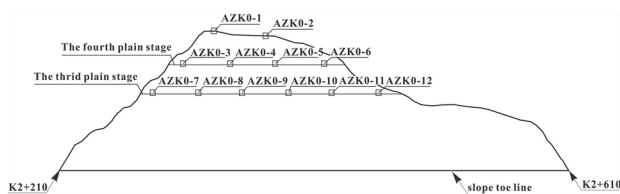
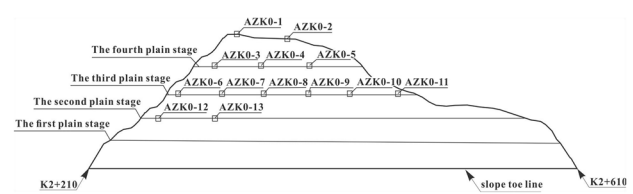
**(a) Schematic diagram of the measuring point layout in the first and second stages**

**(b) Schematic diagram of the measuring point layout in the third stage**

**Fig. 7** Schematic diagrams of the measuring point layouts in each monitoring stage (AZK0-1 and 0-2 in the figure are newly added points in the second stage). (a) Schematic diagram of the measuring

point layout in the first and second stages. (b) Schematic diagram of the measuring point layout in the third stage

fifth-level slopes during excavation. Considering the disturbance and damage of the monitoring points during the long construction process, the monitoring can be divided into three stages. The layout of the measuring points in each stage is shown in Fig. 7.

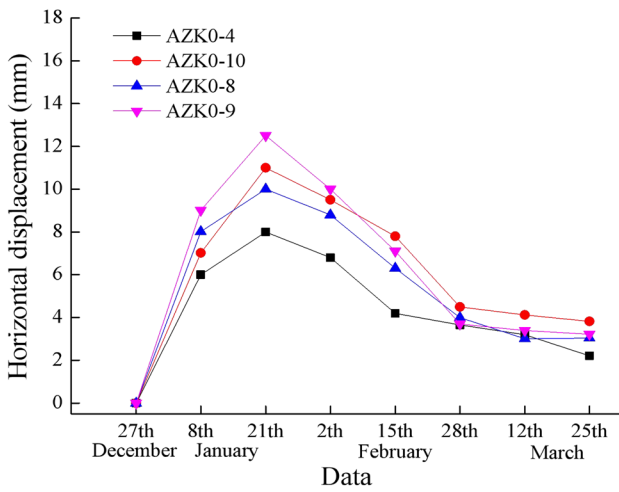
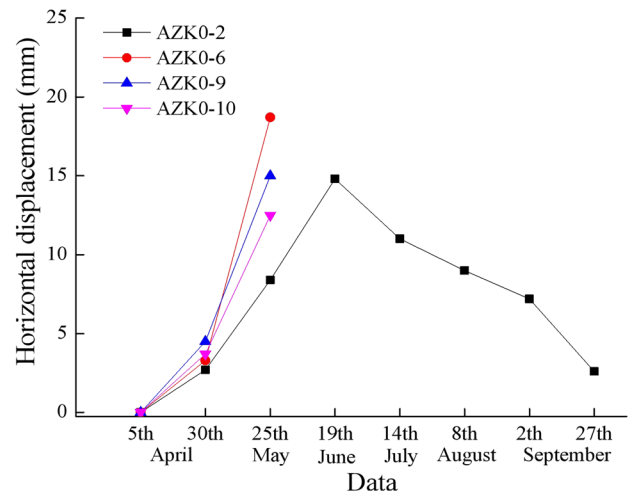
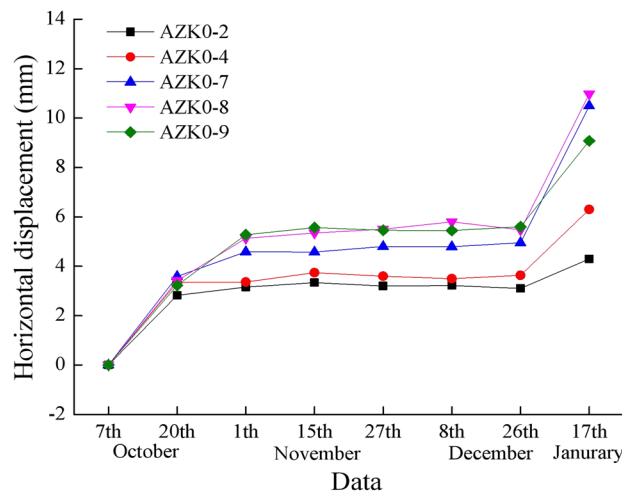
**Fig. 8** Horizontal displacements of typical measuring points during each stage. (a) The first monitoring stage (December 2014 to March 2015). (b) The second monitoring stage (April to September 2015). (c) The third monitoring stage (October 2015 to January 2016)

Due to a large volume of data, the horizontal displacements of the representative monitoring points at each stage are selected to reflect the deformation, as shown in Fig. 8. The first stage started on December 27, 2014. On January 8, 2015, large local deformation occurred on the third-level slope after excavation, causing a sharp increase in displacement at all the measuring points. From January 15 to 20, heavy rainfall occurred in the slope area, which directly caused third- and fourth-level slope sliding and deformation, resulting in abrupt displacement increases of the third- and fourth-level platforms up to 12.5 mm and 8 mm, respectively. The slope remained stable until the rainy season (April ~ June). The second stage of monitoring started on April 5, 2015, and two new measuring points, AZK0-1 and 0-2, were set up on the slope top to monitor the fifth-level slope deformation. The traction deformation and sliding continued under the action of continuous rainfall, which could be verified by a significant increase in measured displacements on May 25, 2015. On June 19, 2015, a landslide that ran through the third- to fifth-level slopes eventually formed and destroyed almost

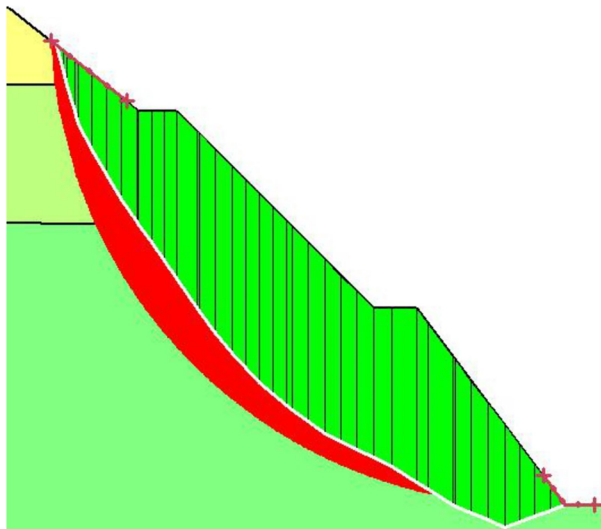
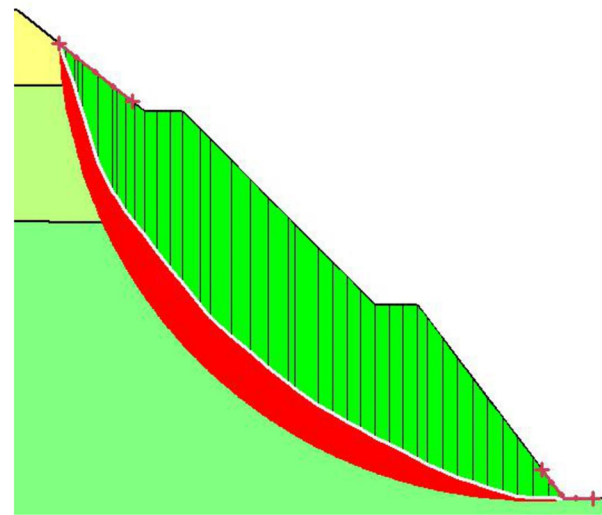
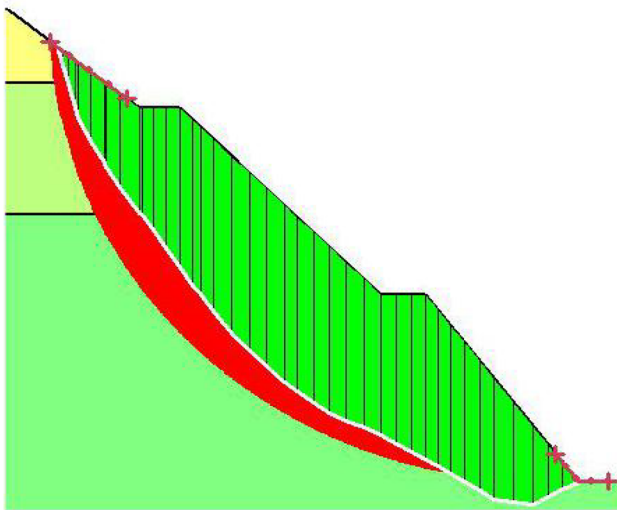
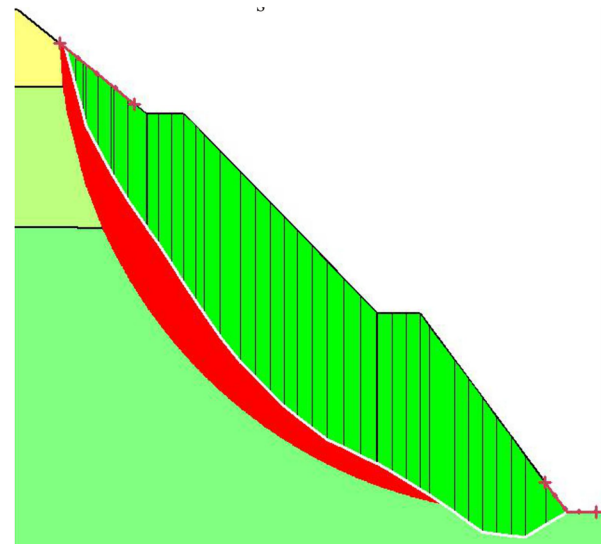
(a) The reduction ratio of 3:1

( $F_s=0.998$ )

(b) The reduction ratio of 4:1

( $F_s=0.982$ )

(c) The reduction ratio of 4:1

( $F_s=0.994$ )

(d) The reduction ratio of 5:1

( $F_s=0.996$ )

Table 2 shows that the safety factors calculated by the partial saturation parameters under the three tested ratios reached the inversion target. Two sets of saturation parameters under a reduction ratio of 4:1 meet the inversion target, with safety factors of 0.982 and 0.994. For the reduction ratios of 3:1 and 5:1, each condition has a set of saturation parameters satisfying the inversion target with safety factors of 0.998 and 0.996, respectively. However, based on Fig. 9 and the final sliding surfaces obtained, except for the result with a safety factor of 0.982, the other inversed critical sliding surfaces near the shear outlet are inconsistent with the on-site situation. Thus, the set of saturation parameters with the highest safety factor of 0.982 under the ratio of 4:1 are selected for subsequent numerical calculations, i.e., the fully weathered tuff parameters are  $C = 18.4$  kPa and  $\varphi = 16.5^\circ$ , and the strongly weathered tuff parameters are  $C = 26$  kPa and  $\varphi = 21.5^\circ$ .

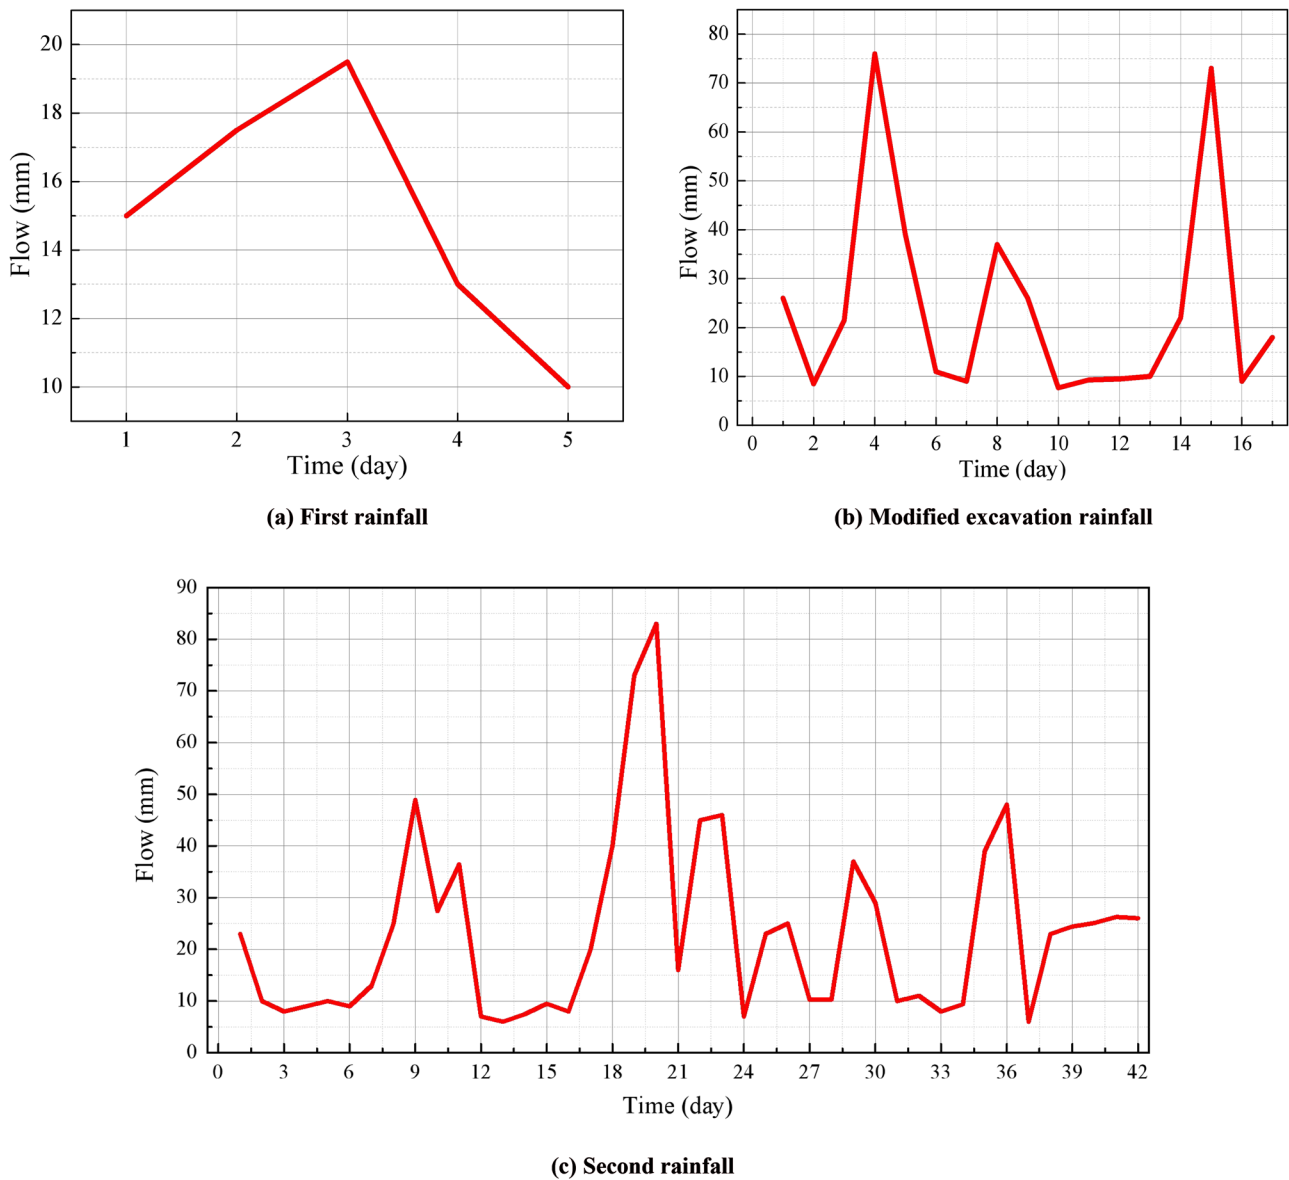
**Fig. 10** The seepage boundary functions of the three rainfall events. (a) First rainfall. (b) Modified excavation rainfall. (c) Second rainfall

The Midas-GTX transient seepage module simulates the rainfall process. The analysis time step is one day. The daily flow during the rainfall period is converted to the seepage boundary functions and applied as the flow boundary conditions. Because no groundwater is found, the initial groundwater level is set in the slightly weathered tuff layer to meet the transient seepage analysis conditions without affecting the analysis results. Meanwhile, for the convenience of analysis, the three rainfall periods of January 2015, May–June 2015, and January 2016 are simplified into three heavy rainfall events. The first two are called the first and second rainfall, respectively, and the later one is called the modified excavation rainfall. According to the meteorological data, the intensity and duration of rainfalls are shown in Table 3 with the seepage boundary functions displayed in Fig. 10.

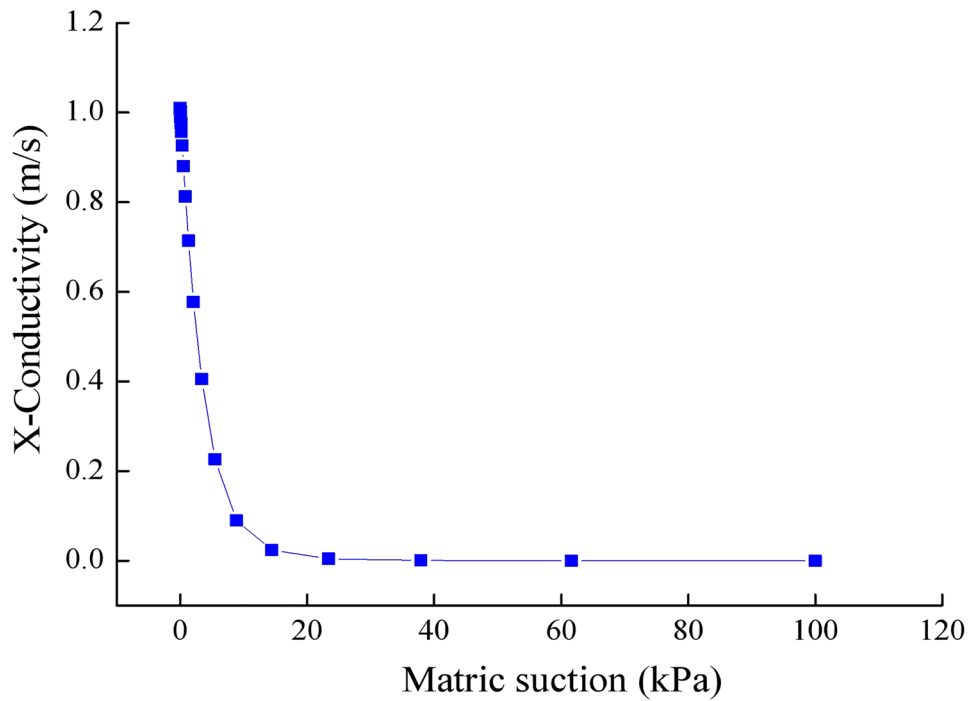
**Fig. 11** Permeability function curve of the silty clay

Because the moderately to slightly weathered layer is relatively deep and has little effect on the slope stability, its permeability characteristics are not considered. According to geological survey data and previous research results (Zhao et al. 2017; Tan et al. 2018), the parameters of the Van Genuchten model and the saturated permeability coefficients  $K_s$  of silty clay, fully to strongly weathered tuff layers are listed in Table 4. Simultaneously, the unsaturated soil permeability function curves and water content function curves are shown in Figs. 11, 12, 13, 14, 15, and 16.

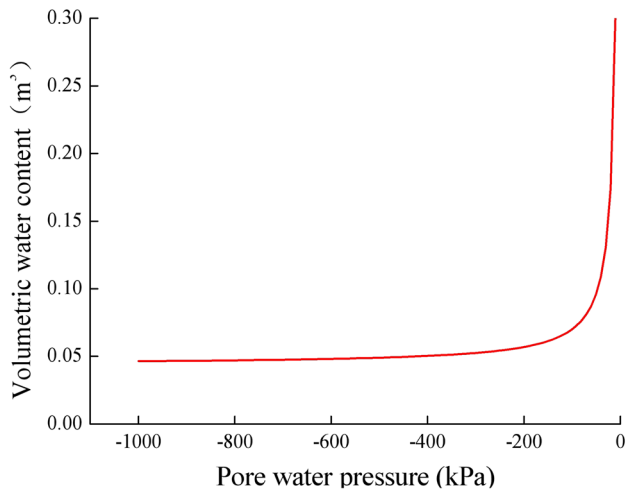
**Fig. 12** Water content function curve of the silty clay

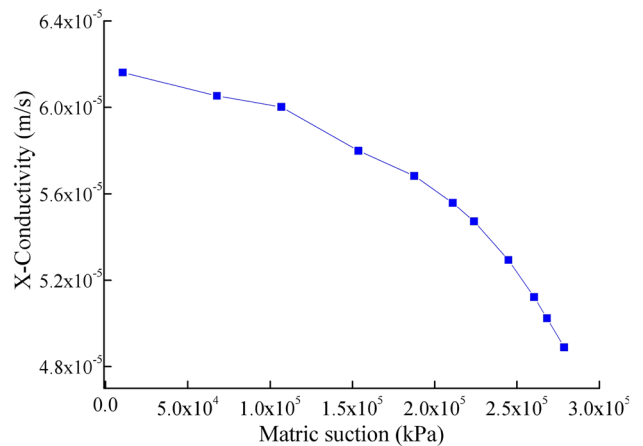
**Fig. 13** Permeability function curve of the fully weathered tuff

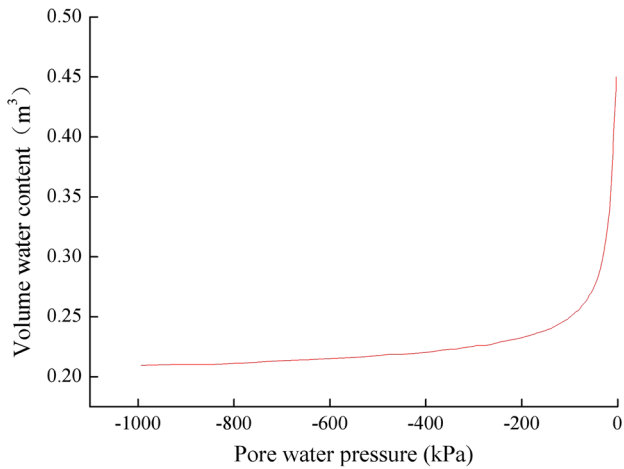
Fig. 14 Water content function curve of the fully weathered tuff

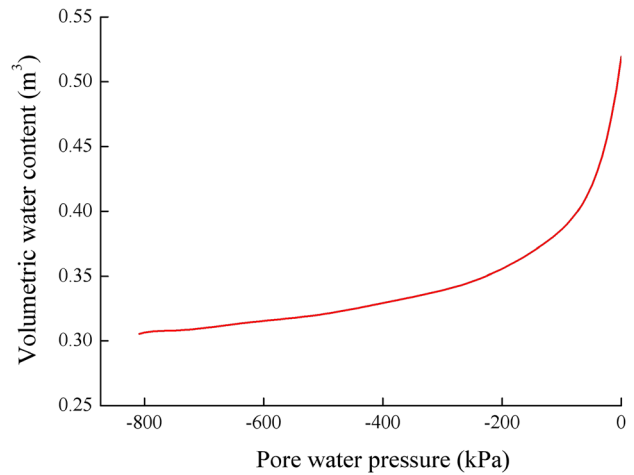
Fig. 16 Water content function curve of the strongly weathered tuff

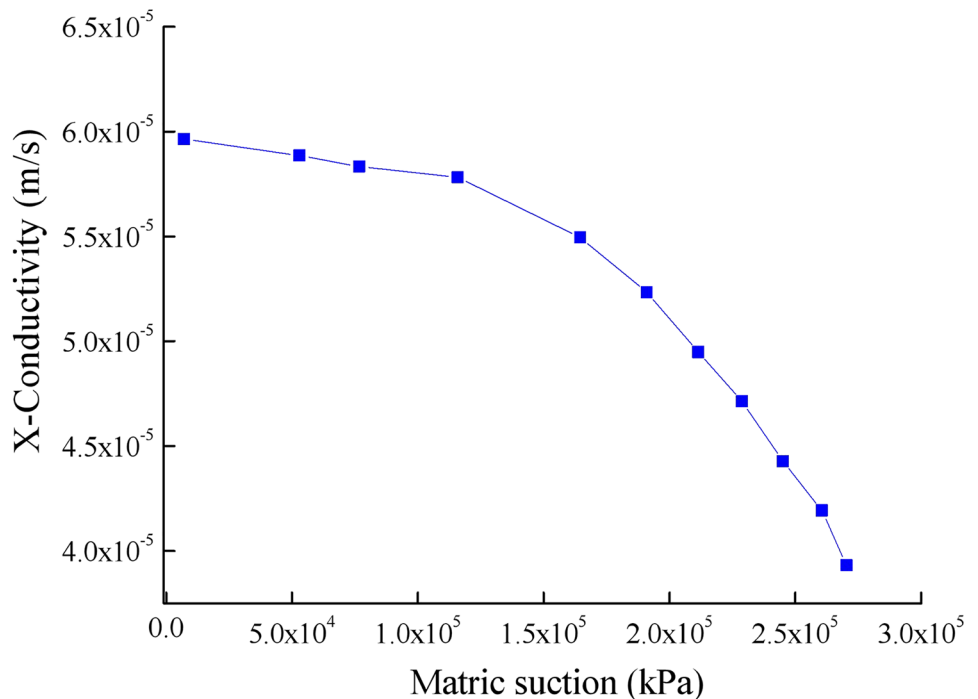
Fig. 15 Permeability function curve of the strongly weathered tuff

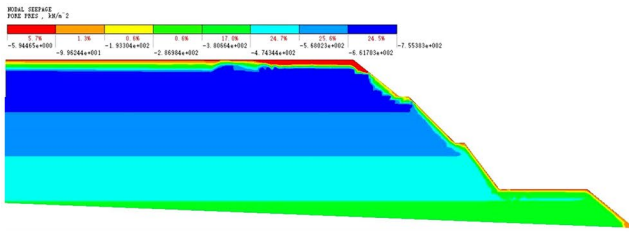
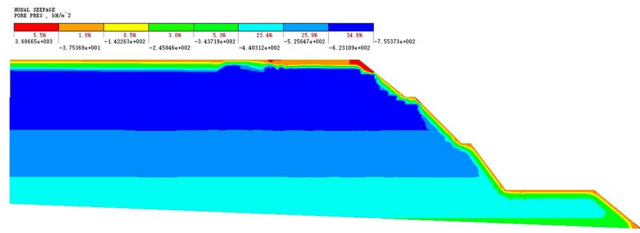
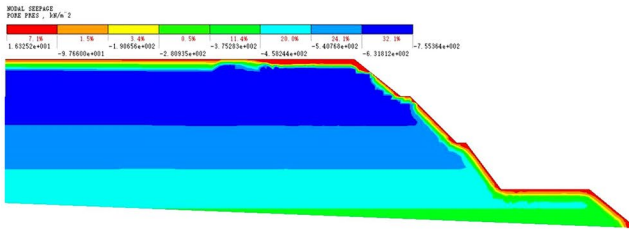
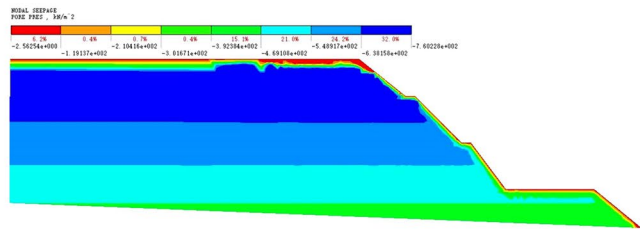
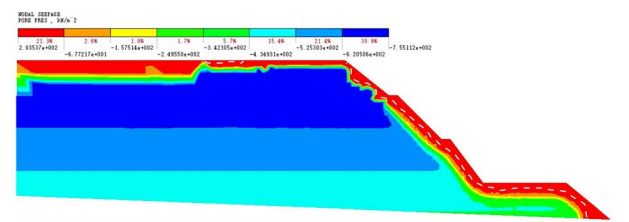
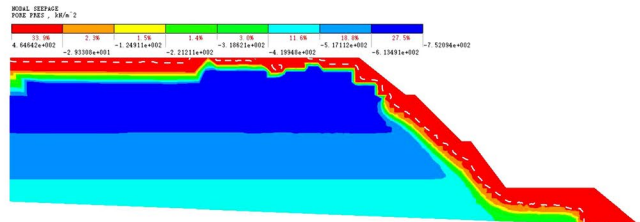
**Fig. 17** Pore water pressure distribution with time induced by three rainfall events. (a) First rainfall (day 1). (b) First rainfall (day 3). (c) First rainfall (day 5). (d) Second rainfall (day 1). (e) Second rainfall

Figure 17 shows the distribution changes of pore water pressure in the early, middle, and final (rainfall end) stages of the three rainfall events. In the early stage, since the rainfall intensity is far less than the permeability coefficient of the rock and soil, the slope is unsaturated, and the pore water pressure is all negative. In the middle stage, the rainfall intensity exceeds the saturated permeability coefficient

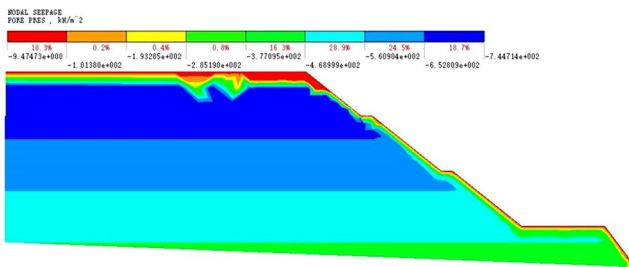
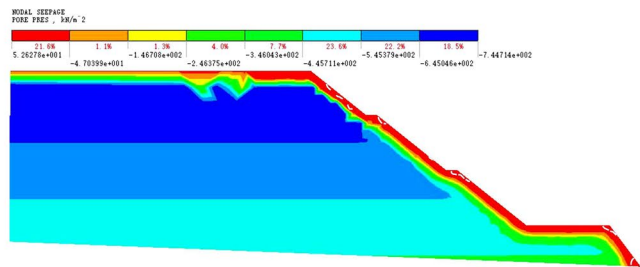
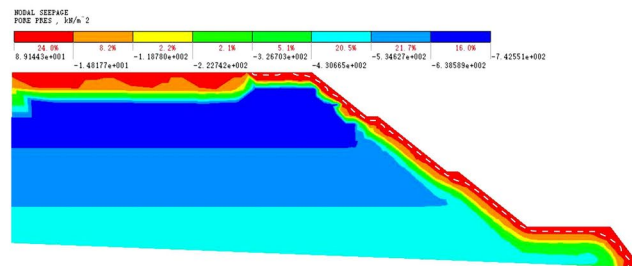
three stages in the chronological order for each rainfall event, i.e. early stage, middle stage, and final stage. The contour maps of pore water pressure induced by the first, second, and modified excavation rainfall seepage are shown in Fig. 17, in which the white dotted lines are the infiltration lines and the soil above them is saturated.

under tension to yield, the slope is unable to greatly deform and slide due to the low stress level. After rainfall, the infiltration rainwater produces a saturated zone again, as shown in Fig. 17. The pore water pressure and the soil’s additional bulk density cause the slope stress level to rise again, and the shear

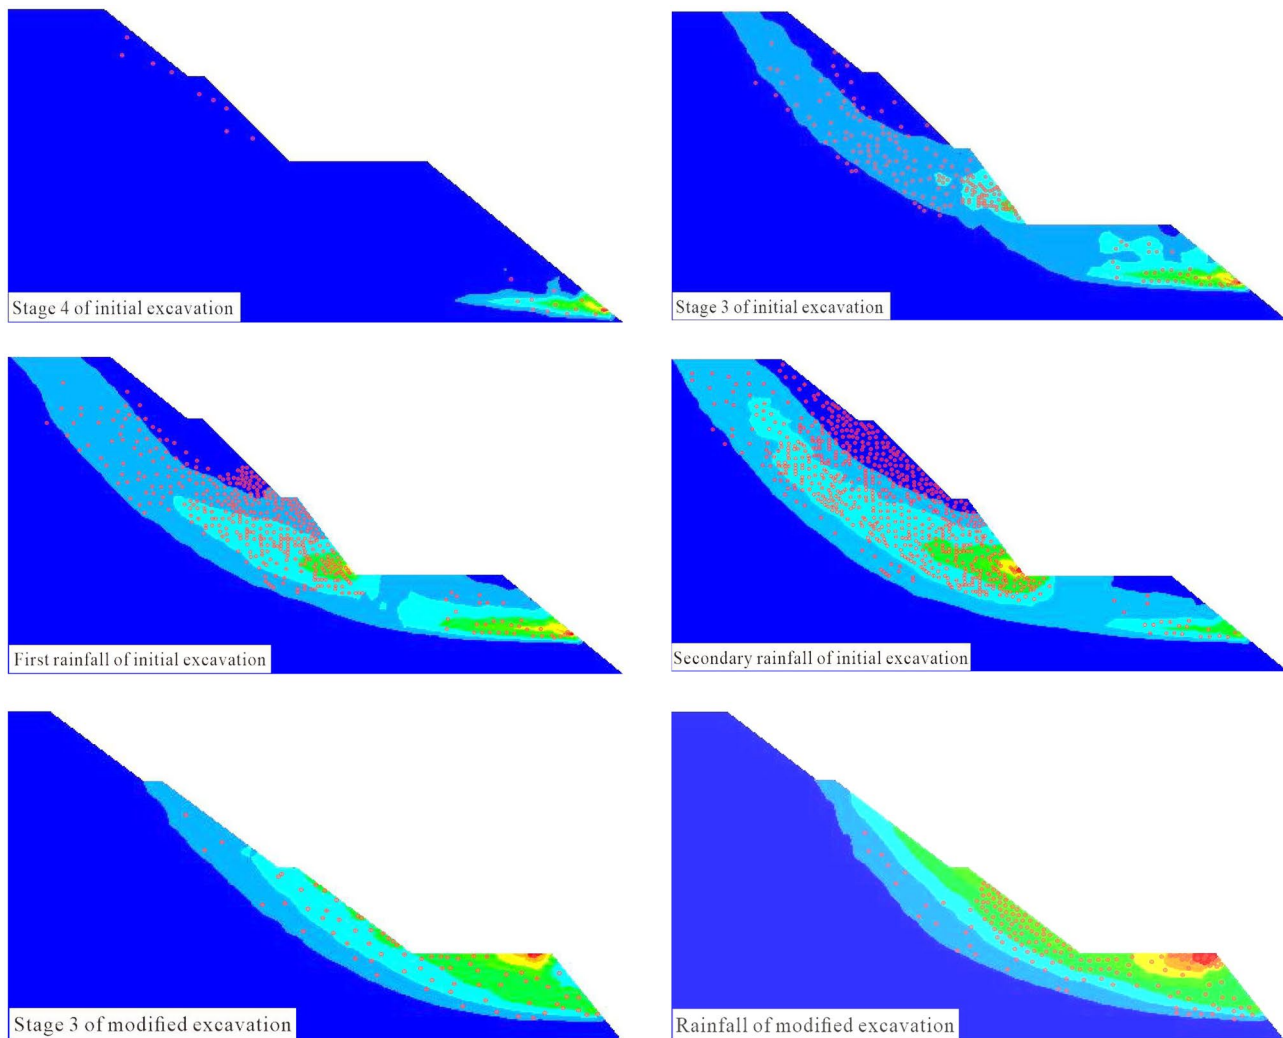
**Fig. 18** Maximum shear strain and yield evolution in the slope (red dots in the figures represent tensile yield elements)

plastic zone to form, and the later rainfall induces plastic zone expansion. A high stress concentration appears in the second platform, while tensile failure mainly occurs in the formed third level slope.

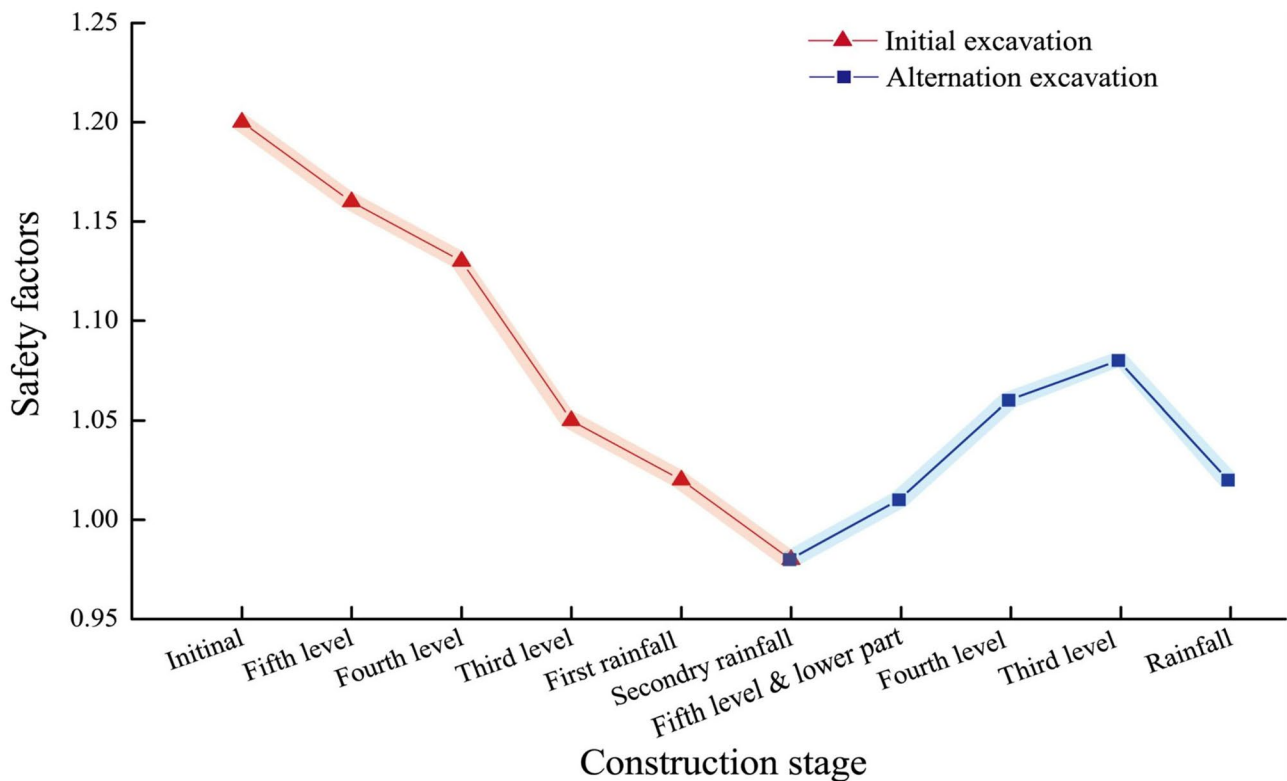
Fig. 19 Safety factor in each stage of the slope excavation sequence

Figure 19 shows the slope stability in each excavation stage. The slope stability first decreases with the excavation process, then slowly rises, and finally decreases rapidly. The safety factors are 1.02, 0.98, and 1.02 for the first, second, and modified excavation rainfall stages, respectively. Considering the parameter inversion calculation result (0.982), the four safety factors are all in the target safety factor range of the stability back analysis, and the safety factors and sliding surfaces of the second rainfall stage and inversion result almost coincide, which demonstrates that the numerical simulation and the inversion analysis have good consistency. According to the slope excavation sequence, the deformation characteristics will be analysed separately in the two excavation stages.

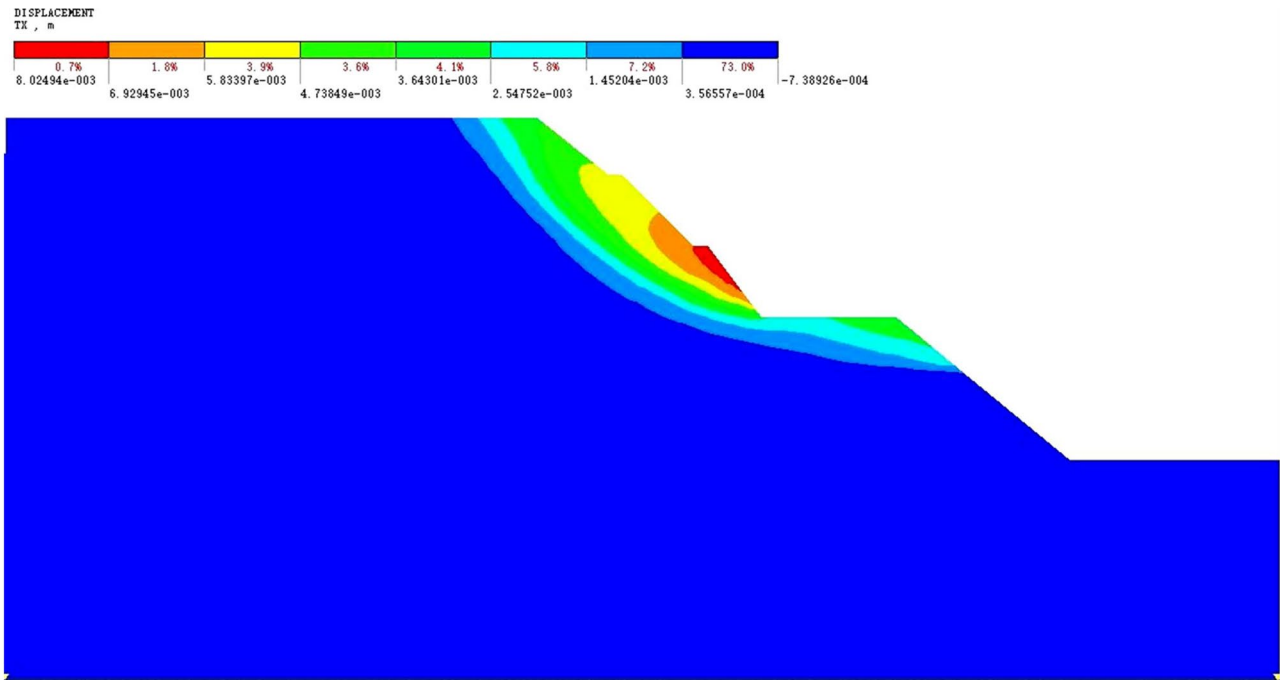
Fig. 20 Horizontal displacement distribution after initial excavation of the third-level slope

The slope stability gradually decreases as the initial excavation progresses. Before the third-level excavation, the slope is in an unloading and rebounding state. Excavation has a small effect on the slope stress, and only a few tensile yield elements appear near the formed surface. After the third-level excavation, the slope enters a shear fracture state, with the safety factor dropping to 1.05, and large local deformation occurs. The maximum horizontal displacement of the initial third-level slope excavation is 8.02 mm, as shown in Fig. 20. Continuous excavation disrupts the slope stress balance and triggers a high stress concentration to form at the excavated toe and subsequent shear slip. Then, the damaged toe drags the upper part of the slope to form the tensile stress zone, as shown in Fig. 21. This area is basically consistent with the maximum shear strain area, indicating that sliding failure is mainly caused by the pulling and stretching of the lower parts and shows the characteristics of typical tensile-shear failure. The slope deformation exhibits an overall sliding trend after the third-level excavation.

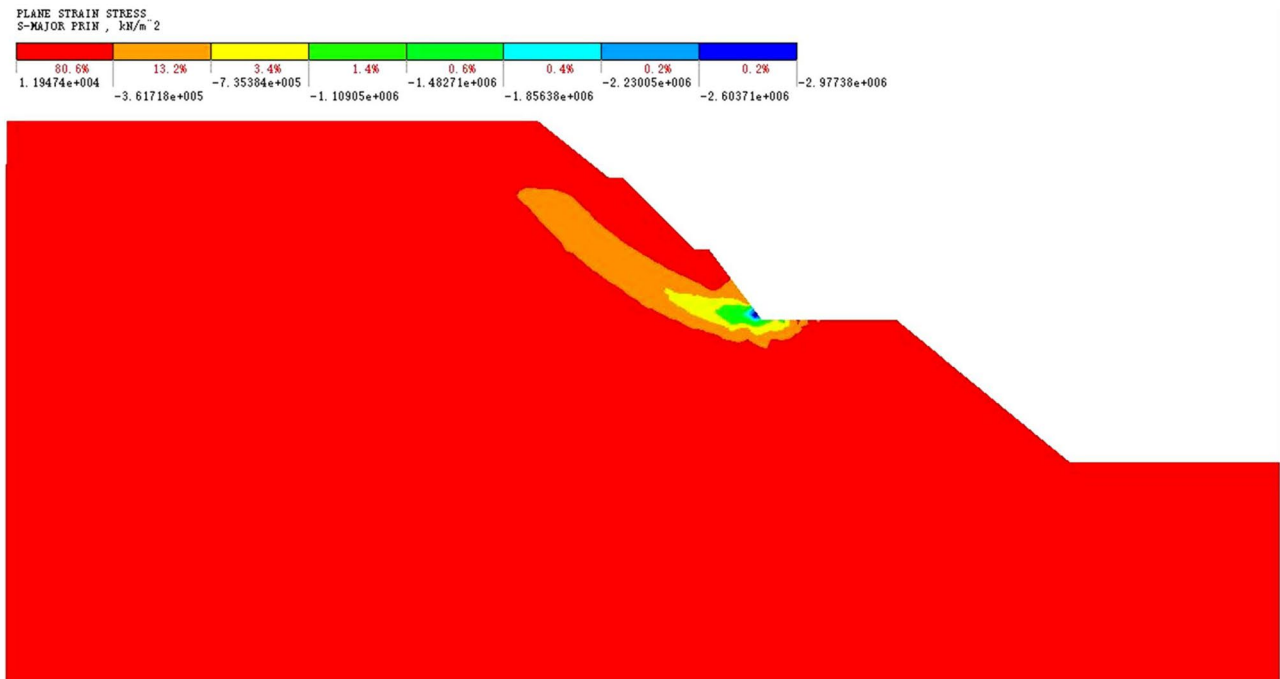
Fig. 21 Maximum principal stress distribution after initial excavation of the third-level slope

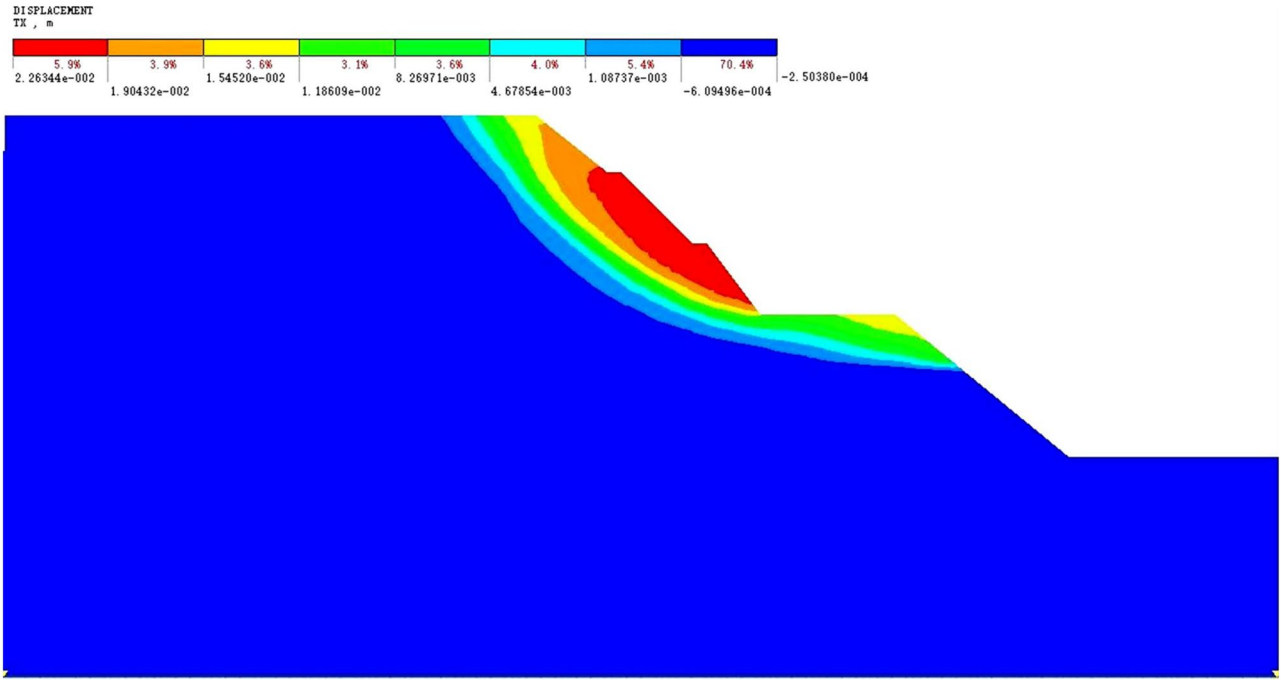
Fig. 22 Horizontal displacement distribution after the second rainfall

mass in the saturation zone decreases and increases rapidly, respectively. The elements that undergo tensile yielding are mainly located in the middle and lower parts of the fourth-level slope. The internal shear yield zone expands, indicating that the tensile-shear failure area extends upwards from the third-level slope. The fourth-level slope is dragged to deform by the lower parts, and the slope approaches the limit equilibrium state. After the second rainfall, the slope failed ( $F_s < 1.0$ ), and the transient saturated zone expands to the inner slope, as shown in Fig. 18. The tensile-shear failure area covers the entire excavated slope level, and a shallow landslide that runs through the third- to fifth-level slopes finally forms, as shown in Fig. 22.

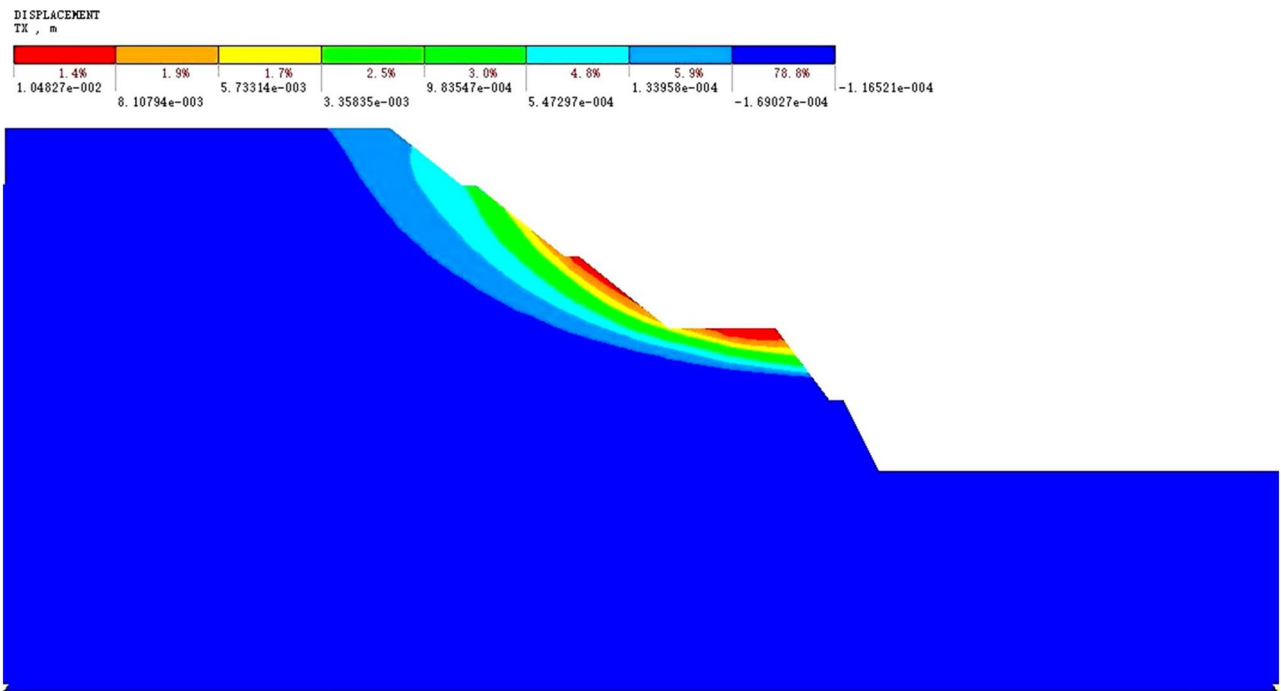
Fig. 23 Horizontal displacement distribution after the modified excavation rainfall

strength is also reduced due to the water softening effect. The toe of the excavated third-level slope is unstable and undergoes further damage, which pulls the middle and upper bodies to form slip through the third and fourth-level slopes, as shown in Fig. 23. The maximum horizontal displacement of the slope

is 10.5 mm, close to the 11 mm maximum horizontal displacement measured at the third platform monitoring point. The simulated deformation range is very similar to the actual sliding failure area, and the simulation is also in good agreement
