Response of landslide deformation to rainfall based on multi-index monitoring: a case of the Tanjiawan landslide in the Three Gorges Reservoir

Abstract

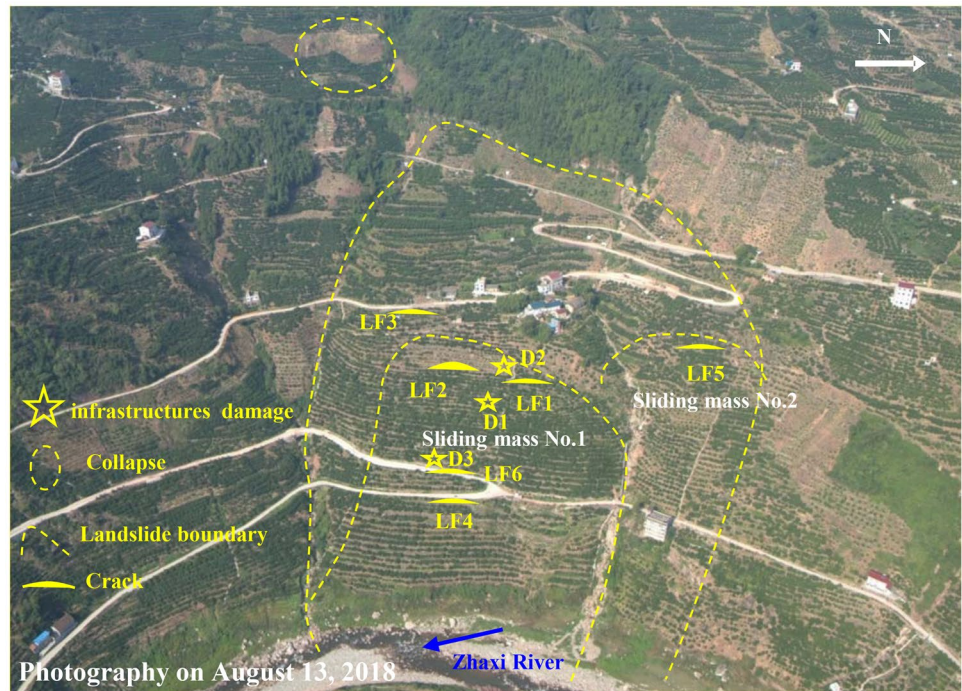
Fig. 2 Panoramic view of the Tanjiawan landslide

Prior to 2014, the surface deformation characteristics of the landslide were not obvious, and only the middle part of the landslide exhibited slight creep deformation. During the rainstorm of 31 August 2014 (mentioned in “Introduction”), three rainstorms produced a total rainfall of 270 mm in 5 days, and the Tanjiawan landslide exhibited obvious deformation and collapse. The deformation occurred as follows. The trailing edge of the landslide, with a volume of approximately 1000 m³, collapsed (Fig. 6a), which damaged the highway (Fig. 6b). The location of the damage is shown in Fig. 2. The middle part of the landslide, with a height of approximately 30 cm, collapsed (Fig. 6c). Two tension cracks (Fig. 6d) approximately 30 m and 8 m in length are visible at the collapse site; the cracks (LF1, Fig. 2) are almost parallel, with a trend of approximately 150°.

In October 2017, owing to the effects of the autumn rain in West China, various degrees of deformation occurred in the front, middle, and back parts of the Tanjiawan landslide. Cracks appeared in the middle and back parts, causing houses to collapse (Fig. 7a). The cracks (LF2; Fig. 2) extended to the left gully; they were approximately 80 m in

length, 1–10 cm in width, and showed a maximum dislocation of 30 cm (Fig. 7b). Cracks appeared at the bottom of the retaining wall along the farm track in the middle of the landslide (Fig. 7c, the location is shown in D1 in Fig. 2), and cement steps were damaged (Fig. 7d, the location is shown in D2 in Fig. 2).

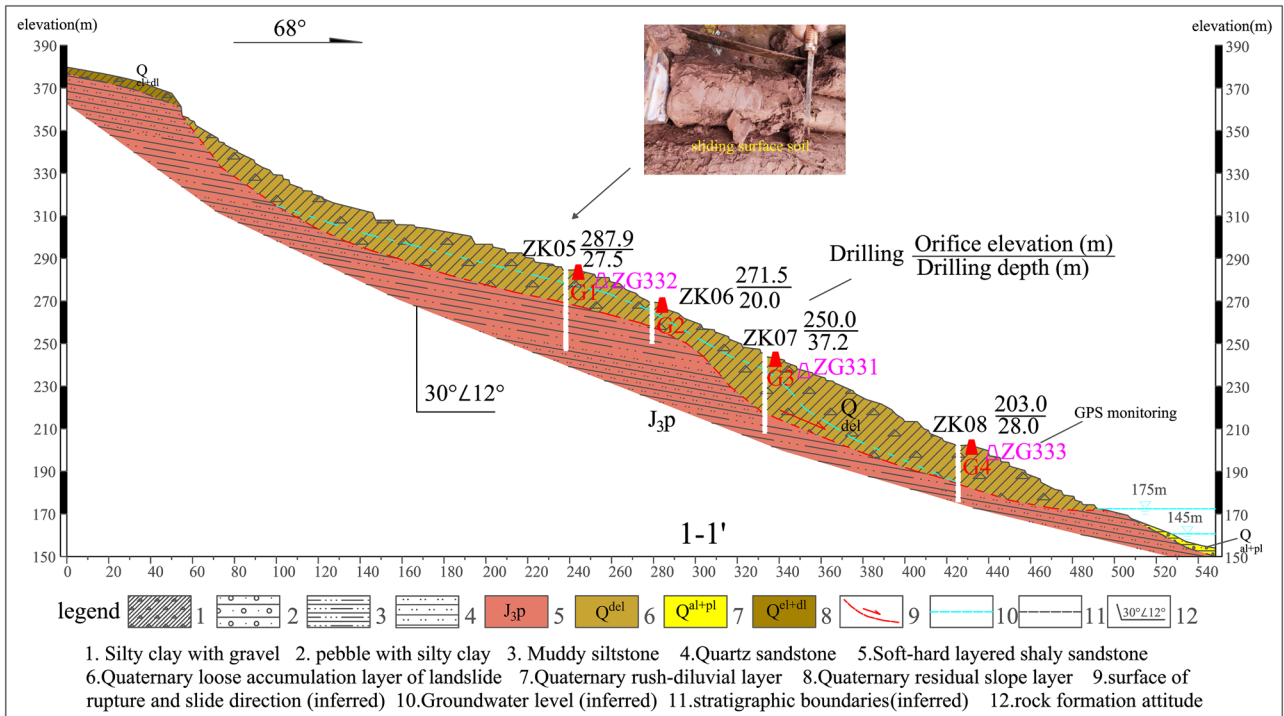
Fig. 4 Engineering geological profile: a geological cross Sect. 1-1', b geological cross Sect. 2-2'

organised and completed a geotechnical engineering investigation of the landslide in 2019, and three main profiles were described. Engineering geological profiles 1–1' and 2–2' on sliding mass no. 1 in the main deformation area were based on the results of a geophysical exploration and drilling (Fig. 4). As evident from the figure, the two main profiles indicate two regions in the longitudinal direction. The upper half of the profile has an overall arc shape, whereas the rupture surface at the back edge is steep, and the middle part is convex. The lower half is linear in shape with a slightly steeper front; the sliding mass at the back of the landslide is thick, whereas the sliding mass at the leading edge is thin. The sliding mass in the middle is thinner owing to the presence of a convex bedrock portion, which also immobilises the upper sliding mass to some extent.

The bedrock is composed of quartz sandstone and purplish-red sandstone-mudstone of the upper Jurassic Penglai Formation. A drilling core is shown in Fig. 4b. It has a soft, sandy structure with thick strata and belongs to the engineering geological group of soft and relatively hard stratified argillaceous sandstone; its mechanical strength is not uniform. According to the exploration data, the purplish-red argillaceous siltstone is fragile when hammered and cracks easily along the layers. Monoclinic structures are present in the area. The bedrock dip angle is 12–15°, and thus, a slope is formed. No fracture zone was found in the exploration area. The photos of the soil samples of the sliding mass soil and the sliding surface soil are shown in Fig. 4a, b. The physical and mechanical parameters and permeability of the landslide soil were determined by field and laboratory tests; the properties of these soil samples are tested in accordance with China geotechnical engineering test code (SL237-1999 1999). Table 1 shows the physical and mechanical parameters of the sliding mass and sliding surface soils.

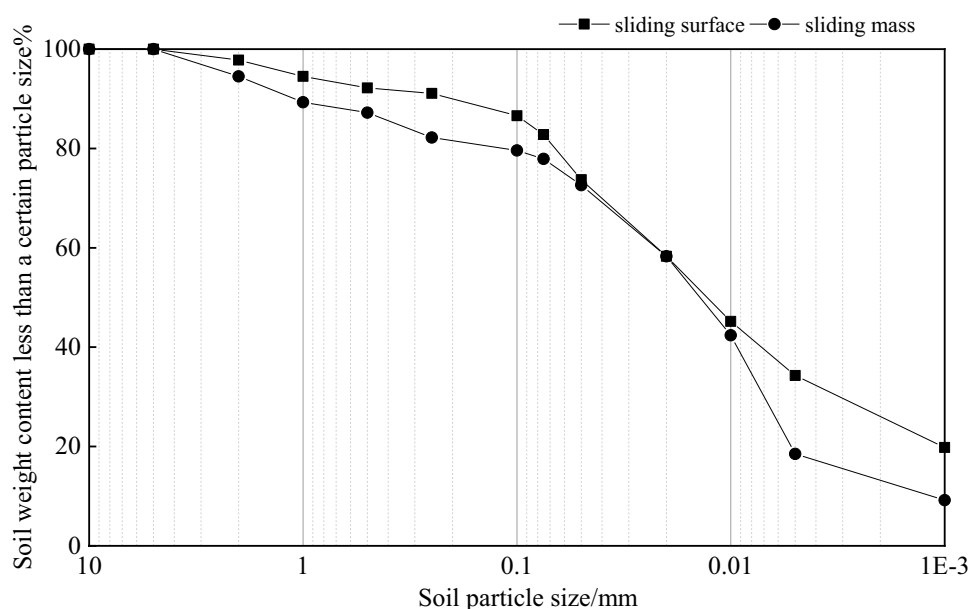
Fig. 5 Grain size distribution curve

The permeability of clay is a key parameter affecting rainfall infiltration (Fig. 5). Therefore, six pit seepage tests were performed in the field, with a test depth of 0.5 m. The permeability coefficient of the surface gravel in the sliding mass soil was in the range of 1.7×10^{-4} – 7.7×10^{-3} cm/s, and the sliding mass is characterised by high permeability in the middle part and low permeability in the rear part of the landslide. In addition, saturated permeability tests of the borehole sliding mass soil from different depths were

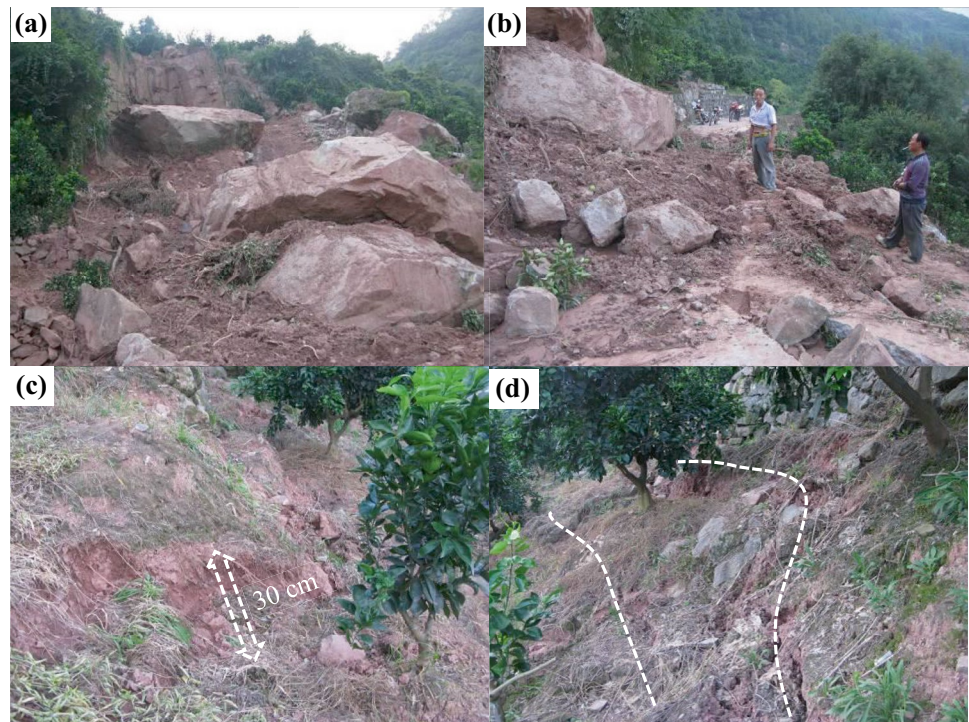
Fig. 6 Deformation of the Tanjiawan landslide after the rainfall on 31 August 2014: **a** large-scale collapse at the back edge of the landslide, **b** resulting damage to the road behind the landslide, **c** collapse in the middle of the landslide, **d** crack LF1 in the middle of the landslide

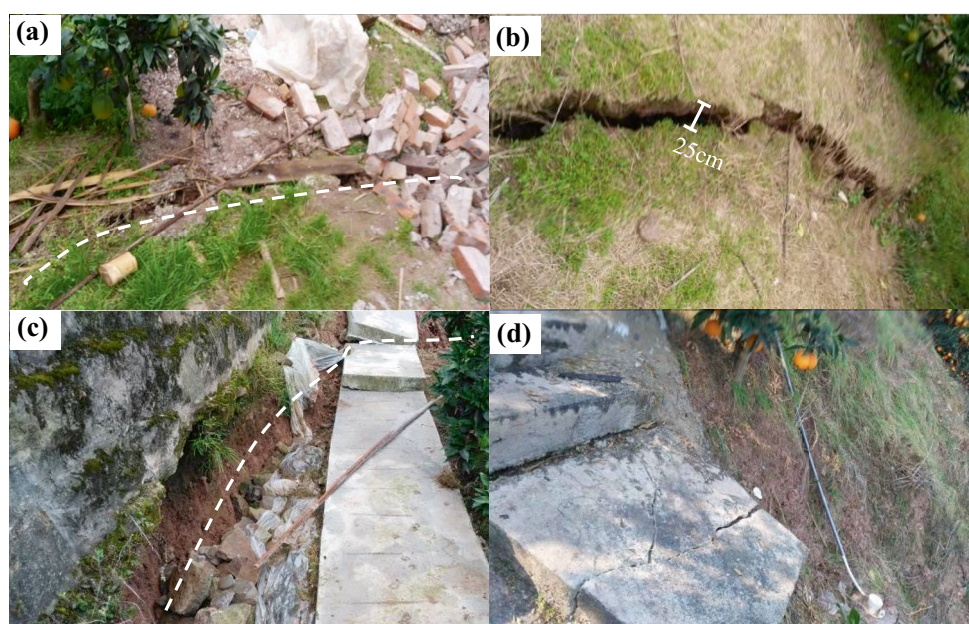
Fig. 7 Deformation of the middle part of the Tanjiawan landslide owing to autumn rain in West China in 2017: **a** damage to houses caused by the deformation, **b** crack LF2 approximately 80 m long, **c** road damage caused by the cracks, **d** damage to the cement board due to the deformation of the sliding mass

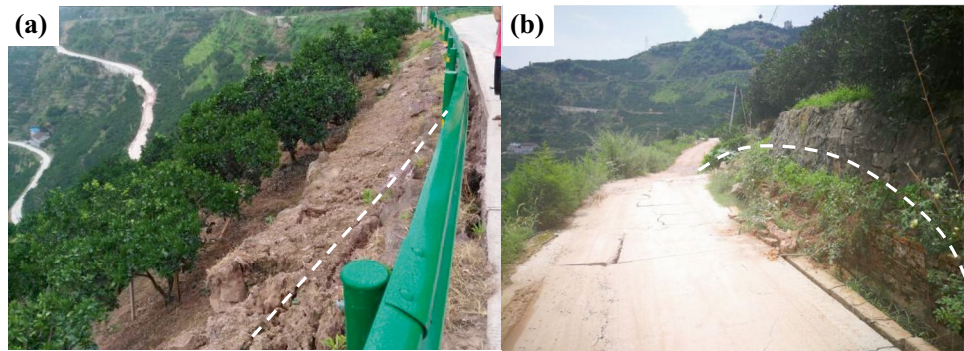
Fig. 8 Landslide deformation caused by rainfall in 2018: **a** crack LF3 outside the highway in the middle of the landslide, **b** crack LF4 in the highway retaining wall at the front of the landslide

The daily rainfall in the landslide area was 121.6 mm on 18 June 2018 and 27.4 mm on 30 June 2018. Owing to these two rainfall events, the surface of the middle of the landslide exhibited obvious deformation, the main manifestations of which were as follows. The lateral crack in the highway in the middle and at the back of the landslide (Fig. 8a) was approximately 50 m long and 2–15 cm wide and was lowered by 5–25 cm (LF3; Fig. 2). The highway retaining wall in the middle and front parts of the landslide bulged (Fig. 8b) and cracked (LF4; Fig. 2). According to the deformation characteristics of the landslide, the main deformation area was labelled sliding mass no. 1, and the area with relatively weak deformation was labelled sliding mass no. 2, as shown in Figs. 2 and 3.

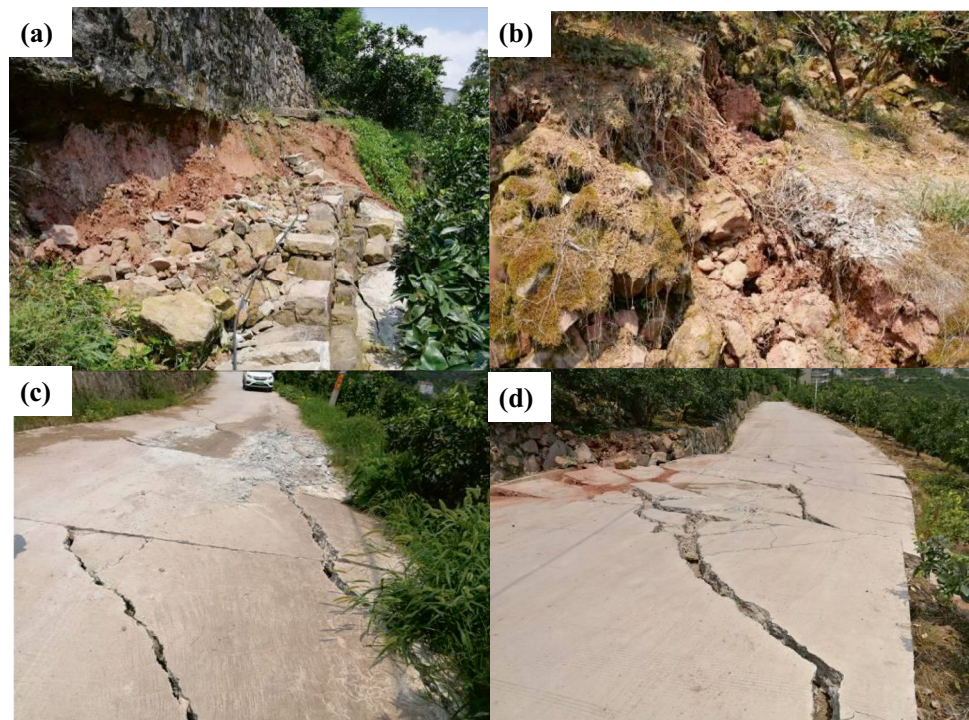
Fig. 9 Intensified deformation throughout the landslide due to multiple rainfall events in June and July 2020: **a** break in the middle of the retaining wall due to sliding mass No. 1, **b** crack LF5 at the back of sliding mass No. 1, **c** intensified deformation of crack LF4, **d** damage of highway due to crack LF6 caused by sliding mass No. 1

greatly deformed. Specifically, the crack deformation in the middle of the landslide intensified, resulting in a small-scale failure of the retaining wall (Fig. 9a). This deformation was a further extension of the original deformation (Fig. 7c). The back of sliding mass no. 1 was deformed, forming a deep crack (LF5, Fig. 2) and resulting in collapse (Fig. 9b). A crack (LF4; Fig. 2) at the front of sliding mass no. 1 caused the sliding mass to slide down and damage the highway (Fig. 9c). In addition, a 15-cm-wide tension crack (LF6;

Fig. 2) developed in the middle part of sliding mass no. 2, which also damaged the highway (Fig. 9d, the location is shown in D3 in Fig. 2).

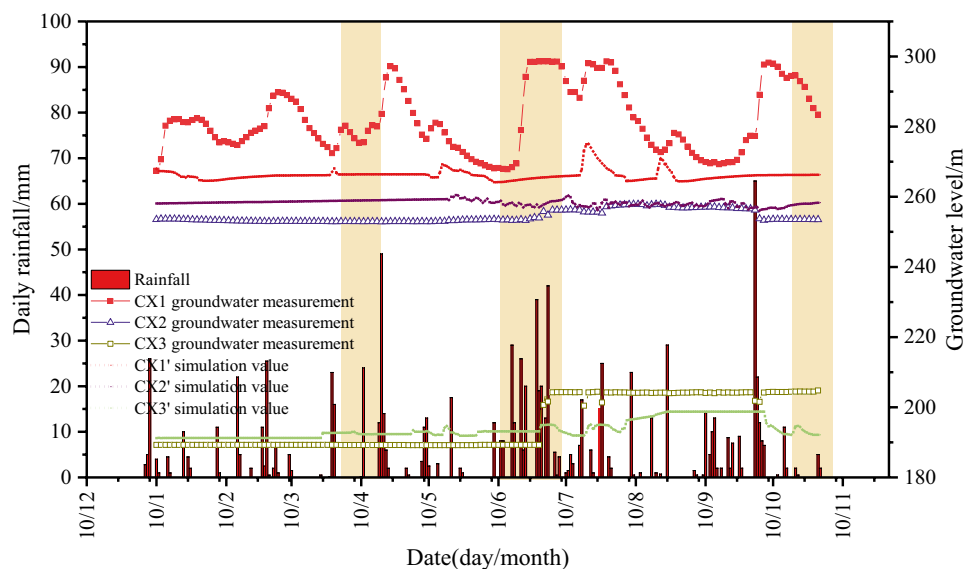
Fig. 10 Relationship between groundwater level and rainfall in the Tanjiawan landslide

Three groundwater level monitoring points, CX1, CX2, and CX3 from top to bottom, were identified in the borehole on the 2–2' main profile of the Tanjiawan landslide in January 2020. A grit pipe was arranged at the bottom of the borehole, and a water level gauge was placed at a position 1 m from the bottom of the borehole. The groundwater level gauge is a pressure level gauge, in which the water level depth at the position of the measuring sensor is converted through the pressure difference; their locations and burial depths are shown in Fig. 3. The groundwater level and daily rainfall measured at these points were plotted in Fig. 10. Owing to the high elevation of the landslide front, the water level scheduling of the TGR does not affect the groundwater level of the Tanjiawan landslide. CX1 at the back edge of the landslide clearly responded to rainfall, and after three consecutive rainfall events, the groundwater level increased considerably and rapidly. There are two main reasons for this. One is the water catchment effect of the concave terrain where CX1 is located (Fig. 4b). In addition, it was speculated that multiple cracks were produced near the CX1 borehole and formed the dominant seepage channel. As there was no significant tension crack at the position of the CX2 and CX3 monitoring points and the permeability of the sliding mass soil was low, the groundwater levels at CX2 and CX3 did not change significantly for several months. However, after a large deformation in the middle and lower parts of the landslide in June 2020, the CX2 and CX3 monitoring points were also affected, and multiple cracks appeared. Subsequently, the water level at CX2 fluctuated by several meters during the rainfall. It is speculated that cracks near the CX2 borehole were generated owing to a previous deformation and formed the dominant seepage channel. After the severe

deformation in June, the groundwater level at CX3 increased sharply (by 15 m) and then remained essentially unchanged at an elevation of 204 m. An inspection of the site revealed that the groundwater level was close to the landslide surface, and because of severe deformation, the borehole at CX3 collapsed, resulting in instrument damage.

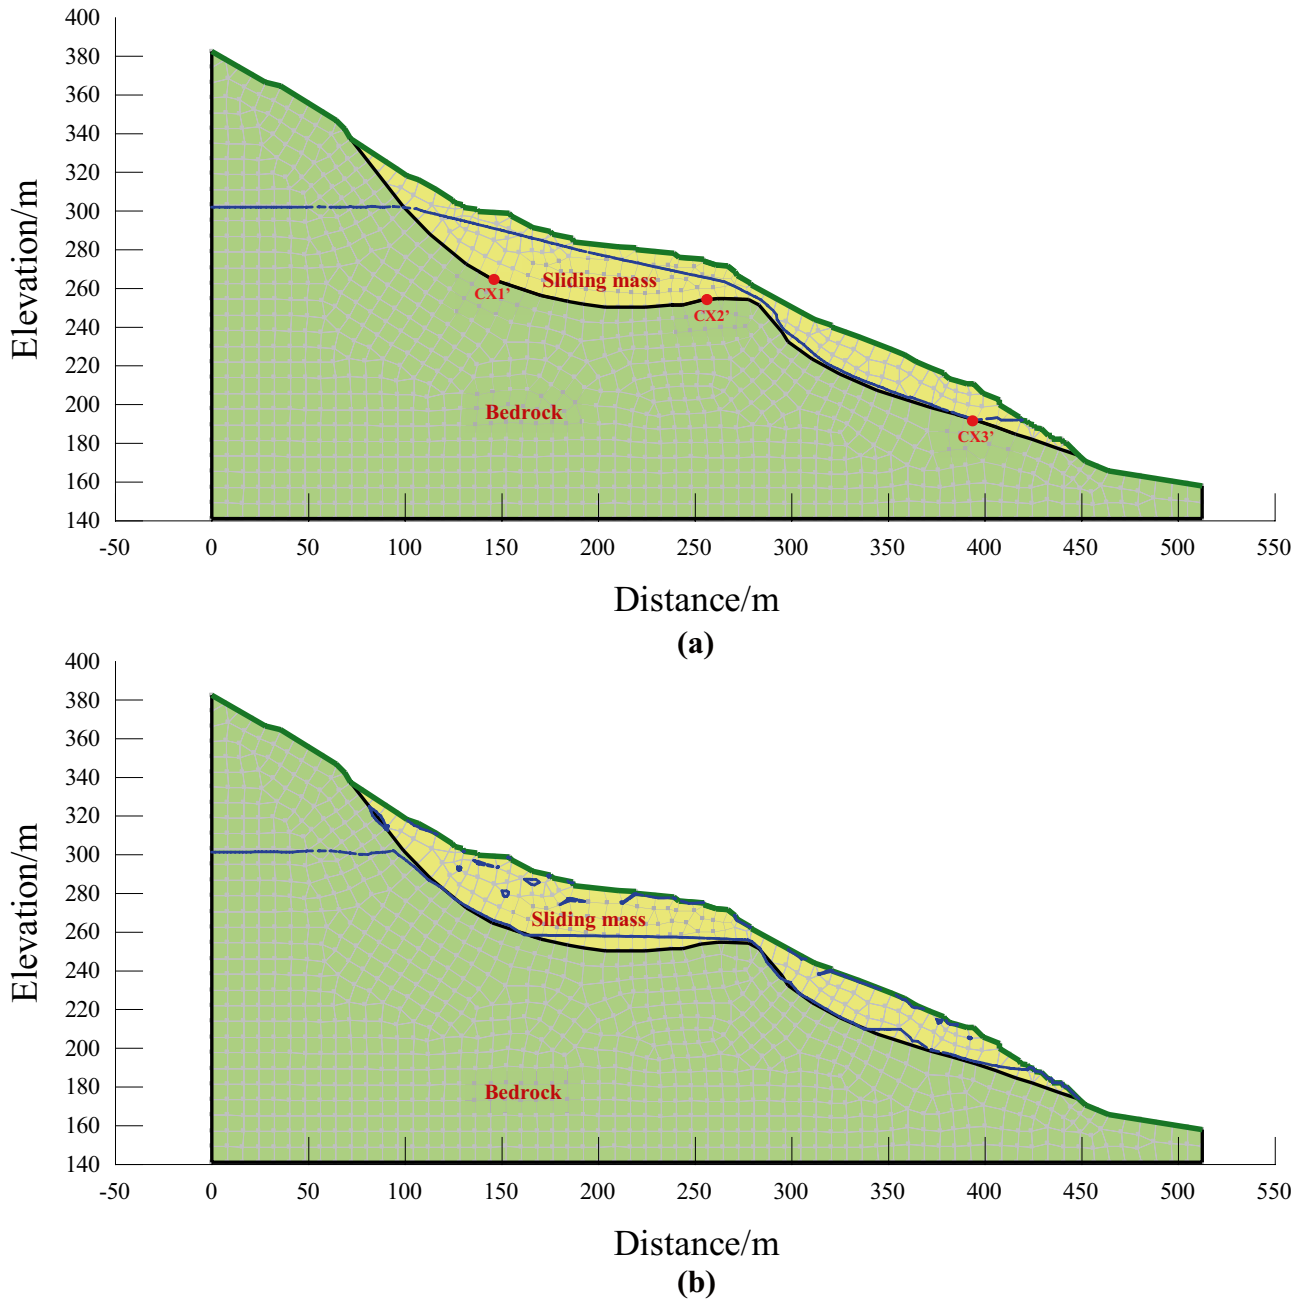
Fig. 11 Seepage simulation of the Tanjiawan landslide: **a** the groundwater level at day 1, **b** the groundwater level at day 305

The changes in the groundwater level monitoring points were not uniform, and the analysis is related to the bedrock bulge and cracks in the landslide mass. To further determine the impact of rainfall on the groundwater level of the landslide, the finite element method software SEEP/W was used to simulate the changes in the groundwater level of the Tanjiawan landslide under rainfall conditions. The rainfall condition used was the actual rainfall from January to October 2020, and the calculation profile used geological profiles 2–2'. The calculated initial water level conditions used the results of the survey, as shown in Fig. 4b, and the unsaturated permeability function used the predicted value from the Fredlund-Xing equation based on the saturated permeability coefficient. The results of the groundwater level calculations are shown in Fig. 11. Multiple local saturation zones were formed by the rainfall in the landslide mass. Compared with the initial water level, the water level at the rear of the landslide changed significantly. In the numerical model, the same monitoring points as those for the actual groundwater levels were selected: CX1', CX2', and CX3', as shown in Fig. 11a. The groundwater level results of the three numerical monitoring points CX1'–CX3' in the calculation period are plotted in Fig. 10. Compared with the actual groundwater level, the groundwater level changed at the CX1' monitoring point which also changed, and the variation range reached 15 m; however, it was still significantly lower than the actual monitoring water level which changed by 30 m. However, owing to the special terrain of the CX2' monitoring point, the simulation results were similar to the monitoring

results, and there was no significant difference. There was a large gap between the simulation results of CX3' and the actual situation. Compared with the long-term unchanged monitoring results of the actual water level, the numerical simulation results showed significant fluctuations with the rainfall cycle. Obviously, the actual groundwater level monitoring at CX3 has technical problems. In general, the influence of bedrock shape on the change in the groundwater level of the Tanjiawan

landslide is relatively large, especially for the CX1' monitoring point. SEEP/W has difficulty in simulating the effect of cracks, but the effect can be seen by comparing the simulation results with the actual results. The developed cracks were also the dominant seepage channel for surface water, causing rapid changes in the groundwater level. In short, the fluctuation in the groundwater level of the Tanjiawan landslide was the main hydrodynamic result caused by the recent large deformation.

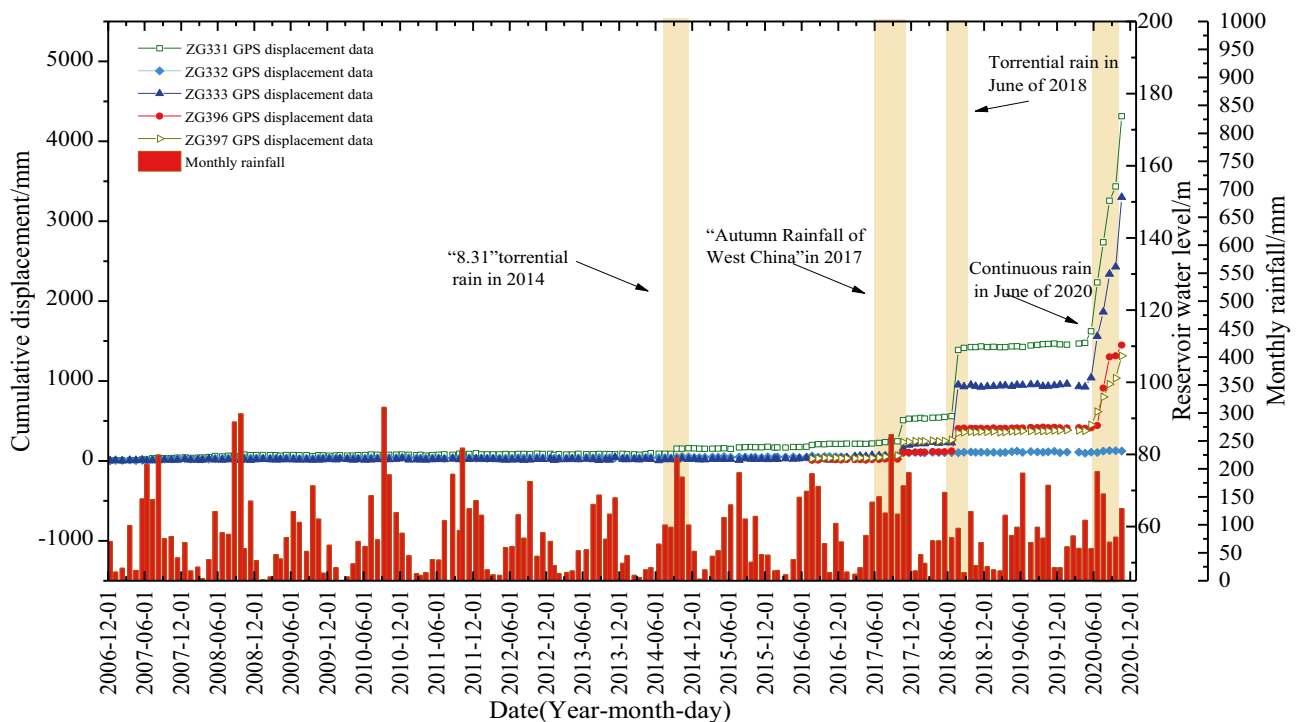
Fig. 12 Response relationship between GPS displacement and rainfall in the Tanjiawan landslide

Since 2014, the Tanjiawan landslide has undergone obvious deformation during repeated rainfall events. To analyse the effects of rainfall on the deformation, GPS displacement data, monthly rainfall data, and reservoir water level data were plotted in Fig. 12. All GPS displacement data are resultant displacements in the horizontal and vertical directions. Owing to the limited wading range at the front of the landslide, fluctuations in the reservoir water level in the TGR do not affect the Tanjiawan landslide. Prior to 2014, the surface deformation of the landslide was dominated by slow creep deformation, and the largest cumulative displacement was at the ZG331 monitoring point in the middle of the landslide, which showed a displacement of only 88 mm. After 2014, multiple monitoring points showed step-like displacement curves. Specifically, in response to the rainfall of 31 August 2014, the displacement of ZG331 increased sharply to 153 mm; the surface deformation is shown in Fig. 7d. Other monitoring points still showed slow creep deformation. During the 2017 autumn rain in West China, the rainfall reached 286.8 mm in July and 409 mm in September and October. The five GPS monitoring points on the landslide all indicated severe deformation; that of ZG331 in the middle of the landslide was the most significant, with a sudden

displacement increase of 265 mm. This rainfall event was also the first time that the entire landslide region underwent deformation. In response to the two heavy rainfall events in June 2018, strong deformation occurred at all the monitoring points on the landslide except at ZG332; again, the most obvious deformation occurred at ZG331 in the middle of the landslide. The cumulative displacement increased sharply, from 560 to 1388 mm, and the surface deformation was obvious (Fig. 8). Subsequently, the landslide can be divided into two deformation zones, the main deformation zone is the no. 1 sliding mass, and the secondary deformation zone is the no. 2 sliding mass. The rear part of the landslide is relatively stable. From 8 to 23 June 2020, several heavy rainfall events occurred in the landslide area, and 42 mm of rain fell on July 2. As a result, sliding mass no. 1 (except for the ZG332 monitoring point) exhibited the largest deformation to date and is still undergoing deformation. From May to October 2020, the displacements of ZG396 and ZG397 increased by nearly 1000 mm, that of ZG333 increased by approximately 2400 mm, and that of the central monitoring point ZG331 increased by approximately 2700 mm. Sliding mass no. 1 showed an overall sliding trend.

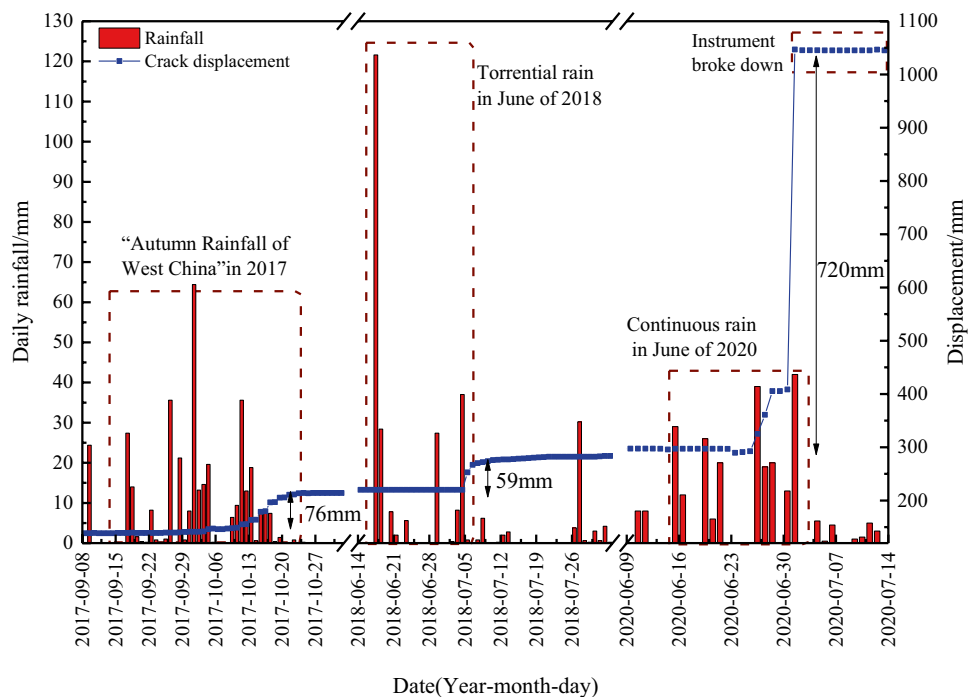
Fig. 13 Automatic crack displacement metre data from ACM1 for recent unusual rainfall events

relationship between monthly rainfall and GPS displacement cannot accurately indicate the real deformation process of the landslide. Therefore, in June 2016, an SRL-16 surface crack metre manufactured by Japan’s Fantian Motor was used to monitor surface cracks (details of the instrument in Wang et al. 2021a, b). The monitor was installed at the crack near the GPS monitoring point ZG331, which has shown the largest deformation, for the automatic daily recording of the crack displacement data. Rainfall has been monitored in the landslide area since April 2017. The plot of the relationship between the measured dynamic crack deformation and daily rainfall (Fig. 13) shows that ACM1 is under continuous tension. Figure 13 shows that the 2017 autumn rain in West China strongly affected the displacement of ACM1, and the cumulative displacement reached 76 mm. The resulting deformation occurred during the continuous rainfall event, under the heavy rainfall of 65 mm on 2 October, and then the deformation continued to increase. The figure shows a steep increase in the displacement of ACM1 induced by heavy rainfall on 5 July 2018. Before the landslide deformation occurred, the daily rainfall in the landslide area was 121.6 mm on June 18 and 27.4 mm on June 30; these rainfall events were the main causes of the deformation. In June 2020, from Fig. 13, we can see a steep increase in the displacement of ACM1 caused by continuous rainfall for several days. Rainfall occurred on 12 of 25 days before the deformation occurred, and the average daily rainfall was 21.2 mm; the rain dramatically increased the displacement by as much as 720 mm. Then, the instrument was damaged and lost its monitoring function.

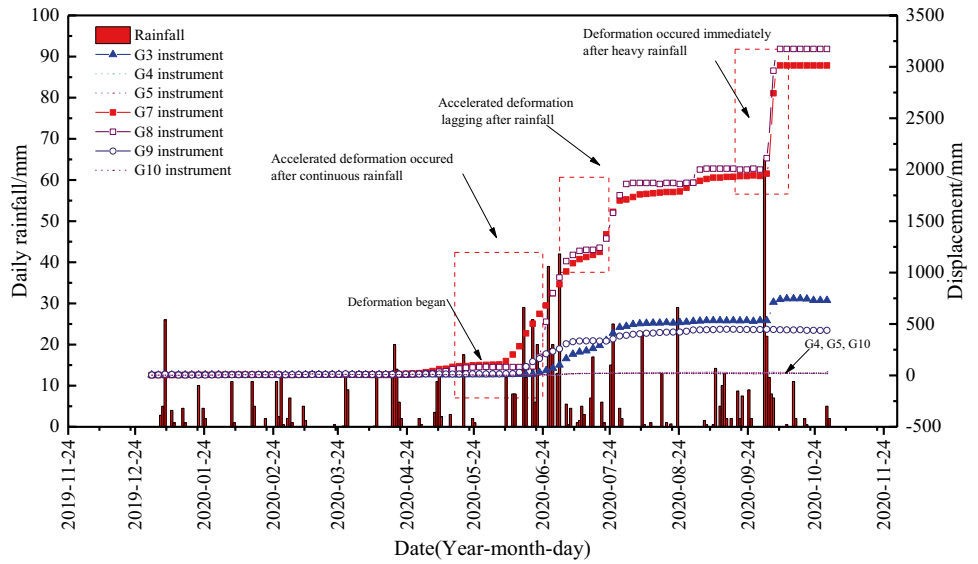
Fig. 14 Response of GNSS monitoring displacement instruments to the rainfall in 2020

The GNSS displacement monitoring instruments that were installed in January 2020 have the advantage of transmitting the information on landslide deformation in real time. Four points with obvious deformation (G3, G7, G8, and G9) were selected to plot the relationship between displacement and daily rainfall (Fig. 14). The displacements at the other monitoring points were the same as those at G5 and did not show obvious deformation. Sliding mass no. 1 clearly showed the most extensive deformation, and all of the monitoring points exhibited a large displacement. The deformation of the back part in no. 2 sliding mass was more obvious. The deformation of the Tanjiawan landslide in 2020 could be divided into three stages: first stage — continuous deformation in late June 2020, second stage — accelerated deformation in late July 2020, and third stage — strong deformation on 3 October 2020. A comparison of the deformation data showed that the deformation in the first two stages had a relatively clear lag with respect to rainfall. The third stage was dominated by the deformation of sliding mass no. 1 that was caused by heavy rainfall (65 mm) on the day before the deformation.

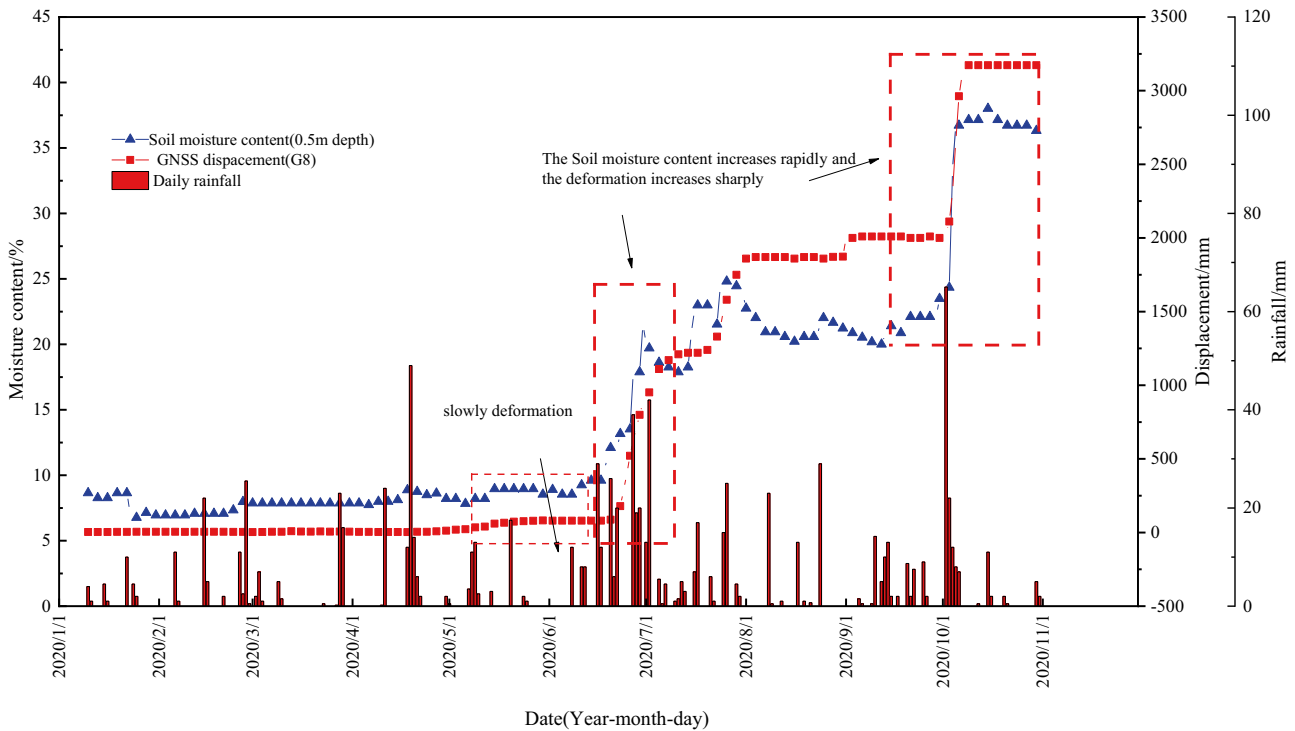
Fig. 15 Relationship among rainfall, soil moisture content and displacement

To further compare the effects of rainfall on the three deformation processes of the landslide, the displacement of G8 (which showed clear deformation) and the soil moisture content at T2, near G8, with rainfall data were plotted as shown in Fig. 15. The soil moisture content sensor was located at a depth of 0.5 m. Prior to April 2020, the rainfall was generally scant, and the soil moisture content was below

10% for an extended period. Several rainfall events in April increased the soil moisture content, and the displacement of G8 also began to increase slowly. During the continuous rainfall in June, the soil moisture content increased rapidly, with a corresponding increase in displacement. In response to the rainfall on 2 October (65 mm), the moisture content increased sharply, nearly saturating the soil, and a significant response in displacement was also observed. Continuous and heavy rainfalls will clearly increase the moisture content of landslide soil; in particular, heavy rainfall may cause the

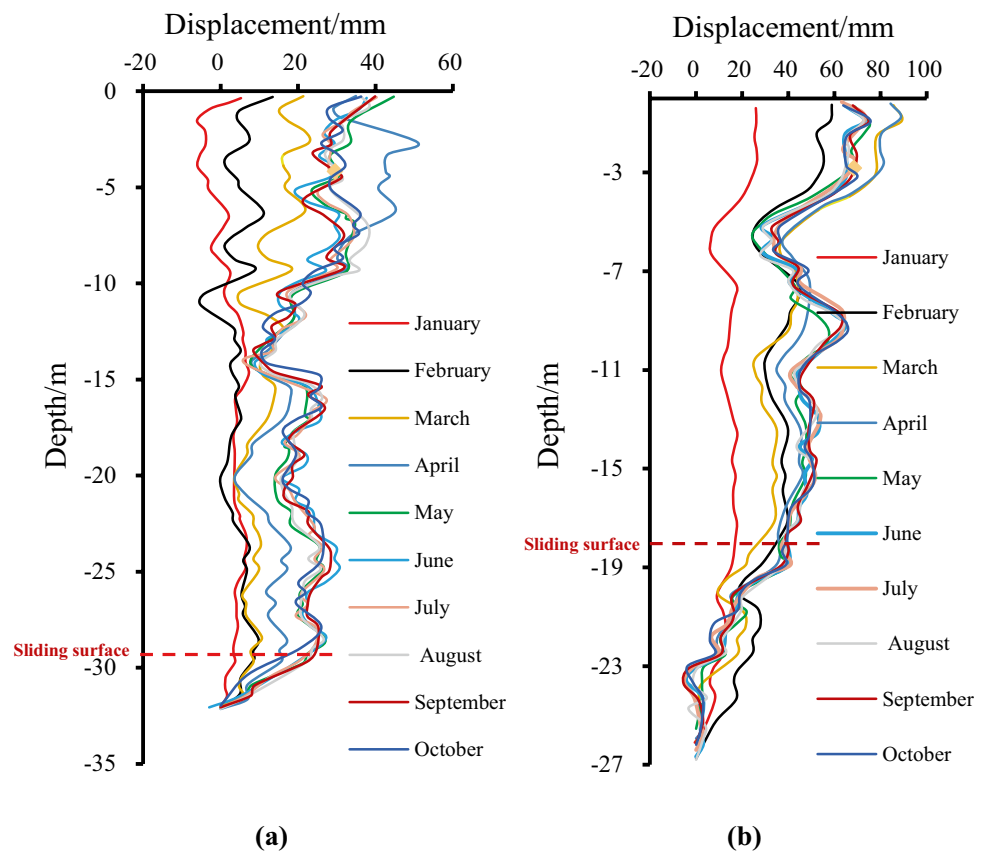
Fig. 16 Deep displacement curve (January to October 2020) at **a** CX2 and **b** CX3

Among the monitoring points, CX2 and CX3 showed obvious deformation (Fig. 16), the sliding surface depths of CX2 and CX3 monitoring points are 29.5 m and 18.1 m, respectively. The deep deformation observed at CX2 appeared mainly at 4–7 m, and the overall deformation appeared at a depth of 15–27 m in June. CX3 showed deformation at a shallow level of 1–4 m. Overall, the 2–2' main profile showed no deep sliding, and no significant deformation of the contact between the sliding surface and bedrock was observed in the survey. However, sliding at the shallow depths was more prominent.

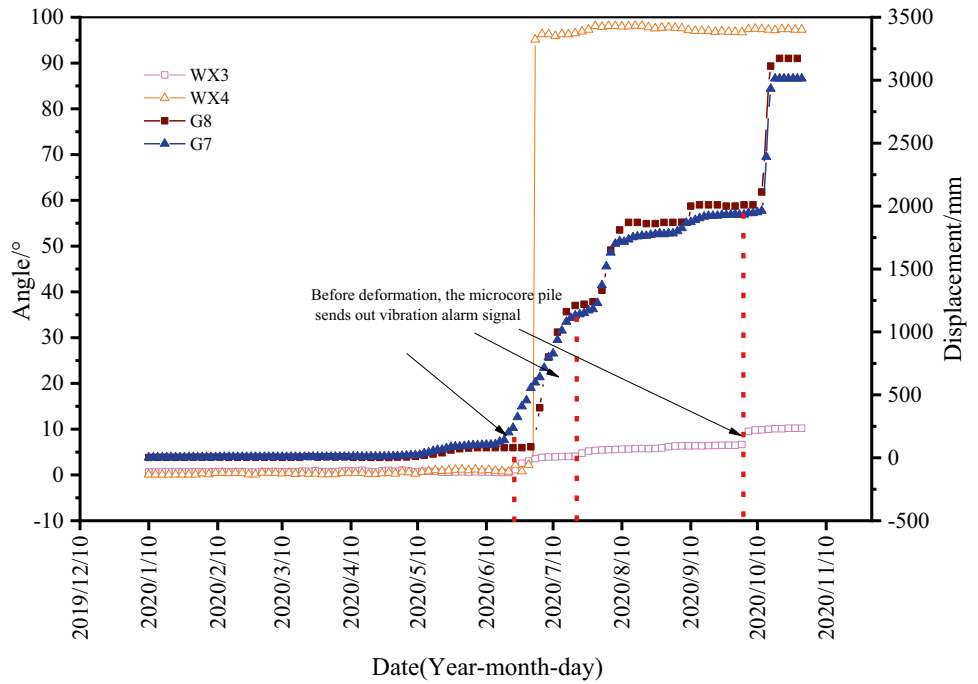
Fig. 17 Microcore pile monitoring data from WX3 and WX4 on the main profile 2–2' and adjacent GNSS monitoring points G7 and G8

Microcore pile is a new type of geological hazard monitoring and warning system that can monitor the vibration acceleration, inclination, and vibration curve, perform sudden displacement calculation, measure other indicators, and conduct real-time warning and data transmission. In particular, it can record the slight vibration that occurs before landslide sliding, which provides a good early warning. Eight microcore piles were placed at the locations shown in Fig. 3 in 2020. The monitoring data of WX3 and WX4 on the main profile 2–2' and the adjacent GNSS monitoring points G7 and G8 were plotted as shown in Fig. 17. The microcore pile vibrated before many strong deformation events, and the change in soil inclination recorded by the pile was consistent with the deformation response of the landslide surface. In particular, the inclination recorded by the WX4 monitoring point increased by approximately 90°,

and it was found that this outburst was severely deformed during surface surveys.

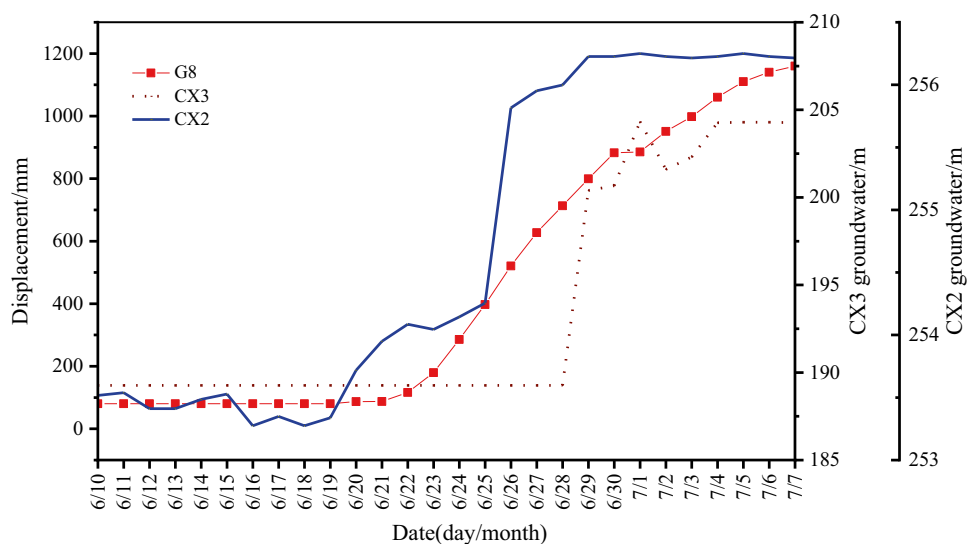
Fig. 18 Relationship between groundwater level fluctuation and landslide deformation

and the data from the adjacent displacement monitoring point G8 from 10 June to 7 July 2020 are shown in Fig. 18. The landslide deformation at CX2, in the middle of the landslide, clearly responded to the change in water level, and the landslide began to deform after the underground water level increased. The groundwater level at CX3 (located at the front of the landslide) increased steeply after the severe deformation of the landslide and was found to be only 4 m below the surface after the event. The groundwater level at CX3 remained stable. The increase in cracks in the landslide allowed rainwater infiltration, and the subsequent increase in the groundwater level produced hydrodynamic pressure that caused the landslide to deform dramatically. The

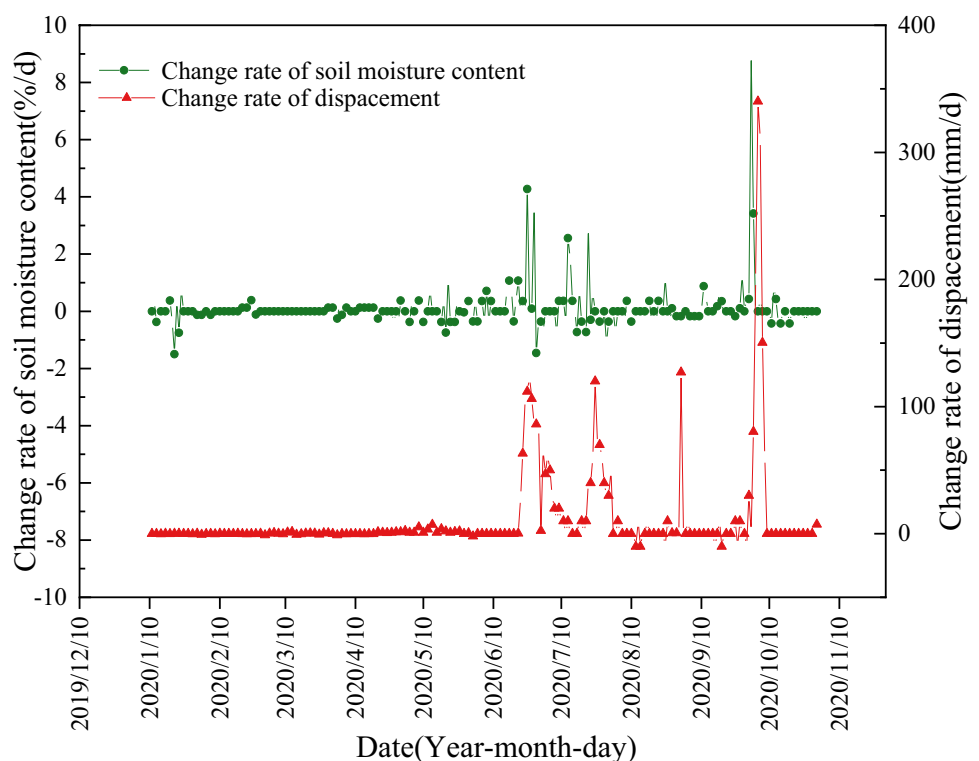
Fig. 19 Relationship between the displacement change rate and soil moisture change rate

Monitoring is one of the important components of landslide early warning systems (LEWS), and the effective use of monitoring results was the main research purpose of this study. Note that the abrupt increase in soil moisture content occurred before the strong deformation of the landslide; hence, this phenomenon can be used as an early warning of landslide instability. However, in general, it is difficult to accurately determine the necessary warning time by directly observing the change in soil moisture content. As shown in Fig. 15, we can find that the rate of change in moisture content has a direct impact on the magnitude of the displacement. The relationship between the displacement change rate and soil moisture change rate is shown in Fig. 19. When the landslide undergoes a large deformation, the change rate in the soil moisture content increases significantly. For example, the displacement change rate on September 1 reached 127 mm/day, which corresponded to the moisture content change rate on August 25 at 1.18%/day. The largest deformation occurred on October 2, 2020, and the moisture content change rate 2 days earlier reached 8.96%/day. When the rate of change in water content was lower than 1%/day, generally no major deformation occurred. Obviously, the change rate in soil moisture content can be used as an important early warning criterion for landslide deformation. Therefore, for LEWSs, we can calculate the change in

soil moisture content every day compared to the previous day, and through long-term monitoring, obtain a threshold moisture content change rate, such as 1%, as the landslide deformation warning value.
