Geomorphological, hydrogeological and geotechnical characteristics of the El Kherba large, deep-seated landslide induced by the August 7th, 2020 (Mw 4.9) earthquake in the city of Mila, northeast Algeria

Abstract

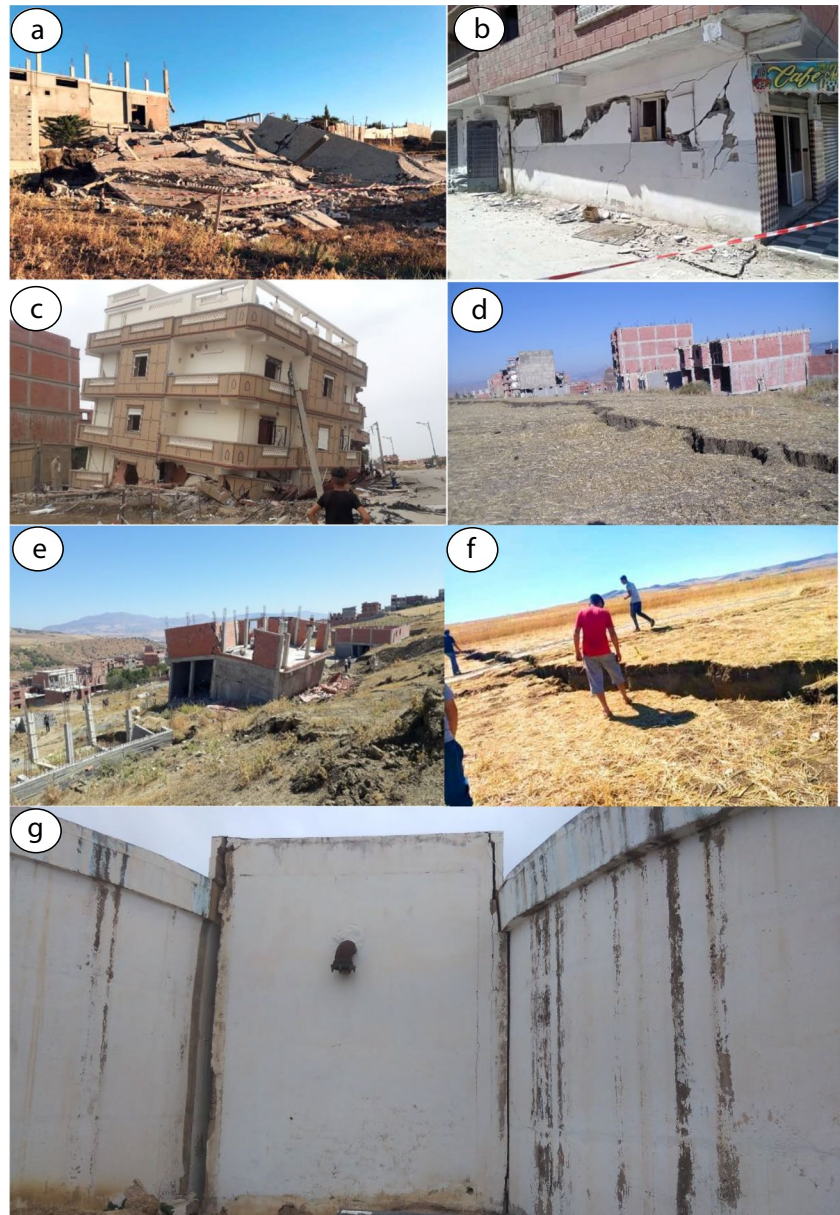
Fig. 2 Example of different damages of buildings and roads caused by El Kherba landslide caused by the August 7, 2020 earthquake event: **a**) total collapse of the structures in El- Kherba city, **b**) cracks in the masonry, **c**) and **d**) partial collapse of the buildings mainly due to the collapse of the soil. **e**) bursting of the house due to the landslide at El Amel city, **f**) collapse and horizontal displacement of the road, **g**) cracks and the opening of the rupture joint in the water tower near the headscarp

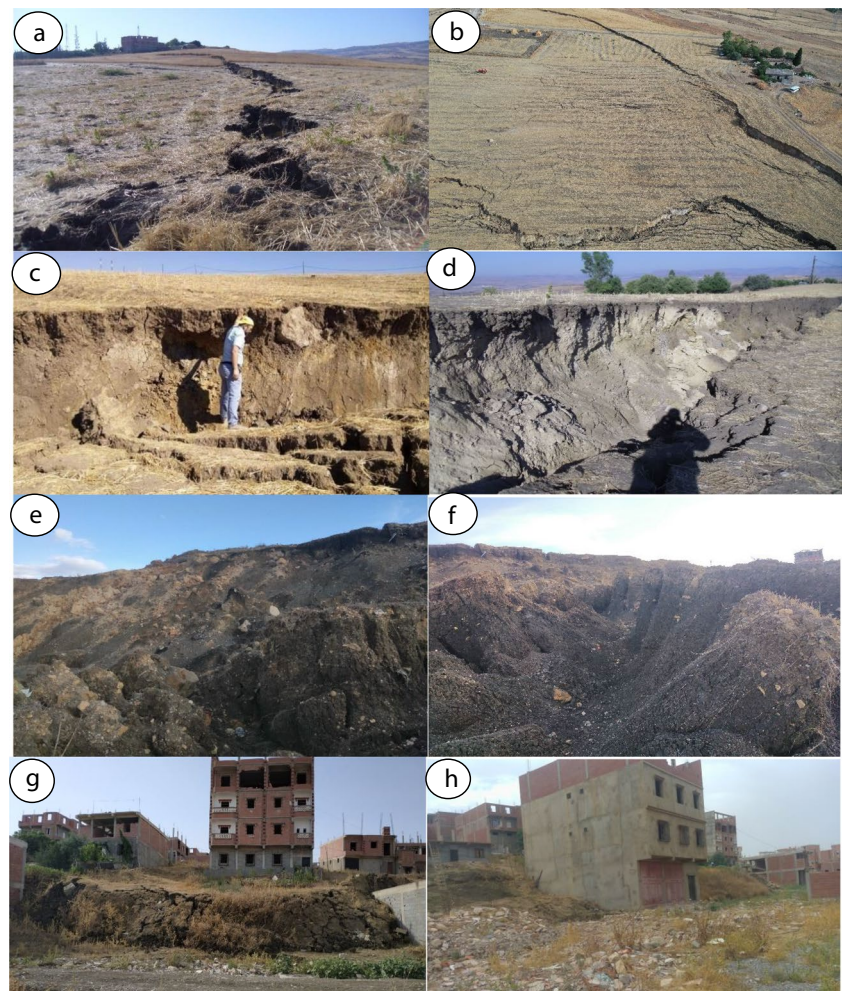
Fig. 7 Field photographs showing the characteristics, types and, deformation characteristics of the El Kherba landslide: a) Main scarp near the water tank of Ain El Kaid, b) E-W oriented transverse cracks and escarpments developed downstream of the main scarp, c) Lateral escarpments oriented NW–SE marking the western limit of landslide at upper El Kherba, d) Large rectilinear lateral escarpment oriented NW–SE with a high horizontal rejection, e) A spectacular escarpment to the immediate north of the water reservoir marking the second main escarpment in the downstream of the landslide indicating ancient movements with a deformation characteristic, f) very extensive and height scarps in downstream related to the reactivated old landslide, g) and h) frontal bulges mobilising the dwellings in El Amel in the landslide toe. The locations of the photos (a-h) are shown on Fig. 9

Morphological observations depict a disrupted landscape marked by numerous cracks, extensive depths, bulges, folds, and slope breaks, as illustrated in Figs. 7 and 8. Collectively, these features characterize an extensive, deep-seated landslide that has mobilized a considerable volume of slope material at a rapid velocity. The entire thickness of the overburden was displaced downslope and deposited on the right banks of the El Kherba River. The lower sections of the landslides display compression ridges, contributing to the displacement of structures. Furthermore, the residential buildings have incurred severe cracking, indicating a deterioration in the situation.

Kaid, which supplies the town of Mila (Fig. 7a). This first semi-circular escarpment is followed by a series of transverse cracks and nested escarpments that develop downstream (Fig. 7b), the most important of which are almost rectilinear and oriented roughly E-W (N 120°E), limiting the semi-circular shape observed on the western side of the El Kherba slide (Fig. 7c).

In the downstream parts of the landslide, the deformations are very important because large and deep transverse cracks are observed with a width of 1 m to 6 m, a longitudinal length of ~ 150 m, and a depth of ~ 10 m (Figs. 7e and f). In this zone, very extensive and high scarps are also observed, with a longitudinal length of ~ 100 to 200 m and a rejection that can reach 5 to 15 m. These scarps form a slope break about 110 m long and 4 to 5 m high, which suggests that this zone corresponds to an old landslide reactivated in a versant with a higher slope. These landslides, which have been known previously, were triggered and reactivated by winter rainfall events. The downstream end of the landslides is marked by chaotic morphology, with frontal lobes and bulges mobilizing the dwellings in El-Amel (Figs. 7g and h) that correspond to the accumulation or depositional zone. In addition, this downstream zone is distinguished by human activities such as backfill surcharges and earthworks visible on satellite images (depicted in white in Figs. 5d and e). The spatial distribution of the observed deformations exhibits a clear correlation with the slope angle, as depicted in Fig. 8.

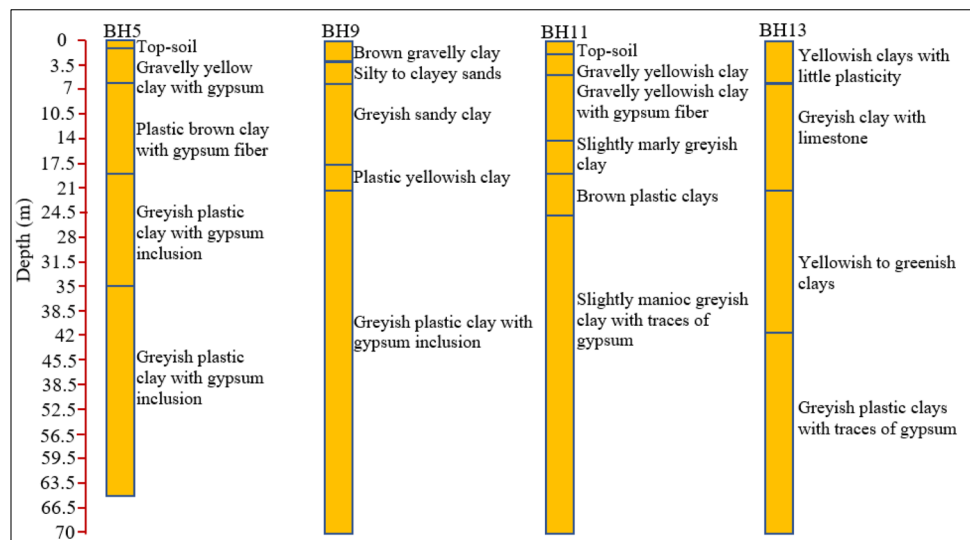
Fig. 9 Examples of the boreholes sections indicated the presence of thin and thick weak interlayers of altered and plastic clays

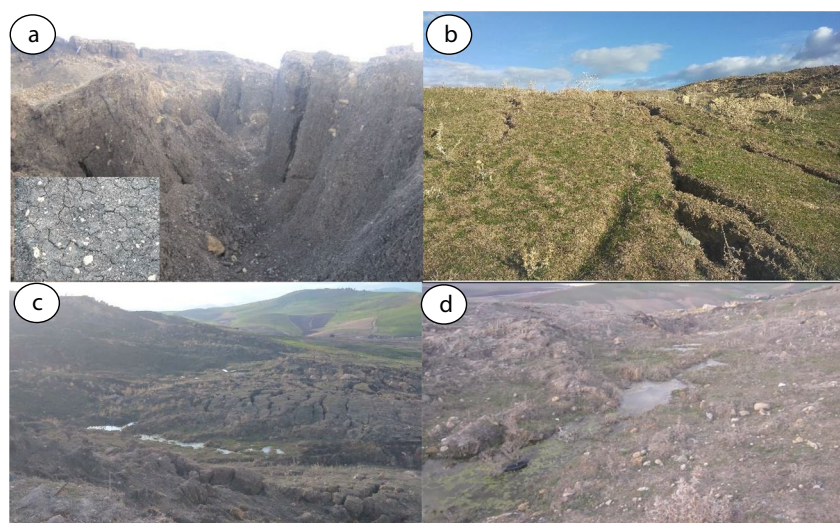
Fig. 10 Geological and hydrogeological characteristics of the clay Miocene formation: a) a weathered, plastic, loose, and porous, clays layer, observed at the landslide body with, a network of widely open shrinkage cracks, characteristics making them favorable for: b) surface water infiltration, concentrated runoff, gully, erosion and gravity phenomena. c and d): Groundwater discharge and water spring observed at the landslide toe after the earthquake event

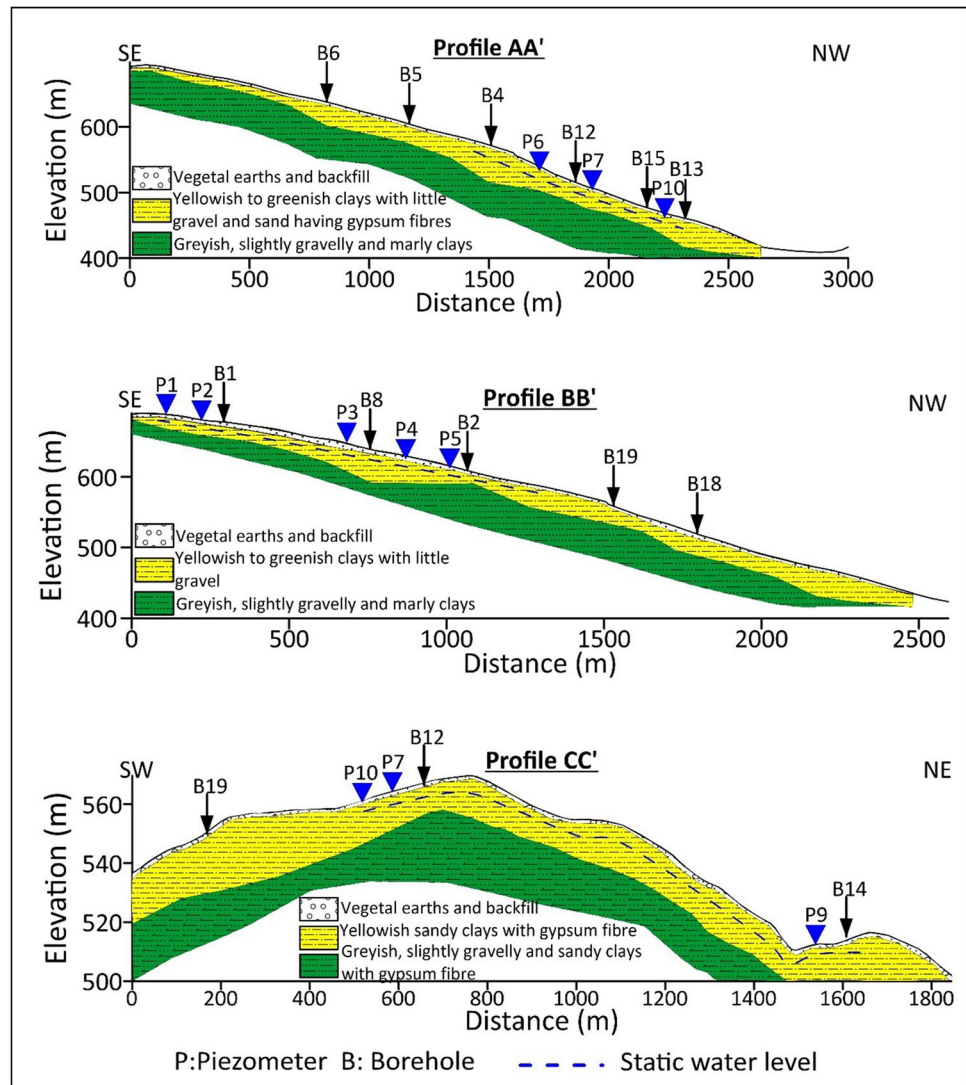
Fig. 11 Geological and hydro-geological cross-sections along the longitudinal and transversal profiles AA', BB' and CC' (locations of the cross sections is shown in Fig. 4) performed from boreholes and piezometers illustrating the lithological structure with static water level

0.29 and 7.9 m. This groundwater, located within the clay deposits, is associated with soil saturation caused by the continuous accumulation of water, likely attributed to the infiltration of periodic winter rainfall. This type of groundwater manifests in the form of pellicular water tables, commonly known as perched water tables, within this particular coherent formation. The presence of perched water tables is indicative of temporary underground circulation at a relatively shallow depth. It's essential to note that while these estimated depths represent the maximum values, they may be minimal during wet seasons. The existence of a shallow water table increases the vulnerability of loose deposits in the area to sliding, particularly in the event of an anticipated earthquake. Figure 11 provides a depiction of the lithological structure of the landslide and the groundwater table in the landslide zone.

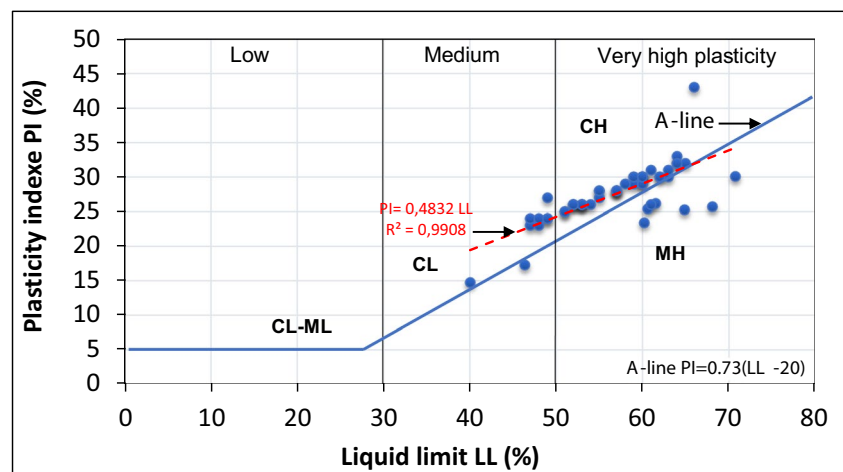
Fig. 13 Atterberg limits of the samples on Casagrande Plasticity Chart. The dashed red line indicates a good linear relationship between PI and LL ($R^2=0.99$)

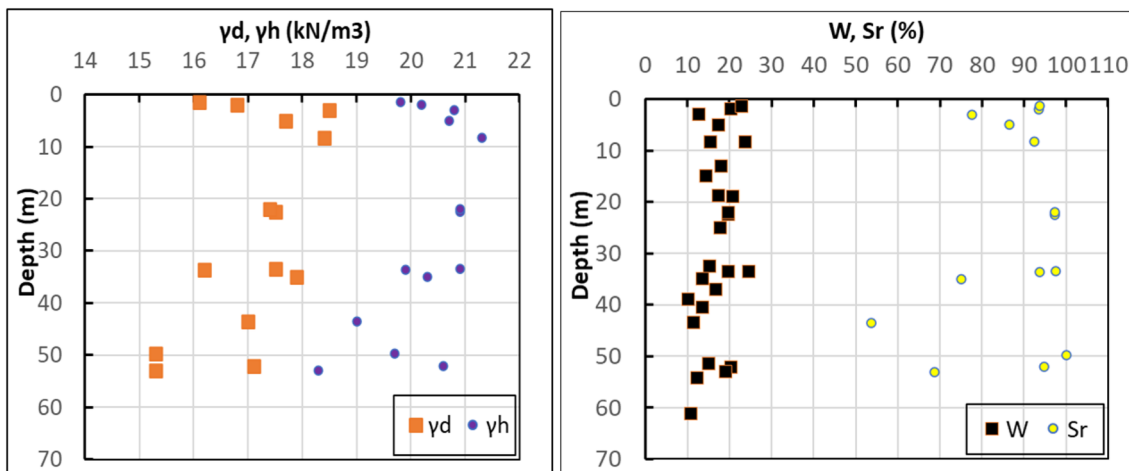
Fig. 14 Variation of γ_d , γ_h , W, and Sr values with depth

degree of saturation are high, with values of 15% and 100%, indicating a condition of low density and high saturation (Fig. 14).

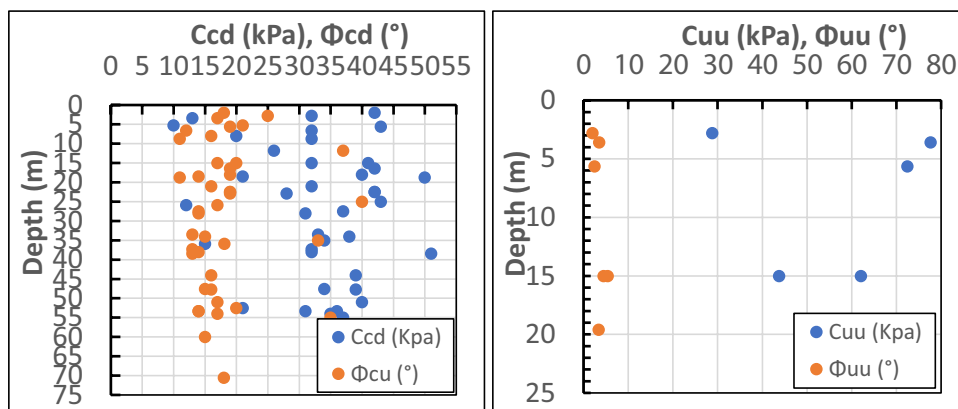
Fig. 15 Variation of the cohesion (c) and the internal angle of friction (ϕ) parameters values of a soil with depth

Results from the direct shear test reveal lower values of cohesion (C_u) and angle of friction (Φ_{cu}) in the range of 10 to 20 kPa/m² and 14° to 21°, respectively, for depths between 3 and 52 m. In contrast, depths of 25 to 60 m exhibit higher values, with $C_u > 31$ kPa/m² and $\Phi_{cu} > 18^\circ$. Notably, gravelly and sandy clays at depths of 3 to 5 m (boreholes B3 and B4) display low cohesion ($10 < C_u < 13$ kPa/m²), while plastic clays at a depth of 25 m (borehole B3) exhibit cohesion around $C_u = 10$ kPa/m². The presence of weak-resistance interlayers may contribute to the development of shear surfaces. The geotechnical characteristics of this soil suggest susceptibility to landslides, particularly local flows during earthquakes or heavy rainfall. The noted low residual

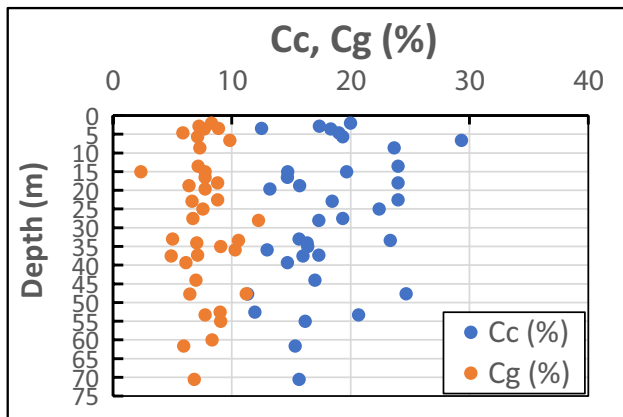
Fig. 16 Variation of the consolidation and compressibility parameters with depth

Consolidation, compressibility and classification The oedometer test reveals a coefficient of compressibility (Cc) ranging from 11.33% to 32.64%, indicating a relatively compressible soil. For the surface layer composed of sandy to gravelly clay, Cc values range from 12.49% to 24% at depths from 0 to 25 m (Fig. 16). Additionally, the coefficient of swelling (Cg) varies between 2.34% and 12.24%, classifying the soil as swelling. The values of consolidation pressure (Pc) range from 95 to 213 kPa, indicating an overconsolidated soil. In the case of altered brittle clays, the B3 survey at a depth of 60 m shows a Cc value of 32.64%, signifying a compressible soil, and a Cg value of 8.33%, suggesting potentially swelling soil. The consolidation pressure Pc = 164 kPa characterizes overconsolidated soil. The results from the oedometer test collectively indicate that the soils are compressible to highly compressible, overconsolidated,

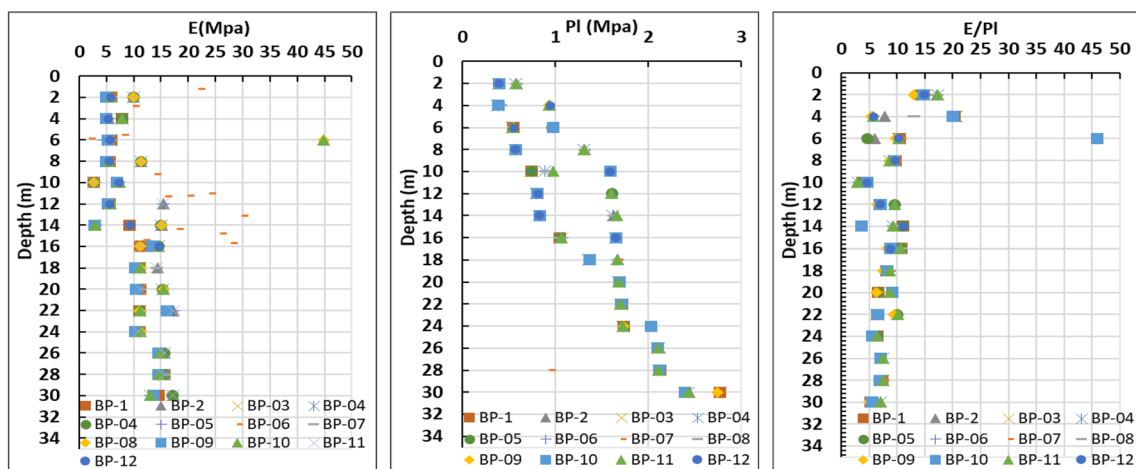
Fig. 17 E_p , P_l and E_p/P_l values from pressuremeters tests

The results from the pressuremeter tests demonstrated a close correspondence between the sliding surface (deformation zone) identified in the El Kherba landslide and the failure depths calculated using empirical relationships outlined in existing literature. In addition, the results obtained from laboratory tests confirm, validate, and support the findings from the field tests. The physical and mechanical properties of the deformation zone approve the presence of a plastic, saturated, weak-resistant, and overconsolidated soil with high compressibility and a significant potential for swelling. This observed variation is believed to be attributed to the shear zone, which induces soil degradation in faulty sections. Further evidence from boreholes indicates the presence of both thin and thick, weak interlayers composed of altered and plastic clays with low shear strength characteristics. Moreover, the frequent earthquakes in the area are identified as additional contributing factors to the observed deformation.

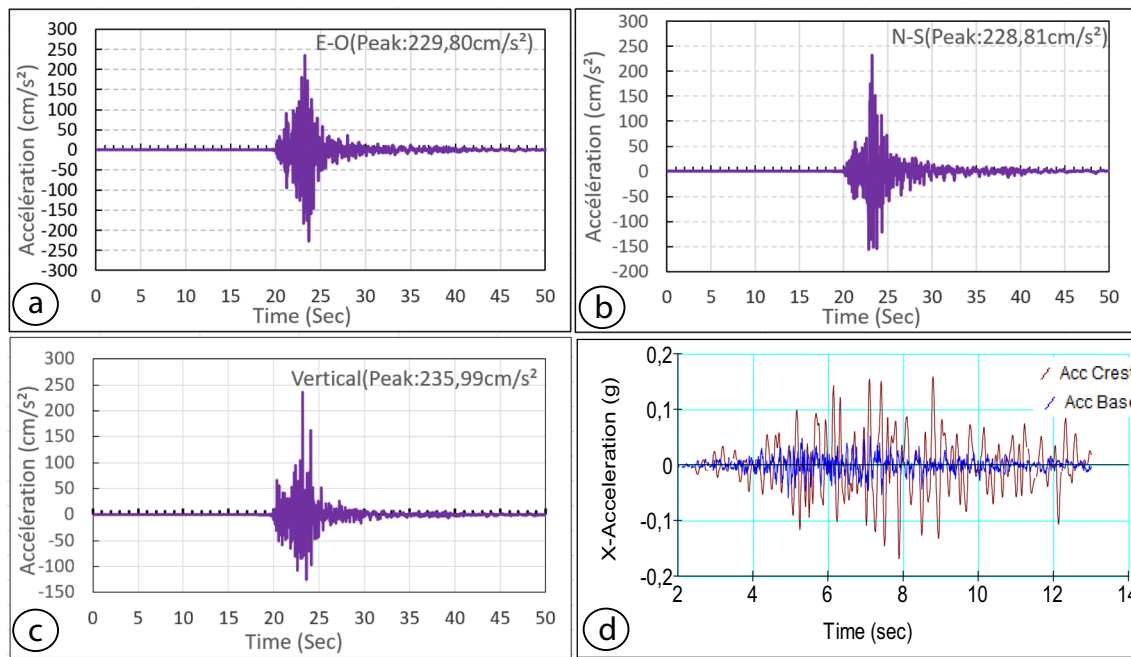
Fig. 19 Seismic records from the BBH seismic monitoring station during the Mila earthquake: (a) accelerations in east–west (EW), (b) north–south (NS) and in (c) vertical directions, respectively, (d) Amplification input (horizontal direction) used in the numerical simulation

is greater than that at depth (Fig. 19). After configuring the model’s input parameters, deterministic analyses were performed to determine the slope stability associated with the combination of earthquake and rainfall. The numerical simulation analyzes the probability of failure (FS) of the slope related to the changes in the pore water pressure caused by groundwater level (rainfall) and earthquake. The factors of safety (FS) and sliding surfaces were depicted before and after the earthquake for section AA' (Fig. 20). The results illustrate that the mean value of FS was greater than 1.5 before the earthquake. However, the mean value of FS decreases to less than 1.5 after the earthquake. The results demonstrate that the groundwater level led to an increase in

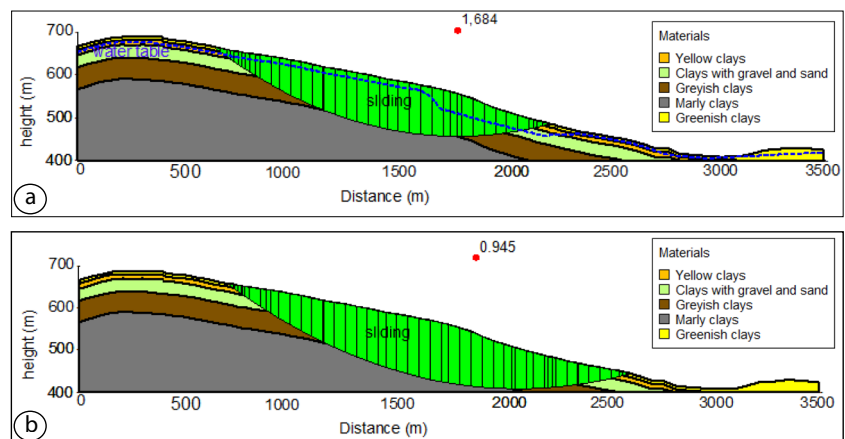
Fig. 20 The numerical simulation results depict the safety factor (Fs) and the sliding surface of the selected cross section: a) before and b) after the earthquake

the pore water pressure ratio and a decrease in the factor of safety by approximately 1.48 times. The pore water pressure ratio increased from 0 before and during the earthquake to 0.286 (Fig. 21), with the factor of safety (FS) value reduced from 1.684 to 0.961. When the pore water pressure ratio reached its high value, the FS value decreased from 1.684 to 0.945. Additionally, the analysis results revealed that the studied slope initiated to instability around 7:30 a.m. on August 7th (after earthquake), when the FS value dropped below one. Subsequently, when the pore water pressure ratio reached its maximum value (Fig. 21), the deformations intensified and propagated over a distance of 2 km towards the downstream part by 10:00 p.m. The variation in pore water pressure caused by precipitation and its influence on

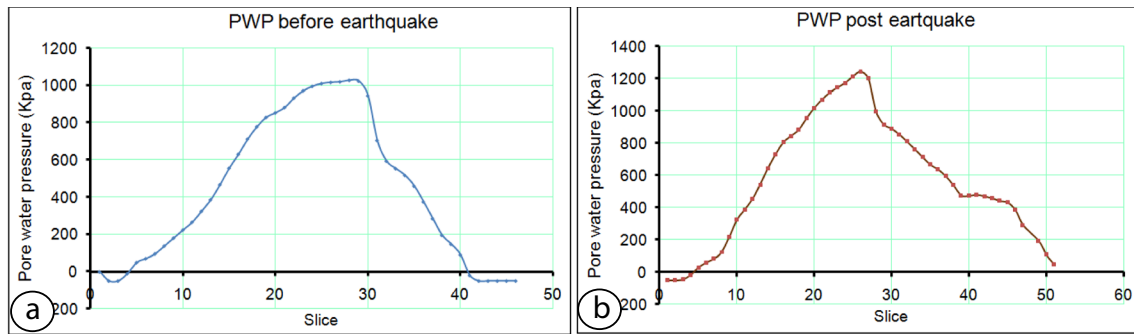
Fig. 21 The numerical simulation results depict the evolutions of pore water pressure ratio in the process of landsliding: a) before and b) after the earthquake

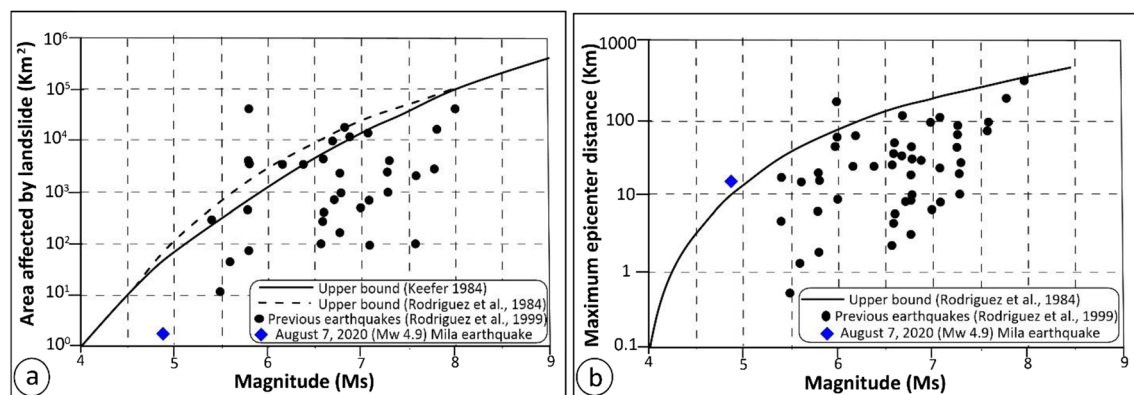
Fig. 22 Comparison of the distribution areas of coseismic landslides induced by the August 7th, 2020 (Mw 4.9) Mila earthquake with coseismic landslides worldwide: (a) Comparison of area affected by coseismic landslides with upper bound limits of Keefer (1984) and Rodriguez et al. (1999) and (b) comparison of maximum epicen-

tral distance to coseismic landslides with the upper bound of Keefer (1984) and data of Rodriguez et al. (1999). Data from Keefer (1984) are from coseismic landslides events occurred before 1980, and from Rodriguez et al. (1999) are from earthquake events occurred from 1980 to 1997

instability is really effective. These findings are consistent with those obtained from field observations. Consequently, landslide occurrences are inevitable in this area following rainfall and earthquake. The potential slip surfaces shown in Fig. 20 indicate that the entire study area is susceptible to deep sliding. As a result, structures located in this area along section AA' experienced significant deformations, reaching near-collapse and collapse levels, as observed from the damages incurred after earthquake, where the lowest FS (= 1) has been obtained from numerical analysis. Numerical simulations suggest that failure is likely to occur within the deep part of the landslide under earthquake conditions. These results are in accordance with those obtained from pressuremeter tests and empirical measurements (Fig. 22).
