Geophysical research applied to the evaluation of percolation conditions of an earth dam

Abstract

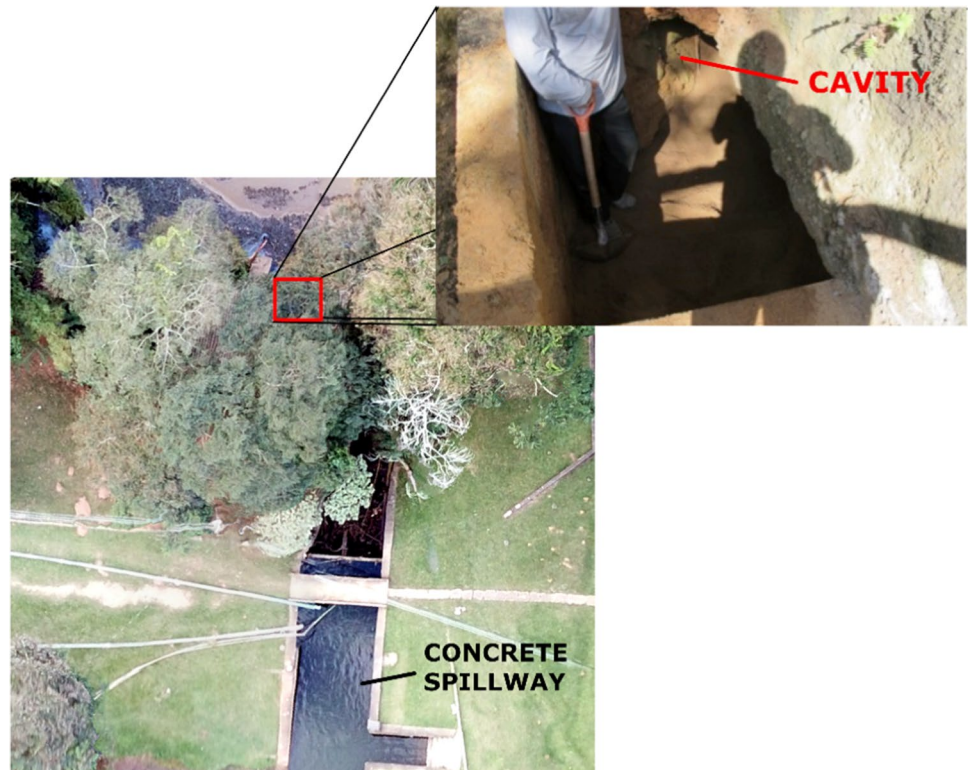
Fig. 3 Location and detail of the erosive cavity caused by piping on the downstream slope (adapted from Minette 2015)

Prior to the geophysical investigation, a process of water loss from the reservoir through the foundation layer of the dam was detected, while an erosion cavity, resulting from a piping process, was identified on the downstream slope of the dam massif, close to the concrete spillway (Minette 2015). Emergency interventions were made to prevent the collapse of the structure (Fig. 3).

the dam massif. In the place where the erosive cavity generated by the piping process (downstream slope, Fig. 3) was previously identified, no water surge was observed on the surface, indicating that the water flow was properly stemmed at the time of visual inspection.

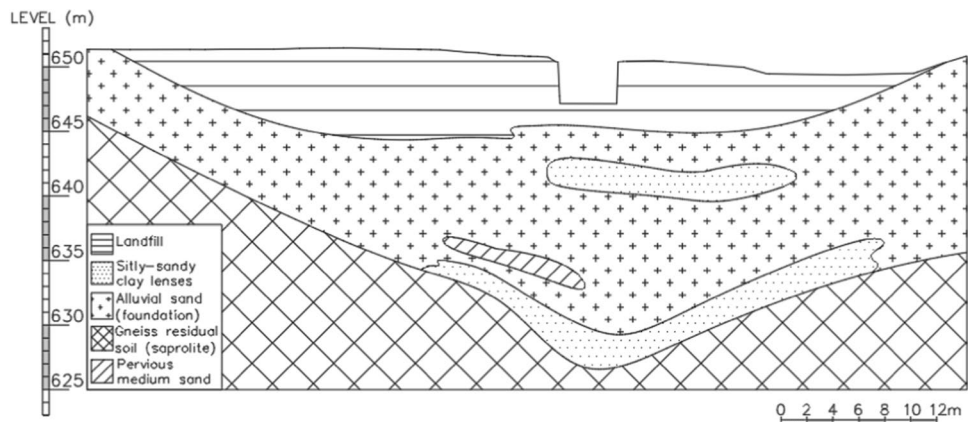
Fig. 4 Geological longitudinal cross-section of the embankment (adapted from UFV 2018)

A report from a percussion drilling (SPT) in the dam carried out in 2018 showed three main geological layers, without determining the depth of the bedrock (Fig. 4), due to limitations in the equipment applied during the investigations. The backfill layer of the dam has a texture varying between sandy silt and red silty clay, with mica, approximately 6 m thick. The foundation layer is composed of alluvial material with a texture ranging from fine to medium sand, with the presence of organic matter, mica and gravel. Below is the residual gneiss soil layer (Universidade Federal de Viçosa 2018; Dalmascio et al. 2019).

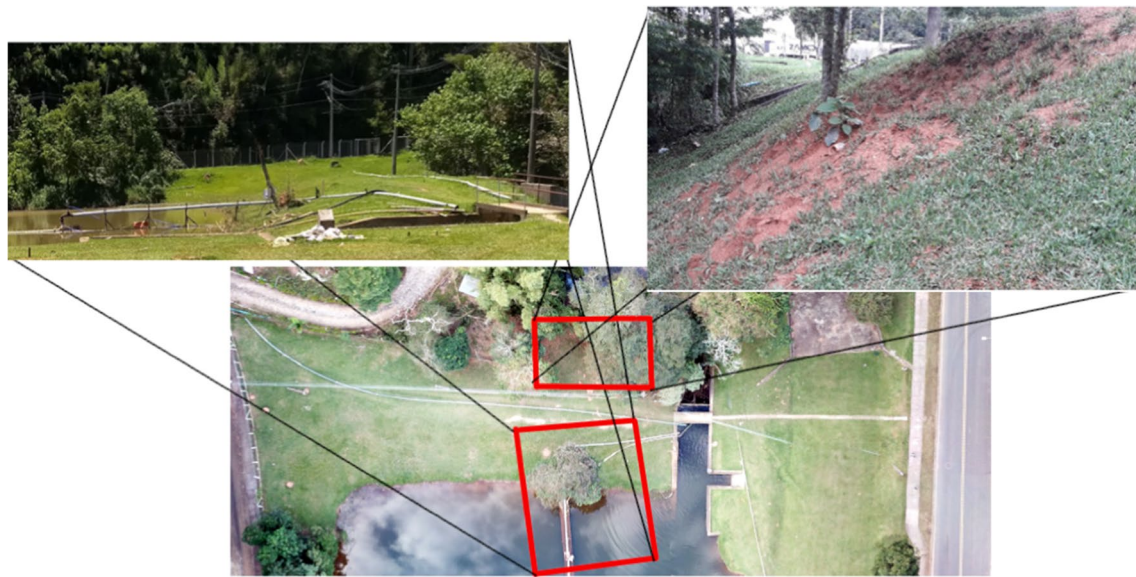
Fig. 5 Large trees and anthills and PVC pipes spotted during the visual inspection stage

Several PVC pipes that are part of the water abstraction system of the reservoir were identified on the dam crest, and the presence of large anthills and large trees on the downstream slope can be observed (Fig. 5). No evidence of problems, such as cracks and erosive cavities, were identified in

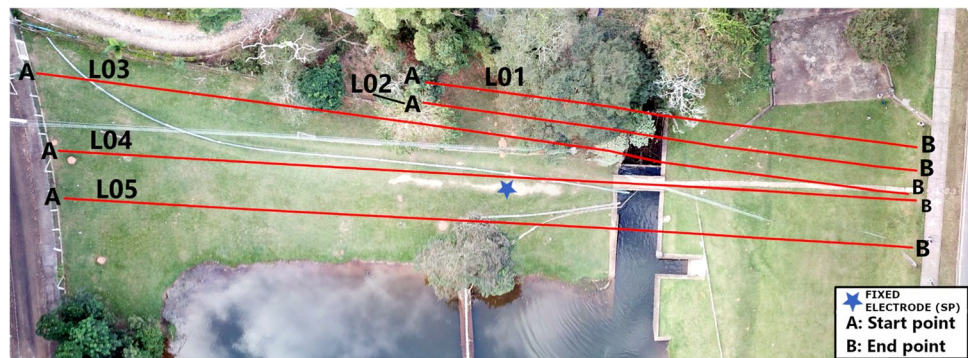
Fig. 6 Line profiles adopted for the geophysical survey

The positioning of line profiles for the execution of the geophysical survey was determined after visual inspection. Five lines were delimited, covering the crest, upstream and downstream slopes of the embankment. The goal was to cover largest possible portion of the study area, as well as all the interest points that were observed during the performing of the visual inspection (Fig. 6 and Table 1). Parallel profiles were adopted due to the small size of the dam, thus, the short distance between the lines did not generate significant data loss.

Investigation by the SP method was carried out along the same line profiles as shown in Fig. 6. Data were acquired using the fixed-base configuration, in which the potential value is measured between a stationary electrode and an electrode that is moved along the survey lines. This configuration was chosen for its easy application and for presenting low cumulative errors (Corwin 1990). The stationary electrode was positioned on the dam crest, close to the L04 line, while the mobile electrode was attached to the ground surface, keeping a spacing of 3 m between each measurement point. At the beginning and end of the readings in each line, the potential was measured at a point close to the fixed electrode, to compensate electrode polarization effects that may occur during data acquisition.

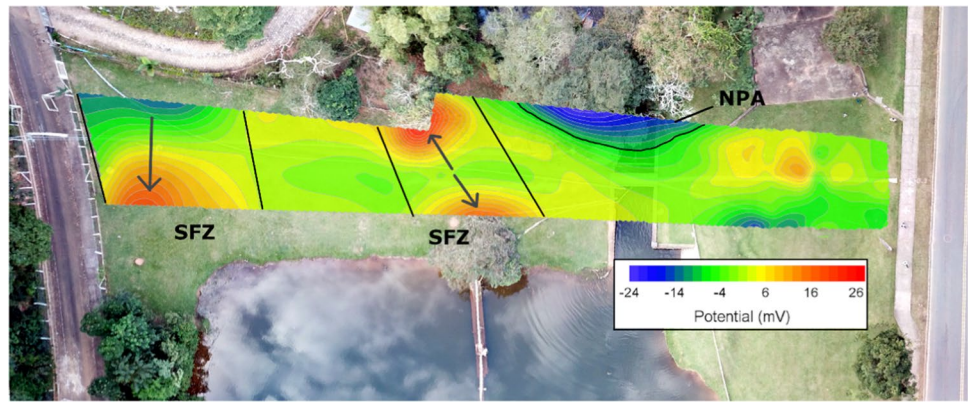
Fig. 11 SP survey results

The results of the SP survey (Fig. 11) indicated two superficial flow zones (SFZs) along the surface of the dam, which have no correlation with water percolation inside the structure. The configuration of potential values in these regions is consistent with the electrokinetic mechanism, with the direction of the flow determined by the local topography, and the potential values increasing downstream, as indicated in Fig. 11. We interpreted that these shallow flow zones were identified due to heavy rains in the study area prior to data acquisition (December 17th–19th, 2021), which were registered by UFV (2021), as presented in Fig. 12.

Also, a negative potential anomaly (NPA) was identified on the downstream slope of the dam, recorded on profiles L01, L02 and L03. This anomaly is located around the concrete spillway, and considering that the subsurface flow through the massif occurs perpendicular to the dam axis, it was associated with an intense cation displacement that may have been caused by a subsurface infiltration.

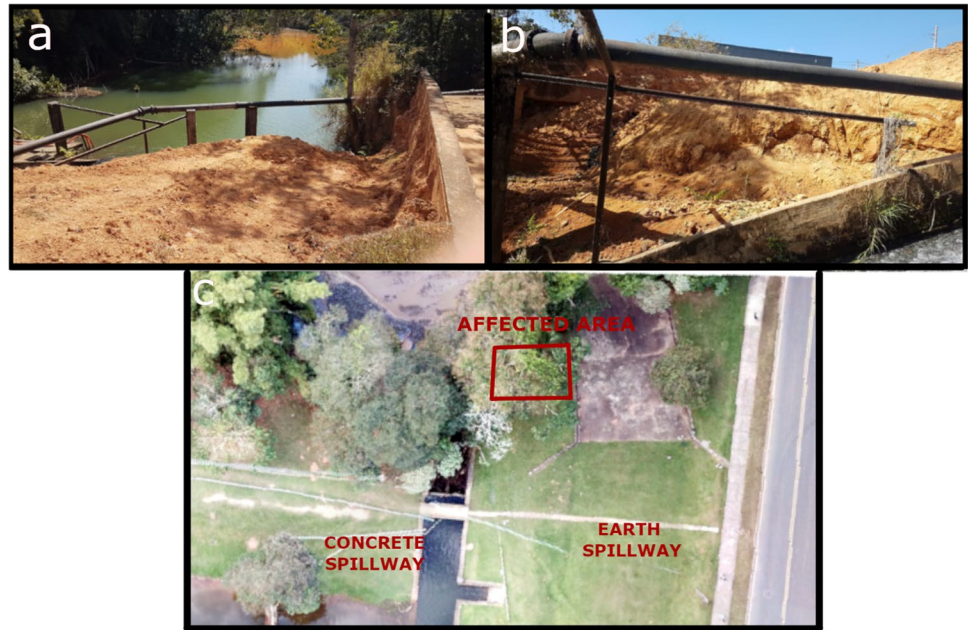
Fig. 13 Register of the landslide occurred on the downstream slope of the embankment. **a)** Upstream view; **b)** Downstream view; **c)** Top view of the dam highlighting the affected area

In July 2022, after the acquisition and interpretation of the geophysical data, a landslide occurred on the downstream slope of the dam, between the two spillways. This was a partial failure, which did not lead to the total collapse of the embankment. As shown in Fig. 13, the area affected by the landslide is located downstream of the features correlated with the occurrence of the zone of preferential seepage (LRZ-3 and NPA), as discussed in Sect. 4.3. Thus, we interpreted that the loss of stability of the downstream

slope of the dam can be correlated with the sink identified in the alluvial sand layer.

This correlation strengthens the coherence of the interpretations of the geophysical data that were presented in this study, since both the ER and SP results indicated the existence of the preferential flow path. Also, this result shows the potential of the application of integrated interpretation of geophysical data on the assessment of the efficiency of structural damage correction in geotechnical structures, since the identified flow path can be correlated with the piping process recorded before the data acquisition.
