Landslides (2004) 1:41–51
 DOI 10.1007/s10346-003-0010-0
 Received: 15 October 2003
 Accepted: 14 November 2003
 Published online: 27 February 2004
 © Springer-Verlag 2004

Claudio Margottini

Instability and geotechnical problems of the Buddha niches and surrounding cliff in Bamiyan Valley, central Afghanistan

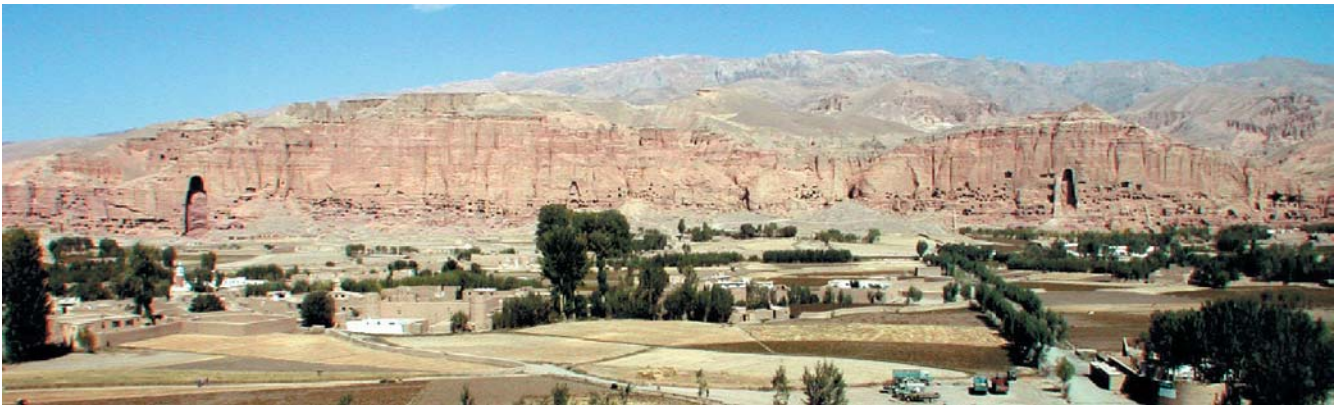
Fig. 2 View of the cliff at Bamiyan, central Afghanistan showing the relationship between the two Buddhas and the caves. The Great Buddha is on the left while small Buddha is on the right

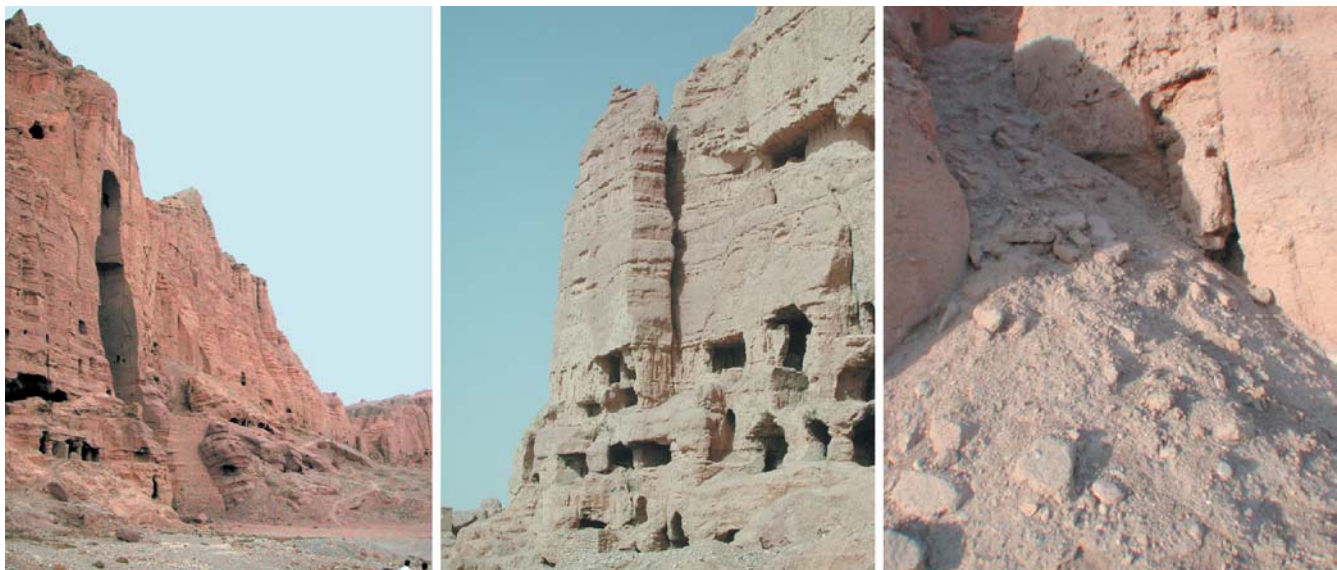
Fig. 4 Geomorphological processes in the Bamiyan Valley (from left to right) includes historical sliding near the great Buddha after human activities, progressive opening of a crack in the outer part of the cliff, weathering of siltstone causing mudflows above the Great Buddha

- Water infiltration from the upper part of the cliff
- Gully erosion in the upper part of the cliff from rainfall and snowmelt
- Progressive opening of cracks in the outer parts of the cliff (Fig. 4)
- Weathering of siltstone strata
- Toppling of large external portions, as well as of isolated blocks
- Occurrence of mud flows in the upper part, probably when the siltstone is saturated (Fig. 4)
- Sliding in a portion of the slope mainly where cracks from the top reach the lower siltstone formation, making it highly fractured and easily affected by weathering (Fig. 4)
- Accumulation of debris at the toe

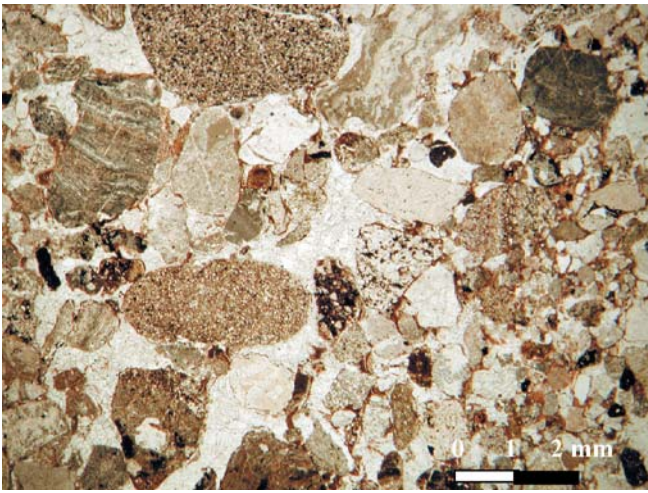
Fig. 5 Thin section view of conglomerate, strengthened by white carbonate cement

In microscope thin sections, the conglomerate (Fig. 5) is composed of monomineral grains and lithic fragments moderately sorted and cemented by carbonates. The monomineral grains comprise poorly rounded monocrystalline quartz, and moderately well-rounded polycrystalline aggregates of quartz. Less frequently observed are polycrystalline aggregates of car-

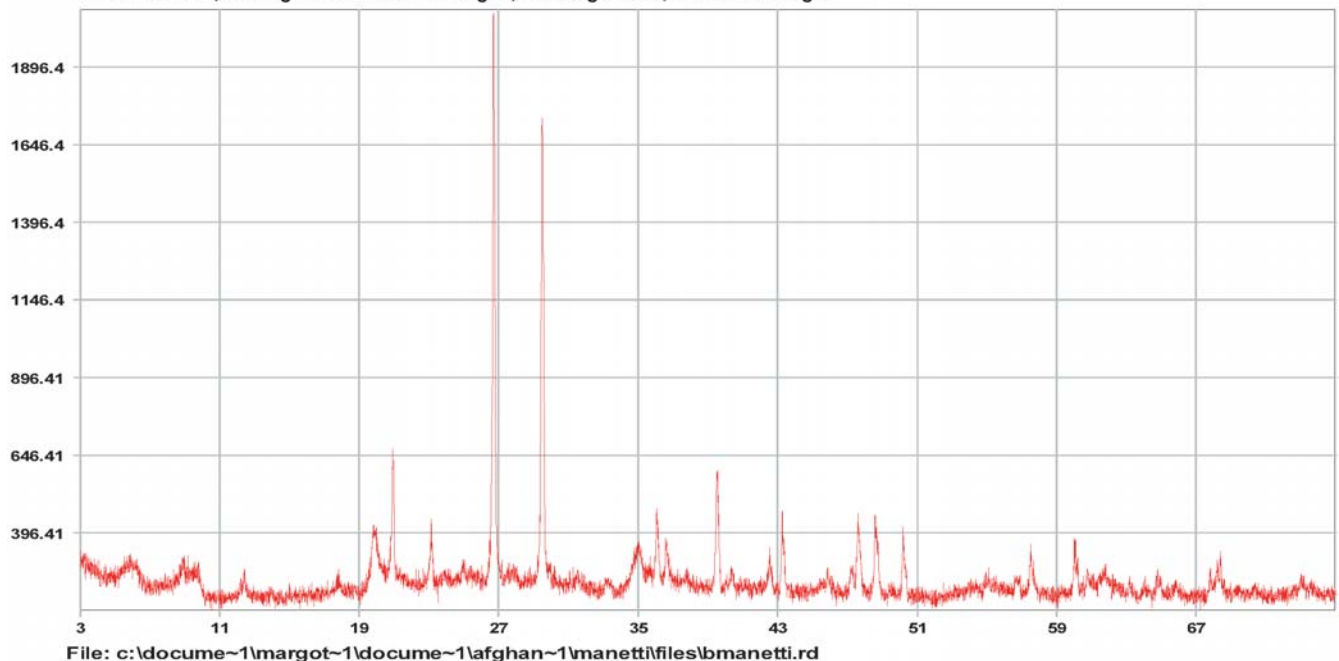
Fig. 6 X-ray diffractometer pattern obtained for a composite sample from the yellow siltstone

X-ray diffraction does not identify soluble salts (gypsum, halite, etc.) in either the conglomerate or yellow siltstone. This contrasts with the flocculation of red siltstone, which indicates that the depositional environment varied over time.

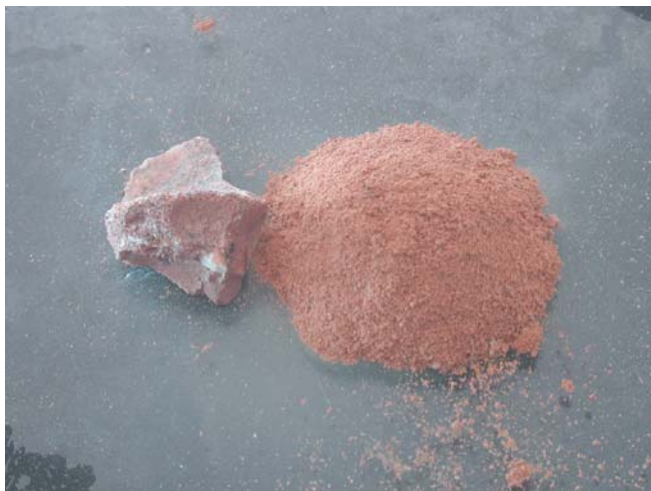
Fig. 7 Stability of conglomerate (*left*) and degradation of siltstone (*right*) after only a few minutes of immersion in water

The depositional environments and diagenetic conditions affect the present-day behaviours of the material; the conglomerate has a permanent cohesion, while the siltstone easily loses cohesion when saturated (Fig. 7). The mechanism for the siltstone's behaviour is probably a slaking process (Franklin and Chandra 1972) and has been investigated by scanning-electron microscopy, as well as by determining physical and mechanical properties in soil and rock-mechanical laboratory tests.

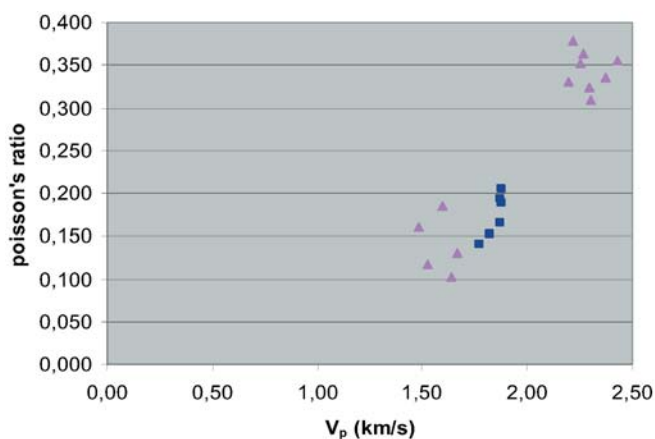
Fig. 8 Seismic p-wave velocities V_p and Poisson's ratios in conglomerate (*red triangles*) and siltstone (*blue squares*). The lower values for the conglomerate are parallel to the sedimentary flux direction

Seismic p-wave velocities V_p were measured in the laboratory for both conglomerate and siltstone (Fig. 8). The conglomerate has values of 2.2–2.5 km/s, and a Poisson's ratio of 0.30–0.40 (for samples perpendicular and transverse to depositional flow direction); a V_p of 1.5–1.7 km/s and a Poisson's ratio of 0.10–0.20 have been measured in the flow direction. The siltstone has a V_p of 1.7–2.0 km/s, and a Poisson's ratio of 0.15–0.20 with no anisotropy.

The lowest seismic velocities in the conglomerate are in the direction parallel to sedimentary flux (and stratification). This implies that, in this direction, seismic waves exhibit lower values because they are mainly crossing the more porous matrix of cemented silt; when seismic waves are crossing the samples perpendicular and transverse to sedimentary flux and stratification, the velocity is higher, probably as consequence of intersecting more solid rock in the grains. The values parallel to the sedimentary flux and stratification of the conglomerate, where matrix is predominant, are much closer to the values measured in the siltstone, indirectly confirming a similar origin and composition.

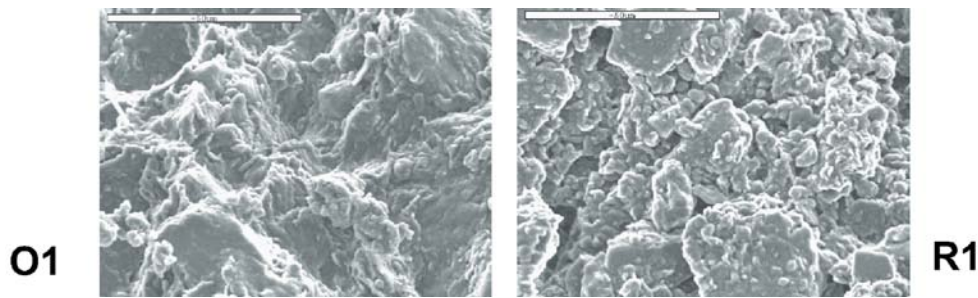
Fig. 9 Scanning-electron microscope microphotographs (1000X) of the siltstone. Sample O1 is undisturbed while R1 is from material first broken down by wetting and then dried to obtain a sample similar to natural conditions

Observation of the samples under SEM demonstrated that the compact, laminar structure (O1 in Fig. 9) no longer existed after the breakdown (R1 in Fig. 9). The laminar structure could be the consequence of the orientation of clay minerals completely filling voids in the siltstone and producing a dense material. The wetted and reconstituted material loses the structure typical of undisturbed samples; it clearly shows the granular composition, where some of grains are laminar, and some are probably clay minerals. The number of voids clearly is higher with respect to undisturbed siltstone, and so the original high density is lost after one wetting-and-drying cycle.

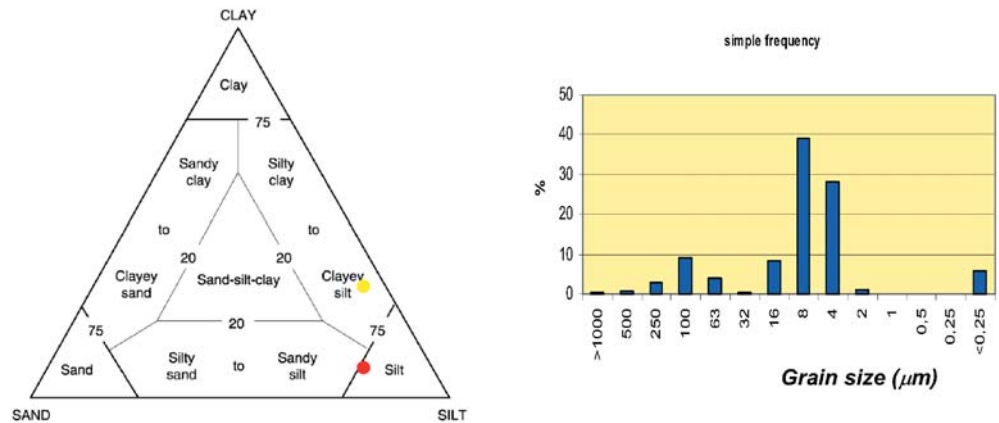
Fig. 10 Shepard (1954) diagram for siltstone grain-size distribution (red dot is from sedigraph and yellow dot is from hydrograph), classifying the material as “silt” (red) and “clayey silt” (yellow). Histogram is from sedigraph

The grain-size distribution of the siltstone is about 7% clay, 76% silt and 17% sand (determined with an electronic sedigraph), depicted as a “silt” on the Shepard (1954) diagram (Fig. 10). The grain-size distribution of another sample of siltstone, but determined by standard hydrometer methods, was 28% clay, 66% silt and 6% sand.

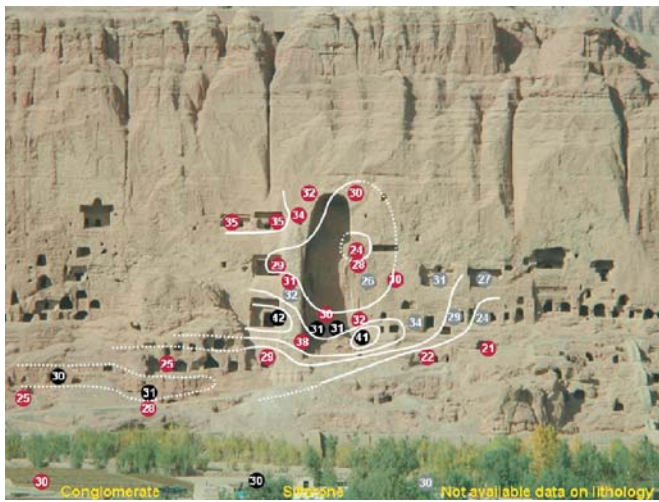
Fig. 11 Uniaxial compressive strength from Schmidt-hammer field survey

The uniaxial compressive strength from field Schmidt-hammer testing highlights the general satisfactory strength of the materials, at least in the dry season (Fig. 11). In the area of both the smaller and larger Buddha, the average values of about 30 MPa for conglomerate and about 34 MPa for siltstone show the materials to be of moderate strength (ISRM 1981). The siltstone generally is stronger than the conglomerate when dry. The situation is completely reversed when the rock is wet, but siltstone appears to make up only 20–30% of the cliff.

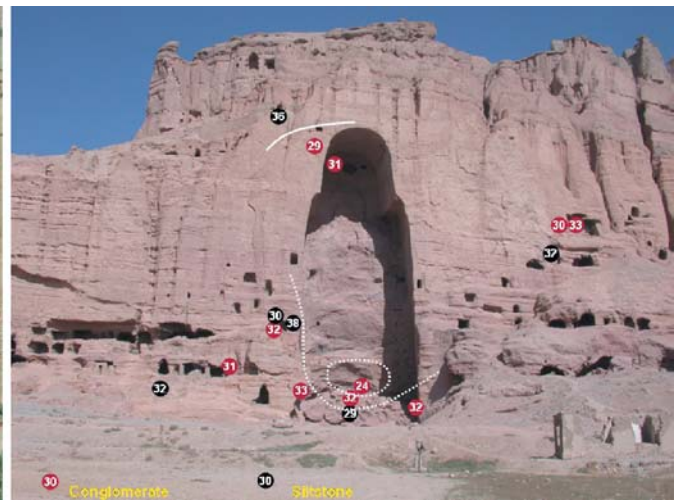
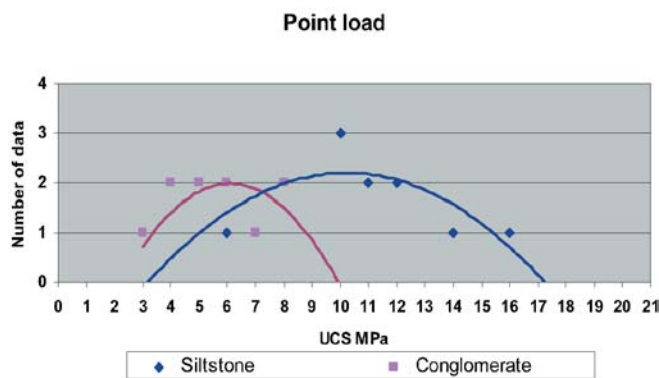
Fig. 12 Uniaxial compressive tests from point load in both conglomerate and siltstone

The in situ strength testing has been confirmed for both siltstone and conglomerate with some point load tests on samples taken outside of Afghanistan (Fig. 12). They show the general higher uniaxial compressive strength of dry siltstone, with respect to conglomerate. In general terms, the uniaxial compressive strength of siltstone (11.0 MPa) is about 30% of that exhibited in in situ tests, while the strength of the conglomerate in point load (5.6 MPa) is about 20% of the in situ Schmidt hammer tests. This difference is not surprising given the limitations of both methods in the indirect definition of uniaxial compressive strength, and the different confining condition of in situ samples and the cubes tested in the laboratory. The field survey gives useful information about the distribution of mechanical parameters along the entire area of investigation.

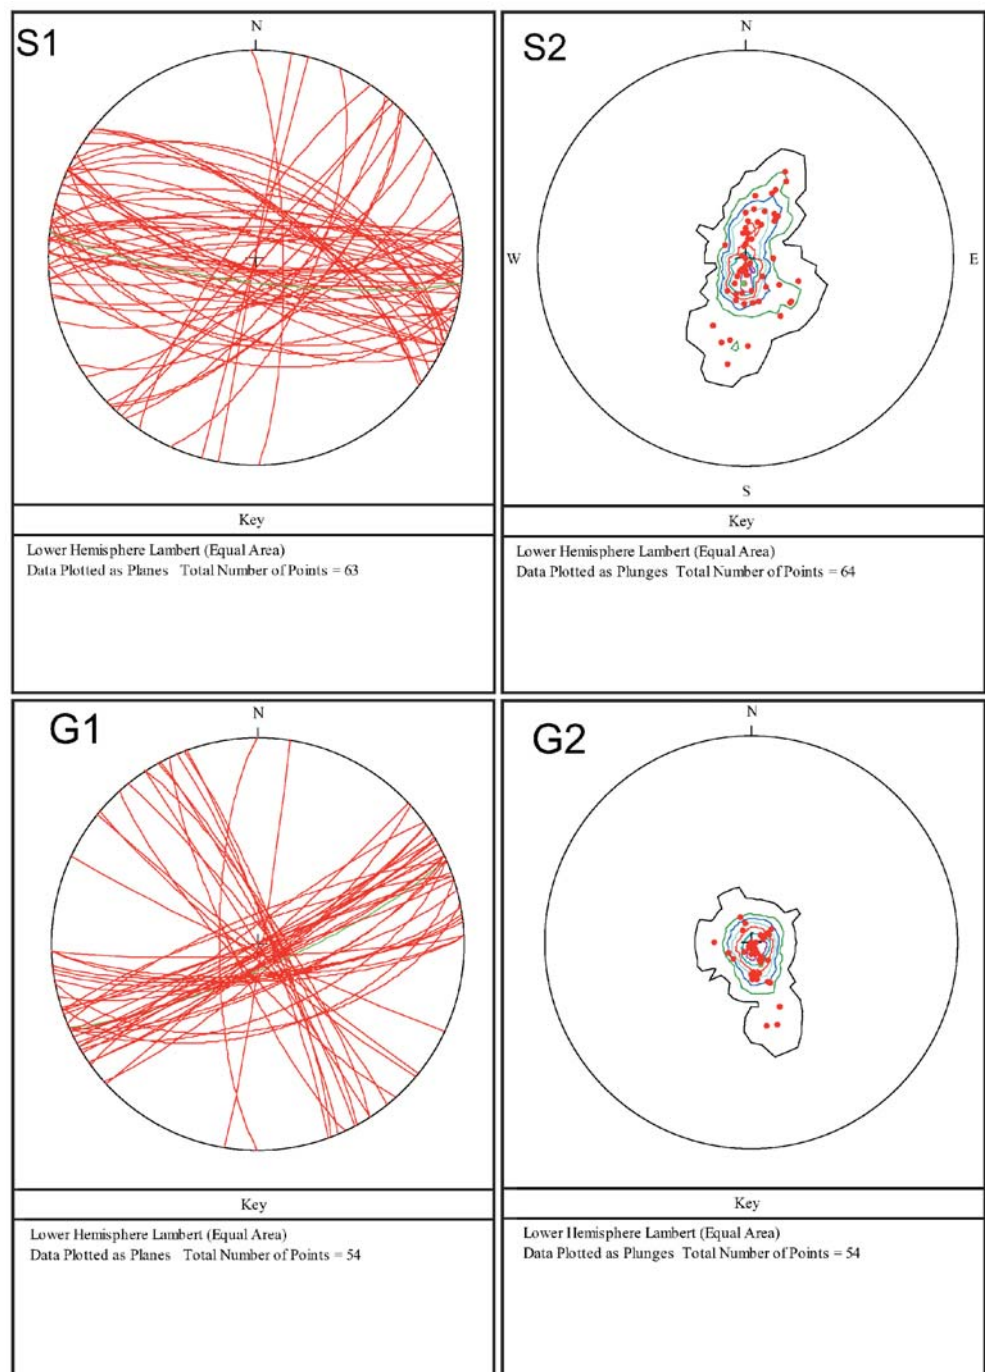
Fig. 14 Stereonet plots for kinematic analysis at the small and Great Buddha sites. *Green lines* represent the slope face. The contour increments every 10%

Possible collapse mechanisms have been investigated by comparing slope morphology and discontinuity patterns (wedge failure, planar sliding, etc.). The coincidence of slope face and major discontinuities patterns can be seen in Fig. 14. This does not satisfy the conditions for planar sliding or wedge failure (Turner and Schuster 1998). Note that some discontinuities plotted in the figure represent the same fracture detected in different vertical levels in the field survey (see Fig. 13 for measurement sites).

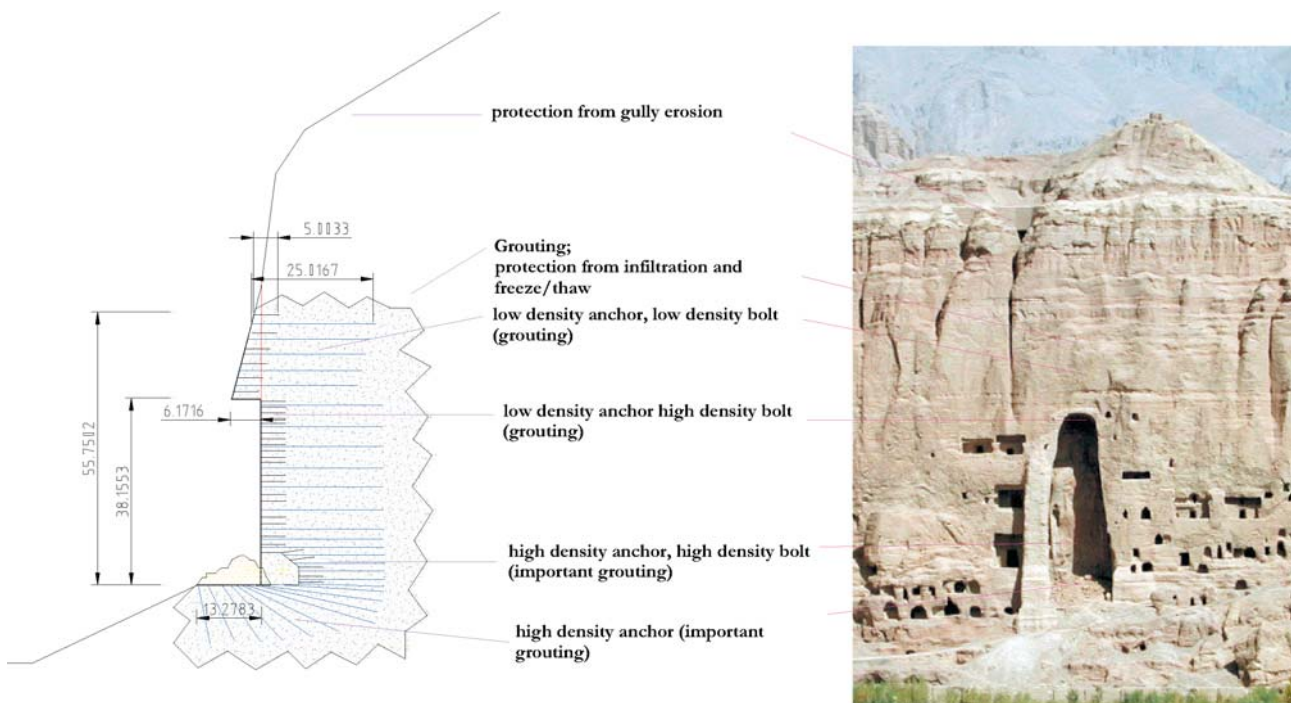
Fig. 16 The working area for the small Buddha site showing the most feasible types of restoration works

plan at the moment because any intervention has to be specified for the local conditions. At the present stage, it is convenient to set up a general master plan to be locally adapted according to further, more specific investigations and data. The master plan includes mainly nails, anchors and grouting, which will have a low environmental impact on the site. The working area and general density of intervention is shown on Fig. 16.
