Landslides (2006) 3:311–321
 DOI 10.1007/s10346-006-0059-7
 Received: 25 October 2005
 Accepted: 11 September 2006
 Published online: 10 November 2006
 © Springer-Verlag 2006

UNESCO World Heritage sites in Italy affected by geological problems, specifically landslide and flood hazard

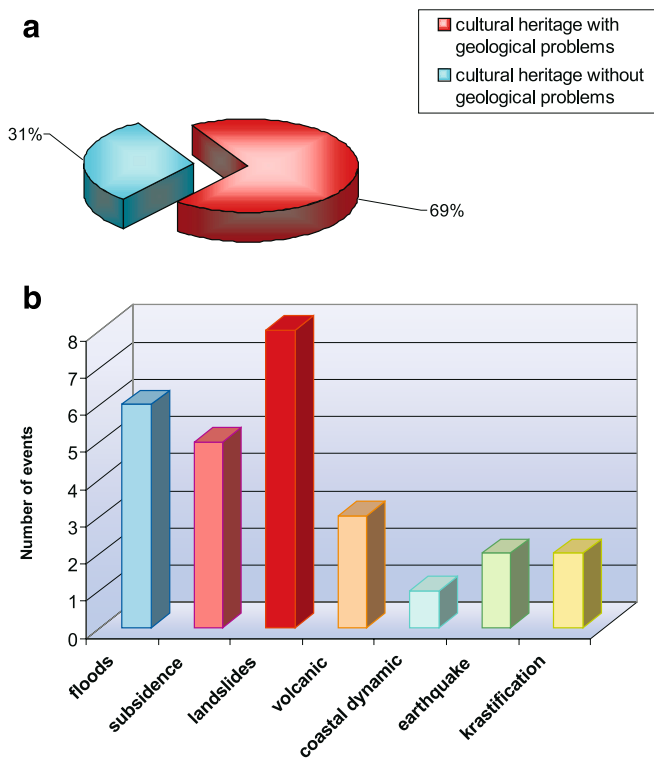
Fig. 1 **a** Graphic representation of Italian cultural heritage monuments included in the UNESCO World Heritage List and affected by geological problems. Many of these monuments are exposed to risk. **b** Graphic representation of the major geological problems affecting the listed Italian monuments. Floods and landslides are the most common problems

The census for the Italian sites on the UNESCO list was carried out by the CNR-IRPI, Turin (National Research Council–Research Institute for Hydrogeological Protection, <http://www.iaeg.it/commbeni.htm>). The 39 listed monuments distributed across the country comprise cultural, archeological, and natural sites, including natural parks. After data collection and creation of a dedicated database, an analysis of the data showed that about 70% of the monuments are affected by geological problems (Fig. 1a). However, this finding should be examined in conjunction

In Italy, hydrogeological risk represents a hazard that ranks second only to earthquakes in terms of casualties and infra-structural damage. The major geological problems for the Italian cultural heritage concerns floods and landslides, whereas subsidence, volcanic eruptions, and earthquakes play a secondary role (Fig. 1b).

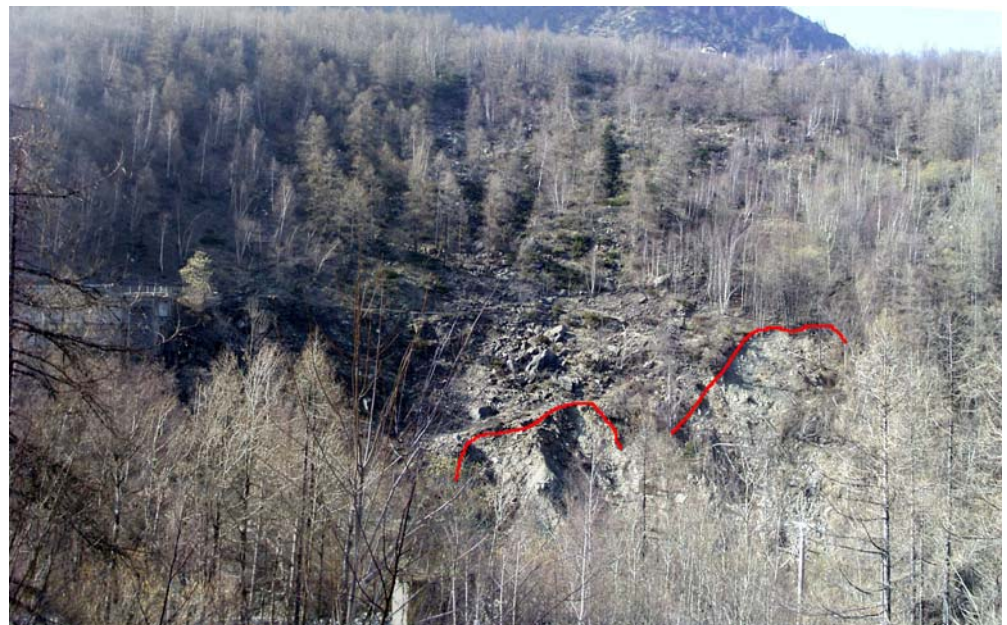
Fig. 3 Frontal view of a slide phenomenon affected the slope near the *Scopriniiera*. The slide partially reactivated during the October 2000 event (red line)

The geosite *Scopriniiera*, formed by the Paola and Gianna mines, lies inside a slope affected by slides, complex landslides in deep-seated gravitational slope deformation, and minor rock fall phenomena (Figs. 3 and 4; Lollino et al. 2004). As mentioned above, predicting landslide hazard depends on many factors, including time and spatial prediction, estimated movement velocity, quantity of material mobilized, and so forth.

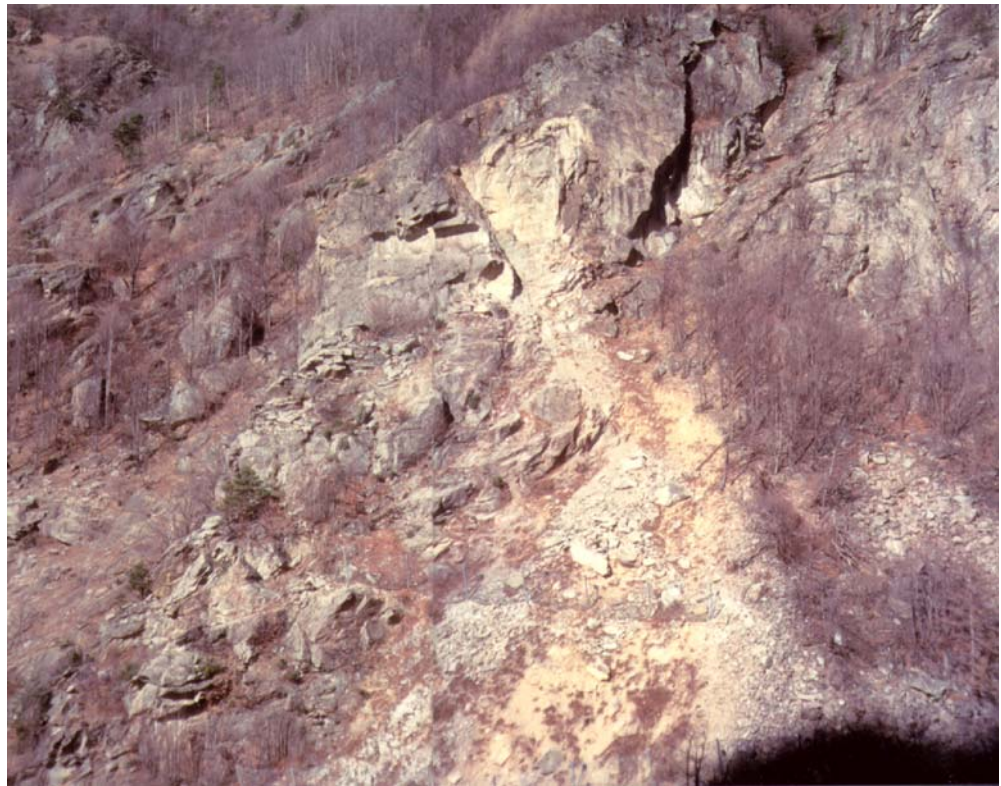
Fig. 4 Rock fall near the *Scoprini* site. The access road to the site is immediately below the fall

An additional consideration is that the minor falls are surface phenomena that do not directly influence the geosite because it is a subterranean mine, but they may negatively influence the

hazardousness of access roads to the site (tourism at indirect risk). Slide phenomena or complex landslides may involve greater thicknesses of material and thus directly influence the geosite's stability (tourism at direct risk).
