Landslides (2007) 4:197–203
 DOI 10.1007/s10346-006-0075-7
 Received: 2 November 2006
 Accepted: 3 December 2006
 Published online: 9 January 2007
 © Springer-Verlag 2007

A complex earth slide–earth flow induction by the heavy rainfall in July 2006, Okaya City, Nagano Prefecture, Japan

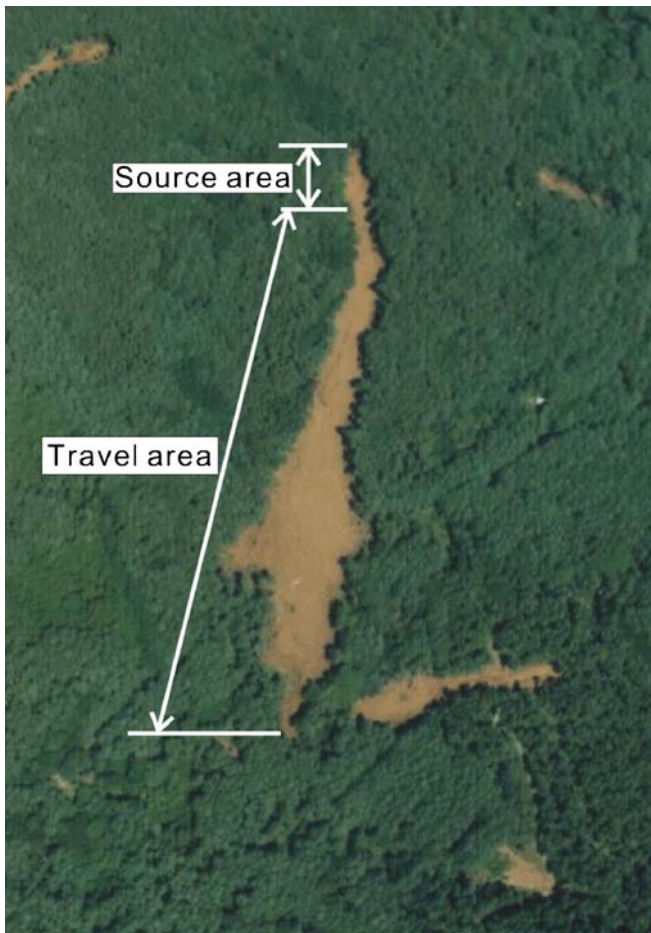
Fig. 1 Aerial view of the complex earth slide–earth flow (photo by Aero Asahi)

failed materials traveled downslope expanding in width until deposition occurred (Fig. 1). Hence, the failed material did not just move downward along the channel, but it widened the travel width while changing into a flow and traveling about 350 m down the gentle slope. The volcanic black ash soils were found along the travel path; the depth of volcanic black ash soils was >1 m, about 100 m downslope of the source area (Fig. 6a) and about 0.3 m at a distance 190 m from the source area (Fig. 6b). The volcanic black ash soils contain much organic matter; therefore, these must have been located at the ground surface layer before the volcanoclastic sedimentation. Permeability tests on undisturbed volcanoclastic soils and volcanic black ash soils sampled by 100-ml steel tubes (height = -50 mm) produced values of 5.8×10^{-6} and 1.1×10^{-6} m/s, respectively. As the volcanic black ash soils had a lower permeability, the volcanoclastic soils overlying black ash soils could have been fully saturated due to the extended precipitation in July 2006. When the failed materials moved downslope, pore pressure within the volcanoclastic soils was likely generated due to the impact of the failed materials on the volcanic black ash soils resulting in the liquefaction and lateral expansion of the flow.

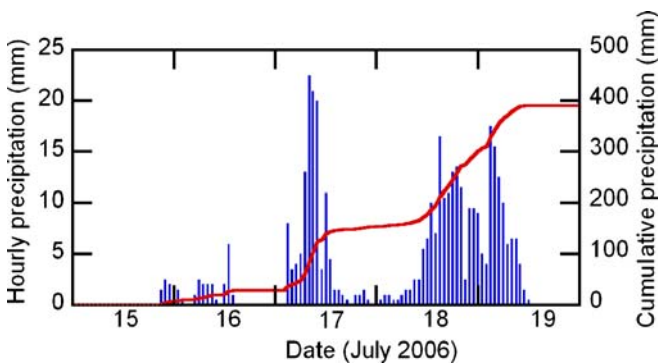
Fig. 2 Hyetograph of the Heavy Rainfall in July 2006 at Suwa AMEDAS observatory (monitored by Japan Meteorological Agency)

Nagano Prefecture is located in the interior of the main island of Japan, and it, generally, experiences lower annual precipitation (1,700 mm) than most of Japan (Ministry of Land, Infrastructure and Transport 2004). The AMeDAS (Automated Meteorological Data Acquisition System) observatory at Suwa, which is closest to Okaya City, recorded an average annual precipitation of 1,307 mm during the 30-year period from 1971 through 2000 (Japan Meteorological Agency 2006a). However, the long-term accumulation of precipitation (the Heavy Rainfall in July 2006) accompanied by a seasonal rain front (Baiu front) fell on the Nagano Prefecture from 15 to 19 July, and a new record for monthly rainfall at the Suwa observatory was set (506.5 mm/month). The maximum hourly precipitation was only 23 mm on 17 July (Fig. 2). The hourly precipitation did not reach 20 mm on 18 and 19 July. Hence, the rainfall intensity during the Heavy Rainfall in July 2006 was not so strong and was not one of the ten highest intensity values in the period from 1948 to September 2006. However, daily precipitation, i.e., daily rainfall on 18 July (148 mm), was the second highest in this 58-year record. Furthermore, daily rainfall on 17 July (125 mm) was ranked as fifth in the same record. Accordingly, although precipitation intensity was not high, the two-consecutive-day rainfall was surprisingly large at Suwa observatory, and many flow-type landslides were triggered. The cumulative precipitation for 5 days was almost 400 mm.

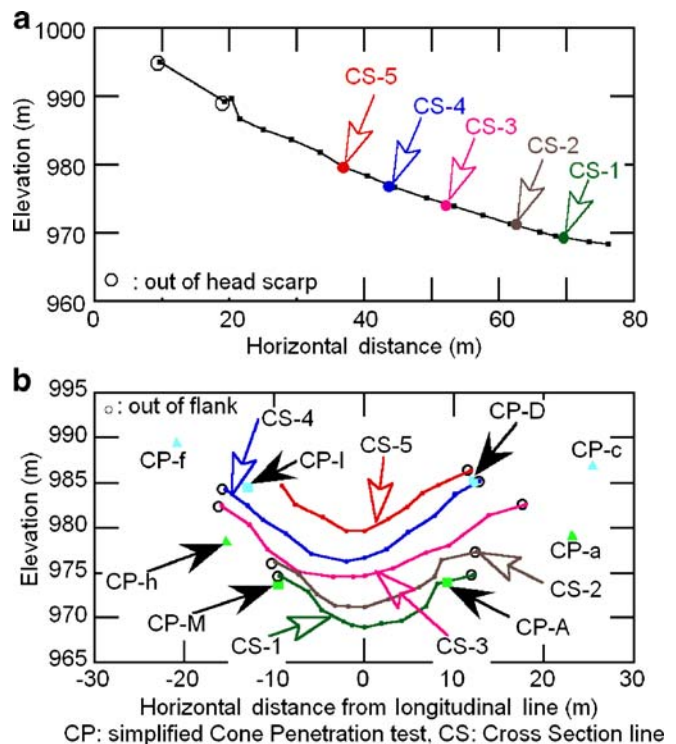
Fig. 3 a Longitudinal section and b cross-section of the landslide

The sliding mass was about 60 m long and 30 m wide, and the maximum soil depth was estimated at about 4 m based on survey data using a prism total station (Fig. 3a and b). Some positions of simplified cone penetration tests conducted on the periphery of the source area are shown in Fig. 3b, and these were corresponding to Fig. 4. $N_{c_{10}}$ values indicate the number of times required for a 5-kg weight dropped from a height of 0.50 m to drive the cone 0.10 m into the soil (Fig. 4). $N_{c_{10}}$ was assumed to define the surface layer of volcanoclastic soils ($10 \geq N_{c_{10}} \geq 0$). Soil depth ranged from 0.7 m (at CP-a) to 3 m (CP-A). Because the maximum soil depth in the

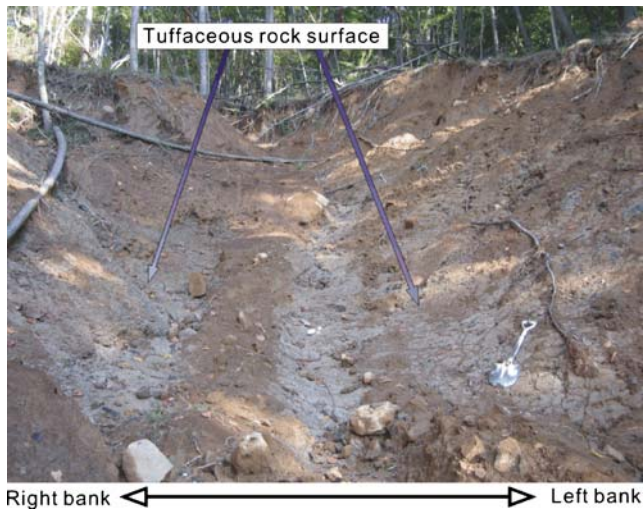
Fig. 5 Photograph of the head scarp of the complex earth slide–earth flow

Clear exposures of tuffaceous rocks were apparent along both flanks of the landslide (Fig. 5). Because these rocks must have had a lower permeability, the excess precipitation must have raised the subsurface water table level into the overlying volcanoclastic soils and triggered the sliding failure. An important point is that the

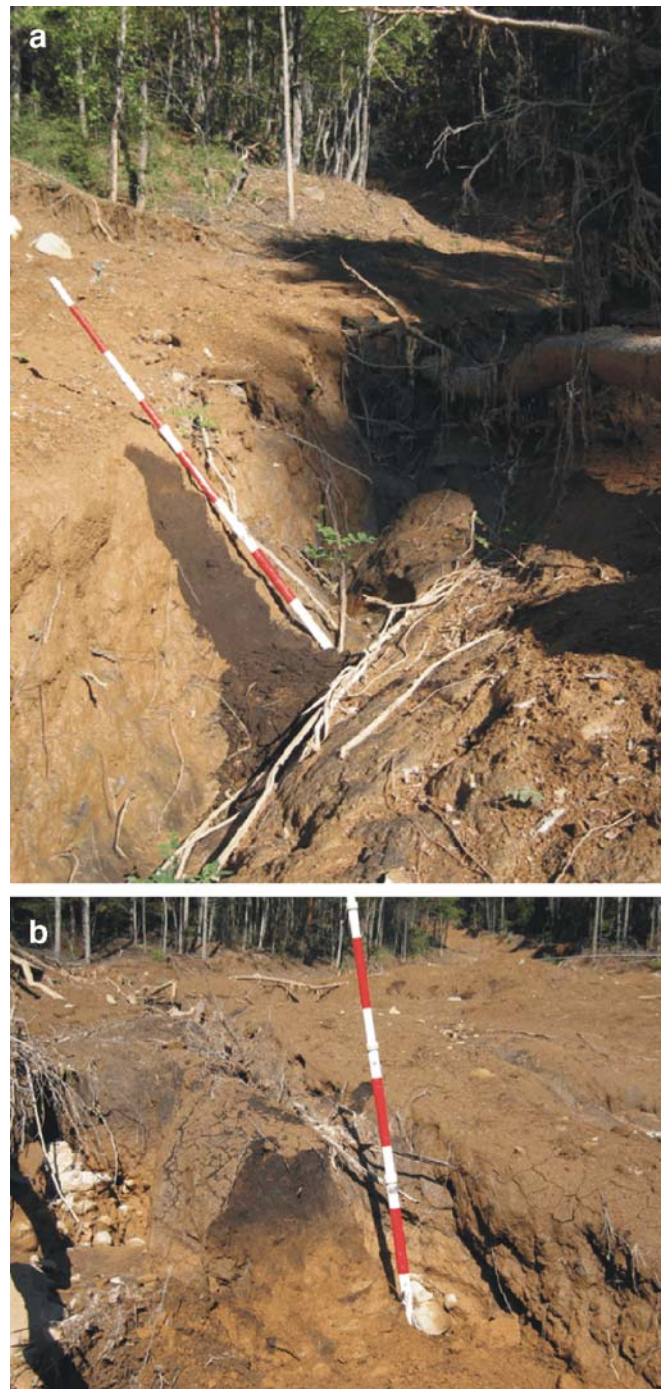
Fig. 6 Volcanic black ash soils found along with travel area: **a** 100 m from the head scarp; **b** 190 m from the head scarp

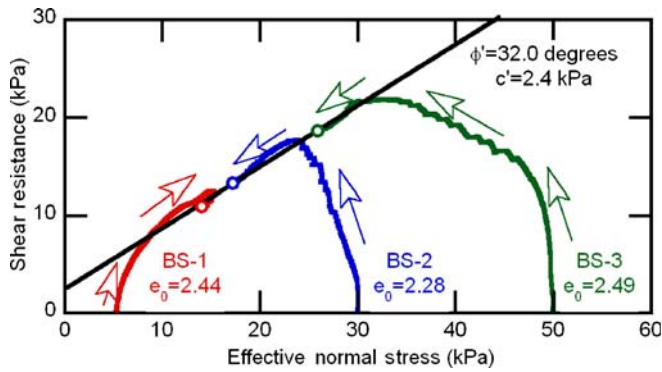
Fig. 7 Effective stress paths of box-shear tests

The effective stress path of test BS-1 with the overconsolidated specimen mostly moved right upward, as the effective normal stress was increased (Fig. 7). In contrast, the effective stress paths of tests BS-2 and BS-3 moved left upward until reaching the failure envelop line, then they proceeded in a left downward direction closely along with the failure envelop line. During the tests, the effective normal stress was greatly reduced, indicating that excessive pore pressure must have been generated along the sliding surface of the landslide mass if saturated undrained conditions were maintained. Although the overconsolidated specimen produced a larger effective normal stress than that of initial consolidation, the normally consolidated specimens produced larger excess pore pressures that led

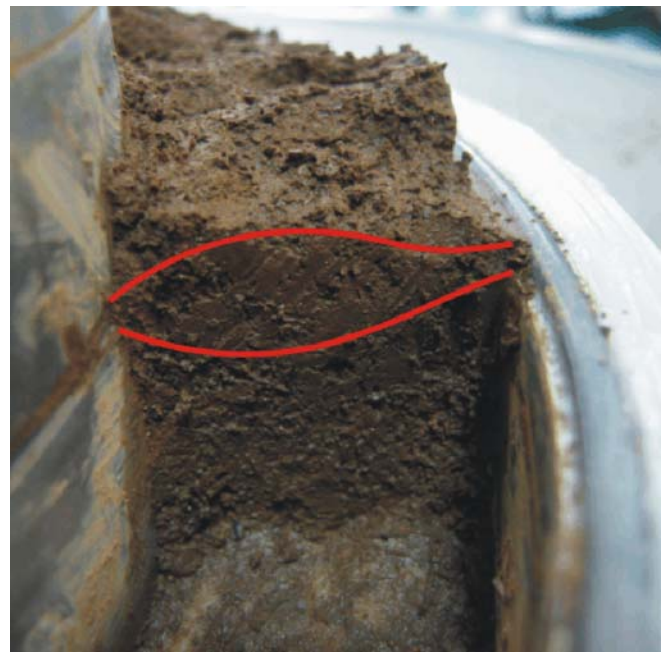
Fig. 9 Photograph of the specimen after shearing

The soils within the shear zone (Fig. 9, designated by a red line) were light brown compared with the darker soils under the shear zone. The grain size distribution curve of soils after shearing shifted

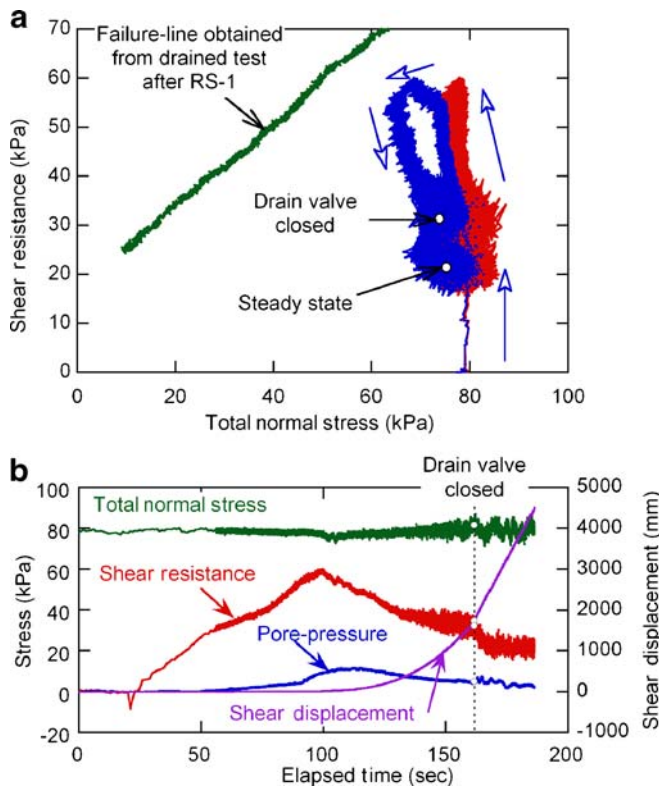
Fig. 8 Results of ring-shear test (RS-1): a stress paths; b time-series data

When shear stress was increased, pore pressure started to increase from about 55 s (Fig. 8b). At 100 s, shear resistance reached

peak value of 59 kPa with pore pressure still increasing as shear displacement started to increase (Fig. 8b). Pore pressure peaked at 110 s. From 110 to 160 s, shear resistance and pore pressure gradually decreased and shear displacement increased exponentially. Once the drain valve was closed to simulate undrained conditions, shear resistance dropped to as low as 22 kPa at steady state conditions at which time the test was terminated at a shear displacement of 4,500 mm (Fig. 8b). During this period, pore pressure fluctuated but, in general, did not increase. The effective stress path rose from the beginning of the test and peaked well below the failure line obtained for drained conditions (Fig. 8a). Afterward, the effective stress path moved left downward and then right downward. When shear resistance decreased to 31 kPa, the drainage valve was closed.

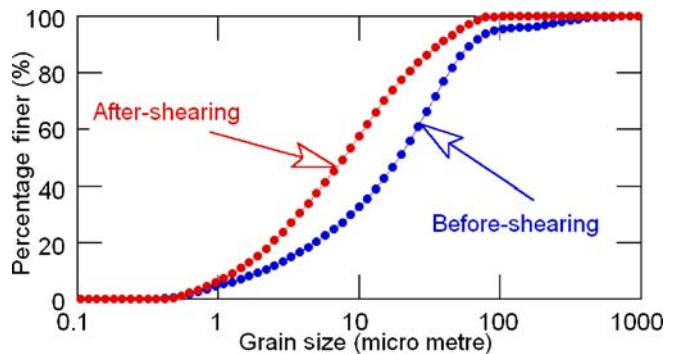
Fig. 10 Grain size distribution curves before- and after-shearing

to the left of the “before-shearing” curve, indicating that soil grains may have become finer due to the shearing (Fig. 10). These results suggest that sliding surface liquefaction (Sassa 1996; Sassa et al. 1996) may have occurred due to grain crushing and comminution when the effective normal stress and shear resistance decreased.

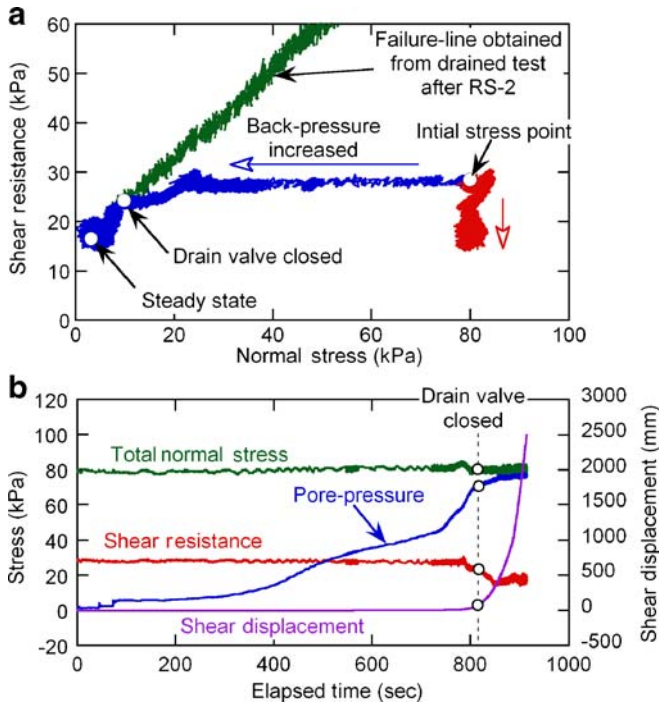
Fig. 11 Results of ring-shear test (RS-2): a stress paths; b time-series data

The initial stress point was set at a 20° gradient on a stress diagram corresponding to the gradient in the source area of the

landslide (Fig. 11). Pore pressure was manually increased throughout the test. Beginning at 730 s, shear displacement started to increase slightly, and beginning at 785 s, shear resistance decreased until 25 kPa. At 815 s, the drain valve was closed to convert to undrained conditions (Fig. 11b). After that, pore pressure continued increasing to 79 kPa, and shear resistance declined to 18 kPa at 2,500 mm shear displacement. These results caused a loss of shear resistance even when the drain valve was open (785 to 815 s), indicating that the soil may have slid due to water table rise up with increasing pore pressure and corresponding declines in shear resistance over the travel distance.

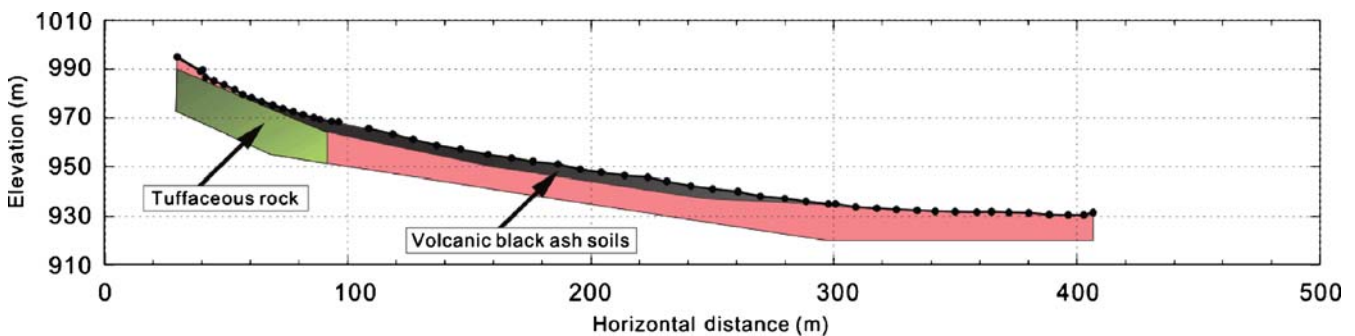
Fig. 12 Schematic illustration of geological structure
