Damage and conservation of the high cliff on the Northern area of Dunhuang Mogao Grottoes, China

Keywords Dunhuang Mogao Grottoes · Cliff · Damage · Protection · Weathering

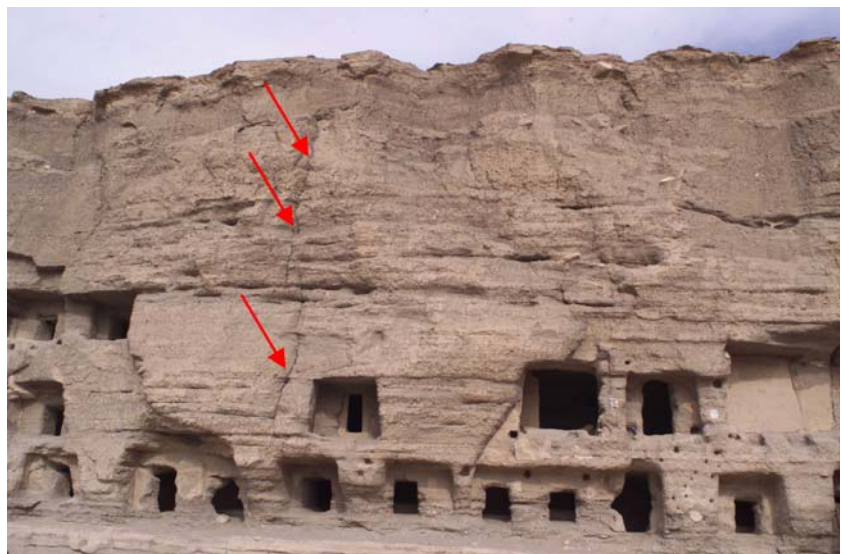
Fig. 9 Unloading fissures parallel to the cliff face of the northern area

and extend only to tectonic fissures as termination boundaries. This group of fissures separates some of the big rock mass from the host rock of the cliff and mostly cut across the caves’ two sidewalls, vault, and floors of the caves. The large rock mass may move down along the fissure faces, causing collapse under gravity (Fig. 9).

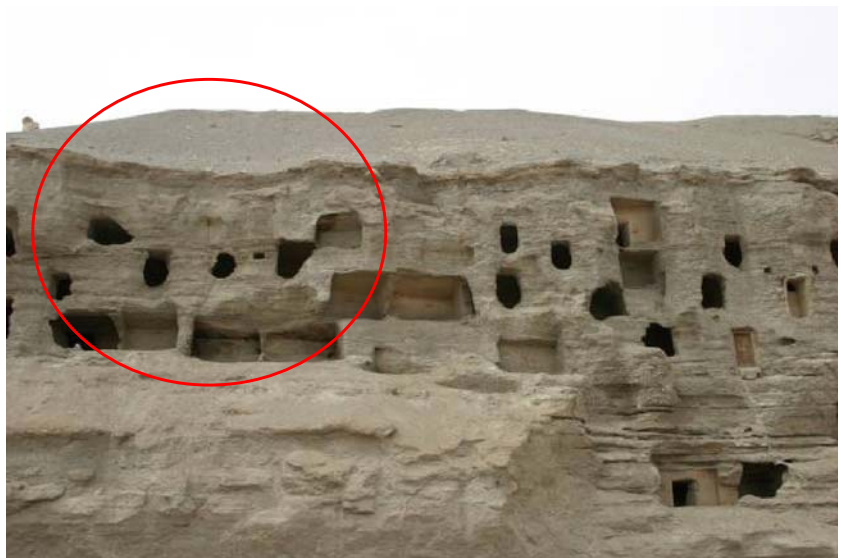
Fig. 10 Intensive distribution of caves in the cliff face of the north area

From a viewpoint of geological engineering, the intensively excavated openings interrupt the balanced state of initial stress in the cliff rock, resulting in a stress concentration in the vertical rock walls between neighboring caves and, therefore, a roof collapse. Damage of many caves in the intensive district will promote the instability of partial slope, as shown in Fig. 10.

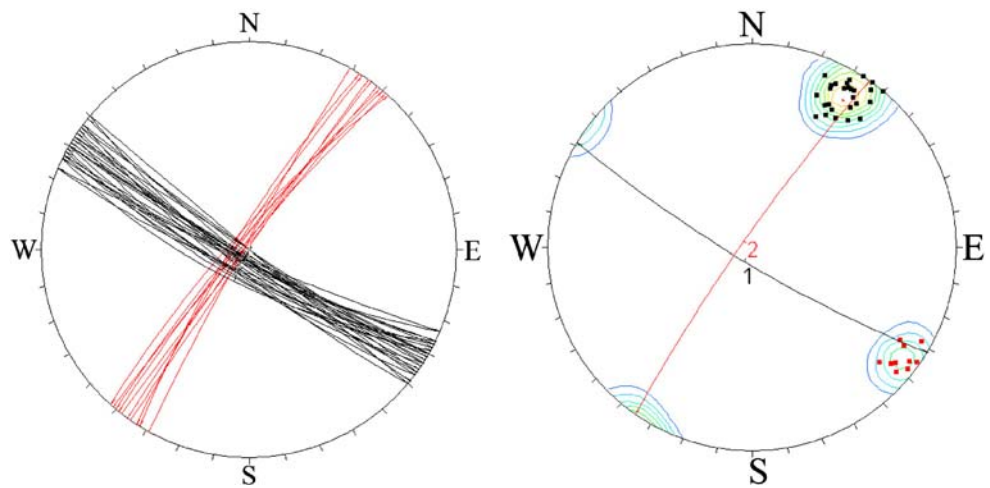
Fig. 11 Stereonet plots (lower Hemisphere and equal area) of representative fissures at the northern area. *Left* data plotted as planes total number of points=37. *Red lines* represent the unloading fissures and *black lines* represent the tectonic fissures. *Right* data plotted as planes total number of points=37. The contour increments every 10%

unloading fissures parallel to the surface of the cliff body. Figure 11 is the statistical results of the representative fissures observed. From Fig. 11, it can be easily found that the unloading fissures, almost parallel to the cliff surface with big lengths, greatly attributed to the large-scaled, dangerous rock blocks on the cliff, which should be mainly stabilized for conservation of the northern area. Meanwhile, the tectonic fissures can also become the channels through which the rainwater could penetrate toward the deep part of the cliff body and then accelerate the weathering of the rock mass. According to the statistics, there are, in fact, 57 caves cut by fissure in the northern area, accounting for 23% of the total caves. This means that the existence of fissures is the first threat to the safety of the caves. Figure 12 shows a small collapse of the cliff body cut by a vertical unloading fissure.

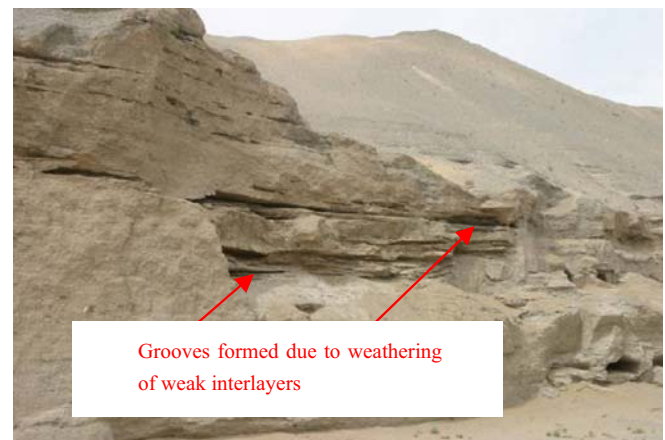
Fig. 13 Weak interlayer in the north area

As an alluvial formation, there are sandstone lens interbedded in the strata, which are very loose and form weak surfaces under weathering conditions. Therefore, the upper hard rock, hanging on weak bottom, subsides gradually under gravity, generating vertical tensile fissures and the collapse of small rock blocks (Fig. 13).

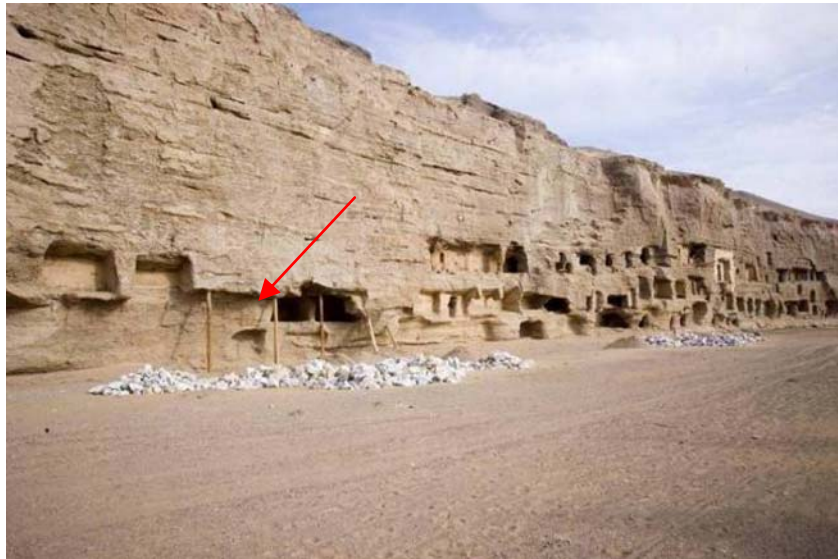
Fig. 15 Collapse caused by historical flood erosion to the bottom of the cliff

Even the cliff rock was cut vertically by unloading fissure, the large-scaled rock mass could stand still without triggering factors such as earthquake or foot erosion. Unfortunately, the Daquan River flooded to the cliff foot in the north area in history (Yao and Peng 2007) until the flood dike was built in front of the north area in the early 1980s. Figure 15 shows the free surface eroded by the historical flood at the cliff foot where some caves were destroyed due to rock collapse along the flood erosion surface.

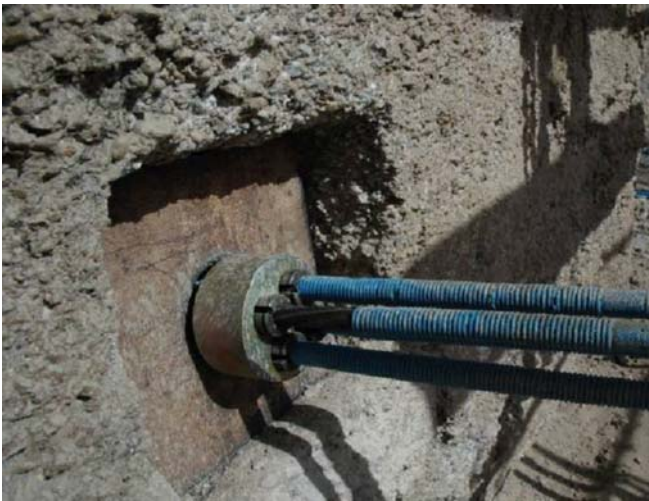
Fig. 18 Installation of an anchor plate

Figure 18 shows the installation of an anchor plate and Fig. 19 shows the distribution of anchor cables outside the cliff surface before cutting off.

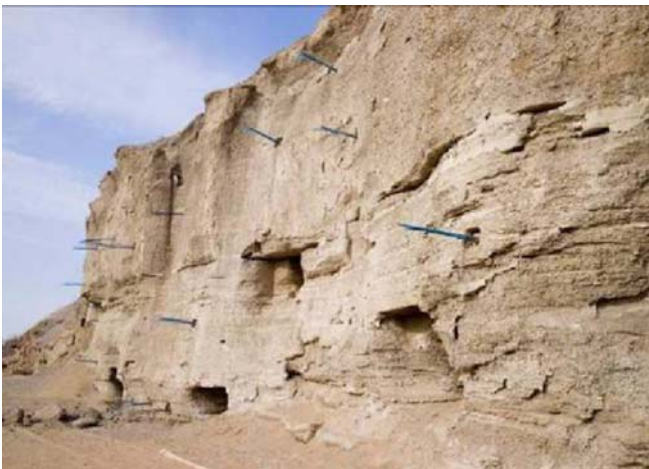
Fig. 19 Distribution of anchor cables outside the cliff surface before cutting off

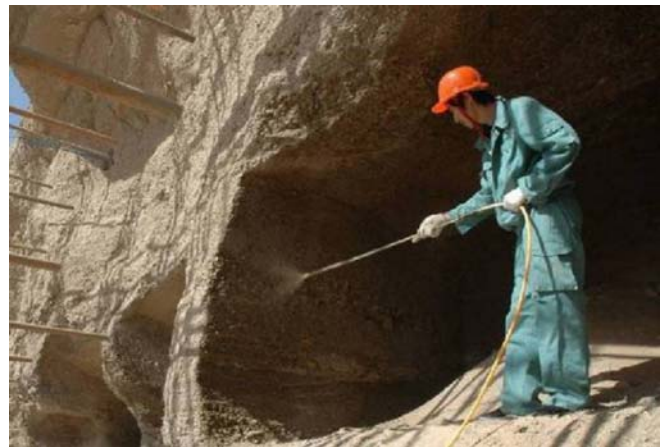
Fig. 22 Construction site of the weather-proof consolidation by PS spray

According to the above circumstances, the weather-proof PS material (Li 2003) has been used to stabilize the cliff's surface. The stabilized area has been divided into three zones: the critical stabilization zone, the priority stabilization zone, and the general stabilization zone according to the location, distribution, quantity, and degree of weathering of the caves in the north area. Different PS concentrations and spraying frequencies have been adopted in accordance with the different weathering degrees of the cliff body. In the final spraying process, a small amount of sedimentary soil with minimum impurity should be added to the PS solution after its milling and sieving to make the surface of the cliff body's appearance look more natural. The color of the cliff face after

construction should be consistent with its original color as far as possible. Figure 22 is the construction site of weather-proof stabilization for the cliff surface by PS spray.

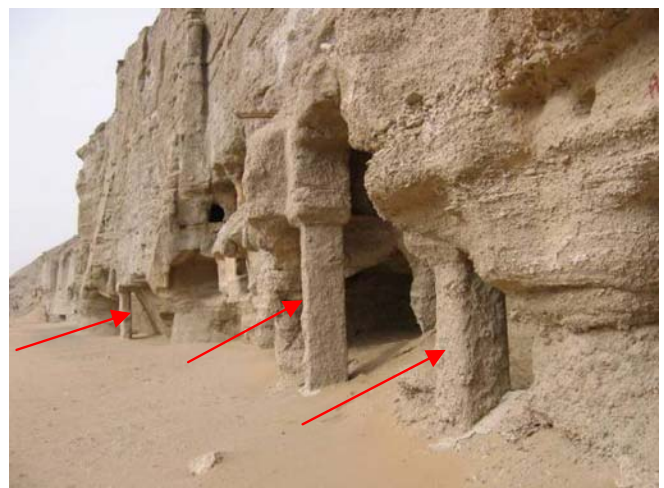
Fig. 23 Column support of the hanging sections at cliff bottom

The recesses at the bottom of cliff body mainly caused by the flood erosion of the Daquan River in history resulted into some sections of the cliff body to “hang in the air.” If an earthquake were to occur, the overhanging rocks will undoubtedly collapse. So, the hanging sections at the cliff bottom are stabilized with columns made by stone blocks (Fig. 23). Onto the column surfaces, PS solution in addition with clay material from weathered cliff rock is sprayed so as to make it as close as possible to its historic appearance.
