Landslides (2009) 6:353–360  
 DOI 10.1007/s10346-009-0158-3  
 Received: 13 August 2008  
 Accepted: 4 June 2009  
 Published online: 9 July 2009  
 © Springer-Verlag 2009

## Remote sensing applications to geological problems in Egypt: case study, slope instability investigation, Sharm El-Sheikh/Ras-Nasrani Area, Southern Sinai

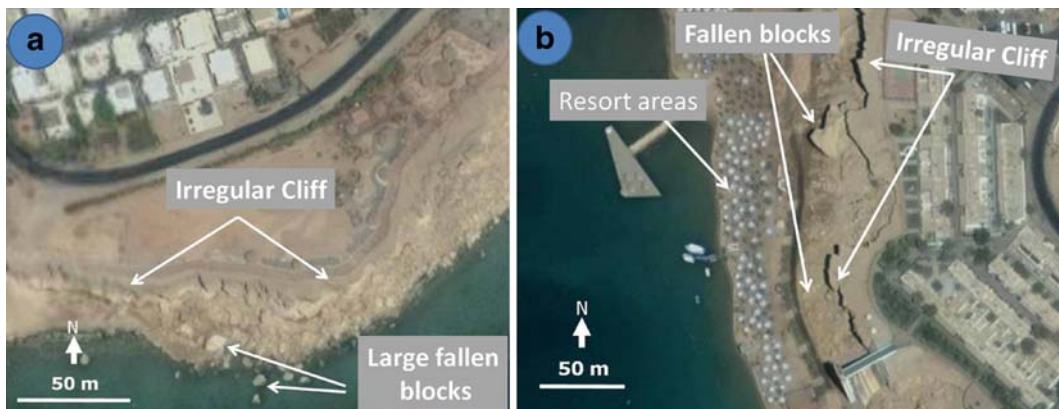
**Fig. 3** High-resolution image (QuickBird acquired on June 2nd, 2007 with 61 cm spatial resolution) showing a portion of cliff in the study area. **a** The presence of large boulders under the irregular cliff. **b** The distribution of resort areas under an

unstable irregular cliff. Note the distribution of the urban areas and the green (irrigated) fields that may increase the potential for slope instability due to problems of water seepage and increased pore pressures

steep slopes and rockfalls from remote sensing imagery is a major challenge. In this study, the high-resolution images were used. This allowed us to detect where buildings, beaches, and traffic routes could be affected by rock falls and/or slides. Endangered areas were thus identified. For mapping the endangered zones, the high-resolution satellite images (QuikBird) were an excellent means and visualization tool. They can replace topographic maps at the scale of 1:2,000 (Fig. 3).

Visual inspection of these images in the GIS environment helped us to detect the fallen blocks and the irregular cliffs that indicate instability (Fig. 3). Generation of a hazard map for the study area was based on two main factors: (1) the presence of irregular cliffs and (2) the presence of fallen blocks that could be recognized from the high-resolution satellite images (as shown in Fig. 3). These considerations result in a hazard rating (red zone) for the instability areas.
