Landslides (2011) 8:49–65  
 DOI 10.1007/s10346-010-0237-5  
 Received: 10 November 2009  
 Accepted: 19 July 2010  
 Published online: 12 August 2010  
 © Springer-Verlag 2010

## Mechanism on apparent dip sliding of oblique inclined bedding rockslide at Jiweishan, Chongqing, China

**Abstract** Because of the existence of a front stable rockmass barrier, the failure pattern of an oblique inclined bedding slope is conventionally recognized as a lateral rockfall/topple, and then a transformation into a rockfall accumulation secondary landslide. However, the Jiweishan rockslide, Wulong, Chongqing, which occurred on June 5, 2009, illustrates a new failure pattern of massive rock slope that rockmass rapidly slides along apparent dip, and then transforms into a long runout rock avalanche (fragment flow). This paper analyzes the mechanism of the new failure pattern which is most likely triggered by gravity, karstification, and the processes associated with mining activities. A simulation of the failure processes is shown, using the modeling software, FLAC<sup>3D</sup>. The results show that there are five principal conditions for an apparent dip slide associated with an oblique inclined

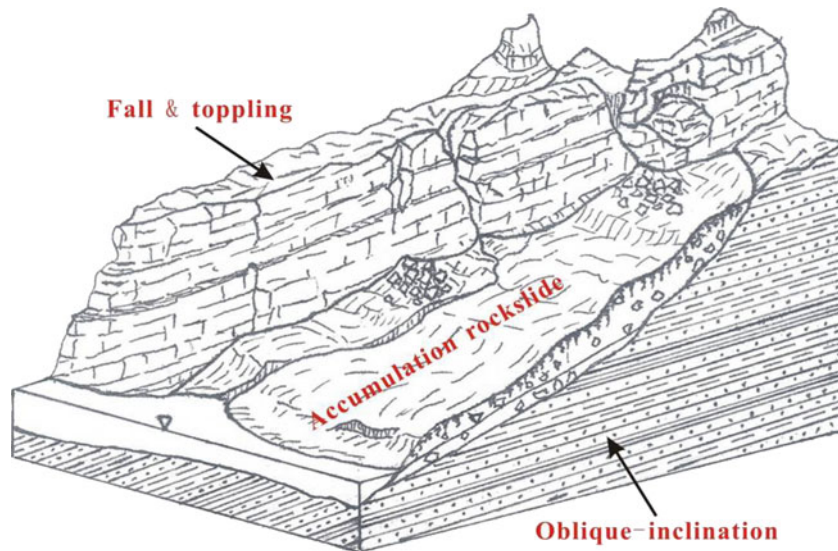
**Fig. 1** Schematic diagram shown oblique inclined bedding slope

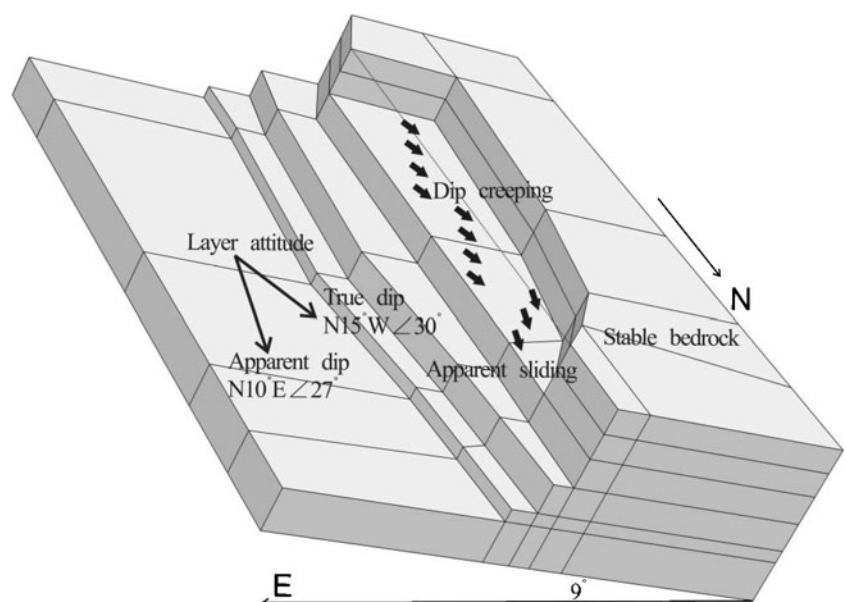
**Fig. 3** Deflected angle between true dip and apparent dip of oblique inclined bedding slope

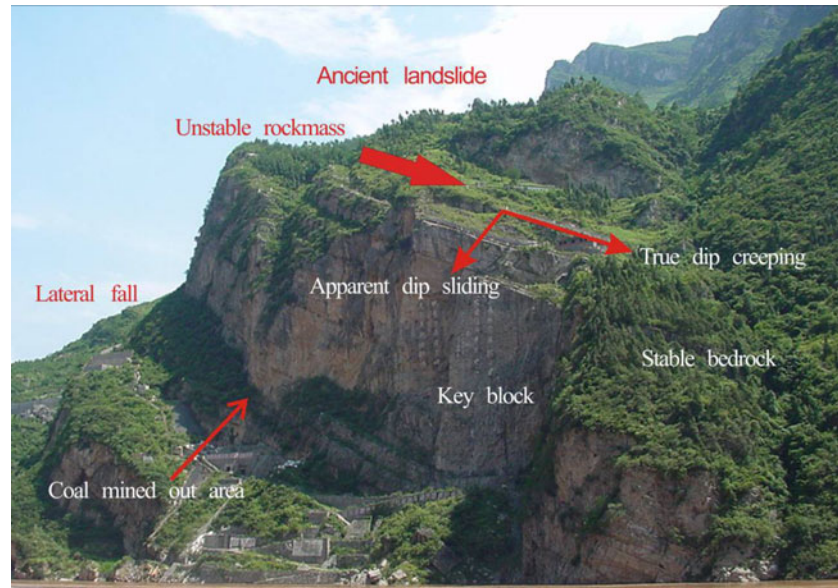
**Fig. 4** Oblique inclined bedding slope of the Lianziya at the Three Gorges (Colluvial landslide is formed by lateral rockfall)

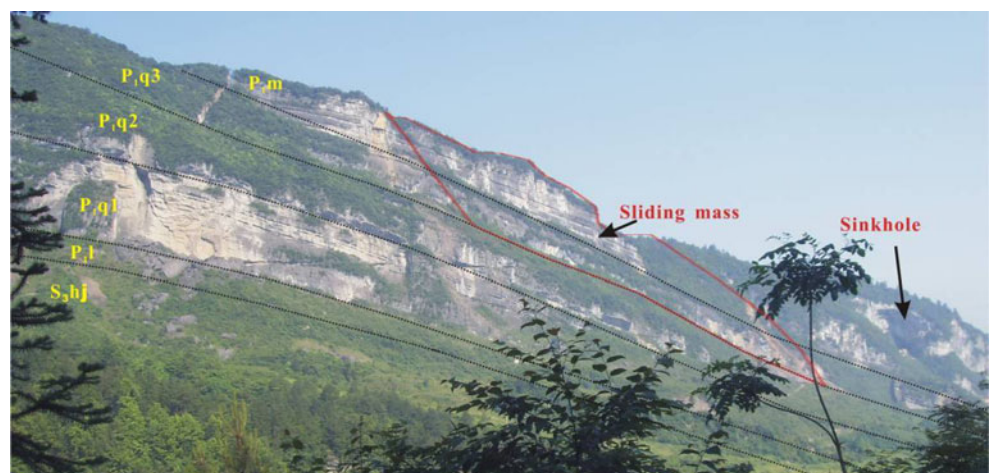
**Fig. 5** Overview of formation of the Jiweishan Hill (5 h before sliding)

P,m- Limestone of Maokou Group; P,q3 Limestone of Upper Qixia Group; P,q2- Limestone of Middle Qixia Group; P,q1 Limestone of Lower Qixia Group; P,l- Ore bed of Liangshan Group; S,bj Sand shale of Hanjadian Group.

The structure of the slope in the Jiweishan Hill is the same as the above mentioned slope (Fig. 7, see also in Fig. 5). The detailed descriptions for formation of The Jiweishan Hill from top to bottom are as follows:

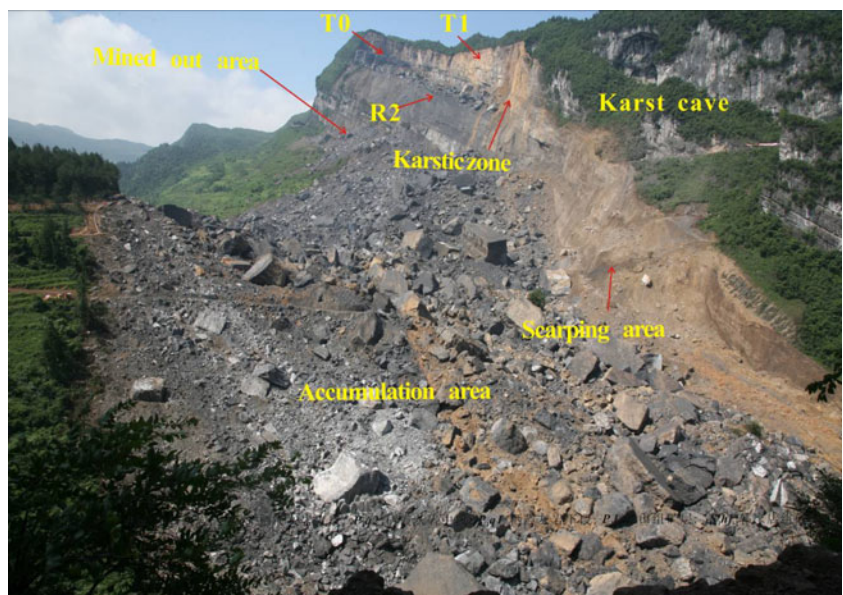
**Fig. 7** Apparent sliding of the massive rock slope along inclined bedding slope

Figure 7 indicates that the Jiweishan Hill is a cuesta, with a height difference of 450 m and a slope gradient of 20~40°. The attitude of bedrock is N 75° E/345°<21~35° with intercalations of multi-layered carbon or argillaceous shale.

The sliding rockmass of Jiweishan Hill was separated from the parent bedrock by two wide karstified fractures containing small caves infilled with clay materials and a sliding plane: the rear boundary was Crack T0, the western boundary was Crack T1, and the bottom soft layer was located at R2 (Fig. 7).

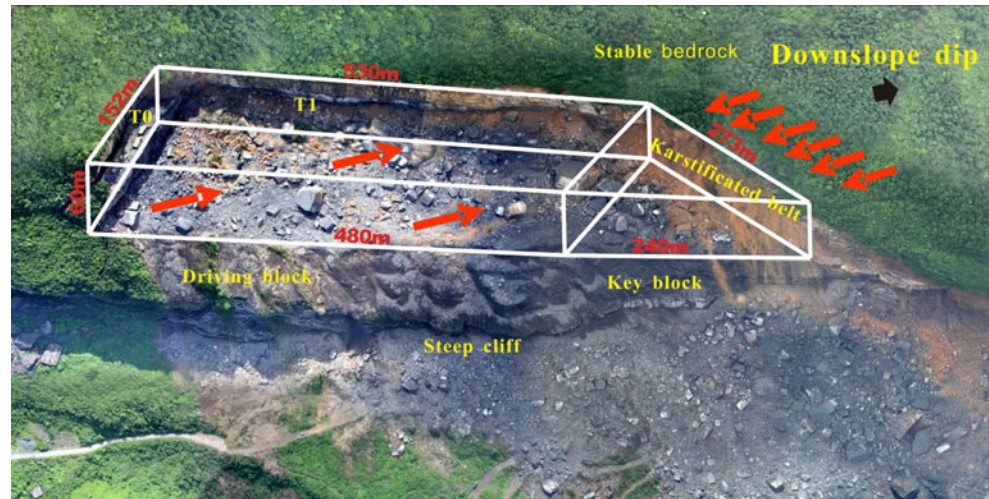
**Fig. 8** Geological model of the sliding mass of the Jiweishan rockslide (before exiting)

The Jiweishan rockslide had the same structure pattern. The sliding rockmass before it began to move was similar to the prismatic body with a maximum length of 720 m, a width of 152 m, a thickness of 60 m, and a volume of 5 million m<sup>3</sup>. The prismatic-body-shaped sliding rockmass could be divided into the rectangular-solid-shaped “driving block” and the triangular-prism-shaped “resisting key block” (Fig. 8).

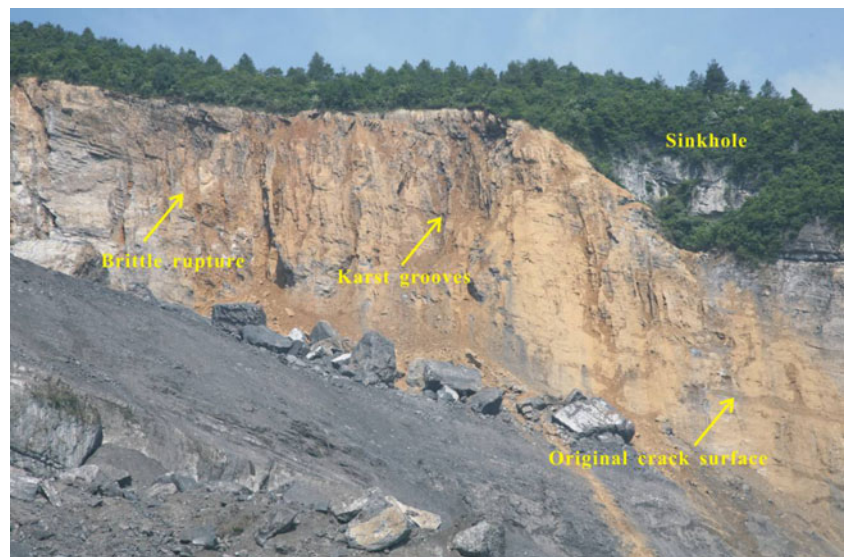
**Fig. 9** Karstified zone and brittle rupture surface at the side of key block (remanted after sliding)

The resisting key block and the lateral stable bedrock were not separated thoroughly due to the fact that Crack T<sub>1</sub> gradually faded away towards the north and turned towards the karstified zone with a direction of N 21° E from north and a length of 273 m where the vertical karst pipes, sink holes, and fissures were located. The maximum diameter of the karst pipes was over 3 m and the voids were filled with brown-yellow residual clay. An accumulated width of karst pipes was about 165 m that indicated the ratio of the solution space length (165 m) and total length of the karstified zone (273 m) in horizontal was over 60%, i.e., only 40% limestone remained to be connected (Fig. 9).

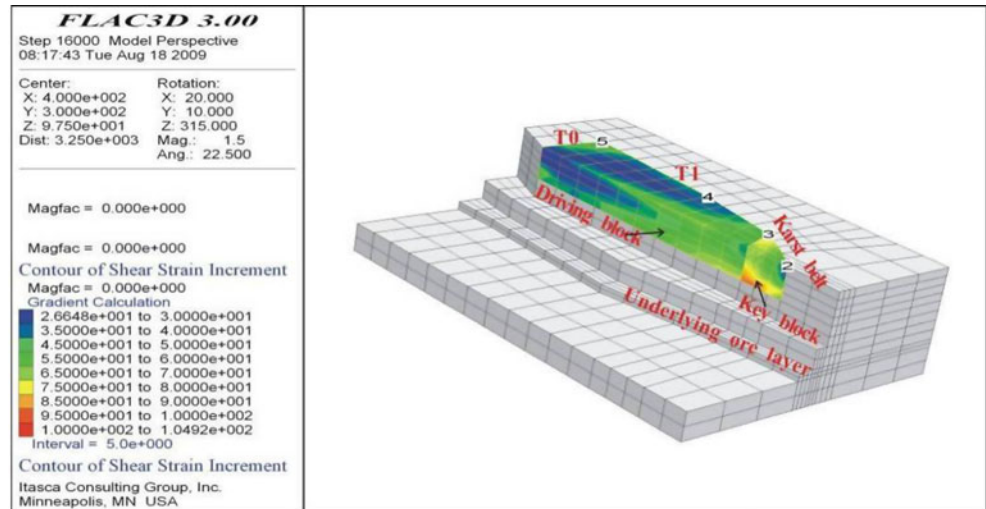
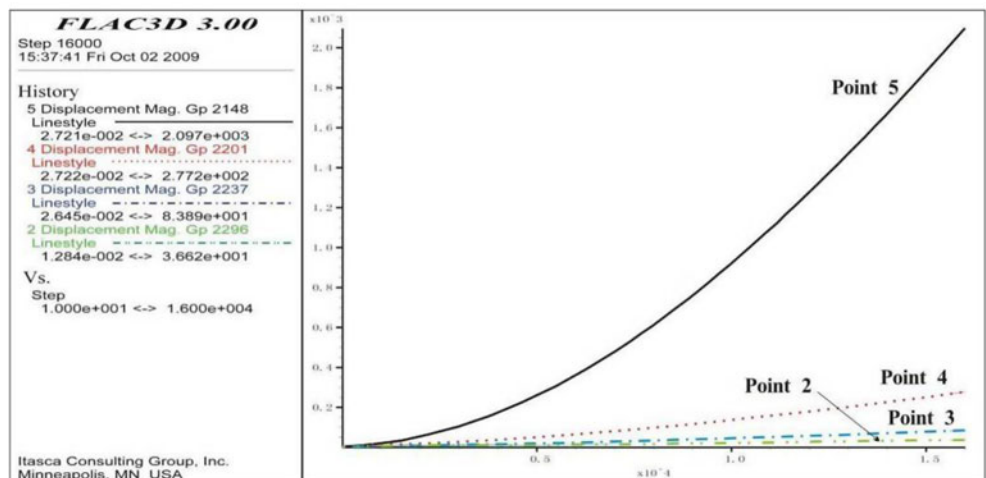
**Fig. 10 a–c** Simulation results of shear strain increment and velocity under nature condition

**(a)** Contour of shear strain increment

**(b)** Contour of velocity magnitude (mm/s)

**(c)** Displacement for points 2, 3, 4 and 5 (mm)

The rockmass creep is simulated along the R2 soft layer with the attitude of N 15° W <21~35° under natural conditions. According to the study on shear strength of the Lianziya unstable rockmass, the peak friction angle for the soft layer is about 30.1°, and the cohesive strength is 280 kPa. Figure 10a indicates the maximum shear strain increment occurs at the bottom sliding surface of the key block, with a value of 100~105, and the maximum value zone of velocity nephogram appears on the top of the key block and at the bottom of the sliding mass adjacent to crack T<sub>0</sub>, with the maximum velocity of 1.50~1.56 mm/s. Figure 10b shows that the

displacement direction is changed from N 15° W to NNE–NE. From Fig. 10c, we can see that the displacements of points 2#, 3#, 4#, and 5# are 10, 25, 100, and 600 mm, respectively, and it shows that displacement of the rear mass (point 5#) amounts to 60 times more than the one in the front part of the mass (point 2#). The displacement result indicates that the rear block is driving and the front block is resisting.

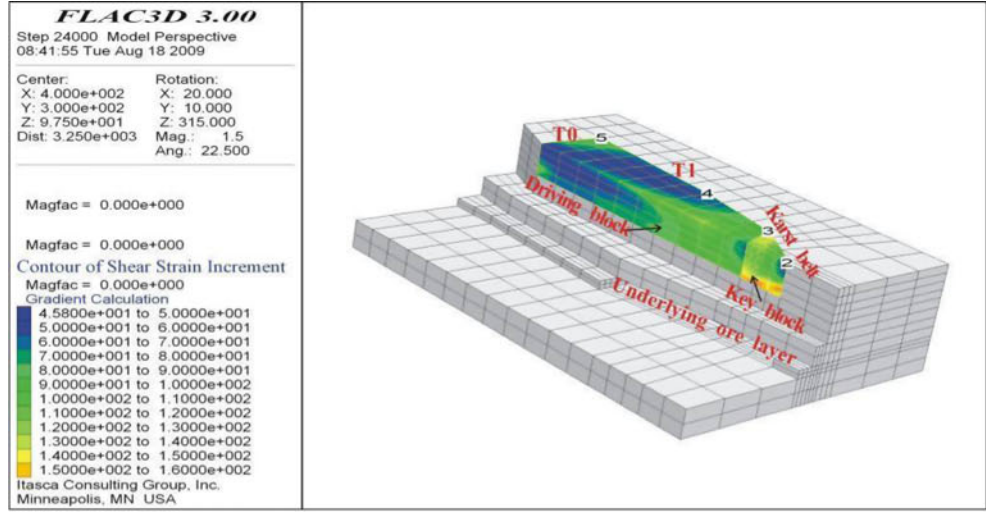
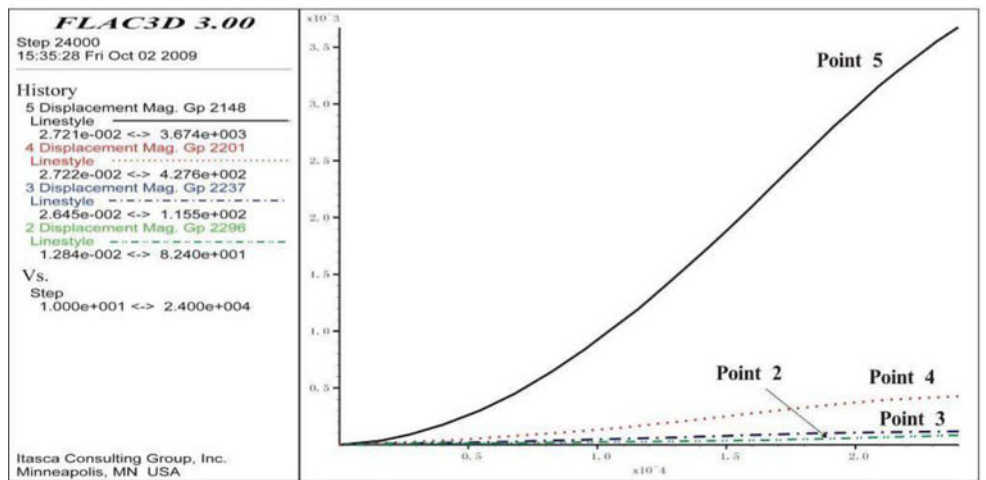
Fig. 11 a–c Simulation results of shear strain increment and velocity under mining condition

(a) Contour of shear strain increment

(b) Contour of velocity magnitude (mm/s)

(c) Displacement for points 2, 3, 4 and 5 (mm)

The disturbance on stress and deformation of the rockmass is simulated under long-term mining condition for iron ore underneath the cliff. According to the characteristics of FLAC<sup>3D</sup>, the mined-out area, i.e., tunnel and gob, is setup by a null material model. The maximum shear strain increment is still located at the bottom sliding surface of the key block, but the value is increased to 150~160 (Fig. 11a); the maximum velocity on the top of the key block and at the bottom of the sliding mass adjacent to crack T<sub>0</sub> is enhanced to 2.00~2.10 mm/s. The general displacement direction is NNE–NE (Fig. 11b). However, compared to that in a natural condition, the downward displacement component is increased greatly, and at the front edge of the key block especially, the downward displacement vector is nearly vertical, which indicates

the failure character. Figure 11c shows that the displacements of points #2, #3, #4, and #5 are 50, 100, 450, and 3,600 mm, respectively, indicating that the displacement of the rear mass (point #5) amounts to 72 times the one in the front mass (point #2). Similarly, the displacement result indicates that the rear block is driving and the front block is resisting. Compared with the one in the natural condition, the displacement at the driving block is increased from 600 to 3,600 mm, but the displacement at the resisting key block is not obvious. Therefore, we can conclude that the sliding force of the driving block is increasing step by step, and the strain energy of the key block is accumulating gradually.

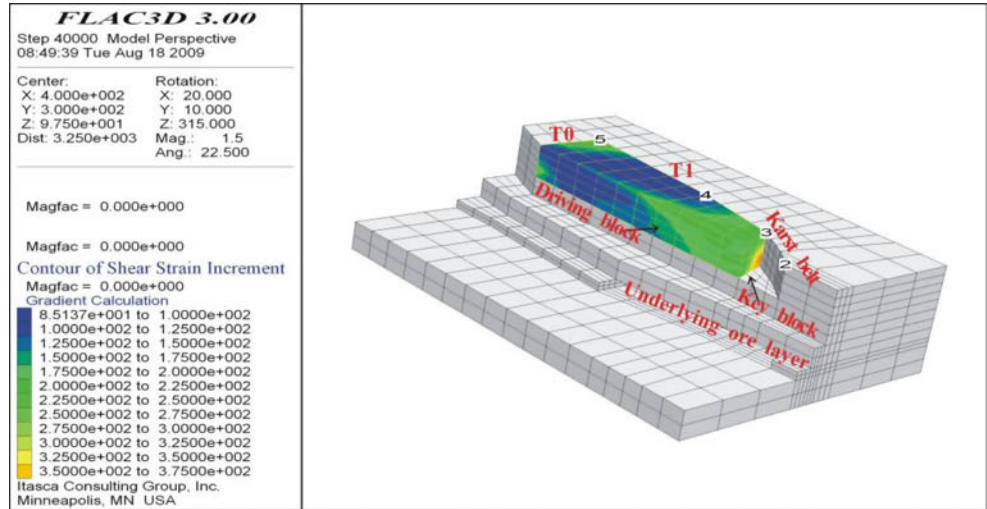
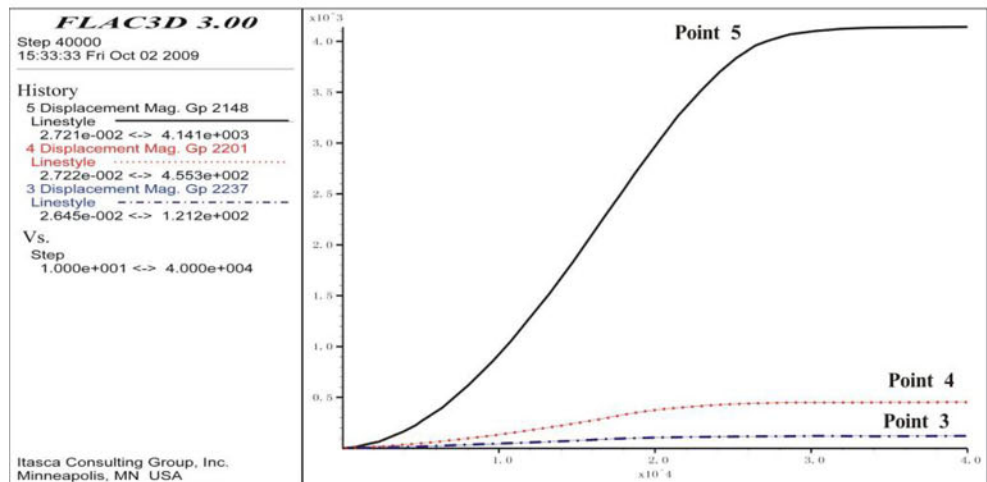
**Fig. 12 a–c** Simulation results of shear strain increment and velocity under key block sudden failure condition

**(a)** Contour of shear strain increment

**(b)** Contour of velocity magnitude (mm/s)

**(c)** Displacement for points 3, 4 and 5 (mm)

The deformation and translational slide of the driving block with a volume of 4.8 million m<sup>3</sup> is simulated assuming the instantaneous brittle failure of the resistant key block along the karstified zone due to the overwhelming driving force from the back. The key block falls suddenly and the front edge of the driving block loses its support (Fig. 12a). The simulation shows that the maximum shear strain increment zone is generated at the front edge of crack T<sub>1</sub>, with the value of 350~375 and the distinct high-velocity zone appears at the front edge of the driving block, with the value of 2.80~2.98 mm/s. The sliding direction for the driving block mass is mainly NNE and the vertical displacement is obscure (Fig. 12b). The displacements for points #3, #4, and #5, with the value of 200, 480, and 4,500 mm, respectively, that show displacement at the rear of the driving block (point #5) amounts to 25 times greater than the one in the front of the driving block (point #3; Fig. 12c). The simulated result of displacement also indicates that the rear block is exerting force. Field investigation indicates that, a few days before the occurrence of The Jiweishan rockslide–rock avalanche, obvious compression bulges and local falls with thousands of cubic meters in volume were generated in the key block. The simulation result above is seems to closely coincide with the real situation (Fig. 13).

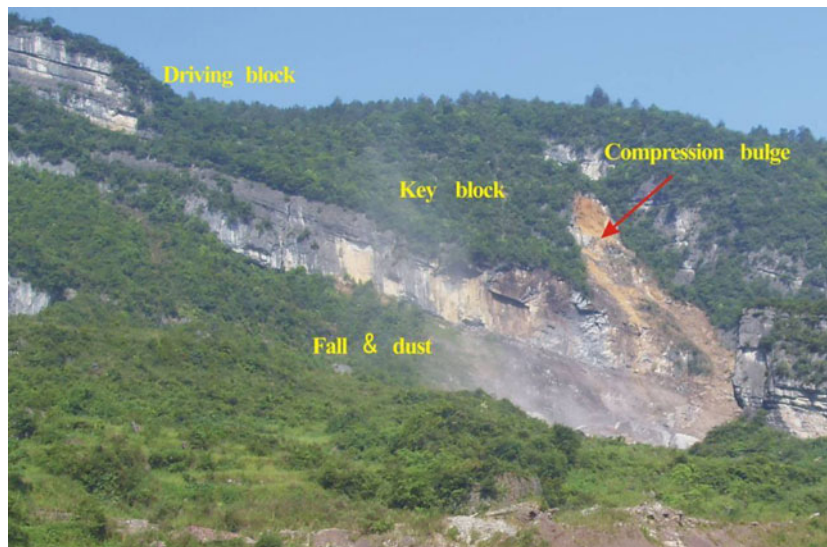
**Fig. 13** Front bulge and fall of resisting key block (5 h before sliding)

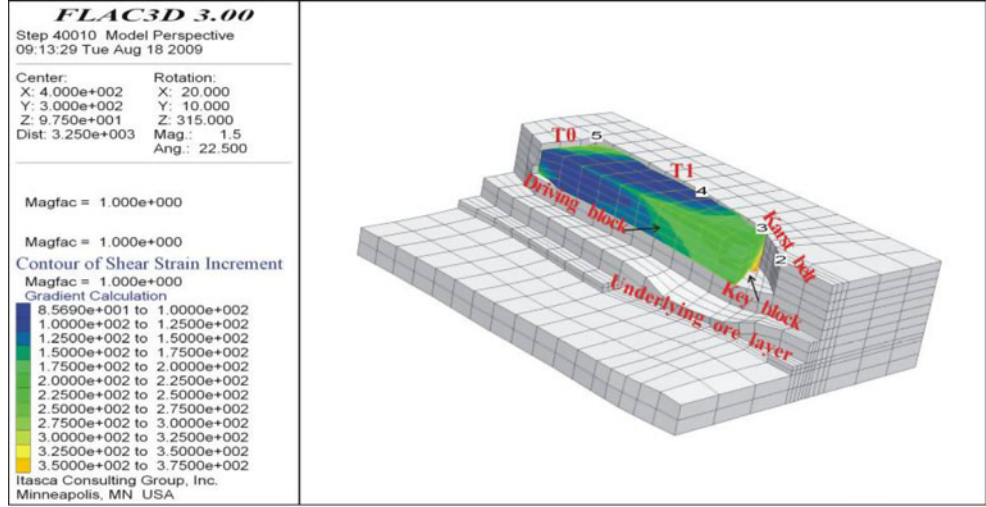
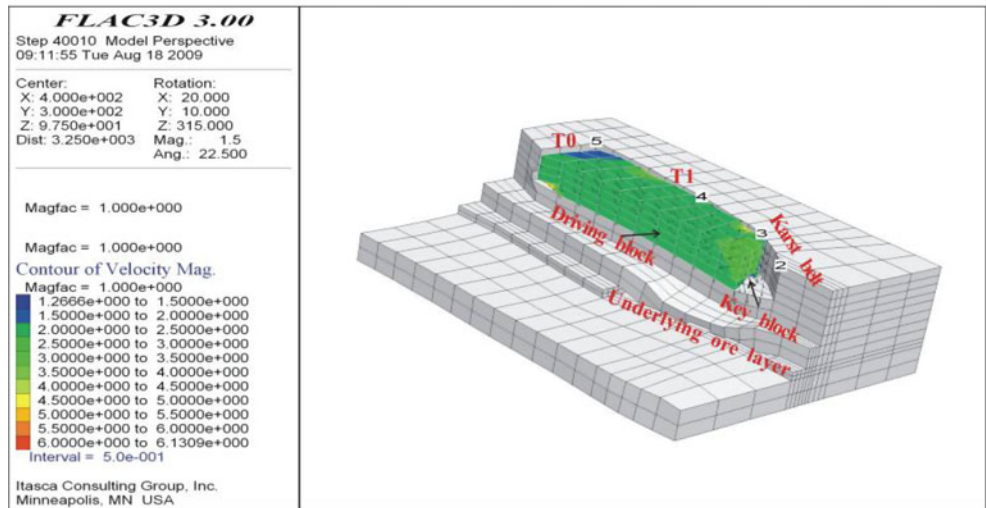
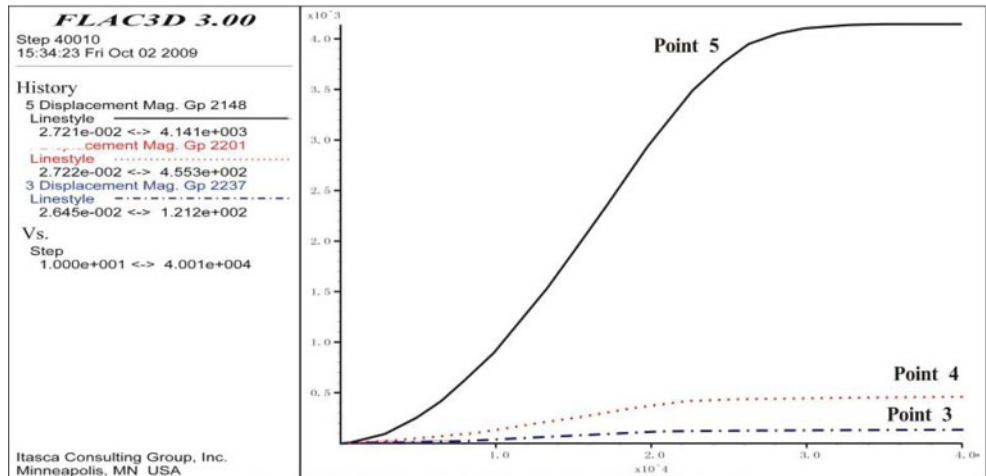
Fig. 14 a–c Simulation results of shear strain increment and velocity under large sliding condition

(a) Contour of shear strain increment

(b) Contour of velocity magnitude (mm/s)

(c) Displacement for points 3, 4 and 5 (mm)

Without the support by the resisting key block, the driving block with a volume of 4.8 million m<sup>3</sup> rapidly slid and it dragged the

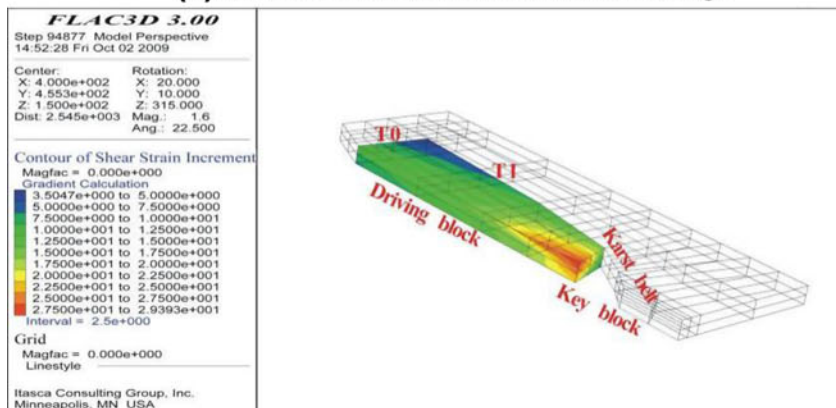
Fig. 15 a–d Simulation results of shear strain increment under 2D lateral sliding condition

(a) Contour of shear strain increment at initial stage

(b) Contour of shear strain increment at creep stage

(c) Contour of shear strain increment at critical stage

(d) Contour of shear strain increment at failure stage

The computed results for FOS under the same four conditions as the above 3D simulation are: the natural evolution condition, the mining-disturbed condition, the key block failure condition, and the large deformation sliding condition, and are listed in Table 4. This represents the resistant sliding processing of the crack T1 and the key block on the rockslide. When the key block failure instantaneously occurs, the sliding direction is deflected to NE and the anti-sliding force is almost zero (Fig. 15 and Table 4). It is worth pointing out that the computed FOS factor for the rockslide here could not be represented as the conventional FOS due to the missing of slide-resistant force on the bottom sliding plane in which the component acceleration ( $g_v$ ) on the bottom soft layer should be 0.866g, i.e.,  $g_v = g \times \sin 60^\circ = 0.866g$ .

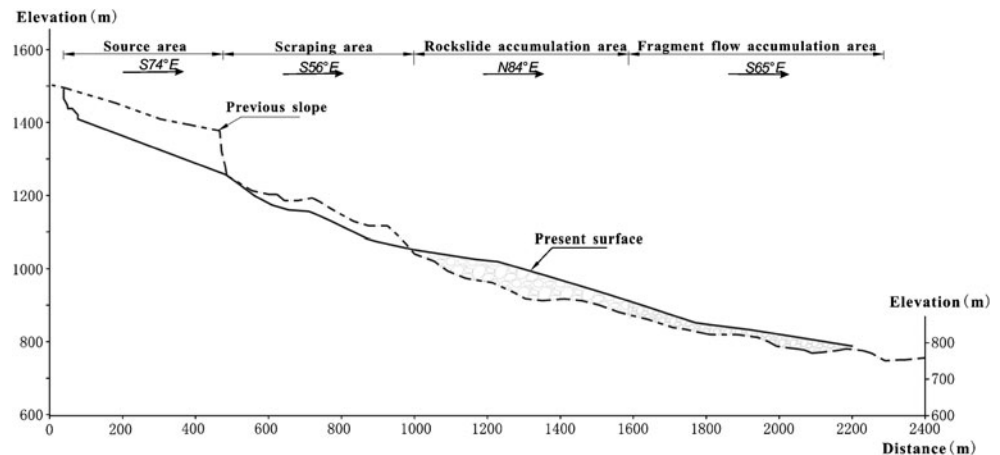
**Fig. 17** Profile map of the Jiweishan rockslide–rock avalanche (fragment flow)
