## Research on catastrophic rock avalanche at Guanling, Guizhou, China

**Abstract** On June 28, 2010, a catastrophic rock avalanche occurred after an extreme rainstorm at Guanling with N 25°59'10" in latitude and E 105°16'50" in longitude, Guizhou, China. This rock avalanche has a long run-out distance of 1.5 km, with 1.75 million cubic meters of debris instantly burying two villages and resulting in 99 deaths. It originated in the coal measure strata, with the upper part of limestone and dolomite, the middle part of the sandstone with gentle inclination, and the lower part of shale and mudstone, together locally with coals. This kind of unique structure, with hard resistant caprock overlying softer ductile rocks, coupled with the central outflow region at the contact zone, has catastrophic potential for rock avalanches and creates challenges for engineering geological/hydrogeological analysis. The topography showed that the hillside slopes were steeper at the upper portion but gentler in the lower portion, looked like the shape of a "boot." The upper steep landform easily led to slope instability due to its high static shear stresses, and the wide middle and lower parts provided

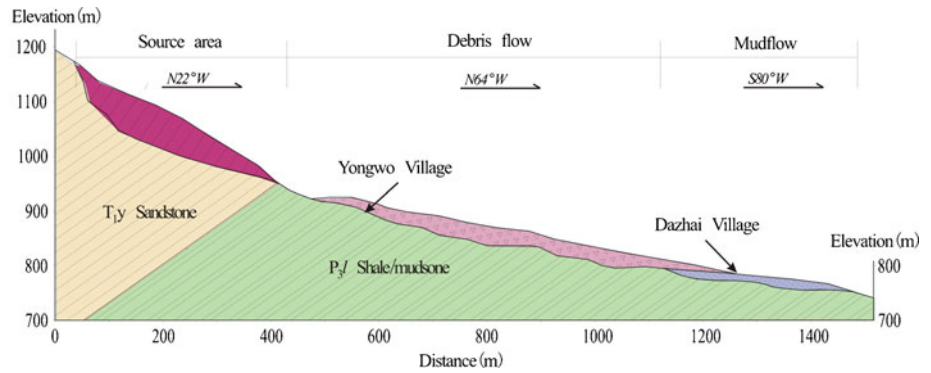
**Fig. 6** Cross-sectional profile of rockslide-debris flow at Dazhai, Guanling, Guizhou

Based on the geometrical relationship in Fig. 6, the effective friction angle is about  $16^\circ$ , so, the velocity when the slide mass reached Dazhai Village is estimated to be 10.76 m/s ( $H = 350 \text{ m}, L = 1200 \text{ m}$ ).

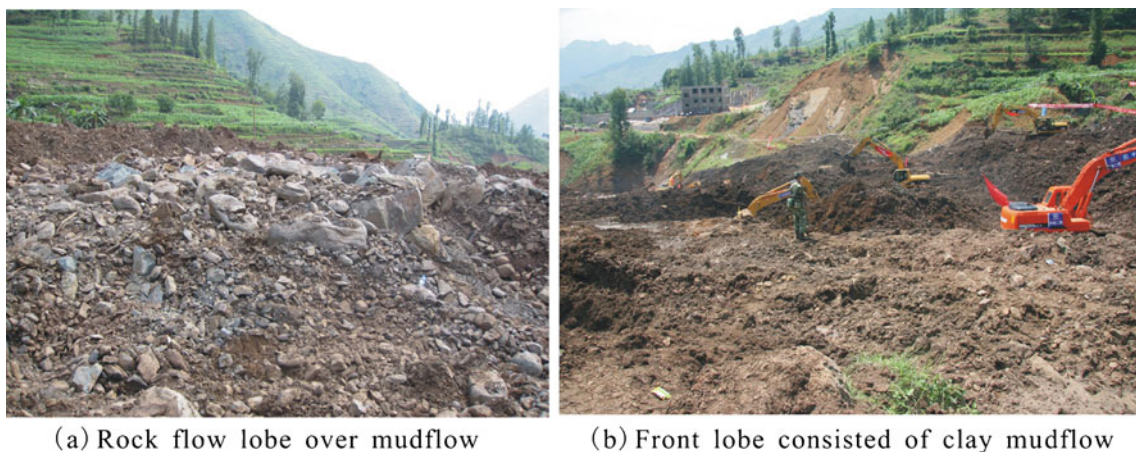
**Fig. 9** Features of the front deposit structure of the mudflow, Dazhai

- (3) The mudflow area. This area has a volume of 0.1 million cubic meters, a thickness of 5 m, a width of 100 m, and a length of 200 m. The middle part of the valley is overlapped by the debris flow with a general thickness of 1 m and clays distributed at the two sides. The cobbles and boulders in this area had rounded features, which is different from that in the debris flow area. It indicates that the mudflow happened in the early stage of movement (Fig. 9a). Investigation shows that the lower part mainly consists of clays with a few cobbles and boulders. Because of high water content, a mudflow formed at the front edge (Fig. 9b).

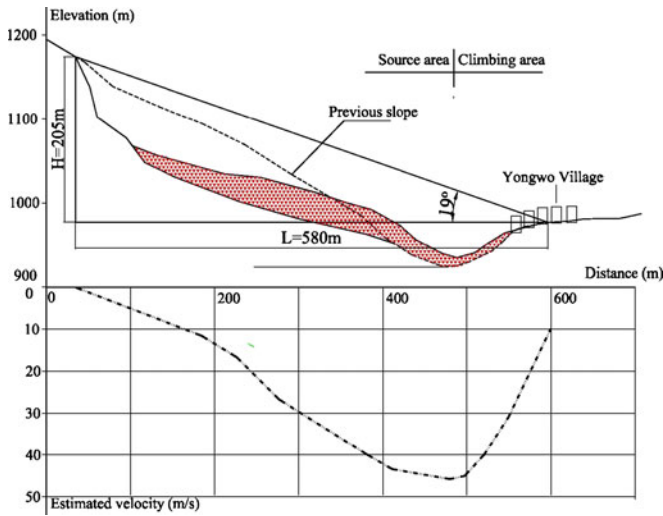
Accordingly, the estimated velocity at the toe of the surface of rupture is 44.84 m/s. When the slide mass reached the valley bottom, a peak estimated velocity is generated with the value of 45.24 m/s. Obstructed by the front furrow bank, the estimated velocity is decreased to 31.42 m/s at the lower part of Yongwo Village. After rising up for 43 m, the slide mass reached Yongwo Village and destroyed houses with an estimated velocity of 10.18 m/s (Table 1, Fig. 11).

**Fig. 11** Geometry of the Dazhai rockslide and velocity at the stage of sliding downward and climbing

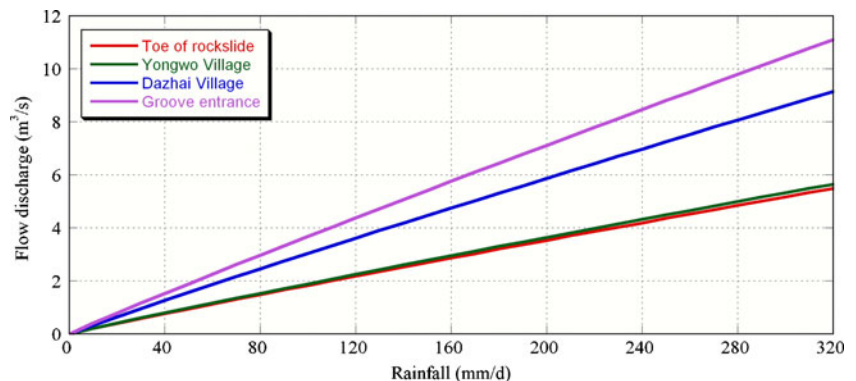
Figure 2 shows that the mean rainfall in June was 309 mm/month, i.e., 10 mm/day. If the maximum rainfall is 100 mm/day, then the flows of the abovementioned four cross sections will be 1.84, 1.9, 3.05, and 3.69 m<sup>3</sup>/s, respectively. If the rainfall is 150 mm/day, the flows will be 2.7, 2.79, 4.48, and 5.42 m<sup>3</sup>/s, respectively (Fig. 13).

**Fig. 13** Relationship between daily rainfall and flow of the gully of the Dazhai rockslide-debris flow

The above analysis indicates that the runoff flow from June 27 to 28 is two times that of the usual rainfall (100–150 mm/day), which resulted in the obvious increase of flow distance and velocity of debris. At the same time, because of the increased flow, the old deposits (limestone blocks) at the rockslide toe could have been eroded, which might have contributed to the slope instability.
