Landslides (2012) 9:117–130  
 DOI 10.1007/s10346-011-0277-5  
 Received: 20 May 2010  
 Accepted: 30 May 2011  
 Published online: 11 June 2011  
 © Springer-Verlag 2011

## Kinematics of the Cerca del Cielo, Puerto Rico landslide derived from GPS observations

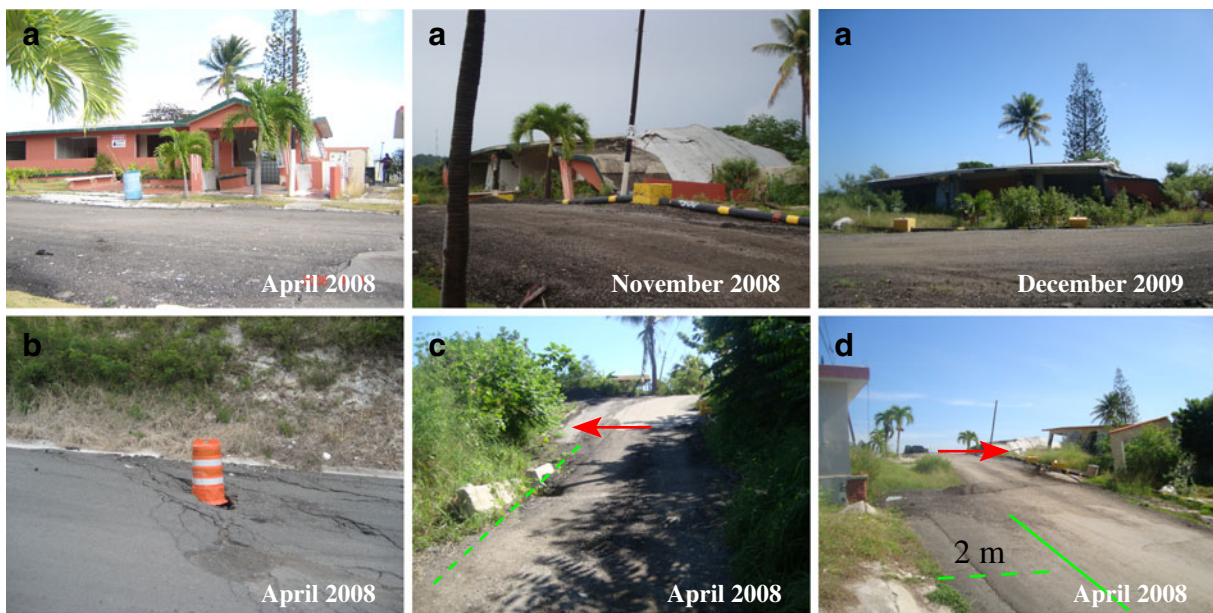
**Fig. 2** Buildings and roads destroyed by the continuous movement of the landslide. Photo locations are marked in Fig. 1

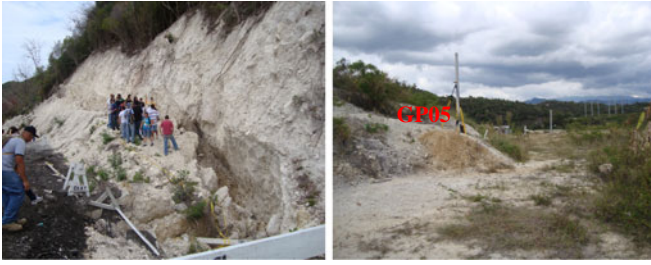
**Fig. 3** Photos showing the head scarp (left) and the toe area (right) of the landslide

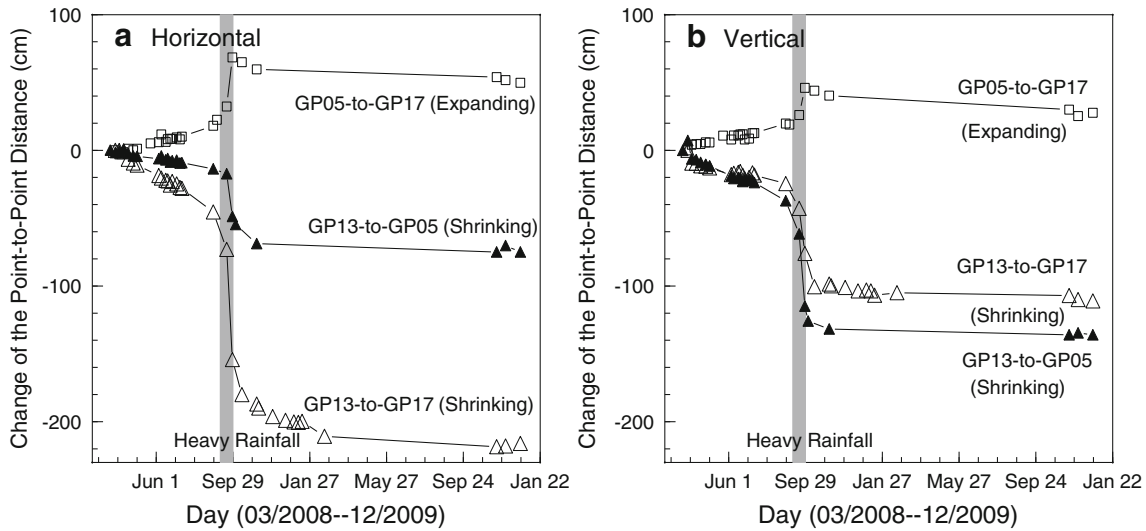
**Fig. 8** Plots showing the changes in the size of the sliding mass during the time span of March 2008 to December 2009. The distances between head benchmark GPS13 and two toe benchmarks GP05 and GP17 were increased, while the distances between the two toe benchmarks were decreased

The sliding mass showed well-defined zones of depletion and accumulation. The depletion zone (the head area) was characterized by minor scarps and several traverse cracks. The accumulation zone (the toe area) was characterized by horizontal spreading and vertical rising. Kinematic heterogeneities in the landslide body were recognized by displacement vectors illustrated in Fig. 6. Figure 8 illustrates the changes in benchmark-to-benchmark distances between one head benchmark (GP13) and two toe benchmarks (GP05 and GP17) during the time span of

March 2008 to December 2009. The distances between the head benchmark GP13 and the two toe benchmarks GP17 and GP05 were reduced by 2 and 0.7 m horizontally and 1.3 and 1 m vertically, which indicated shrinking of the landslide in the sliding direction. The distance between the two toe benchmarks, GP05 and GP17, increased by 0.8 m horizontally and 0.3 m vertically during the time span, which indicated extension of the toe area.

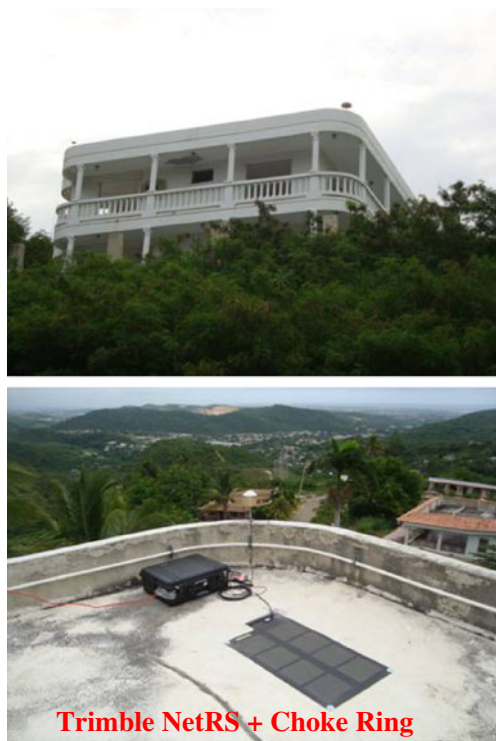
**Fig. 10** The continuous GPS station on the two story building at the head of the landslide. The GPS station was equipped with a Trimble NetRS GPS receiver and a choke ring antenna. The GPS receiver was powered by a battery charged by solar power

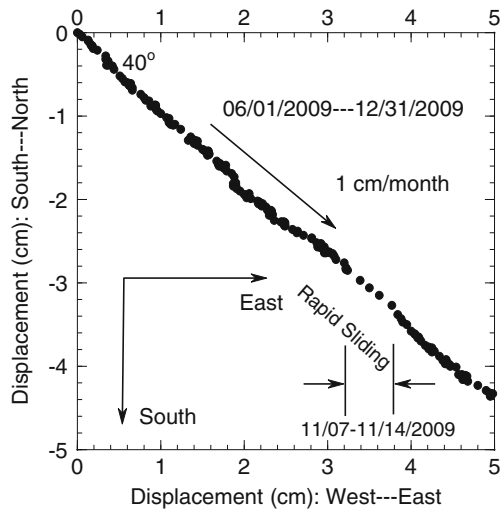
**Fig. 12** The horizontal sliding track of the landslide derived from the continuous movements illustrated in Fig. 11. The total horizontal displacement was about 6.5 cm (0.9 cm/month)

Figure 12 shows the horizontal sliding vector of the continuous GPS antenna during the time range of June to

December 2009. It shows a steady movement to the southeast ( $40^\circ$ ). The rapid movement induced by the prolonged moderate rainfall in November 2009 did not affect the sliding direction. The total horizontal displacement was about 6.5 cm (0.9 cm/month), far less than during the same period in 2008. The total displacement in the latter half of 2008 was about 2 m horizontally and 1 m vertically (Fig. 5). The slower movement in 2009 was largely correlated to decreased rainfall during the year. Figure 13 shows the rainfall data recorded by the USGS meteorological station during the years 2008 and 2009. The total rainfall during 2009 was only about 60% of the total rainfall occurring in 2008. Note that the total rainfall recorded by the rain gauge at the landslide site during 2009 (Fig. 11) was slightly larger than that recorded by the USGS weather station. Due to topography effects, rainfall varies greatly across the island. The average annual rainfall on the southern coast of Puerto Rico is close to 100 cm (The Climate Source Inc 2002; Larsen and Webb 2009). The total rainfall in 2009 was about 85 cm, slightly below average.
