Accumulation characteristics, mechanism, and identification of an ancient translational landslide in China

Keywords Reservoir · Qinghai–Tibet Plateau · Dadu River · Accumulation characteristics · Translational sliding · Mechanism · Identification

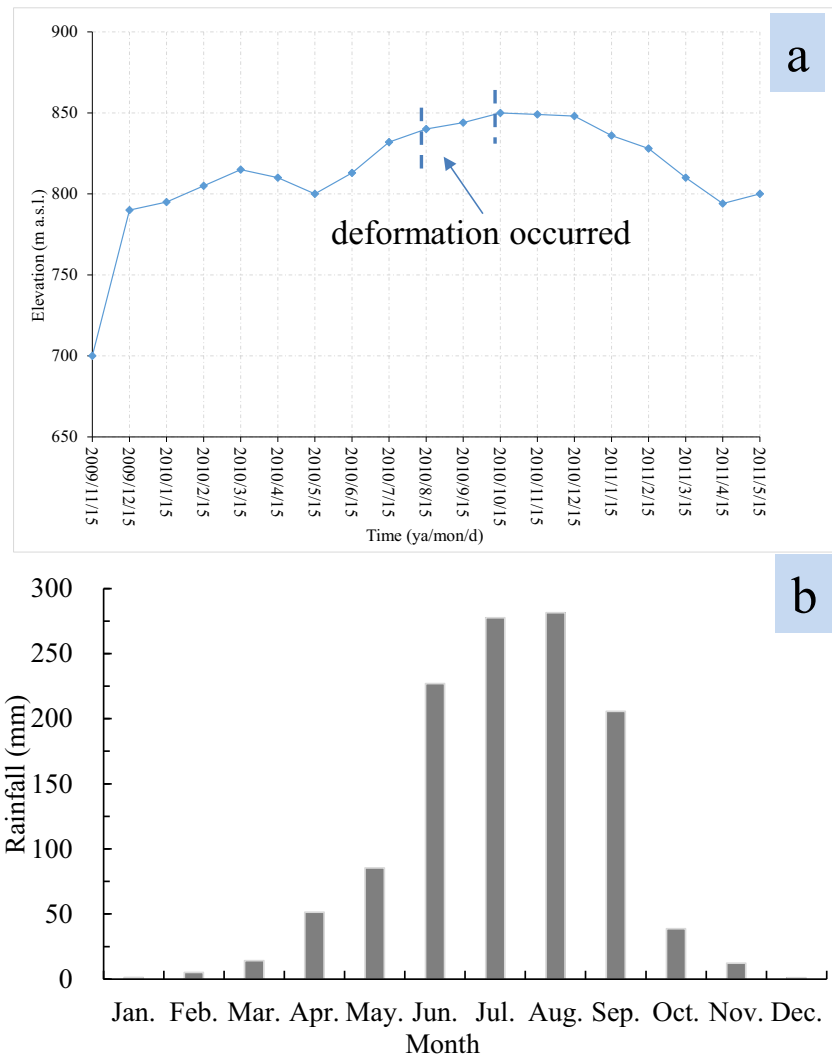
Fig. 2 a Variation of water level of reservoir in the first year. When the water level rose to 840 m a.s.l. at Aug 15, 2010, the deformation occurred in the west part of the accumulation, including tilted buildings and subsidence of ground. **b** Distribution of monthly average precipitation per year. Most of the precipitation concentrates in June to September, accounting for about 82.6 % of a year

The Pubugou reservoir started water filling on November 1, 2009, and increased to 850 m a.s.l. on October 13, 2010 (Fig. 2a). When the water level increased to 840 m a.s.l. on August 15, 2010, deformation occurred in the western part of the accumulation; e.g., buildings were tilted and ground subsided. The climate in the landslide area is subtropical monsoon, with an annual average rainfall of 1,200.9 mm. Thus, rainfall is always concentrated in June to September every year, which accounts for approximately 82.6 % of the total annual rainfall in this period, as shown in Fig. 2b.

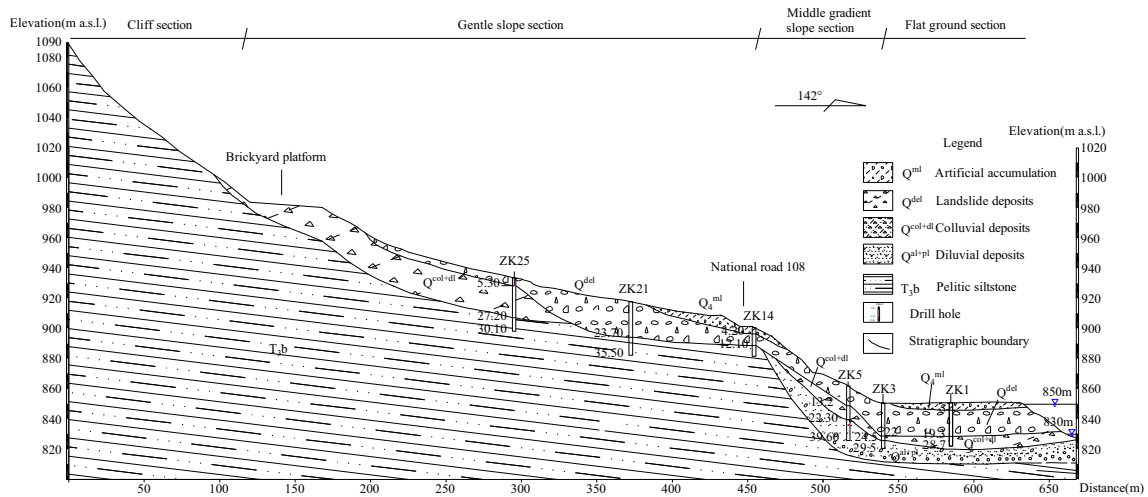
Fig. 4 Profile I-I'. A thin layer of particulate particles is on the top, and the medium is a layer containing abundant giant rock. Four sections of slope gradient are clearly seen

Located upstream of the landslide, zone A is a low-lying northward depression. The elevation of the front edge is approximately 840 m a.s.l. (covered in water), and that of the trailing edge is 990 m a.s.l. The height difference is 150 m. Zone A is approximately 550 m long and 350 m wide. This zone has an area of $20.3 \times 10^4 \text{ m}^2$, a volume of $324.8 \times 10^4 \text{ m}^3$, and an average thickness of 16 m. The western border of zone A coincides with the ancient landslide, and the eastern border is at the junction of Shuangjiaping village and the flat ground of brick factory. The northern boundary is the flat ground of brick factory, which coincides with the trailing edge of the entire landslide, and the front edge reaches the water level. The cross section of zone A is shown in Fig. 4, in which the material structure could be clarified.

In terms of structure, zone A is composed of loose sediments with an uneven thickness of 20 to 30 m. Owing to excavation, the thickness near G108 is 10 to 15 m (see Fig. 4). The site survey and drilling data reveal that the upper section is a thin layer of gravels, breccia particles, and sand. The landslide deposits in the middle are mainly composed of large stones that are 1 to 3-m diameter (Fig. 5) and gravelly soil. The lower section is composed of grayish yellow silt clay with 20 to 30 % gravels, which are commonly angular to sub-angular and have diameters of 2 to 7 cm. The

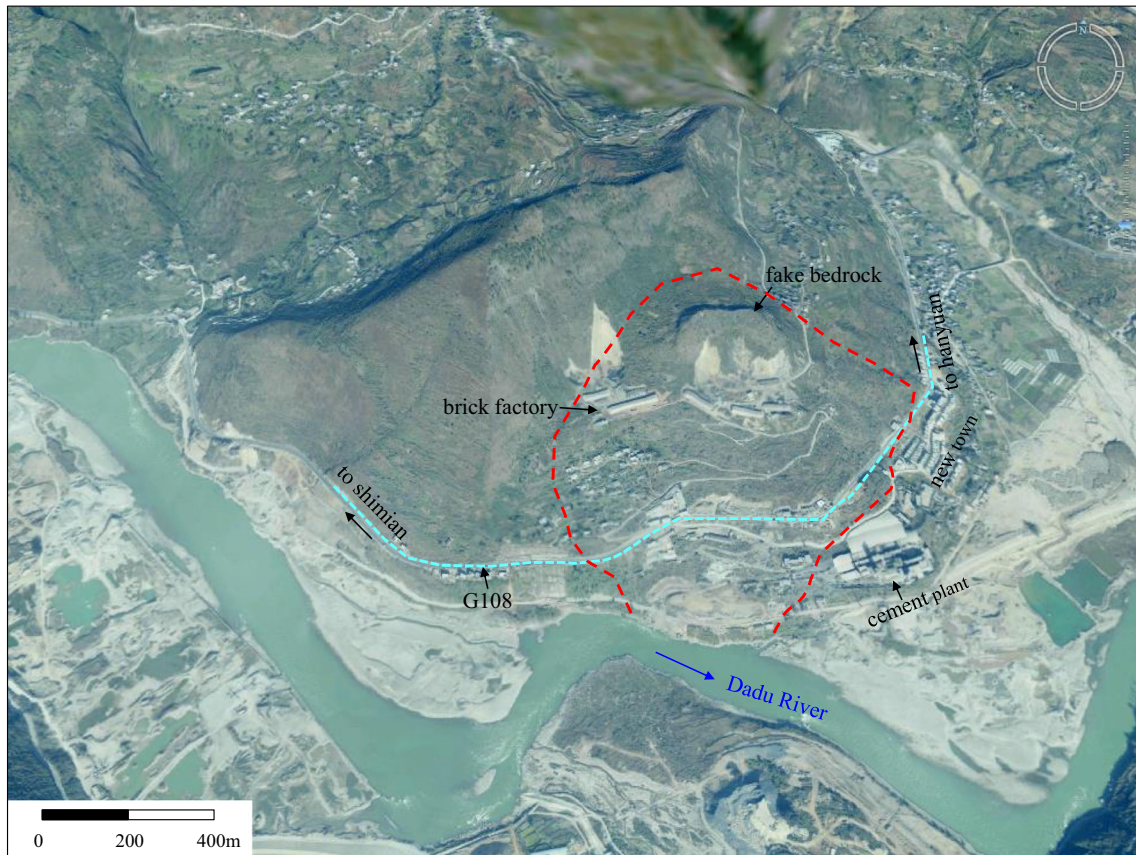
Fig. 5 Aerial image of landslide area, the gentle topography of landslide area, and isolate rock mass are both clearly observed

can be divided into four sections: the cliff section, which is from the peak of the Liangtai Mountain to the brick factory flat ground, with a slope gradient of 40° to 60° and exposed bedrock, the gentle slope section, which comprises the area from the brick factory to the national highway G108, with a slope gradient of 7° to 15° , and covered by loose sediments, where settlements and cultivated land are widely distributed, the middle gradient slope section, which is from the national highway G108 to the flat ground and has a slope gradient of 22° to 36° , where deformations are most serious, and the flat ground section, which includes the lower and flat ground next to the river, that is, in front of the dike dam. The four sections could be clarified in the cross section I-I', as shown in Fig. 4. In addition, a bar-type rock mass is likewise located in the east of the brick factory flat ground. A long depression parallel to the vertical scarp can be found between this rock mass and the Liangtai Mountain. The topography is so special that this area is easily identified and observed in the field and aerial photography survey (Figs. 5 and 6).

mountain. By contrast, the topography immediately becomes gentle in the landslide area, with a slope angle of 10° to 20°, and is developed into a settlement of local resident, as shown in Fig. 5. Topography saltation occurs in alpine gorge region, is often caused by landslide, and will be the first important evidence of landslide identification in field investigation.

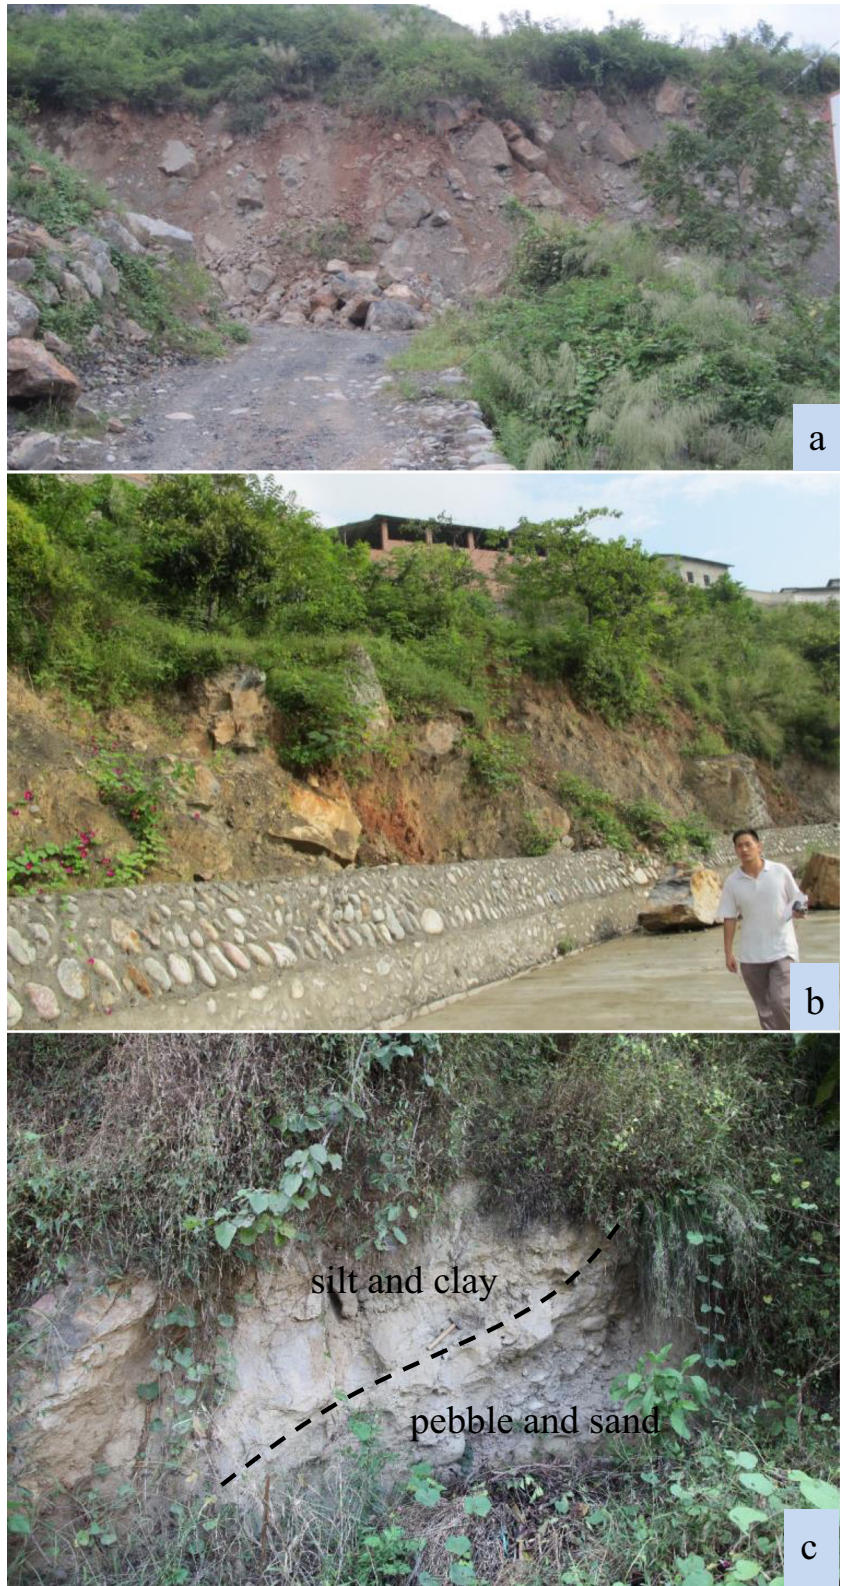
Fig. 7 Giant rock exposed in the slope. **a** In the middle part, inside of the national road G108, most of the rocks with volume more than 1 m^3 . **b** At the front part next to a water channel, near the water level. **c** Alluvial deposits exposed behind the cement plant, with pebble and sand

walkover survey, as shown in Fig. 7a, b. The third layer is residual colluvial deposit. The main contents of this layer are 50 % gravel, 25 % rock, 10 % breccia particle and sand, and 15 % silt and clay. The depth of this layer ranges from 2.5 to 14.3 m. This layer mainly distributes in the lower sector of the accumulation below G108 and is rarely observed in the upper. The lowest layer is alluvial deposits and consists of approximately 50 % pebble, 25 % boulder, 15 % gravel, and 10 % sand slit. This layer is not completely revealed

through drilling but is partially exposed on the surface behind the cement plant, as shown in Fig. 7c.

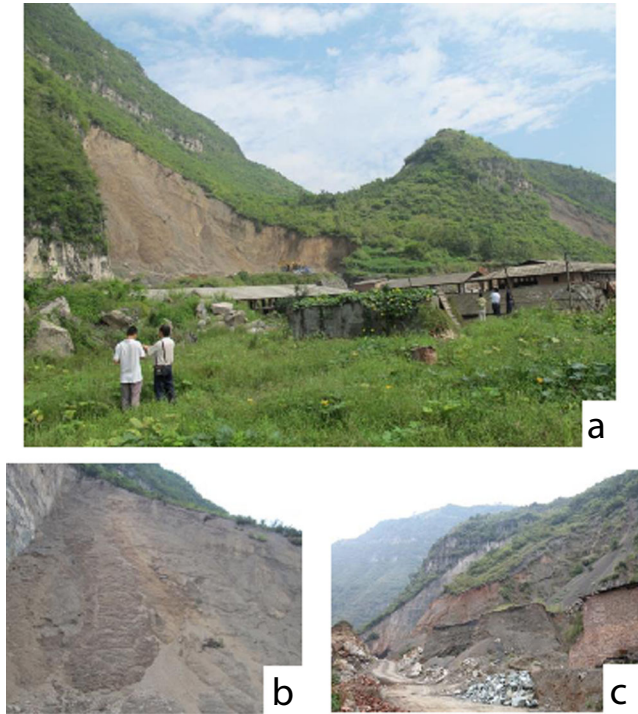
Fig. 8 Characteristics of zone B. a Western edge of fake bedrock in zone B. b Residual deposit in the depression with gravel, sand, and silty clay. c Residual deposit at the southern part of fake bedrock

part is higher than the both ends. Approximately 80 % of the depression, which is 60 to 70 m thick, is filled with residual deposit. The residual deposit is mainly composed of silt clay, breccia particles, and a few granule particles (see Fig. 8).

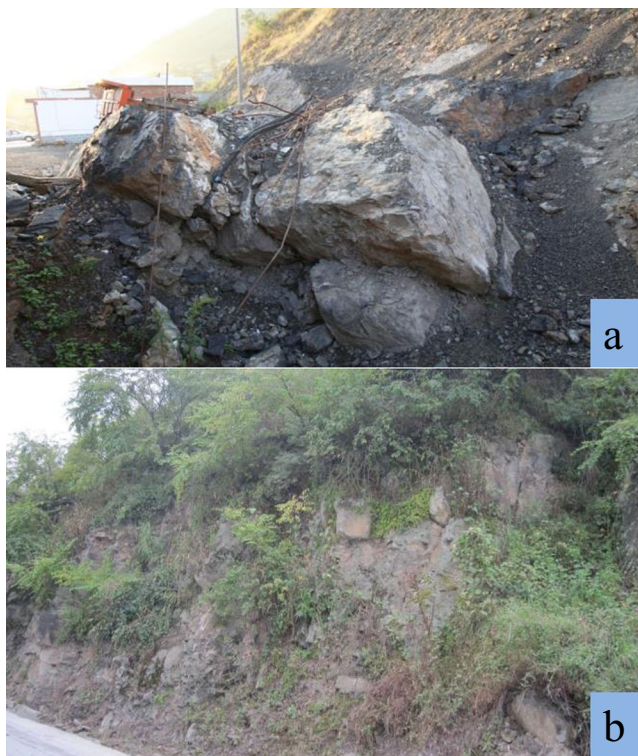
Fig. 9 Deposits of the zone C. a Large blocks at the inner side of national highway G108. b Giant block, retaining the original order of strata

The drilling survey shows that the thickness of accumulation in this zone is approximately 30 to 60 m. The material structure is similar to that of zone A, which is primarily composed of giant blocks that could reach several meters in diameter, and some larger blocks keep the original order (Fig. 9).

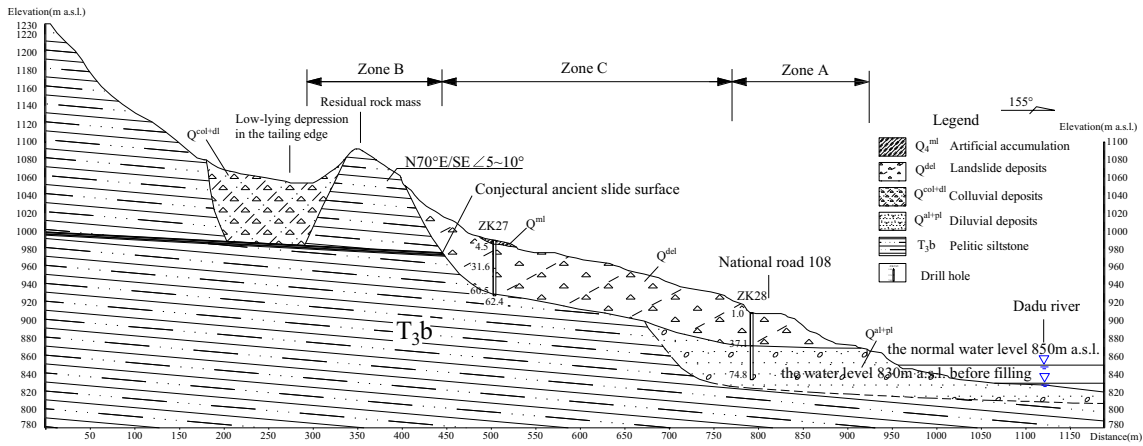
Fig. 10 Profile H-H' principal section of this accumulation. The direction is 156° that is estimated as the main sliding direction of ancient translational landslide. Additionally, zone A, zone B, and zone C are all could be observed

The exploration drilling and field investigation shows a thick layer of alluvial deposit underlain, which is likewise exposed at the front part of zone C (Fig. 10), including pebbles and sand (Fig. 7c). This layer of alluvial deposit is a terrace II (Xiong et al. 2009), which is approximately 50 m higher than the water level of 830 m a.s.l. before water filling of reservoir in the landslide area. Therefore, the landslide occurred as soon as the terrace formed. No deformations occurred in zone C after the impoundment of the Pubugou reservoir.

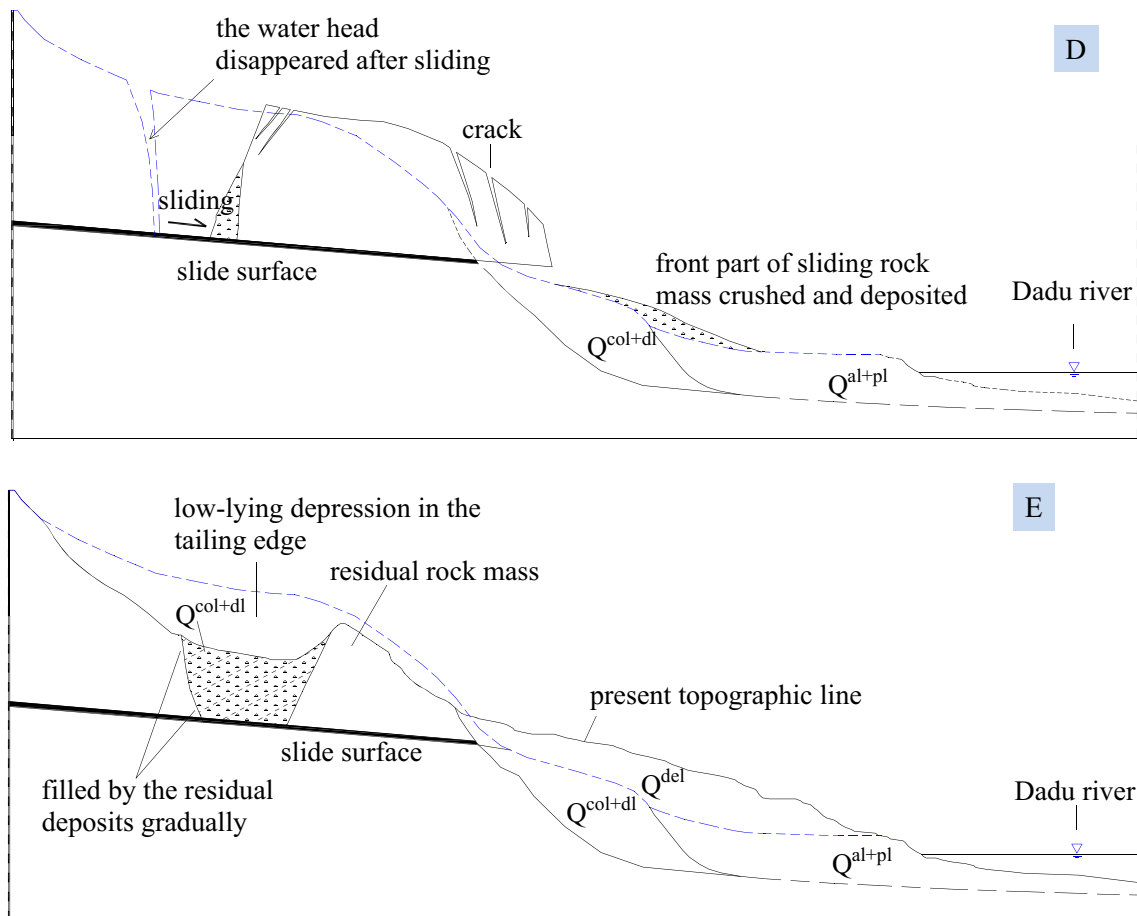
Fig. 11 Conceptual model of mechanism and forming process of this landslide accumulation. **a** Rainfall infiltration and converge. **b** Vertical fissures above the weak intercalation become into one big crack as a long trough. **c** Tremendous uplift pressure and hydrostatic pressure are formed. **d** Translational sliding occurs and the water head decreases, and most parts of the slide rock mass remain on the slope and hang on the air. **e** Long-term geologic force remolds the topography to present situation after the sliding occurred

1. A weak intercalation occurs, such as shale and gypsum band, as well as numerous vertical tectonic and weathering fissures with the rock mass in the NE–SW strike. In the event of a heavy rainfall, the water seeps into the rock mass along the vertical fissures and converges to the weak intercalation (Fig. 11a).
2. The weak intercalation would be softened or undergo argillization and slip or squeeze out to the free surface (Zhao et al. 2012). Meanwhile, the vertical fissures above the weak intercalation would become a large crack as a long trough (Fig. 11b). The long-vertical scarp and the tension gully (Fig. 6a) next to the northern landslide boundary are the best evidence to justify the process of large crack formation.
3. Hydrostatic pressure is formed in the large vertical crack, and the water flow induces tremendous uplift pressure to the weak intercalation (Fig. 11c).

When the water head in the crack becomes zero, the moving rock mass gradually stops under the effect of shear resistance. In this process, the front part of the moving rock mass is crushed, which accumulates along the slope below the sliding surface (the weak intercalation), whereas most parts of the rock mass remain on the slope and hang on air. On the trailing edge, a long-wide deep valley remains (Fig. 11d).

5. Given that the sliding surface is tens of meters higher than the river, the rock mass pushed out is hanged on air. Affected by the terrain, no support occurs under the bottom of the rock mass pushed out, and zone A is sunken in the bank slope. Owing to its own gravity, the bending failure of rock mass occurs and is divided by the ridge in zone C, which accumulates on the slope. Zone A is the main accumulation area (Fig. 11e).
