Landslides (2016) 13:9–23
 DOI 10.1007/s10346-015-0554-9
 Received: 16 April 2014
 Accepted: 5 January 2015
 Published online: 14 January 2015
 © Springer-Verlag Berlin Heidelberg 2015

Heavy-rainfall-induced catastrophic rockslide-debris flow at Sanxicun, Dujiangyan, after the Wenchuan Ms 8.0 earthquake

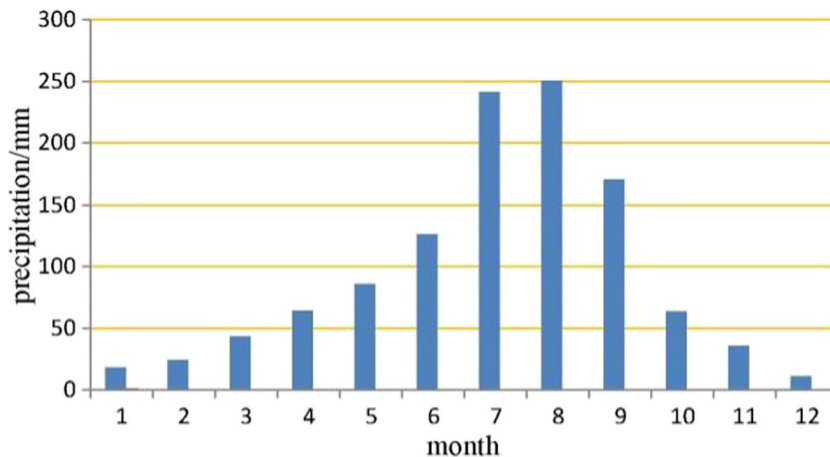
Fig. 3 Diagram of mean month precipitation at Dujiangyan from 1987 to 2012

With regards to precipitation, this area belongs to the middle semi-tropical moisture monsoon climate of the Sichuan Basin with abundant rainfall which is concentrated from May to September of every year. According to the 25-year precipitation statistics from 1987 to 2012, the mean annual precipitation is approximately 1100 mm. The precipitation from May to September accounts for 80 % of the annual rainfall, among which August has the maximum mean monthly precipitation of up to 243 mm (Fig. 3).

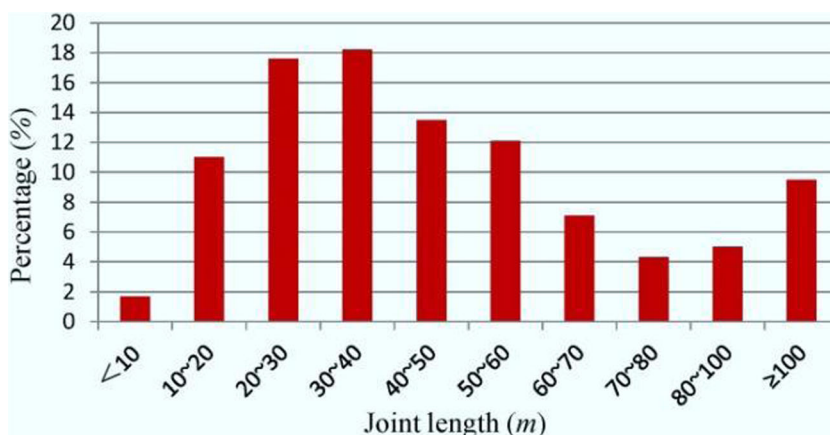
Fig. 4 Joint length and percentage in and around the Sanxicun rockslide

Field surveys on rockmass structure indicated that the parent rock of the Sanxicun rockslide was thick blanket sandstone and siltstone of the Cretaceous Guankou Formation (Kg) doped with small amounts of sandy mudstone. The bedding of the parent rock is $110^{\circ}\angle 16^{\circ}$, indicating that it has a flat dipping bedrock slope. Remote sensing image presented that the rockslide body was cut into block structure by the three sets of preferred joints and a soft layer. The north and west sides of the rockslide body were free faces since its east one was obstructed by mountain. This resulted in a deflection in the principle slide direction from 110° (true dip angle) to the northeast direction (apparent dip angle). Figures 4 and 5 show the three sets of preferred joints in the rockslide and adjacent areas: (1) joint crack belt in NE–SW direction, (2) joint crack belt adjacent to E–W direction, and (3) joint crack belt adjacent to S–N direction. Combining joint crack direction and geomorphologic features, the first set of joint surfaces can be judged as inclined tension crack surfaces with a crack occurrence of $324^{\circ}\angle 75^{\circ}\text{--}80^{\circ}$. The second set of joint surfaces can be judged as transverse tension crack surfaces, which are parallel to the rear tension surface and are known as “killing ditch” big cracks in residents with a crack occurrence of $3^{\circ}\angle 86^{\circ}$. The third set of joint crack surfaces can be judged as longitudinal tension crack surfaces with a crack occurrence of $288^{\circ}\angle 70^{\circ}\text{--}80^{\circ}$. The length of joint cracks in rockslide and adjacent areas is between 10 and 60 m. The numbers of the above three sets of joint cracks are more than 70 % in total, which reflects the preferred controlling characteristics on rockslide body, and the lower microrelief also reflected the consistency along the joint cracks.

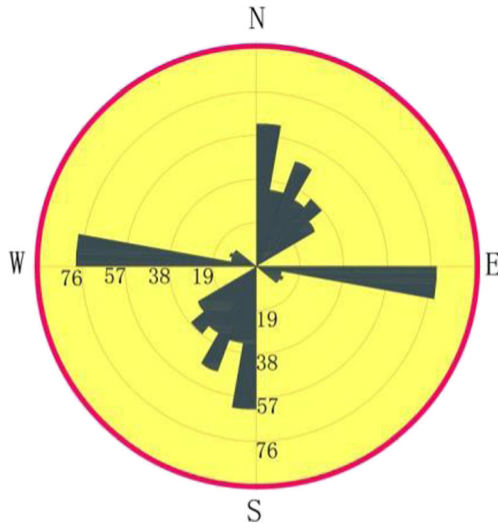
Fig. 5 Joint preferred direction in and around the Sanxicun rockslide

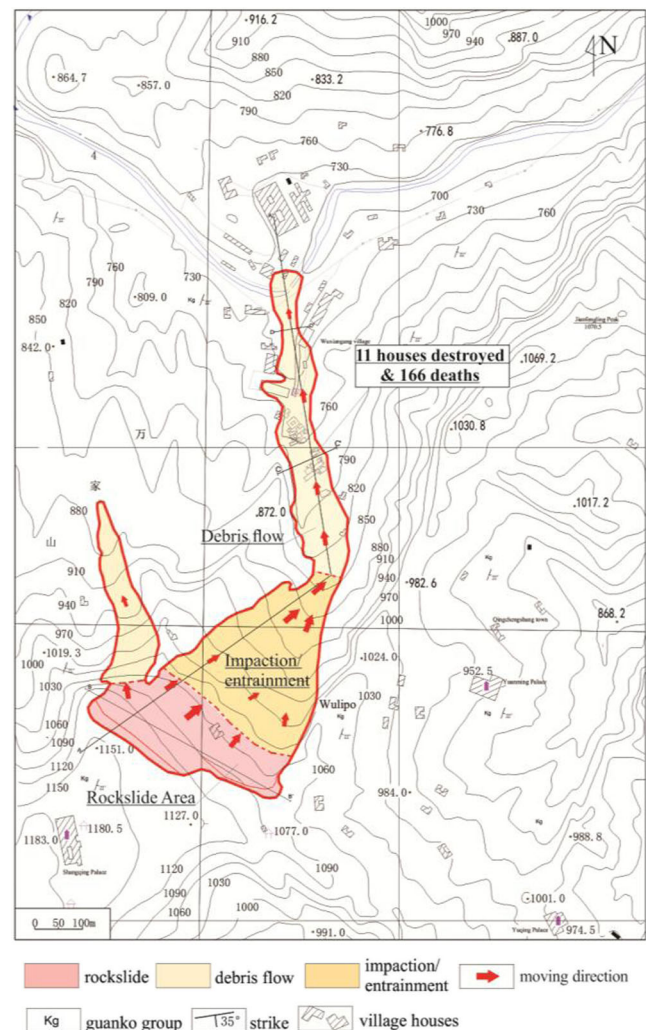
Fig. 6 Map of Sanxicun rockslide-debris flow

The front of the rockslide source area had a scarp with an elevation difference more than 20 m (NNE direction). The west side of the rockslide source area was a deep cut valley. The upper boundary of the rockslide source area was a tension fracture created by preferred joints along the NWW–SEE direction. It was recorded in the literature that this crack had been formed 400 years ago and had a maximum width of 10 m and a visible depth of up to 25 m (Fig. 12a) (Li 1998). After sliding, the maximum continuous extension length of this fracture was 250 m, and the width was 64 m (Fig. 12b). There were several tension cracks parallel to the “killing ditch” in the residues of the rockslide. These cracks had lengths of up to 100 m, splitting rocks into multiple blocks. The east boundary of the rockslide extended to the NNE–NE direction joints along the valley (also see Figs. 6 and 8). The rockslide was

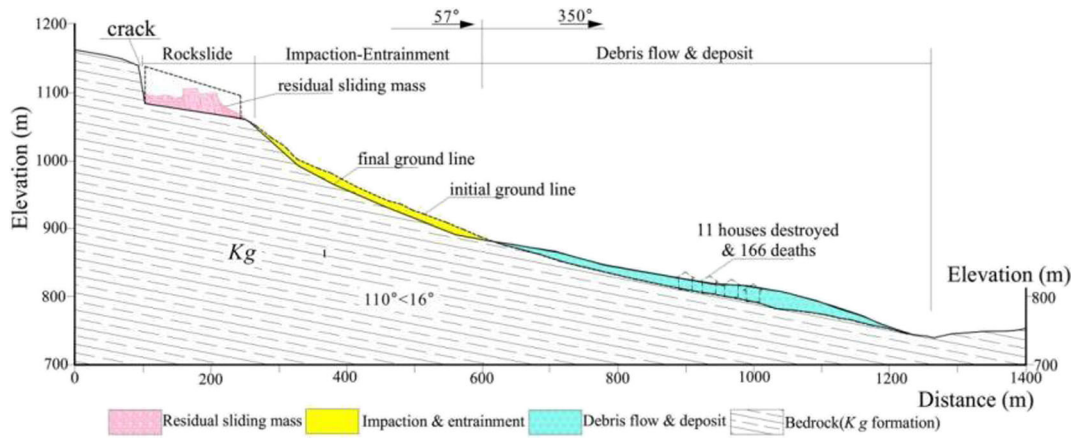
Fig. 7 Longitudinal profile of rockslide-debris flow at Sanxicun

(Fig. 17, also see Fig. 7). The model has three sub-blocks at the stages of cracking and creeping, and then front block sliding away according to the remote sensing images. Since the water level that filled in tension cracks of rockmass during the rainfall has not been actually tested, an approximate method using the percentage ratio of filling level to crack thickness is used for trend analysis.

Figure 20 shows the movement status of the sliding mass under different simulations by the F-V model. After a shear failure 300 m away from original location (also see Fig. 7), the front edge of the sliding mass took 47 s to arrive at a location 1100 m away from original location. Due to the application of water flow in the valley,

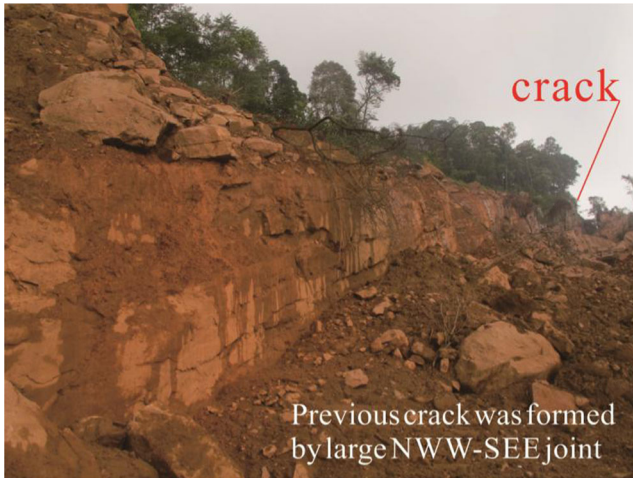
Fig. 9 Previous crack at back border of rockslide at Sanxicun (also see Fig. 8)

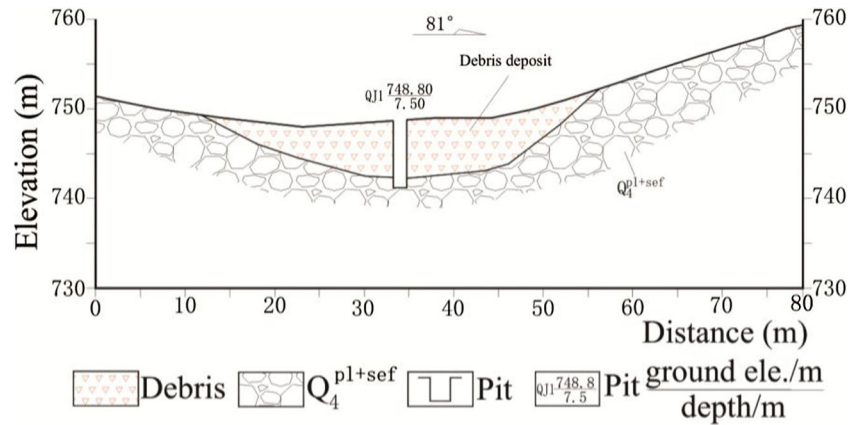
Fig. 11 Cross-section of debris deposit at Sanxicun (D-D') (also see Fig. 6 for the section layout)

The rockslide converged with the flood in the valley at 600 m to form a debris flow and continued to move forward. When moving forward 700 m, the mud level in the confluence was as high as 18 m with a volume of 356,700 m³ (Fig. 20d). When it arrived at 800 m, the mud level in the confluence was as high as 22 m with a volume of 371,100 m³ (Fig. 20e). When it arrived at 800–1000 m, houses were destroyed, and the volume increased to 388,800 m³ (Fig. 20f, g). Subsequently, the debris flow continued to move downward and the mud height in the confluence decreased from 17 to 12 m with a resultant volume of 398,400 m³ (Fig. 20h, k). The difference of the debris flow between the estimated volume of 360,000 m³ from the field observation and the calculated volume of 398,400 m³ based on the computer simulation is 38,400 m³. It should be noted that, when the water in debris flow was exhausted, the thickness of the solid accumulation was generally <8 m (Fig. 21, also see Figs. 10 and 11).

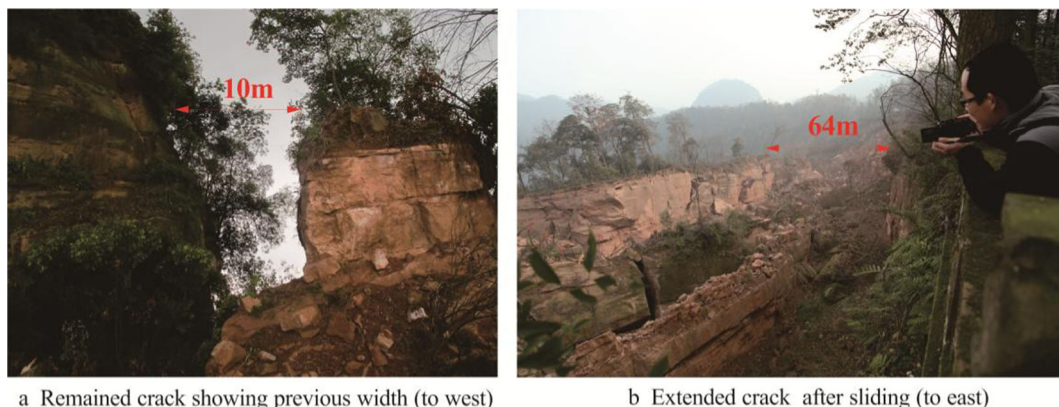
Fig. 12 Photos showing the width of back crack of rockslide before and after sliding

movement of the weak bottom layers along the inclined direction. The penetration of rain along the steep inclined cracks produced hydrostatic pressure, which applied to the rear edge of sliding mass and also formed uniform uplift pressure. This uplift pressure resulted from the evident slide at the bottom weak zone. The pressure was applied to the free face area from the rear edge to the front edge of sliding mass, where there was a certain thickness of gentle inclined crack zone and good water permeability (Fig. 16b, also see Fig. 12b).

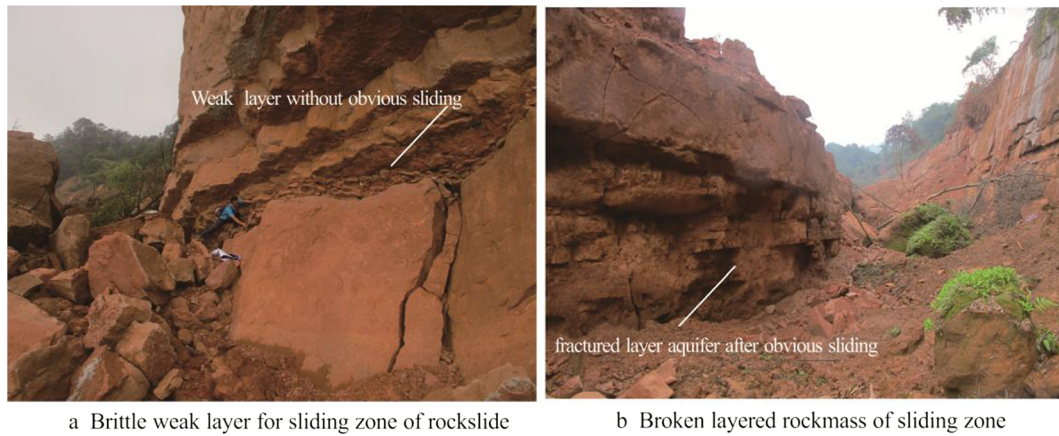
Fig. 13 Fractured rockmass showing a rich water-bearing layer

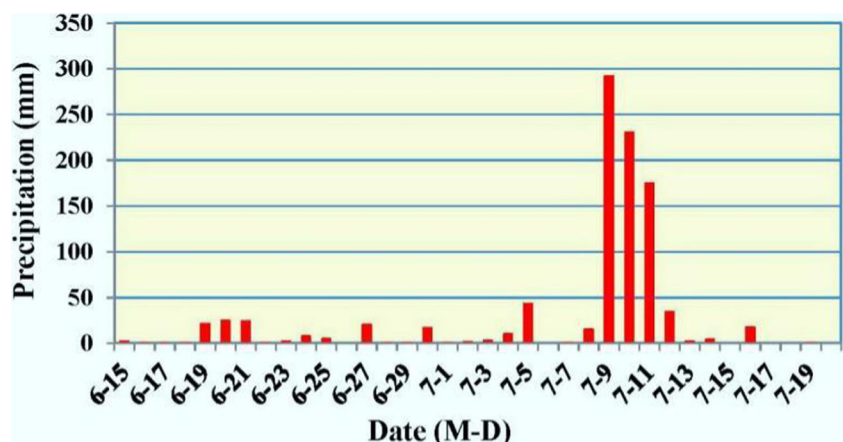
Fig. 14 Diagram of heavy rainfall at Dujiangyan from June 15 to July 19 of 2013

monitoring stations of Dujiangyan all reached above 250 mm, the monitored rainfall at the other 12 stations exceeded 500 mm, and the accumulated maximum precipitation was 1059 mm. This heavy rainfall achieved a historic record. It has been the heaviest rainfall since 1954 when Dujiangyan began to record meteorological data (Fig. 14).

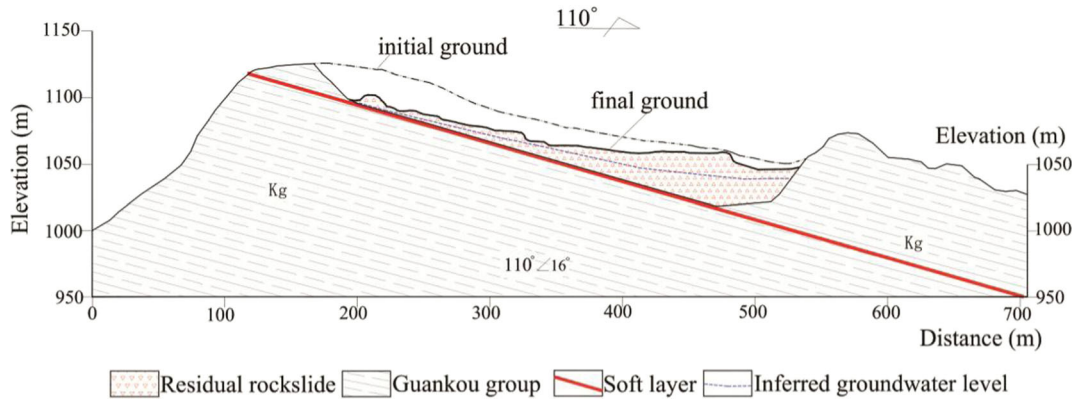
Fig. 15 Dip-direction profile section of rockslide at Sanxicun

The Sanxicun rockslide met the two conditions mentioned above. First, it must be noted that the section cut along a true dip angle of 110° of rockmass (Fig. 15, also see Fig. 6) that was basically parallel to the rear edge tension fracture. The highest ground point prior to sliding was located at the west boundary at an elevation of 1125 m, and the lowest ground point was at the east boundary at an elevation of 1050 m. There was an elevation difference of 75 m between these two ground points. The east boundary was not only the slide-blocking boundary but also the water barrier for groundwater due to the compression of rockslide movement along true dip at the early stage. This configuration

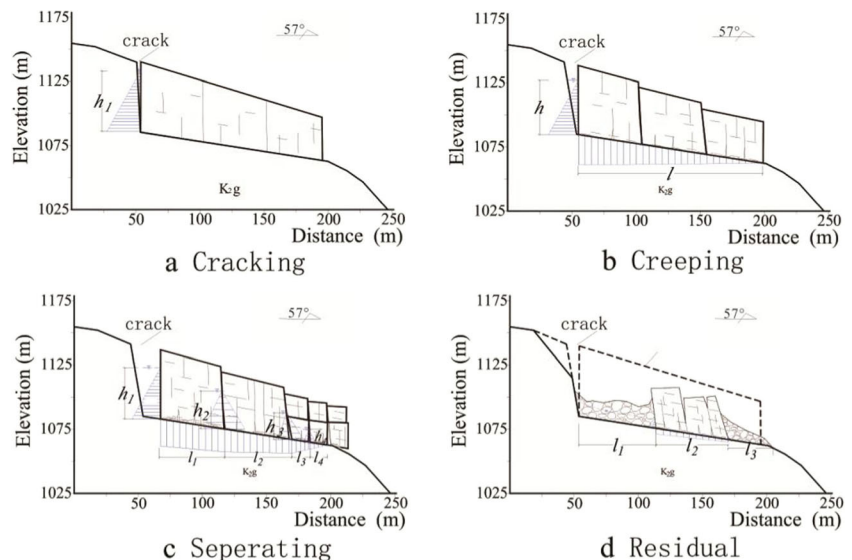
Fig. 16 Sliding pattern of cracked layered rockmass under water pressure

assured that the groundwater in rear edge tension fracture could steadily reach the needed height before sliding and at the early stage of sliding. It could be speculated from Fig. 15 that the groundwater in the tension fracture could keep a relatively steady depth due to a closed hydrogeological condition not easily yielding to discharge formed by the oblique apparent dip layered rockmass. Secondly, the heavy rainfall before and during the rockslide not only exceeded the record of recent decades but also created a duration record. This kind of continuous several-days-long extreme heavy rainfall was enough to provide the necessary groundwater lastly recharge and seepage into the crack during the rockmass sliding. Thus, the slide of the rockmass could be generalized into four stages of cracking, creeping, separating, and residual accumulation (Fig. 16).

pressure on the rear edge of rockmass. However, the gently inclined cracks along the bottom of the rockmass were not well developed and had poor water permeability; therefore, penetrating uplift pressure could not occur (Fig. 16a).

In the early stage of rock separation, the cracks in sliding mass were not filled by groundwater. Therefore, the bottom uplift pressure generally exhibited a triangle distribution, i.e., $P_u = \gamma hl$ (Fig. 19a). With the increase in movement, the rockslide was gradually separated, and the wedging expansion from the groundwater in cracks correspondingly increased and expanded. This resulted in the bottom uplift pressure changing overall and exhibiting a composition distribution of a trapezoid and triangle (Fig. 19b, also see Fig. 16c), i.e.

This stage corresponds to the process that the decrease in groundwater hydrostatic pressure after the shear failure of rockmass resulted in a slow slide of material on a gentle dip surface (Fig. 16d). In the process of a large slide, rockmass further separated to stone blocks. The major application of groundwater during rainfall was represented by pore water pressure. However, in relatively large rocks, hydrostatic water pressure and uplift pressure were still jointly applied. The resultant process of a laminated rockslide would be an accumulation slide.

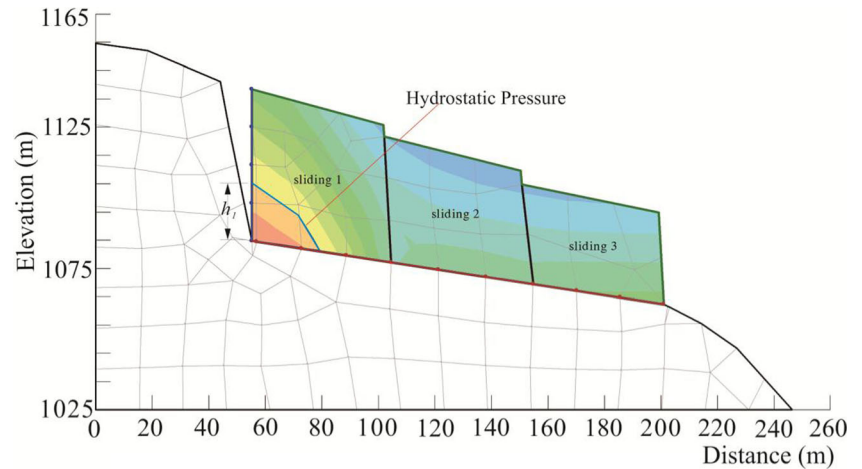
Fig. 17 Seepage analysis with hydrostatic pressure (cracking stage)

A calculated model is conceptualized according to the hydrogeological condition and rockmass structure, in which the size of model has the same size as the actual rockslide with a longitudinal length of about 140.6 m and a height varying from 55.6 to 34.7 m

When cracks are not filled with groundwater, the factor of safety (FOS) equaled 1.105 (Table 1), which indicates that rockmass is generally stable. However, the rear edge of rockmass is subject to hydrostatic pressure with the increase in the filling depth of groundwater. The corresponding safety factor decreases. When the filling depth (h) of groundwater reaches 60 % of the tension crack thickness at the rear edge of rock, the hydrostatic pressure (P_s) applied to the rear edge of rockmass can be determined by the equation:

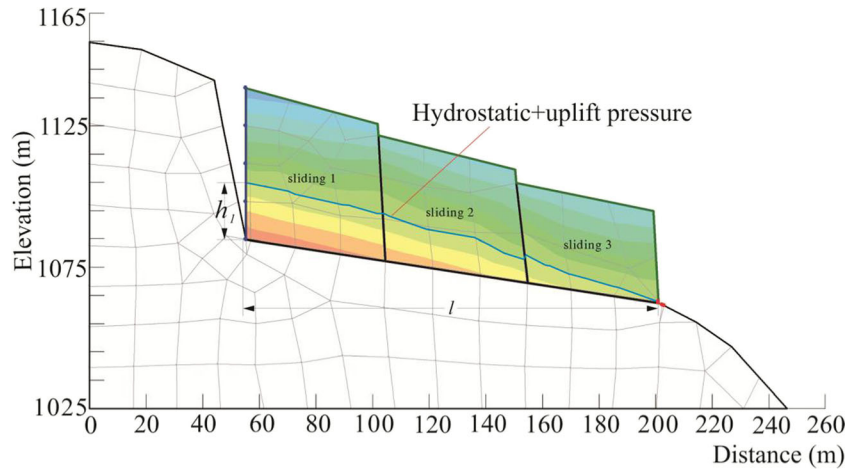
Fig. 18 Seepage analysis with hydrostatic and uplift pressure (creeping stage)

The sliding mass was simultaneously subject to the application of rear edge hydrostatic pressure (P_s) and bottom uplift pressure (P_u) (Fig. 18 and Table 1).

When the filling depth (h) of groundwater reached 60 % of the rear edge tension crack thickness (H), the sliding mass was subject to not only hydrostatic pressure of 5248.8 kN/m at rear edge but also to uplift pressure at the bottom with a value determined according to the following equation:

This situation corresponds to a FOS equal to 0.819 and a sliding status. This superposition effect results in an evidently lower FOS. Actually, under joint application of hydrostatic pressure and uplift, if the filling depth of groundwater exceeds 20 % of the crack depth

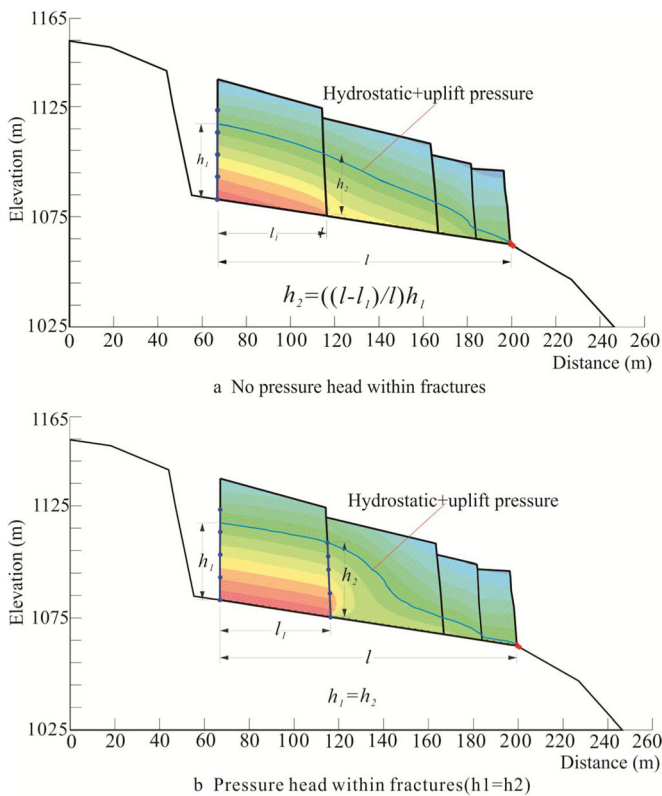
Fig. 19 Seepage analysis with hydrostatic and uplift pressure (separating stage)

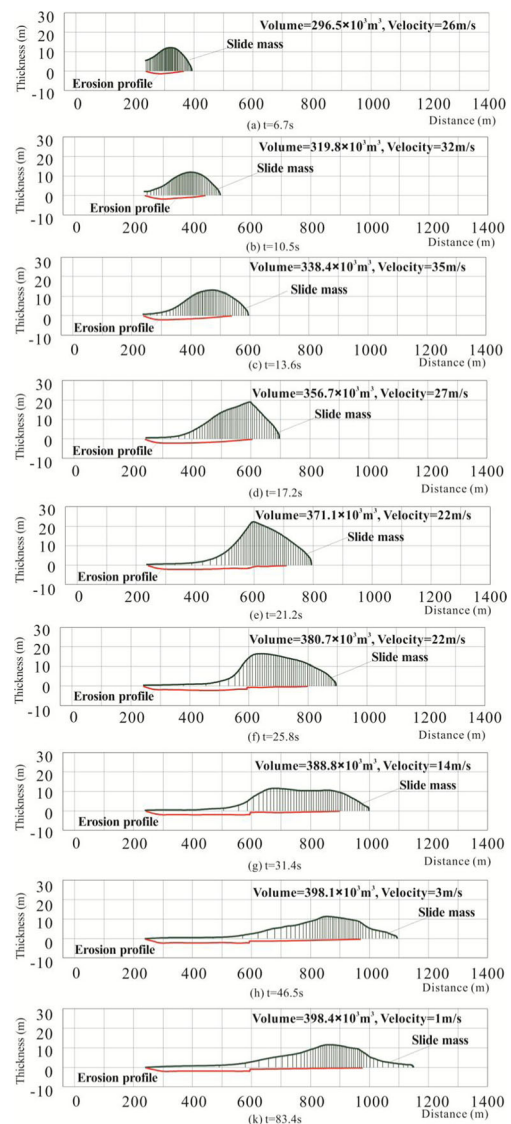
Fig. 20 Scenario of 2D depth profile of rockslide-debris run-out at Sanxicun

volume of 296,500 m³ (Fig. 20a). When moving forward 500 m, the rockslide continued to shovel down the slope surface to a depth of 2–3 m with a resultant volume of 319,800 m³ (Fig. 20b). When moving forward 600 m, a shoveling zone with a length of 250 m and depth of 1–3 m was formed, and the resultant volume of the rockslide increased to 338,400 m³ (Fig. 20c).

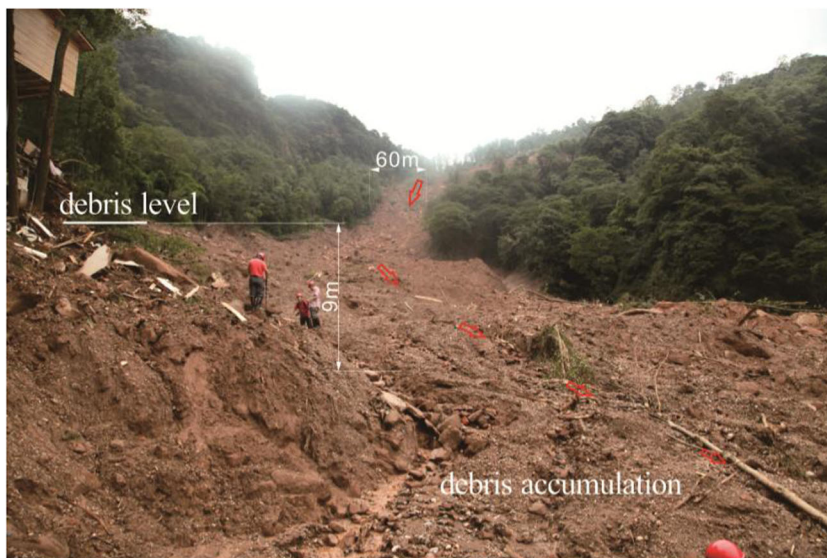
Fig. 21 A height difference of 15 m between the level and accumulation of debris

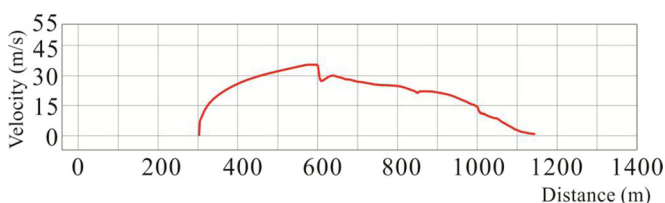
Fig. 22 Velocity of slide mass vs. distance of run-out of rockslide debris at Sanxicun

If the initial velocity at the shear failure of the rockslide is set to zero, the sliding velocity kept increasing between 300 and 600 m (Fig. 22, also see Fig. 20). This sliding velocity reached a maximum value of 35 m/s at the location of 600 m with a movement time $t=13.6$ s. After entering the valley, the rockslide was transformed into a debris flow, and the corresponding velocity decreased to 28 m/s. At the distance of 800 m, the velocity before destroying houses was 22 m/s with a corresponding moving time of $t=21.2$ s and a time interval of $\Delta t=21.2-13.6=7.6$ s. Between the distances of 800 and 1000 m, 14 houses were destroyed, and the movement velocity decreased to 14.2 m/s with a corresponding moving time of $t=31.3$ s and a time interval of $\Delta t=31.3-21.2=10.1$ s. After that, the rockslide continued to move forward approximately 100 m with a corresponding moving time of $t=46.7$ s and a time interval of $\Delta t=46.7-31.3=15.4$ s. Finally, the rockslide tended to stabilize at 1250 m with a corresponding moving time of $t=46.7$ s and a time interval of $\Delta t=83.4-46.7=36.7$ s.
