The 27 February 2014 San Leo landslide (northern Italy)

Abstract The report describes a recent landslide occurred in San Leo (northern Italy), an outstanding village from the historical, architectural and landscape point of view. On February 27, 2014, around 6PM local time, about 0.30 Mm³ of rock detached from a sub-vertical cliff and fell into the facing valley, producing a roar and a shake, which was initially perceived by the inhabitants as an earthquake, then followed by a dust cloud produced by the fragmentation of material during the collapse. Fortunately, nobody was injured, neither the landslide damaged any relevant structure; anyhow, it is still posing a severe threat to the village and, above all, to the fortress that represents an architectural masterpiece dating back to the middle ages. An outlook of the event will be given, along with the description of the peculiar geological and geomorphological features driving the slope instability phenomena, which indeed are widely diffused in the entire region. Lastly, an overview of the landslides, which historically affected the village, is also given, showing how natural hazards can influence the history of a site.

Keywords

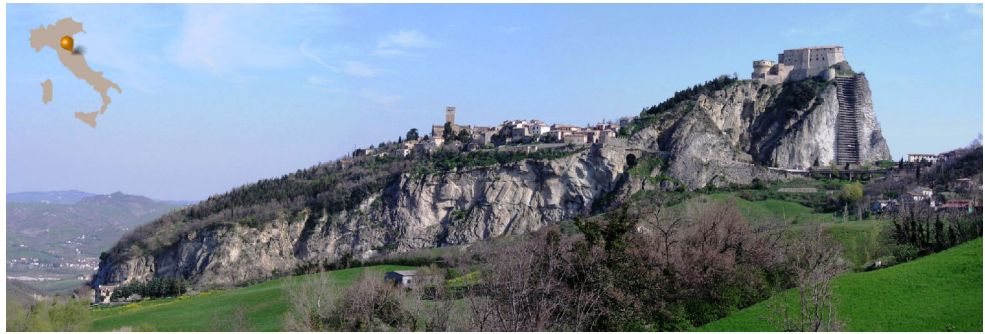
Fig. 1 South view of San Leo (Emilia-Romagna Region, northern Italy). The photo shows the rock slab lying over a hilly landscape, with the village in the middle and the fortress on the east side, where the rock cliff reaches the maximum height (photo O. Nesci, April 2005)

The citadel gained great fame first as an impregnable military fortress and later as an extraordinary prison, due to the morphological features of the site. In fact, the village of San Leo rises at the top of a limestone and sandstone slab of approximately 0.5 km², bordered by vertical and overhanging cliffs up to 100 m high, above clayey gentle slopes. Indeed, the morphology looks like a “cuesta”, with the highest altitude towards east, where the fortress is built, and then sloping toward west, where the historical downtown developed (Fig. 1).

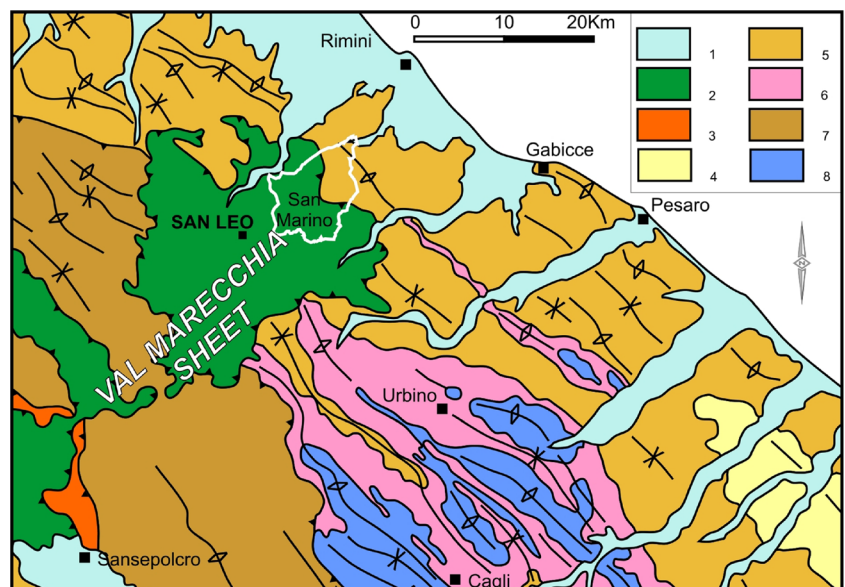
Fig. 2 Geological sketch of Montefeltro area. Legend: 1 continental Quaternary deposits; 2 Ligurian, Subligurian and Epiligurian units; 3 Tuscan units. Umbria–Marche–Romagna sequence and post-evaporitic sequence of Apenninic–Padanian border; 4 marine Quaternary deposits; 5 Messinian–Pliocene sequence; 6 secondary basins sequence; 7 principal basin sequence. The main fold axes are also shown

San Leo rock plate is located on the south side of the Marecchia River Basin. The structural setting is characterised by alloctonous geological units belonging to the so-called “Val Marecchia Sheet”, a nappe overlying the autoctonous geological units of the “Umbria-Marche-Romagna” geological sequence (Fig. 2). The “Val Marecchia” Nappe encompasses several geologic units, from the older—*stratigraphically lower*—Ligurian units to the younger—*stratigraphically upper*—Epiligurian units, dating back to Oligocene and Pliocene. Epiligurian units are formed by hard rocks and are well differentiated from the Ligurian units that are characterized by a dominant clayey fraction.

The structural setting drives the morphology, with rock slabs generally verging toward east and northeast, according to the main direction of fault and fold axes (Fig. 2). Bedding layers in the rock slab are mainly WSW dipping. At the north-western edge the bedding dip is chaotic, while at the south-eastern cliff edge the bedding dip direction quickly turns to WNW. On the west side, vertically bedding, parallel to the cliff wall, can be observed, but local variations can be observed owing to prolapsed bedding. The structural features are mainly influenced by discontinuities such as faults and joints of tectonic origin (Spreafico et al. 2013).

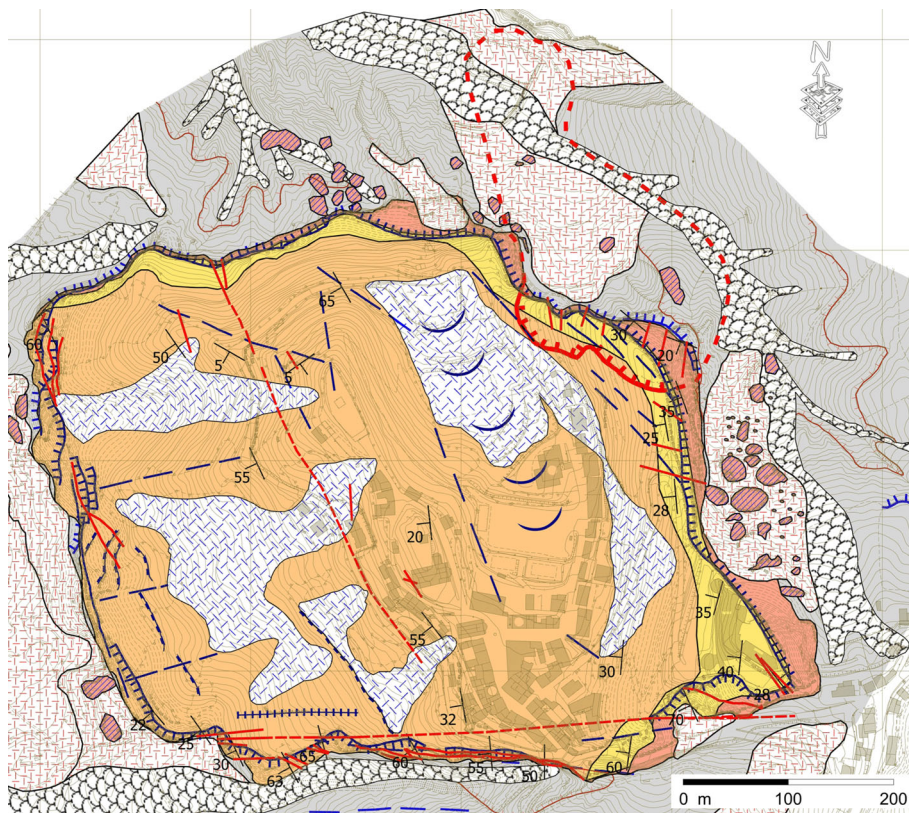
Fig. 3 Geomorphologic map of San Leo rock slab

The rock plate is made of limestone belonging to the “San Marino” geologic formation at the base and glauconitic arenaceous–calcareous sediments of the “Monte Fumaiolo” geologic formation at the top (Fig. 3). The lower part of the “San Marino” geologic formation is composed of thick weakly bedded calcirudite layers, whereas a strongly bedded calcarenitic facies outcrops in the upper part.

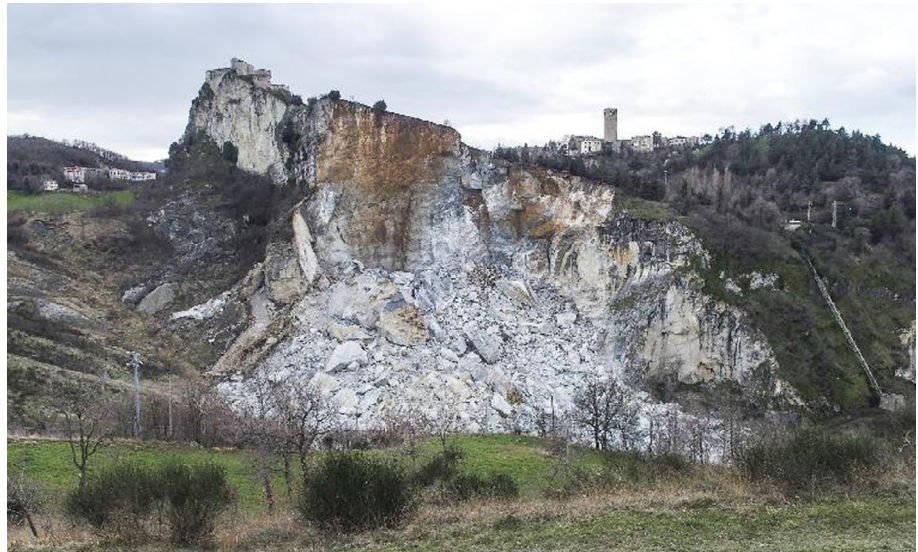
Fig. 4 East view of the landslide occurred on February 27, 2014. On top of the rock slab, the downtown village is visible, along with the fortress on east face (*left side*). The photo shows the contact between the rock slab and the underlying clay shales and the oxidation of the main scarp

On February 27, 2014, 16:56':37" (UTC), a rock mass initially estimated to be between 0.45 and 0.50 Mm³, detached from the NE cliff of San Leo rock slab and collapsed onto the facing valley (Fig. 4).

stretching for about 400 m along the river valley. An aerial view (Fig. 7) shows the master joints visible in the upper crest, now approaching the first houses of the village. The oxidation of the landslide main scarp is also clearly visible (as in Fig. 4, too), indicating the infiltration of water through open fractures; certainly, the exceptional snowfall of February 2012 when the snow cover reached a thickness of 2.25 m and lasted for some weeks, greatly contributed to the progressive opening of the fractures.

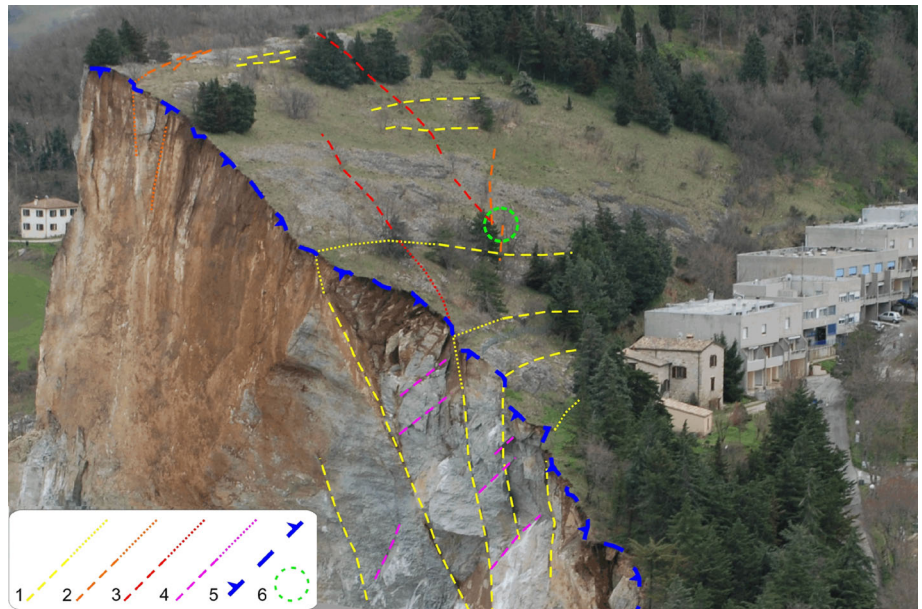
Fig. 7 Prospective view of the main scarp and the crest of the landslide, which is now very close to the nearest houses of the village. 1–4 main joint sets, 5 present landslide scarp, 6 sinkhole related to fracture intersections

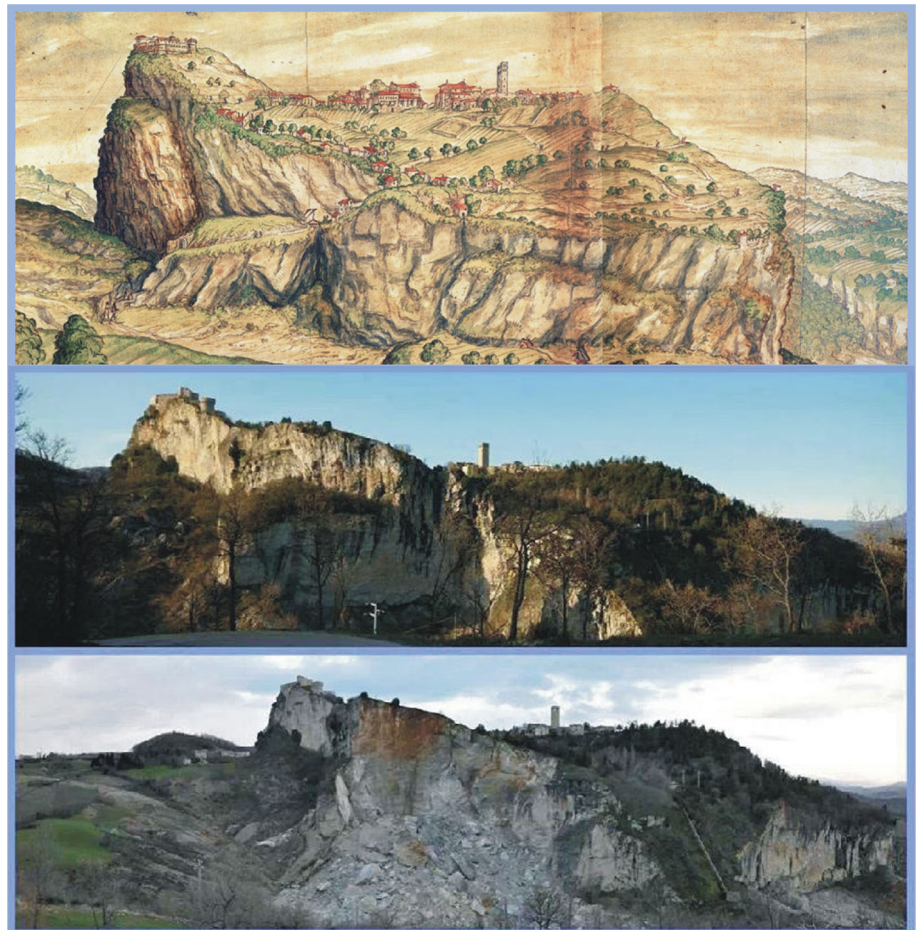
Fig. 8 Comparative pictures showing the evolution of the north-eastern cliff face of San Leo village. *Top* Watercolour by the painter Francesco Mingucci, 1626AD; most of the blocks visible along the rock cliff face are now missing due to a number of landslides that occurred since the seventeenth century. *Middle* the same cliff face portrayed in the watercolour as it appeared at the end of twentieth century. *Bottom* present view of the cliff face after the landslide of February 27, 2014. On the *right side of bottom figure* is visible the cliff face produced by the 2006 landslide, best pictured in Fig. 9

One of the most outstanding documents is the watercolour by Francesco Mingucci, which dates back to 1626, where the eastern face of the cliff is portrayed (Fig. 8, top).

Comparing the watercolour with present day pictures of the rock cliff (Fig. 8, middle and bottom), it can be observed that large

volumes of rock along the cliff face are now completely missing, as well as the lack of a massive prism just beneath the fortress where the present cliff edge has retreated reaching the north tower. The

neighbourhood visible in the watercolour at the top of the cliff edge completely disappeared due to the landslides that affected the cliff in the first half of 1600 and destroyed also the old access to the

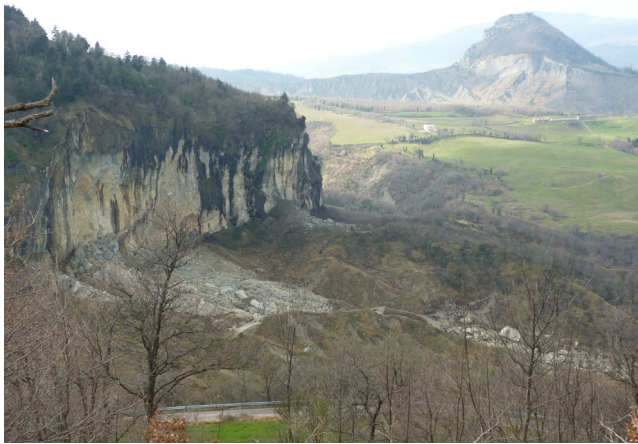
Fig. 9 On the foreground, the 2006 landslide that affected the northern cliff face; clearly visible, at the toe, the landslide debris. On the background, Maiolo hill, similar to San Leo, where the night of May 29th, 1700 a landslide buried an entire village, remarking the diffusion of such phenomena in the whole Montefeltro area

In another document, a letter from a notable man, it is reported that between 1700 and 1800 a great number of landslides occurred, to the point that “the village is now completely surrounded by them”, wrote the notable man in his letter. In this regard, a strong increase in the occurrence of landslide phenomena has been observed in the whole region since the second half of the second millennium, probably related to the Little Ice Age (Mann 2002) whose peak was reached at the end of the seventeenth century and whose effects on the stability conditions of the region has been well ascertained and documented (Piastra et al. 2005). As a matter of fact, the night of May 29th, 1700, a nearby village (Maiolo, visible on the background of Fig. 9) was completely buried by

As a matter of fact, a significant landslide occurred on May 11th, 2006 along the north face of the cliff (Fig. 9). A volume of approximately 50,000 m³ detached from the cliff, and some inhabitants reported to have perceived the movement like an earthquake followed by a dust cloud and a strong wind due to the sudden movement of the landslide mass. Successively, the rock debris fallen onto the underlying clay shales, reactivated an earth flow that moved at a speed of about 1 m/day, which activated, in turn, other landslides downstream. A number of countermeasures were adopted in different sites since the 1970s to control both the rock falls along the cliff and the earth flows at the valley bottom, such as, respectively, rock bolts and retaining walls (D’Ambra et al. 2004), none of them seeming to have been resolute.

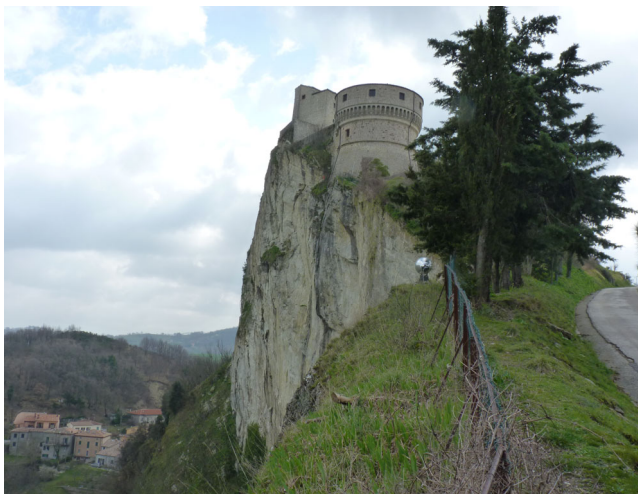
Fig. 10 Detail of the east-facing rock cliff beneath the fortress’ north tower. The vertical fracture developing below the tower is already open, as clearly shown by the presence of vegetation and debris in the upper part

Finally, what is notable today is the temporal and spatial trend of the slope instability phenomena, which appear to be propagating from north to south in clockwise direction (2006 north face, 2014 northeast face). This poses a crucial question: if the trend continues, could the fortress be the next asset to be seriously threatened in the near future (Fig. 10)?
