## The 2 September 2014 Shanshucao landslide, Three Gorges Reservoir, China

**Abstract** A Shanshucao landslide, large displacement landslide, took place on 2 September 2014, at 13:19 in Zigui County, Hubei Province, central China, which was about 42 km from the Three Gorges Dam. It was located on the left bank of Luogudong River, which was a secondary tributary of the Yangtze River. Just as the well-known Qianjiangping landslide, this landslide was considered to be one of the longest displacement consequent slope failures, which was characterized by red layer rock landslide. This event has become an outstanding and valuable reference for landslide study and is of particular importance for understanding the influence of the stability of the slope in the Three Gorges Reservoir Area. The geomorphological and geological conditions of the landslide were investigated to identify and characterize previously discontinuous and slide stratum bed. The hydrogeological and geomechanical features were also analyzed. It was found that the landslide was triggered by both the long and heavy rainfall and the rising water level of the reservoir at high speed.

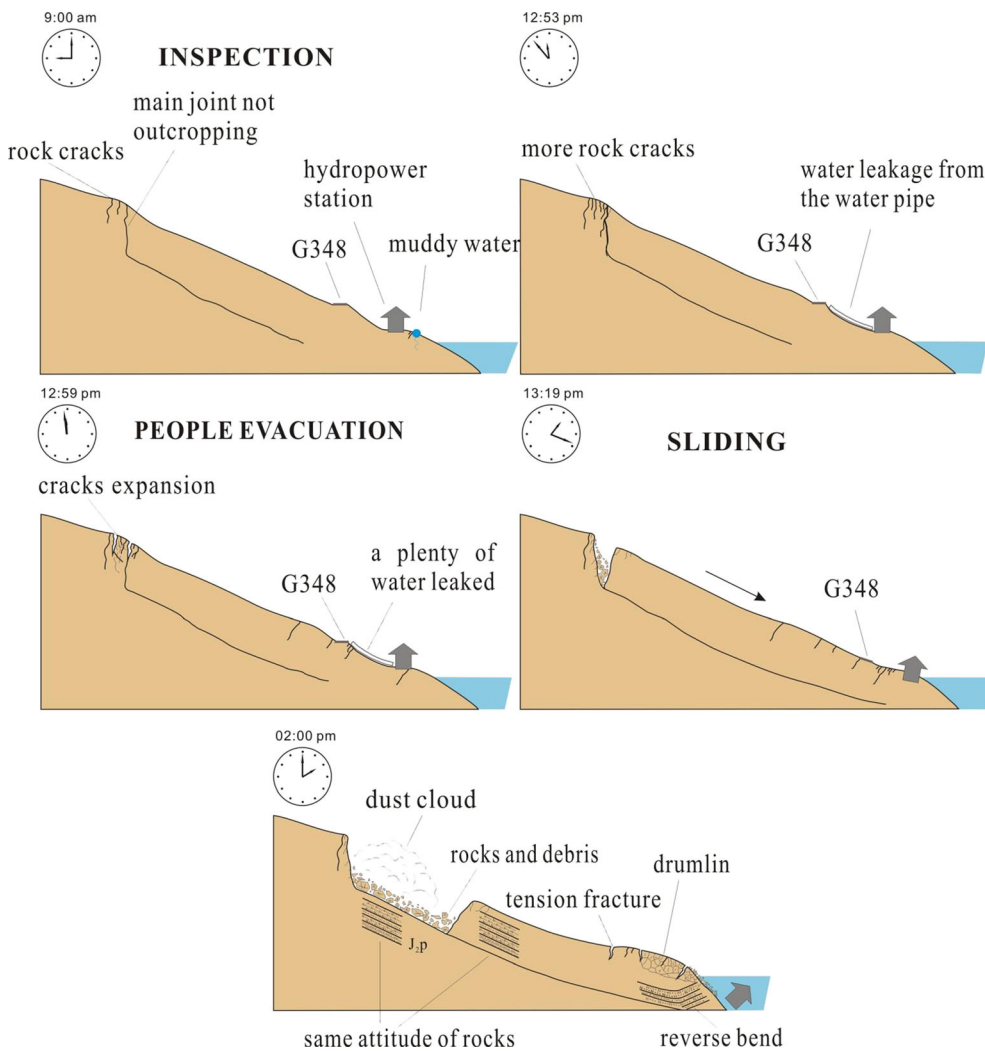
**Fig. 4** The time evolution process of the Shanshucao landslide

9:00 am, some muddy water overflows at the lower part of the slope close to the river, and some rock cracks outside the back scarp were found. Figure 4 displays the time evolution process of

the Shanshucao landslide. At 12:53 pm, a few cracks appeared on one side (close to the landslide) of pressure pipeline below the national road, with water leakage. Approximately 6 min later, a large water leak from both sides of the pipe (Fig. 5a) was observed. After that, a blast of turbid water gushed out of the ground at the right boundary (164 m). All people, including local inhabitants and staves who worked in the Daling Hydropower Station, were informed to emergency escape and evacuated out of the sliding mass at 13:00 pm. Afterwards, the large-scale rock mass began to slip at 13:19 pm and completed at 14:08 pm except small block of rockfall that occurred from the newborn overhanging cliffs, the south boundary of the main rock sliding area (I) and scarp. The commander of this event and witness, Yu Zuzhan (the Director of Bureau of Land and Resources in Zigui County), stated that he could hear a loud roar at the distance of 400 m from the landslide, then see a great deal of dust cloud rose from the rear area of the landslide (Fig. 5b). There were still small rock blocks intermittently till 17:18 pm.

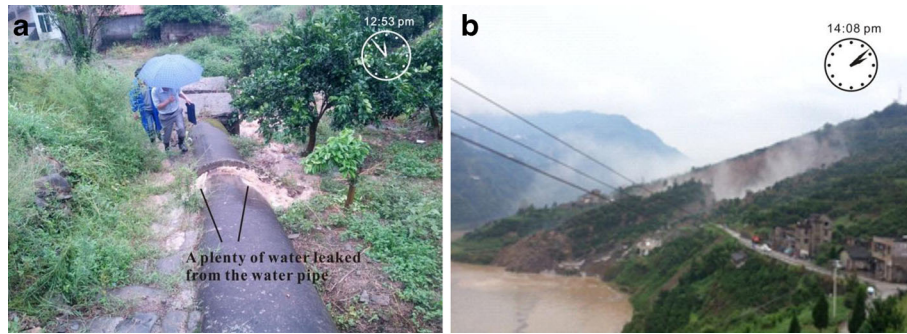
**Fig. 5** Photos of the day's event. **a** Water leaked from the water pipe prior to large displacement failure. The man with umbrella is the commander of this event, Yu Zuzhan. **b** The sliding mass slipped with dust cloud

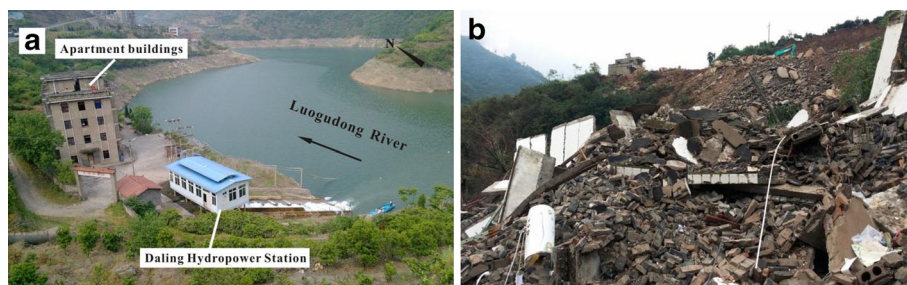
**Fig. 6** View of the lower part of the Shanshucao landslide. **a** Daling Hydropower Station and three five-storey apartments prior to slope failure (taken on April 30, 2013). **b** Daling Hydropower Station disappeared and three five-storey apartments rubble (taken on September 17, 2014)

The Daling Hydropower Station (installed capacity of 1000 kW), situated on the lower part of slope, was completely destroyed and slipped underwater, and three five-storey apartments were completely demolished and broken to pieces. The power supply for the town was interrupted due to the crooked transmission pole. Additionally, the national road (G348), a country road, houses, and around  $20 \times 10^4$  m<sup>2</sup> area of orange planting were seriously damaged. A direct economic loss of nearly 32 million RMB was caused by the geohazard. Fortunately, there were no fatalities in this event, primarily due to the accurate prediction, good decision making, and timely evacuation of the residents. The event is of special focused not only because a whole hydropower station has been firstly destroyed by the landslide but also because the stability of the consequent slope is of significantly important under the rainfall effect and the influence of the alternated filling-drawdown cycles in the Three Gorges Reservoir Area (Xu et al. 2013; Jian et al. 2014).

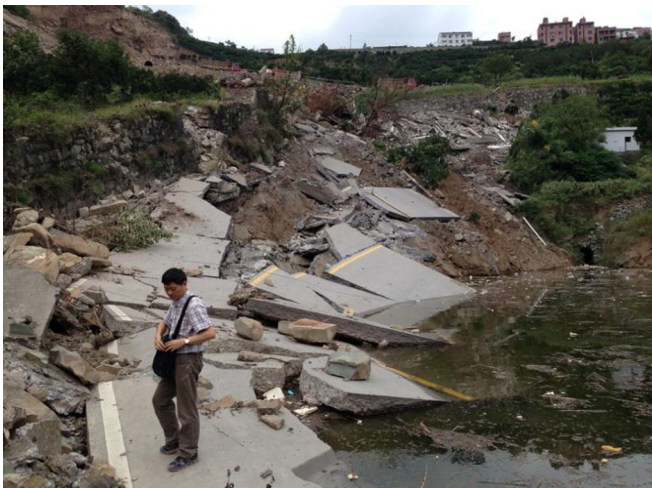
**Fig. 7** View of the lower part of the Shanshucao landslide, road G348 was moved at great differential displacements, and the concrete pavement broken into pieces

Owe to brilliant decision and decisive evacuation, no one was injured. However, there was still serious economic loss caused by the Shanshucao landslide. The direct economic loss was incurred to 32 million RMB. It was the first time that a hydropower station was completely destroyed and disappeared into the water. Three five-storey apartments on the lower part of slope near the hydropower station were shattered (Figs. 6 and 7). Two hundred meters of the national road (G348) was moved 5–100 m displacement, the maximum displacement occurred in the main rock sliding area (I) and reached 100 m and the relatively small displacement occurred in the tractive area (III) (Fig. 7). Twenty hectares of orange

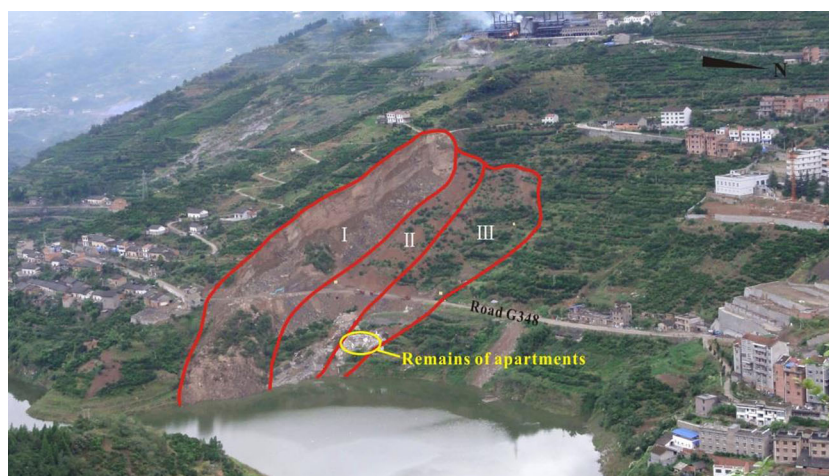
**Fig. 8** View of the Shanshucao landslide and landslide subzones

Figures 8 and 9 illustrate the extent of the Shanshucao landslide and subzones. The landslide had an irregular rectangular shape, with a length of 350 m and a maximum width of 140 m. The highest elevation of the main scarp was about 283 m. The national road (G348) was situated in the middle part of the slope (elevation 204 m), and the hydropower station was located in the lower part of the slope (about 160 m elevation) prior to sliding. The remains of the apartments and concrete pavements were in the lower part of the landslide (Fig. 8). The gradient of the upper part of landslide was basically the same as the original slope angle of 18–20°, although it changed the direction (to 40–65°) below the national road (G348). The elevation of the water level was 162.31 m on the day of the event, so some lower part of the landslide was buried under the water. Based on the sliding distance and substance of sliding mass, the Shanshucao landslide was divided into three subzones (Fig. 9): the main rock sliding zone (I) and two separated slipped zones (II and III).

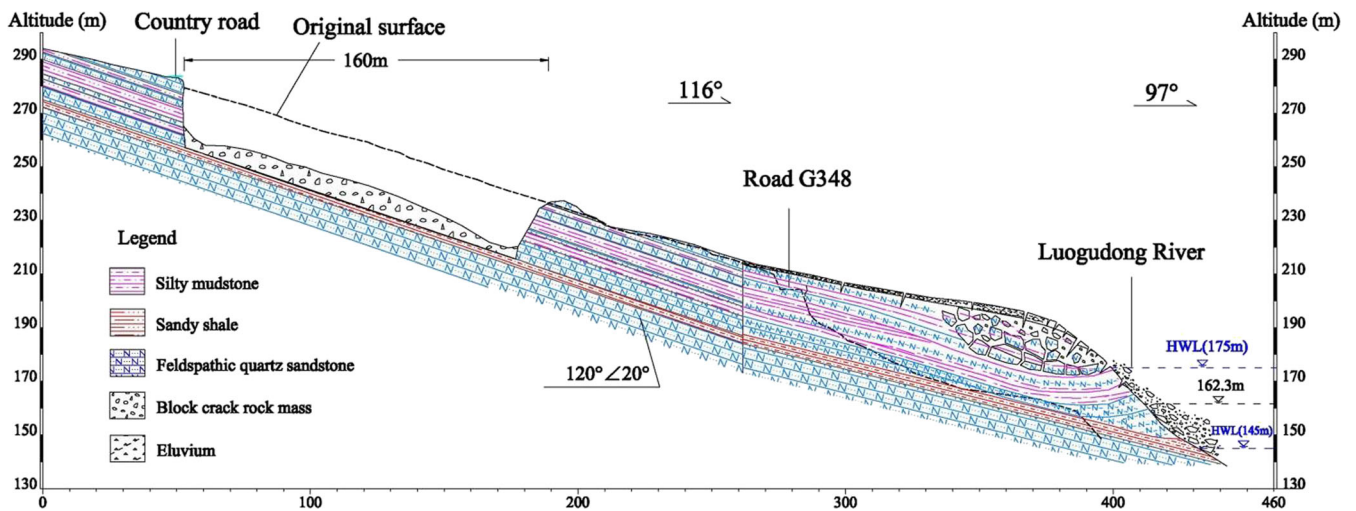
**Fig. 10** Geological longitudinal section (line A-A in Fig. 9) of the landslide

Figure 10 is a longitudinal section of the main rock sliding block (zone I) of the Shanshucao landslide. It shows that the slope angle is around  $22^\circ$ . The bedrock is feldspathic quartz sandstone, silty mudstone, and sandy shale of the Middle Jurassic Qianfoya formation ( $J_{2q}$ ), with the dip direction of  $120^\circ$  and dip angle of  $20^\circ$ . The landslide, obviously, occurs in the consequent slope, which is the facility-sliding stratum for landslide in Three Gorges Reservoir.

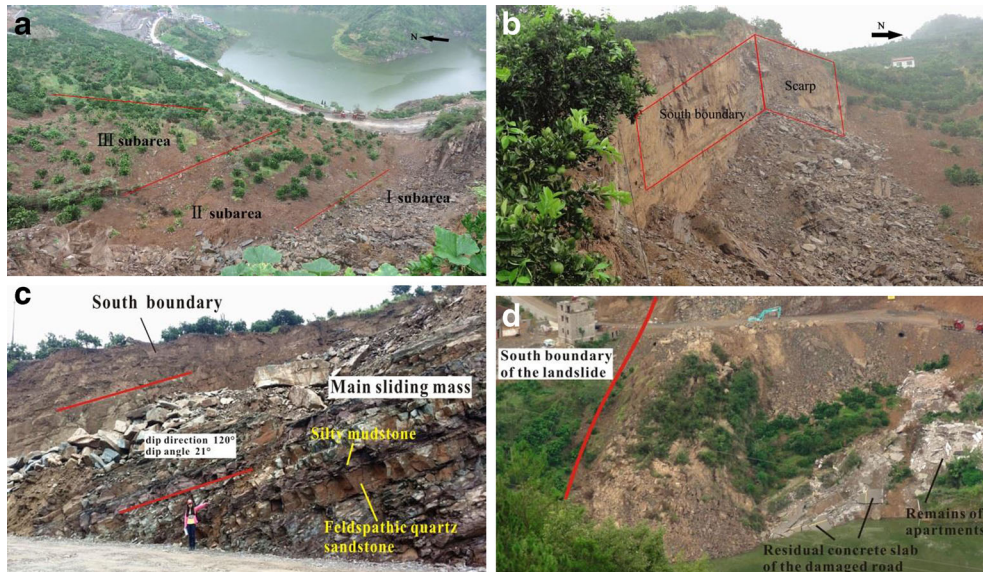
**Fig. 11** Photographs showing structure characteristics of the landslide. **a** The landslide was divided into three subzones. **b** The south boundary at the upper part of the landslide. **c** Main sliding mass in the upper part of the landslide. **d** The sliding mass in the anterior part of the landslide

The very interesting special boundary conditions of Shanshucao landslide were two free boundaries and two separating planes (Fig. 11). Two free boundaries are the following: one is the overhanging rock cliff, which is composed of the left boundary (north boundary) for the main rock sliding mass (I); and the other is river valley, which is the free space (east boundary) of sliding for landslide zones I, II and III. Two separating planes are the following: one is an assembly discontinues through set 2 fractures with strike  $N 40^\circ E \angle 80^\circ$ , which forms the right side boundary (south boundary) and incises rock mass and bed from the slope for the main rock sliding mass (I); and the other, an assembly discontinues through set 3 with strike  $N 75^\circ W \angle 85^\circ$ , which makes up the scarp boundary (west boundary) and incises rock mass and bed from the vertical slope and connected plane of back scarp (on the west). The north and east boundaries of slope are free, resulting in no friction to resist sliding, which is similar to that of Qianjiangping landslide (Liao et al. 2005).

The sliding mass at upper part of zone I, rock blocks with different sizes (Fig. 11a, b), is lithologically and structurally the same with the bedrock. The remaining mass at the middle part of zone I as shown in Fig. 11c, not only the occurrence of stratum but also the attitude, is just the same as the original sedimentary and overhanging rock cliff on the right boundary of the landslide. It indicates that the main rockslide zone I was an integral

translational motion. However, the sliding rock blocks at the lower part of zone I are chaotic, turned, and squeezed since the sliding mass was resisted by the riverbed and pushed by upper sliding mass. This resulted in the formation of a drumlin at slope toe, which elevated about 15 m (height)×65 m (width) above the ground (Fig. 11d).

The sliding mass of zones II and III consists of the residual deposit of Quaternary and rock debris originated in sedimentary of the Middle Jurassic Qianfoya formation ( $J_{2q}$ ) (Fig. 11a).

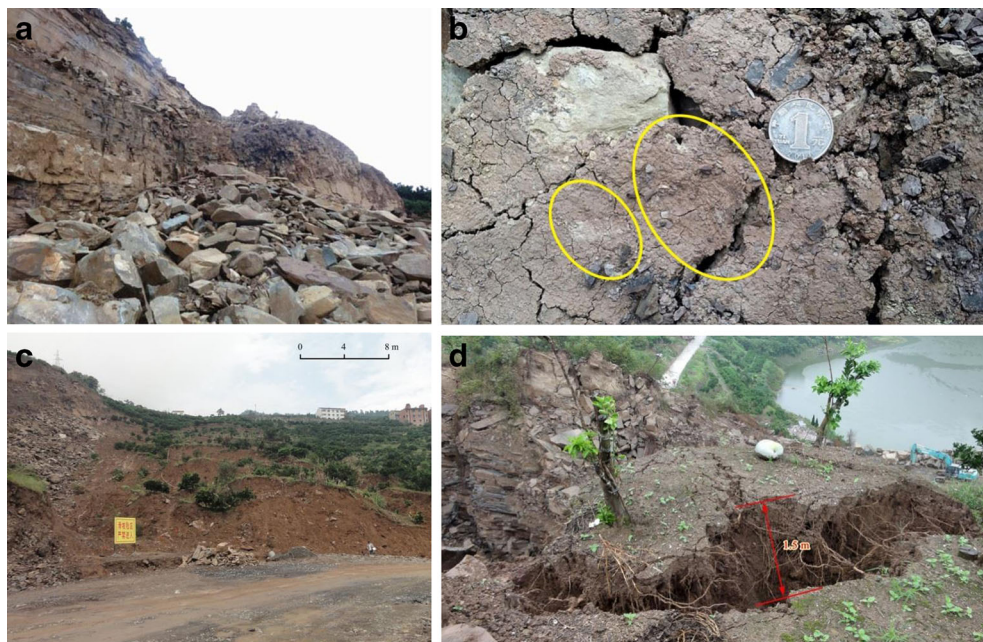
**Fig. 12** Photographs showing the deformation characteristics of the landslide. **a** A great deal of rock blocks and debris in disorder in the upper part of zone I. **b** Scratches on the rock layer between zone I and zone II. **c** Cracks in zone II widely distributed in step-shaped. **d** A big crack along the edge of the south overhanging cliff

Some changes had taken place in topography after this failure event. Figure 12a shows a great deal of rocks and debris in disorder in the upper part of zone I, due to the second collapse of scarp and new-born overhanging rock cliff induced by unloading. The rock layer was nearly vertical with scratches on it for squeezing between I and II subareas (Fig. 12b). Citrus tree on surface land of zone II and zone III, exhibiting slanting and falling, behaves as drunkard, which is a typical displacement feature of landslides. Cracks

in these zones distribute widely in the step shaped (Fig. 12c). Besides these, there is an unloading area nearby the south overhanging rock cliff, where it develops an amount of cracks with different extent sizes ranging from 0.03 to 1.5 m. The closer the crack to the edge of the new-born cliff, the longer and more open it becomes. Figure 12d shows a deep and large crack opening along the edge of the cliff, with the approximate width of 1.5 m resulting from the unloading effect.

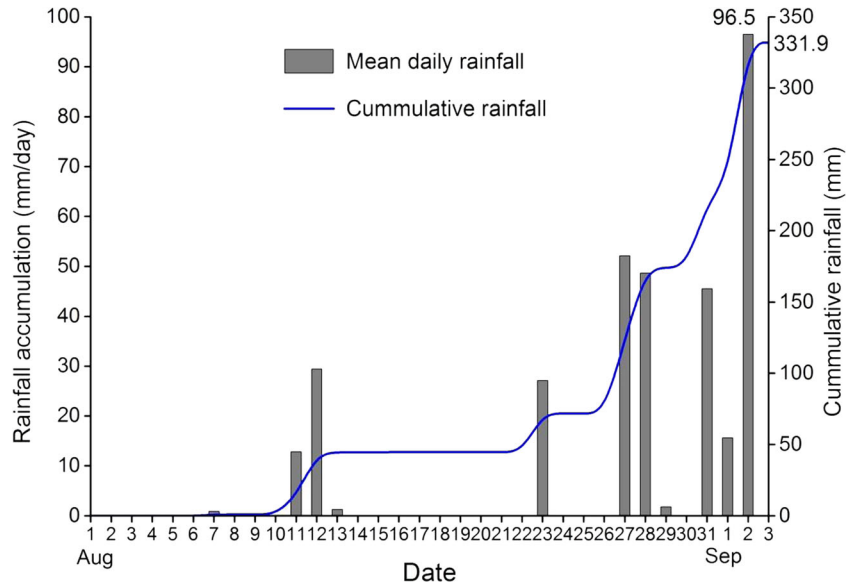
Fig. 13 Precipitation monitored and the cumulative rainfall (from 1 August 2014 to 2 September 2014) in Shazhenxi Station

It is assumed that there is an association between rainfall and landslide due to the week of intense rainfall. Precipitation from 1 August 2014 to 2 September 2014, monitored in Shazhenxi meteorological station, is depicted in Fig. 13. It is clear that high intensity and duration of rainfall was clustered into the last 6 days. The

rainfall on 2 September 2014 (the day of landslide event) was significantly larger than other daily rainfall amounts, reaching up to 96.5 mm. Total rainfall accumulated for 33 days before the event reached as 331.9 mm, which was a very large value in this area.

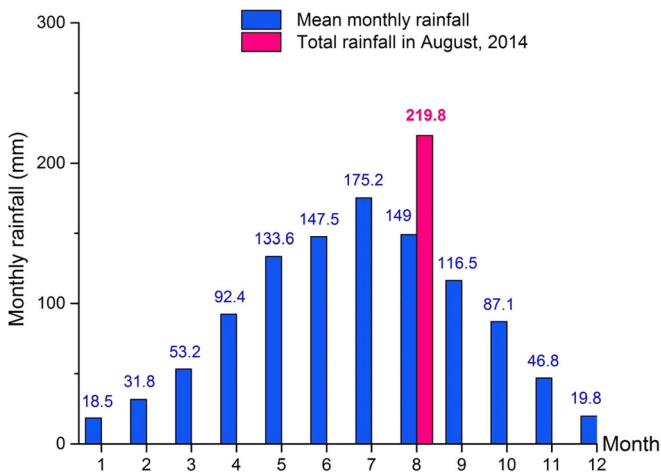
Fig. 14 Mean monthly rainfall of the landslide area over the years

According to the historic records, the rainfall in the landslide area mainly occurs from May to September, with the maximum mean monthly rainfall being 175.2 mm in July and the second being 149 mm in August (Fig. 14). However, the total rainfall in August 2014 reached up to 219.8 mm, which is 1.48 times of the mean monthly rainfall.

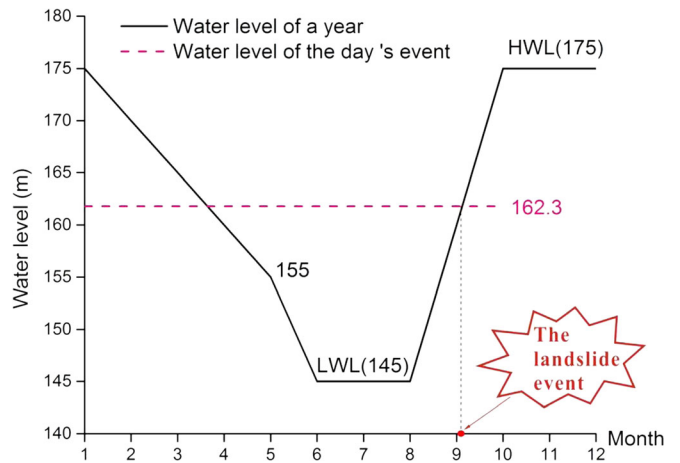
Fig. 15 The annual change of the water level of the Three Gorges Reservoir

The Shanshucao landslide occurred during the period of impoundment of the Three Gorges Reservoir, when the water level changed from the lowest water level (LWL, 145 m) to the highest water level (HWL, 175 m). The change of the annual water level of Three Gorges Reservoir is shown in Fig. 15. Figure 16 demonstrates that the amplitude of water level fluctuation is around 1 m except on September 2, reaching up to 3.8 m dramatically. The rapid rising level has a big impact on the lower part of the slope, where the water content of rock and soil changes suddenly. Firstly, the strength of rock mass in the lower part reduces greatly by soaking in the reservoir water and underground water. Secondly, the uplift

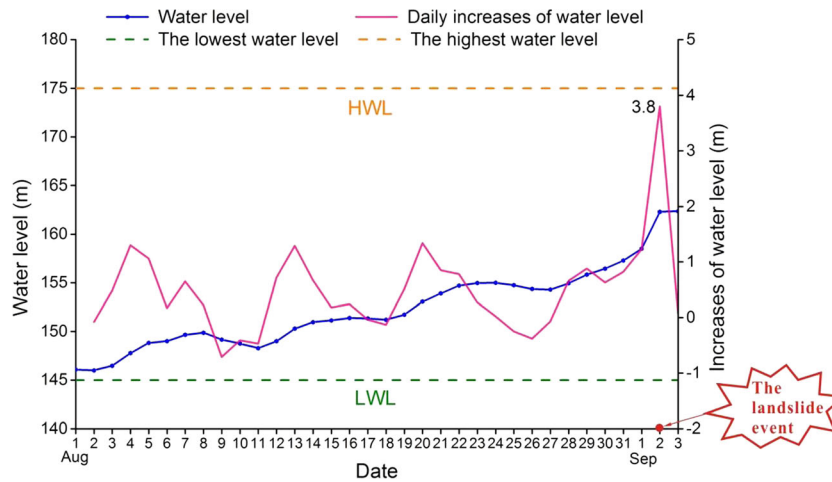
**Fig. 16** Changes of the water level from 1 August 2014 to 2 September 2014 (according to the information of China Three Gorges Corporation)

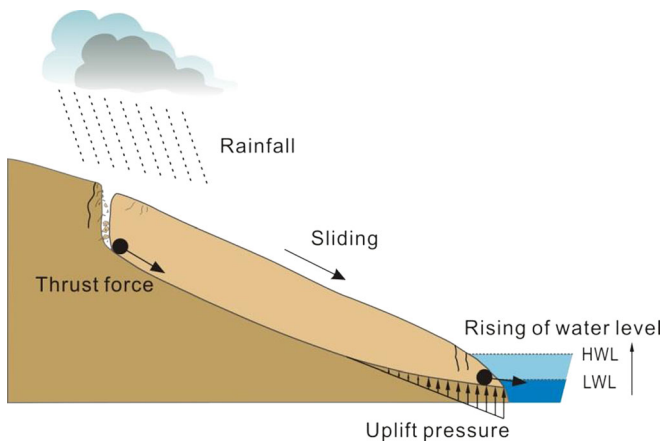
**Fig. 17** The failure mechanism of the Shanshucao landslide

Figure 17 shows the mechanism sketch of the Shanshucao landslide. It is deemed that there are two start-sliding sources in the event: one is at the top of the landslide, and the other is at the foot of the landslide. The cracks and argillation layer in the slope were filled up by infiltration water because of the long rain in August and heavy rain on 2 September 2014, which caused the fracture propagating, pore water pressure growing, and shear strength decreasing of the slope. The fracturing and underground water pressure in the scarp and head push the mass sliding due to the heavy and prolonged rainfall. The groundwater level is rapidly increased by the rising of the reservoir water level that forms larger hydrostatic pressure at the potential sliding surface. Thus, the uplift pressure at the foot, where the mass is submerged, is greatly increased at extreme rapid rate on 2 September 2014, and the normal stress is reduced. In other words, the anti-sliding force is minified, and the sliding force is increased due to the uplift

pressure (Tang et al. 2014; Wang et al. 2014). It can be concluded that the Shanshucao landslide is initiated by two start-sliding sources and deduced that the landslide will not occur only by heavy raining or only by reservoir water level rising factor.
