Landslides (2017) 14:1403–1418
 DOI 10.1007/s10346-017-0796-9
 Received: 28 June 2016
 Accepted: 5 January 2017
 Published online: 28 January 2017
 © Springer-Verlag Berlin Heidelberg 2017

Stability evaluation and prediction of the Dongla reactivated ancient landslide as well as emergency mitigation for the Dongla Bridge

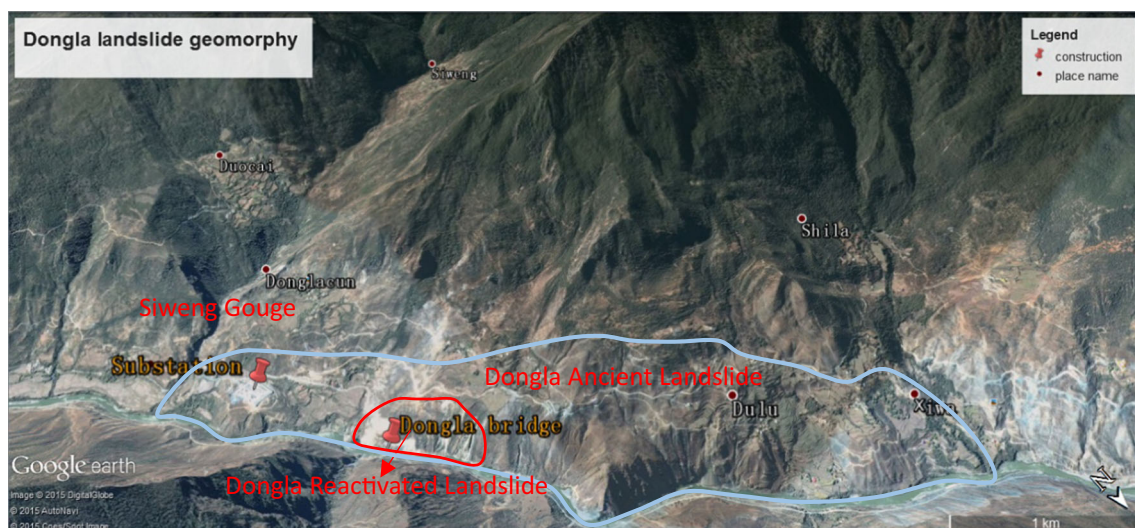
Fig. 2 Delineation of the Dongla Ancient Landslide and Dongla Reactivated Landslide

The Dongla Reactivated Landslide (DRL) is located in the Shuiluo River, 10 km upstream from Shuiluo Village, and 100 km upstream from Muli County of Sichuan Province, China. It is located within an impoverished and sparsely populated mountainous region, connected previously by only poor-quality roads (Fig. 1). Hydropower has recently been developed in this area, and in order to provide a vital road link to a 500 kV electricity substation as well as access to other counties, the 134 m long Dongla Bridge which crosses the Shuilou River was completed in 2011 at the cost of 8 million Yuan. Unfortunately, due to inadequate geological exploration, the bridge abutment was located within a preexisting ancient landslide (Fig. 2), known here as the Dongla Ancient Landslide (DAL).

The drainage basin of the Shuiluo River is located at the transition area between the Qinghai-Tibet and Yunnan-Guizhou Plateaus, in the eastern Hengduan Mountains. The geomorphological pattern is an erosion terrain inclining from north to south with complicated geomorphic types. Due to deep incision cut by the river, the stretch where the DRL developed is 50–60 m wide with a characteristic “V”-shaped valley and 40°–50° bank slopes (Fig. 2).

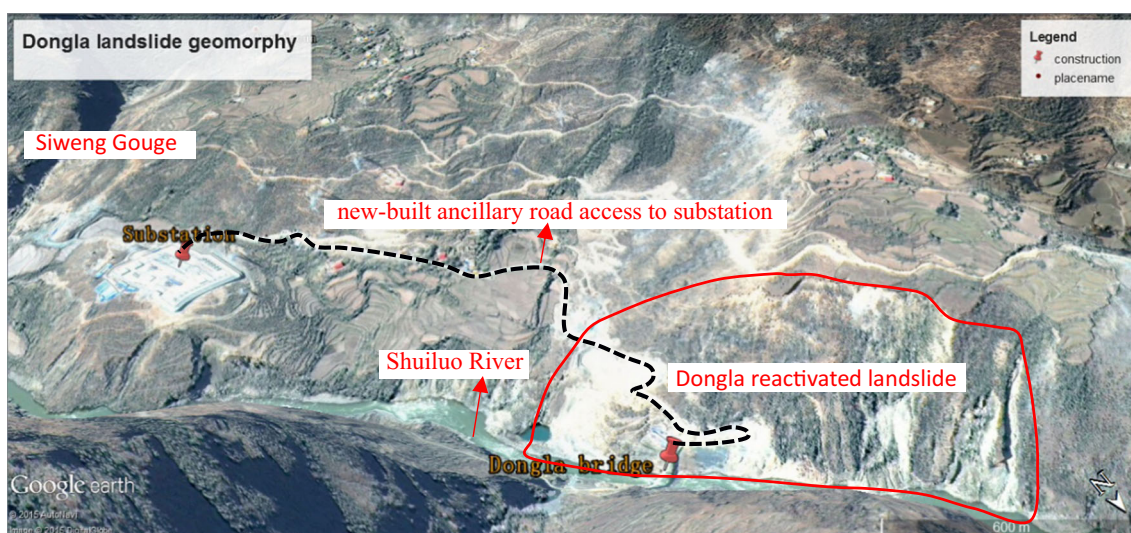
Fig. 3 Location of the Dongla Bridge and Dongla Reactivated Landslide. The construction of the Dongla Bridge and the new ancillary road (black line), as well as the gold mining pits and the gold washing pond destabilized the slope

In addition, the engineering excavation for the new-built ancillary road and bridge construction (Figs. 3, 4, and 5) undercut the toe of slope, resulting in a reduction in the stabilizing force. The influence of this excavation is discussed in detail in “Stability evaluation of the DRL” and “Reactivity mechanism of the DRL” section.

Within the DAL, the width of the DRL source zone along the river is 1200 m, the length is 420 m, the area is 300,000 m², and the estimated volume is 6 million m³ (Figs. 3 and 4). The head scarp is at 2310 m asl and toe at 2115 m asl, resulting in 195-m elevation difference and an average gradient of 28° for this near-planar, translational slide. The chair-shaped rear scarp subsidence is approximately 40–60 m (Figs. 3 and 6). As shown in Fig. 6, the long tensile cracks at the rear and the shear cracks at the lateral boundary make the surface water and rainfall easily infiltrate into the slope.

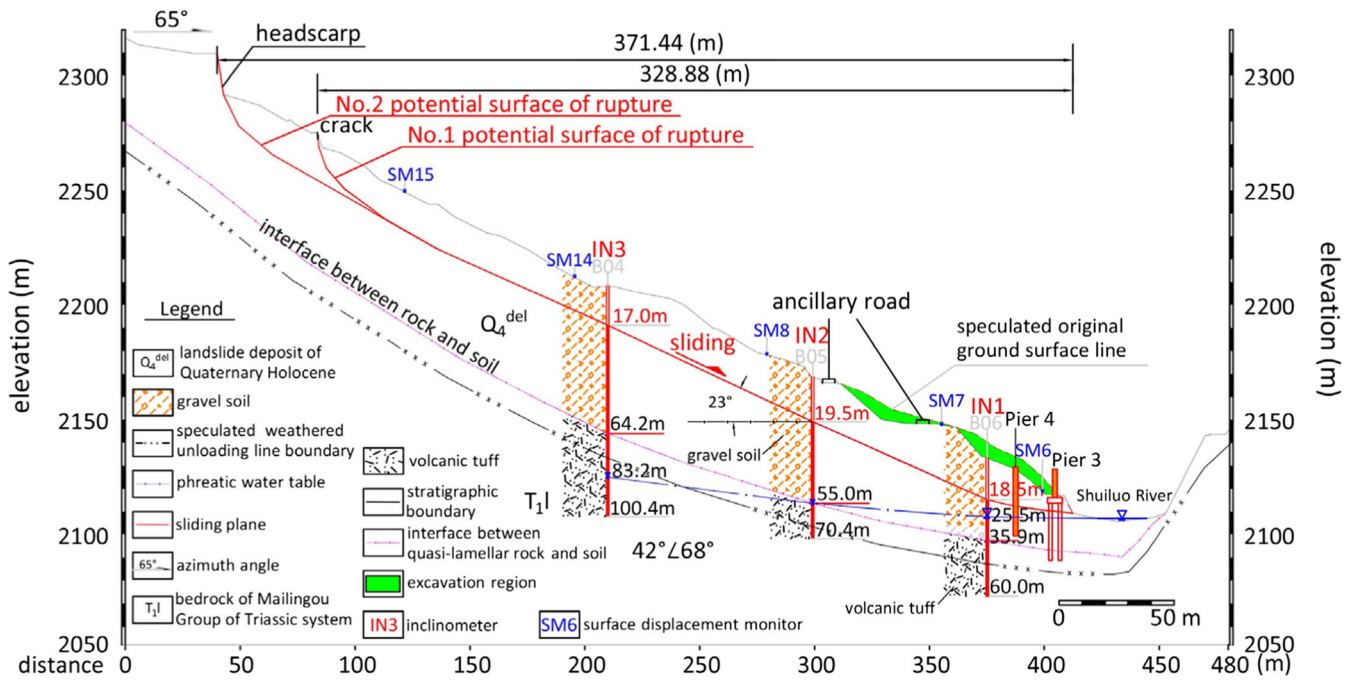
Fig. 5 The monitoring deployment on the geological cross-section (B-B) of the DRL. IN1–IN3 represent the inclinometers, and SM6–SM15 represent the surface displacement monitors

thereafter breached quickly. Considering the seismicity of this area, together with the existence of two escarpments, it seems that the DAL slid twice due to a combination of large earthquake and or precipitation during the Quaternary Pleistocene. A few exploratory holes were drilled at a maximal depth of 100 m to find the sliding plane of the DAL, but this was unable to be confirmed, although fragmental quasi-lamellar tuff rock was located at 36–64 m in depth (Fig. 5).

Three piezometers, P1, P2, and P3, were installed at the bottom of the boreholes (Bo6, Bo5, and Bo4) (Figs. 4 and 5), corresponding to the location of IN1, IN2, and IN3, respectively. The Darcian permeability coefficient, k , of the chaotic landslide deposits was found to be $1.0\text{--}1.4 \times 10^{-3}$ m/s ($\sim 80\text{--}120$ m/day). This high value indicates that any groundwater flowing in the landslide would be highly influenced by the river and recent precipitation. However, the observed groundwater level from piezometers readings was determined as about 2110, 2115, and 2125 m asl, respectively, which is located beneath the sliding plane. Therefore, it would have little

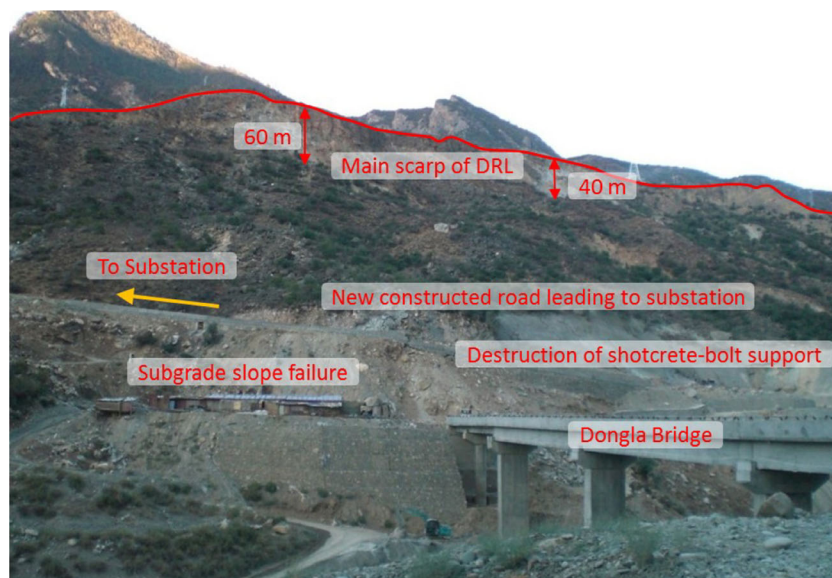
Fig. 6 Main scarp and local deformation features of the DRL. Viewing toward southwest

at the toe of the DRL, collapse of the ancillary road slope, and small brittle fractures on the bridge were observed (Fig. 6). All the failure signs indicated the occurrence of an active landslide (Dong et al. 2015). To try to prevent further deformation, some supporting systems (steel arch and shotcrete-bolt) on the road slope at the hairpin bend were installed in December 2011, but these did not produce the desired effect. From 2012 to 2014, the situation got worse, and many fractures on the top and bottom surfaces of the bridge abutment emerged, putting its operation in danger.

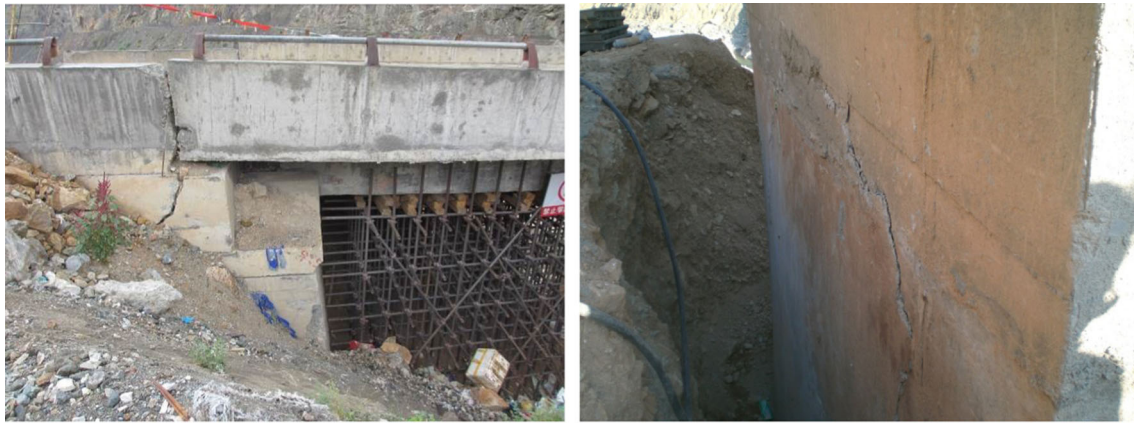
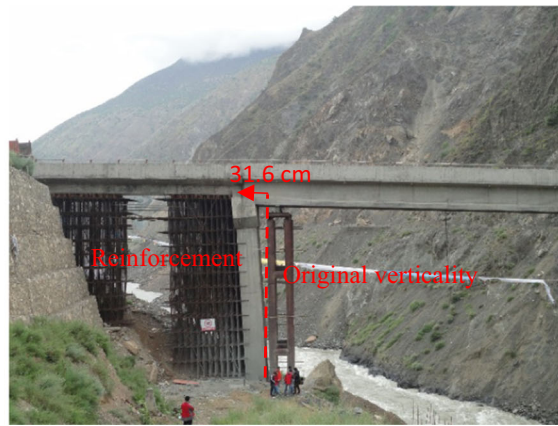
Fig. 9 Damage to bridge abutment and dislocation of bridge deck slab. a Crack of west abutment. b Burial cracks on the back surface of Pier 2. c Deformation of Pier 3

interaction between the thrust of the DRL and the resistance of the bridge’s piers led to large and complex local deformations. The main deformations included bulging and fracture of the bridge deck, distortion and toppling of Pier 3, and bulging and cracking of the retaining wall behind Pier 2 (Fig. 9). Considering the contrast between the deformation of the retaining wall behind Pier 2 and the absence of cracks on the surface of Pier 1 (furthest away from the landslide bank), we inferred that the exit of the sliding plane was at the foundation cap of Pier 2. Until January 2013, the

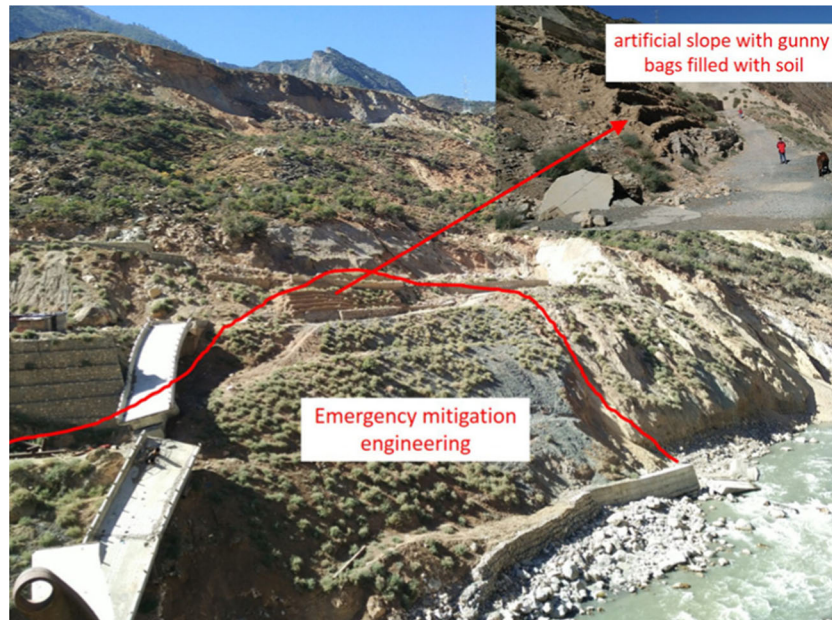
Fig. 15 Artificial slope (photograph taken 12th December 2015)

The artificial slope was constructed between 4th and 20th February 2013, resulting in a satisfactory reduction in the sliding rate (Fig. 11), such that the cracks in soil stopped widening, as inspected visually. On 9th May 2013, nine vehicles carrying the heavy electrical equipment with a total load of 1400 kN passed over the Dongla Bridge. The real-time monitoring showed that, in the process of transportation, the bridge structure produced no abnormal displacement (Dong et al. 2014). Moreover, in the period between 3rd and 28th September 2013, the landslide movements by inclinometers decreased to an average value of less than 6 mm/day.

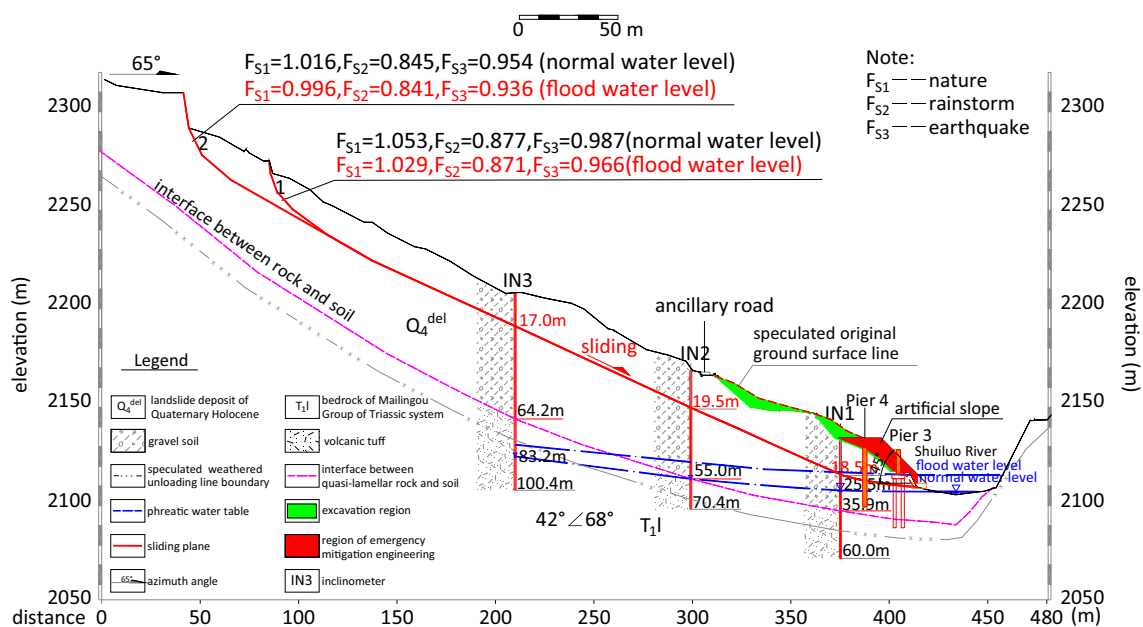
Fig. 16 Stability coefficients of the DRL under different scenarios (B-B cross section)

The integral stability coefficients of the DRL were calculated under three scenarios with two water levels (Table 6 and Fig. 16), which shows that the DRL would be unstable under both rainfall and earthquake conditions.

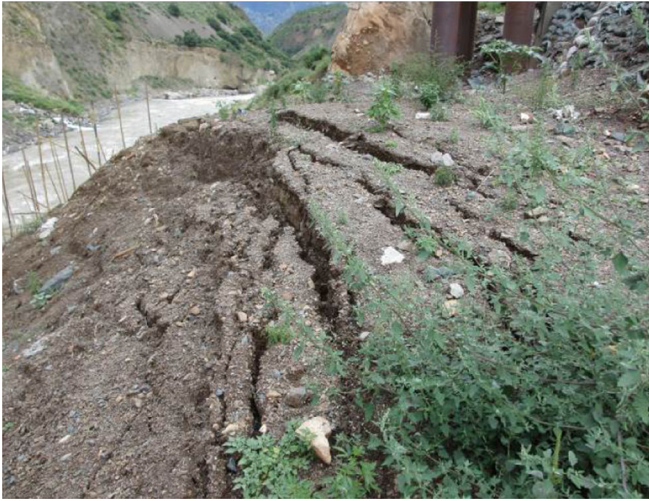
Fig. 17 New emerging arc tensile cracks on the artificial slope (photo taken February 2014)

Although the sliding rate of the DRL was decreased by the emergency mitigation, the displacement still increased slowly. In February 2014, a number of tensile cracks emerged on the artificial slope, presenting a potential risk to the stability of the bridge (Fig. 17). Although the landslide would not be expected catastrophically accelerate under the state of low-speed deformation (Picarelli 2011), a sudden increase of the driving force (due to an inundation, heavy precipitation, or earthquake, etc.) could still lead to the destruction of the bridge. In the worst case scenario, river blockage or surge generation could happen because of the volume, location, and activity of the DRL (Macfarlane 2009). Considering the volumes involved, in the worst case scenario where the moving mass slid coherently in wholly translational sliding, it could block the Shuiluo River and form a landslide dam with a calculated maximum height of 20 m in accordance with the thickness of the

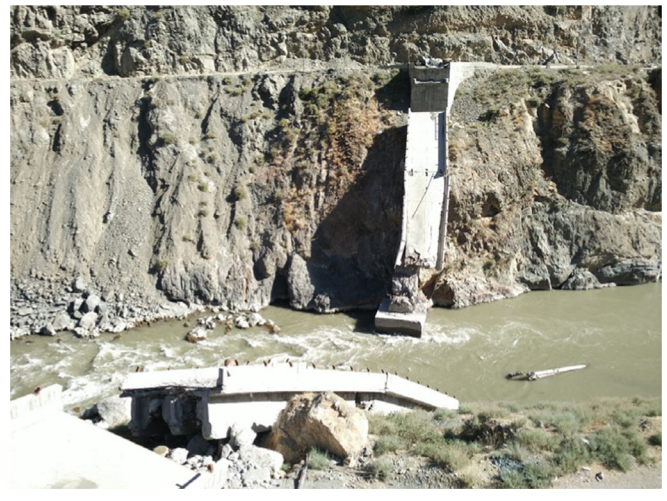
Fig. 18 Dongla Bridge was dismantled by bomb explosion on 12th July 2015

proprietor was in the dilemma of whether sustaining the existing Dongla Bridge with stabilization construction, which would be expensive and probably useless in the long term under the complex geological condition, or establishing a new bridge instead. After comprehensive comparison, the second plan was adopted. Thus, the old bridge was dismantled via a controlled explosion (Fig. 18), and a site to build the new bridge was chosen downstream outside the DAL. In the meantime, the observation of the DRL is still being undertaken to avoid potential landslide hazards.
