Successful early warning and emergency response of a disastrous rockslide in Guizhou province, China

Keywords Landslide early warning · Monitoring · Emergency response · Mitigation measures

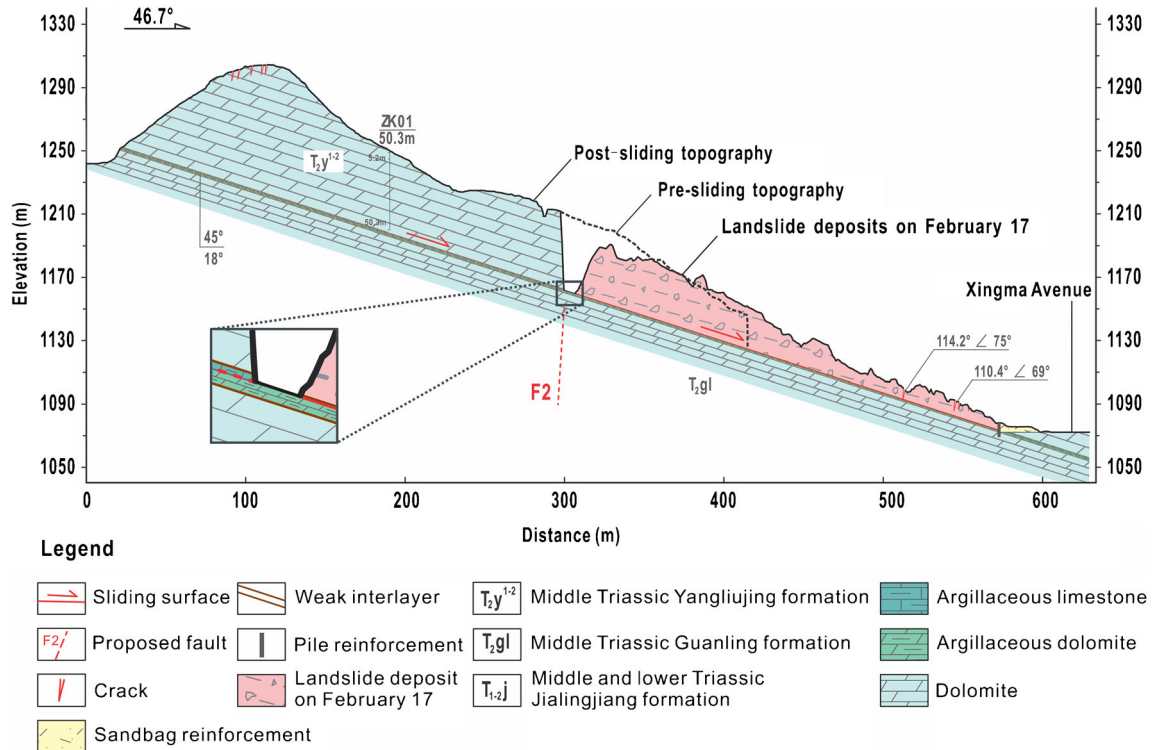
Fig. 3 Longitudinal profile taken along line 1–1' (Fig. 2) of the rockslide after 17 February 2019

As illustrated in Fig. 3, the rockslide body mainly consists of gray-white-colored thick and layered dolomite, a hard competent

rock mass, which slid along a weak layer of bedrock mostly consisting of argillaceous limestone and argillaceous dolomite (see the inset in Fig. 3 for enlarged view showing argillaceous limestone, argillaceous dolomite, and weak interlayer) with an estimated volume of 1.4 million m³. In between the dolomitic rock layers, a 2–5-cm-thick interlayer of clay is found along the front edge of the rockslide. The relative height difference between the peak of the rockslide scar and the road at the foot of the slope is around 252 m. The weak clay interlayers might have made the rock mass prone to sliding under a gravitational effect. From this longitudinal profile (Fig. 3), it was confirmed that the ~40–50-m-tall dolomite block sitting at the uphill with a ~45° slope angle will no longer be stable without additional reinforcements at the slope toe. Considering these aspects, pile reinforcements were constructed and temporal sandbags were stacked at the slope toe, which helped to reduce the impact and travel distance during the 17 February 2019 rockslide (see Sect. [Early warning and emergency mitigation measures](#) for details).

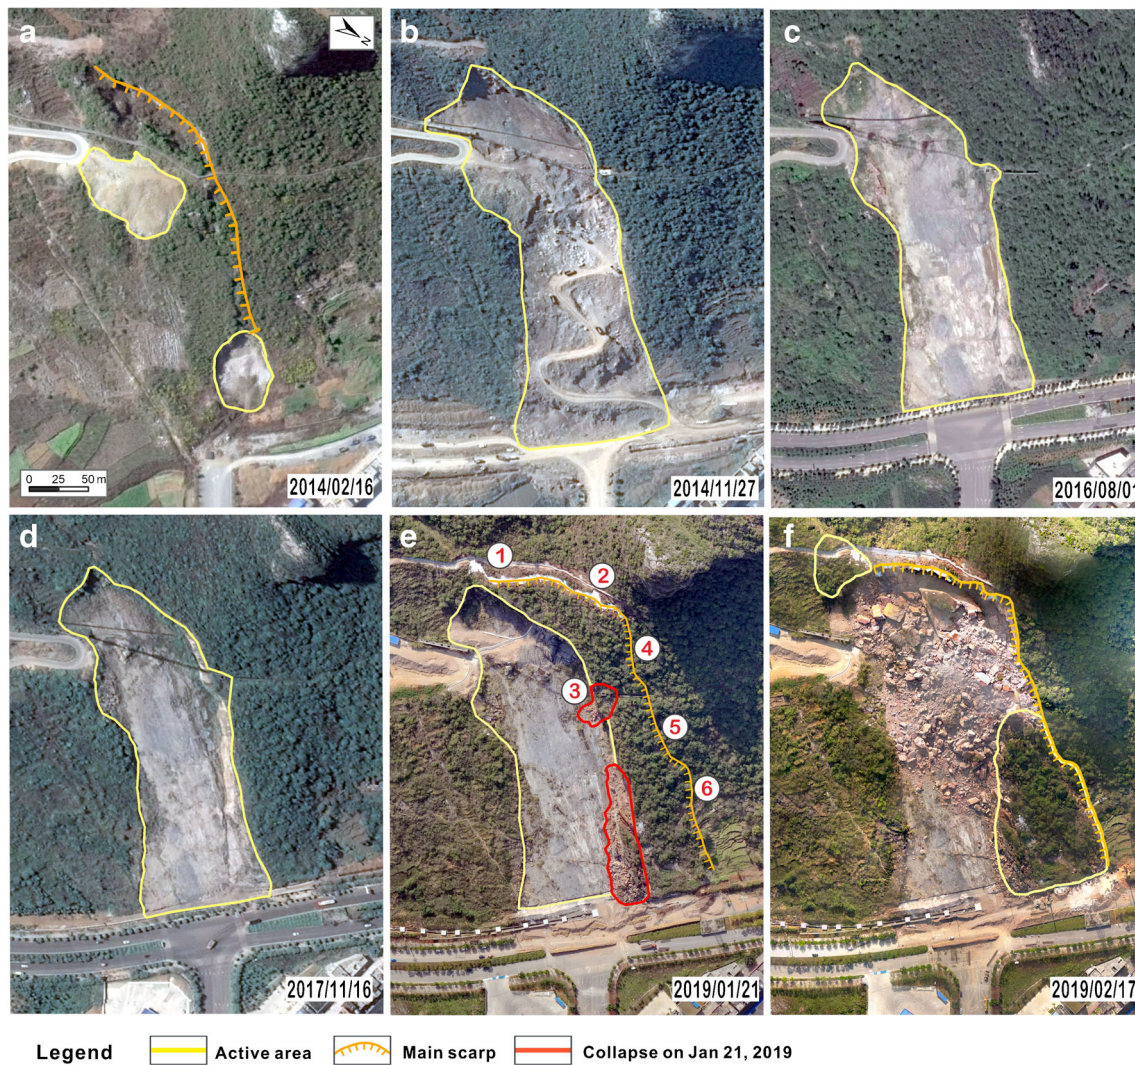
Fig. 4 Visual interpretation of historical deformation of the rockslide from Google Earth images (the date is shown using YYYY/MM/DD format), **a** 2014/02/16, **b** 2014/11/27, **c** 2016/08/01, **d** 2017/11/16, **e** 2019/01/21, and **f** 2019/02/17. The numbers (1), (2), (3), (4), (5), and (6) in (e) are locations of photographs (see Fig. 5) taken along the orange scarp line

The deformation history of the rockslide was analyzed using multi-temporal images obtained from Google Earth since February 2014. The results demonstrate how the discontinuities of the rock mass, i.e., cracks were widened and developed under the influence of anthropogenic activities (Fig. 4a–f). In 2014, there was road construction and expansion of the existing road. The rock mass at the toe of the slope (Fig. 4a) has been excavated, which eventually exposed a major discontinuity (main scarp in orange). The major discontinuity/opening seen in Fig. 4a suggests that the slope had

side on 21 January 2019. The latest and large rockslide occurred at 5:53 a.m. on 17 February 2019, whose boundary is shown in Fig. 4f. This new failure was at the scarp and the sliding surface of the previous rockslide. Figure 4f also shows the highly deformed area affected by the first rockslide, where intensive cracks were developed in Zones I and II and eventually, these zones were found to be potentially unstable after the 17 February 2019 event.

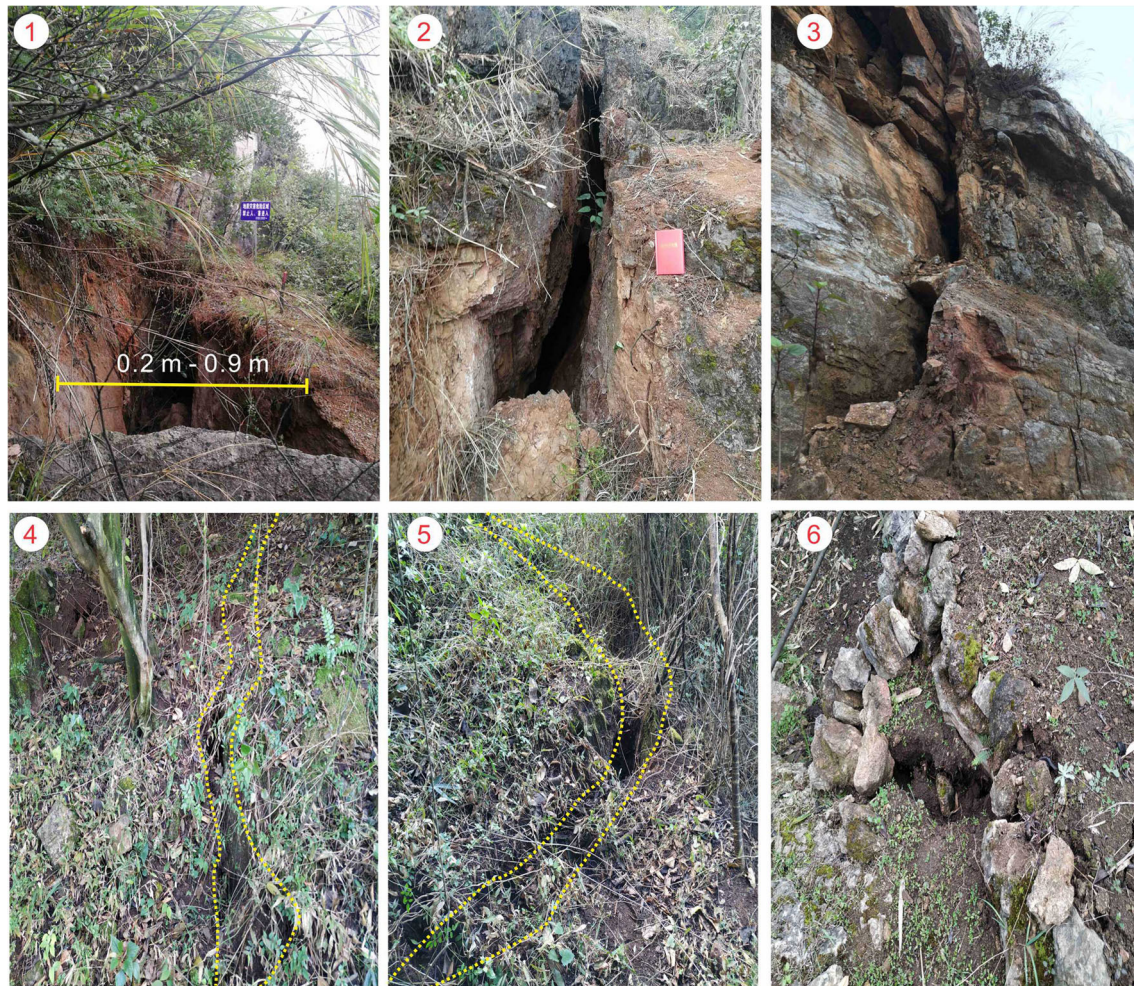
Fig. 5 Enlarged view of discontinuities and cracks found along the landslide scarp (orange line in Fig. 4e) before the 17 February 2019 rockslide. Yellow dotted lines show the cracks surrounded by vegetation

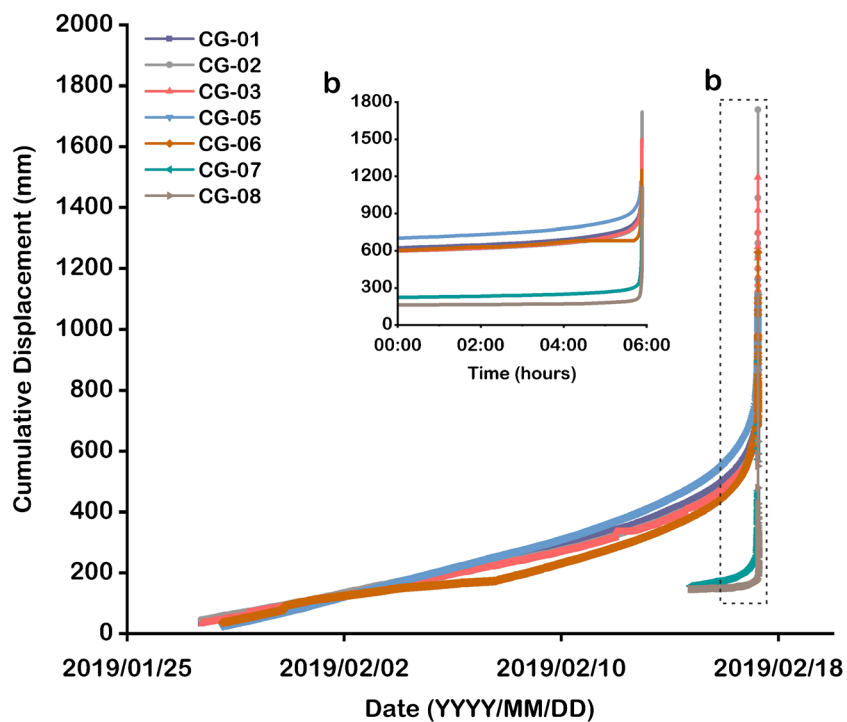
Fig. 7 Displacement measurements from different crack gauges

Among these different sensors, the cumulative displacement obtained from crack gauges present the most continuous and reliable data during the accelerated deformation stage (Fig. 7). It is very important to capture the crucial information of displacement during imminent sliding, and in this aspect, crack gauges were preferred and its monitoring data was taken over to the LEWS instead of other displacement-based monitoring devices, i.e., GNSS. The displacement measurements from the crack gauges

are shown in Fig. 7. A continuous progressive failure has been observed from the data. The inset inside Fig. 7 shows the progressive increase in rockmass displacement few hours before the failure.

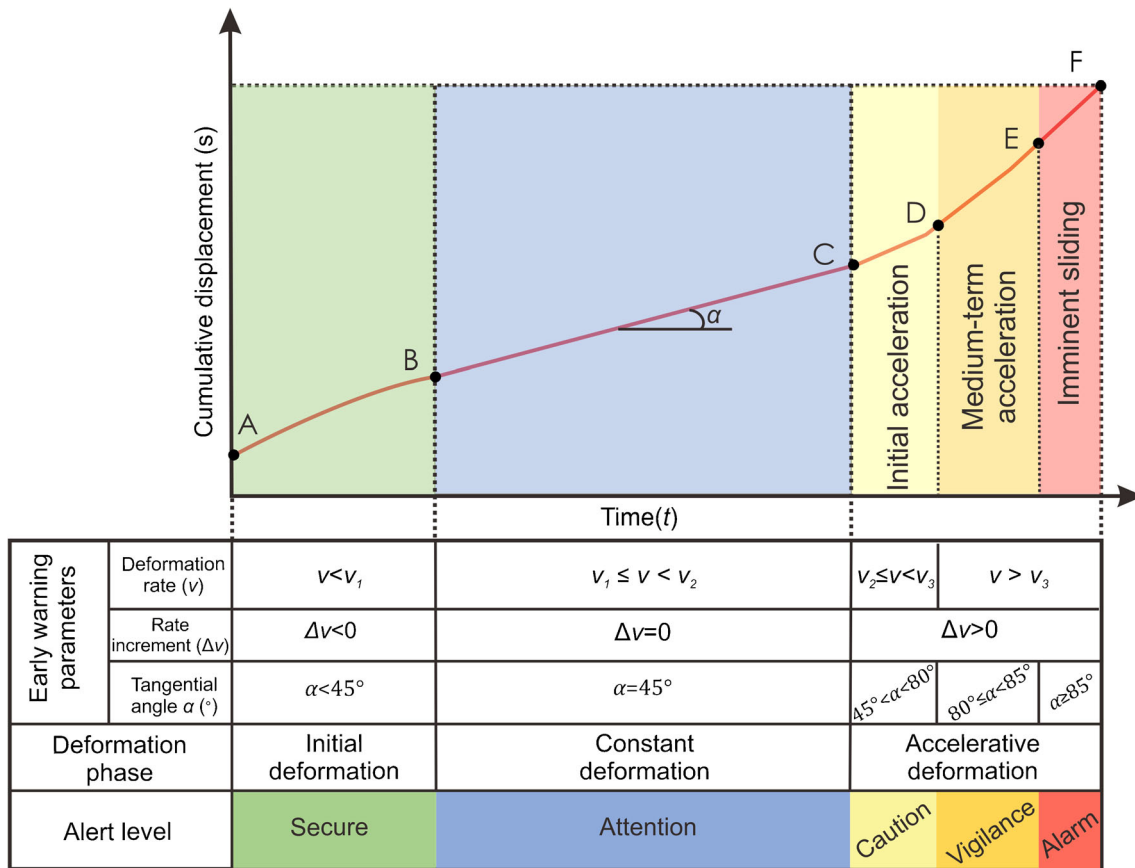
Fig. 9 Concept of warning criteria of the landslide early warning system developed by SKLGP

displacement-time curve at a given time and is used to specify different alert levels. Wang (1999) concluded that the value of α before imminent failure is generally 89° to 89.5° based on back analyses of a considerable number of landslides. Their finding proves that similarity of tangential angle exists among different landslides. This tangential angle method was verified using nine numbers of landslides with different failure mechanisms including rockslides (Xu et al. 2009, 2011) and loess landslides (Qi 2017; Qi et al. 2018). Altogether we analyzed deformation trends of more than 100 numbers of landslides, and out of those, details of 62 loess landslides are described in Peng et al. (2018). These back analyses of more than 100 landslides help to divide the accelerated phase into three sub-phases as illustrated in Fig. 9, which also shows the details of the warning model in our LEWS. Compared with the traditional thresholds of displacement and velocity, the thresholds of the tangential angle can be used for various types of landslides (see Sect. **Early warning and emergency mitigation measures**).

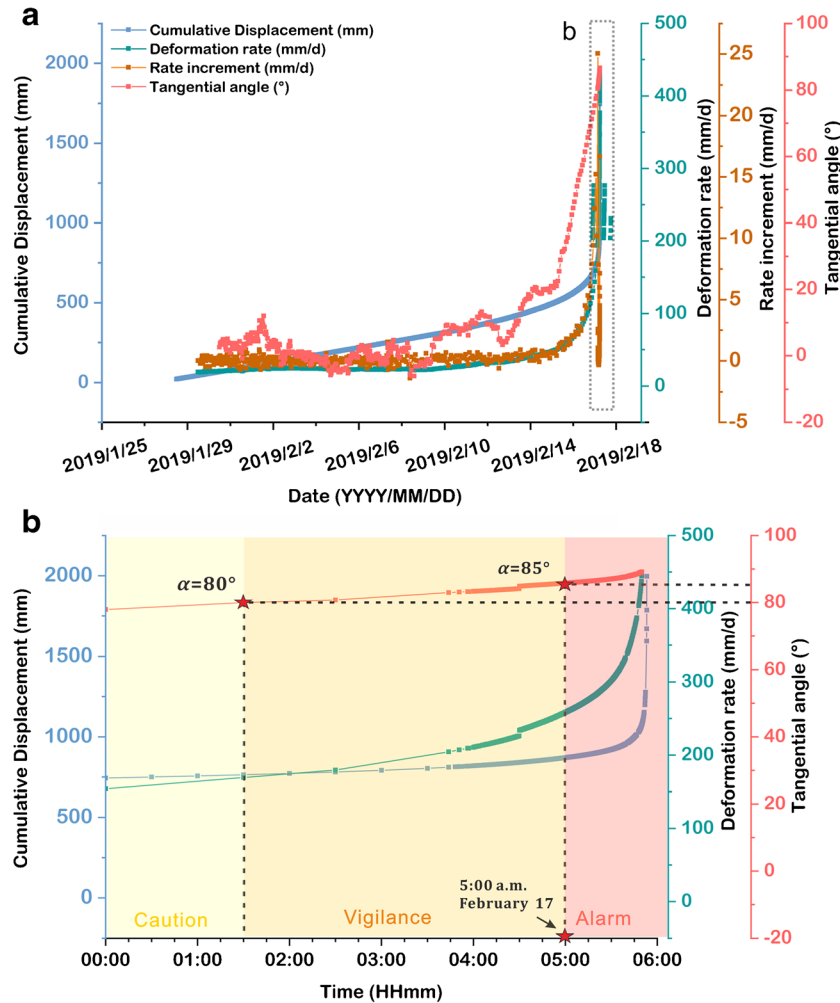
Fig. 10 Cumulative displacement obtained by crack gauge C-05 and the derived curves of α , v , and Δv with corresponding alert levels a data from 27 January 2019 to 17 February 2019 and b data few hours before the failure

The curves of velocity (v), tangential angle (α), and rate increment (Δv) were derived as shown in Fig. 10a. Xu et al. (2011) highlight the importance of fixing the time interval, determining the deformation rate, and the method for calculating the α (Fig. 9) starting from the initial deformation phase. However, in our case, it is worth to note that the slope has already reached the phase of constant deformation when devices were set up and hence the LEWS straightaway started analyzing the real-time data and issued the alert level as discussed in Sect. **Background**.
