Landslides (2020) 17:301–312
 DOI 10.1007/s10346-019-01283-8
 Received: 15 January 2019
 Accepted: 13 September 2019
 Published online: 24 October 2019
 © Springer-Verlag GmbH Germany
 part of Springer Nature 2019

A new prediction method for the occurrence of landslides based on the time history of tilting of the slope surface

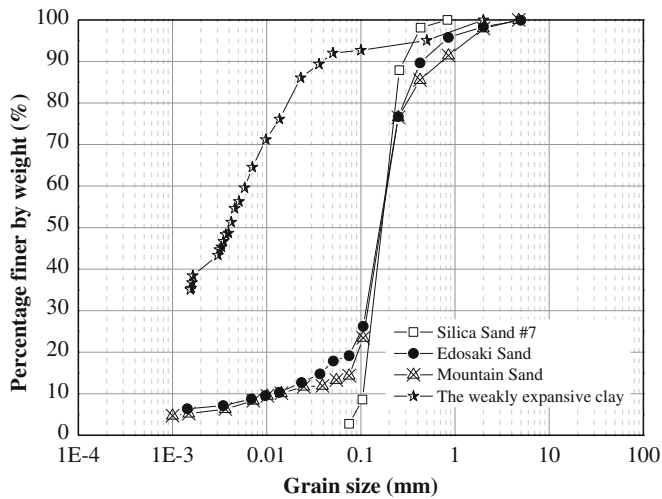
Fig. 1 Particle size distribution of Materials

was 5×10^{-2} cm/s. The particle size distribution of the mountain sand is presented in Fig. 1. The slope model had a gradient of 2:1, and the size was 2.4 m in length, 3.8 m in width and 1.2 m in height as shown in Fig. 4. The main part of the slope model was built on a base, of which the permeability was 5×10^{-3} cm/s, while the toe of the slope model was located on a layer made of loam with the permeability of 5×10^{-6} cm/s. There was a water tank filled with

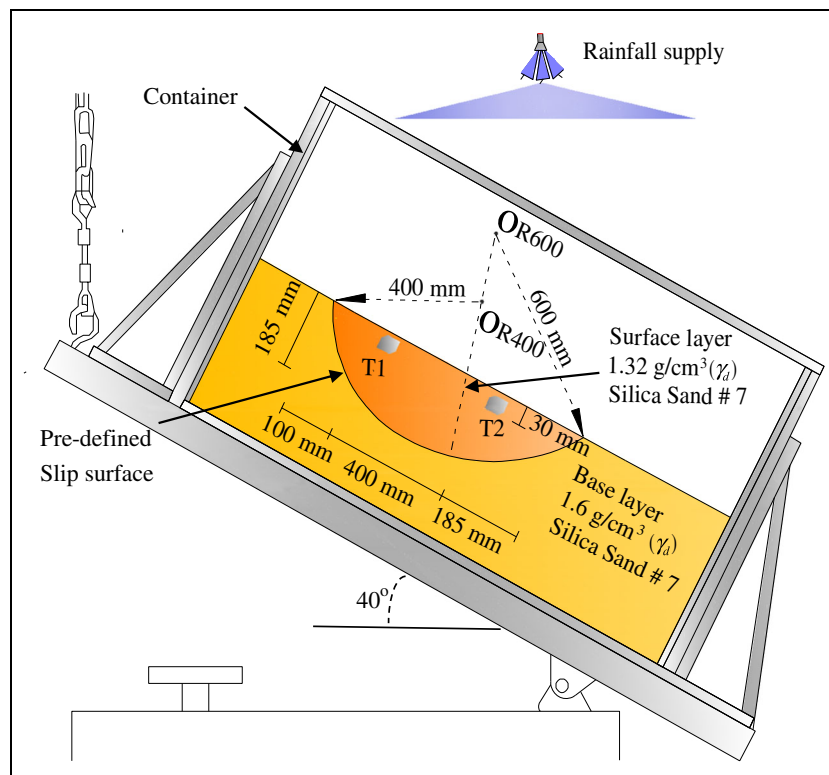
Fig. 2 The cross section of the slope model and the arrangement of apparatuses in Model Test 1

behaviors of the slope. Details for T1 and T2 are provided in Fig. 2. In next step, the slope model was tilted to an angle of 40° using the lifting chain fixed at one end of the container, and then artificial rainfall was applied with a constant rainfall intensity of 70 mm/h to induce the slope failure.

The tilt sensors in Model Test 1, T1 and T2, which were set in the surface layer above the slip surface as shown in Fig. 2, tilted backward when the slope was sliding, and positive tilting angles were obtained (Fig. 8). On the other hand, the tilt sensors in Model Test 2, together with a rod reaching the depth of the slip surface (Fig. 3), tilted forward during the slope sliding, and negative tilting angles were observed as indicated in Fig. 11. In addition, similar to the results in Model Test 2, tilt sensor T1 with the length of 200 mm

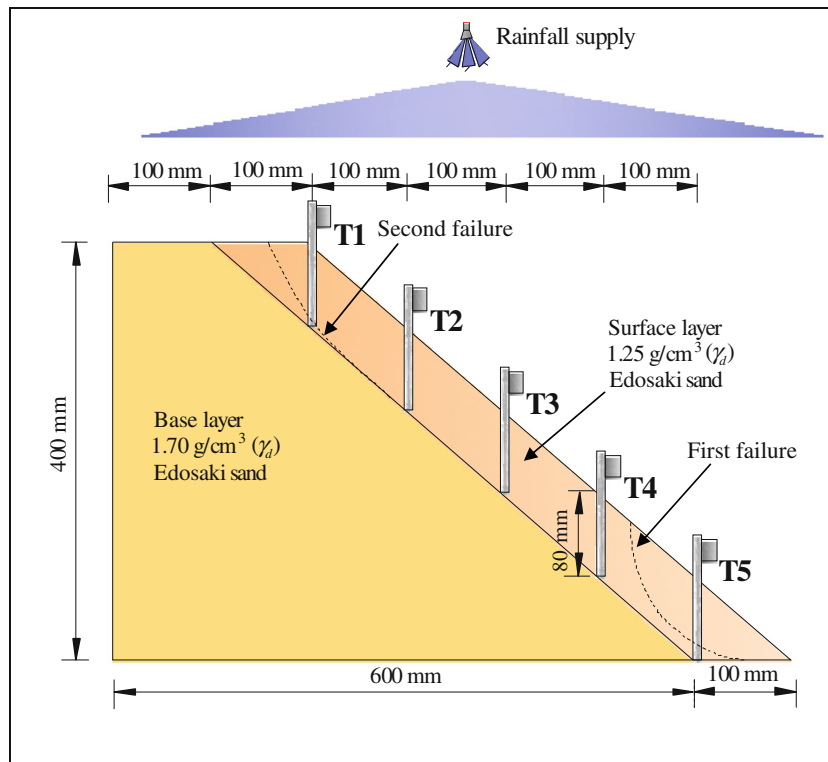
Fig. 3 The cross section of the slope model and the setup of apparatuses in Model Test 2

The illustration of this test and the arrangement of the instruments are presented in Fig. 3. As shown in Fig. 3, the slope model consisted of the base layer and surface layer, which were made of Edosaki Sand procured from a natural slope in Ibaraki Prefecture of Japan (Fig. 1). The G_s of this sand was 2.68, and the permeability for the surface layer was $4.70 \times 10^{-3} \text{ cm/s}$ while that for the base layer was less than $1 \times 10^{-3} \text{ cm/s}$. The base layer of the slope model was made of Edosaki sand with a water content of 14.6%, and the dry density in this layer was about 1.70 g/cm^3 close to the maximum dry density of this material. Compared with the base layer, the surface layer was built with looser dry density around 1.25 g/cm^3 , and the initial water content in this layer was 10%. The thickness of the surface layer was 100 mm with the inclination of 36° . Five tilt sensors were inserted into the surface layer, and the interval between these tilt sensors was 100 mm at horizontal direction as shown in Fig. 3. In this test, the slope failure was also induced by applying artificial rainfall with the constant rainfall intensity of 70 mm/h .

process of the slope in this test is indicated in Fig. 3. As shown in Fig. 3, the slope failure began at the bottom part of the slope before the second failure occurred, and the tilting behaviors of the slope in the first failure was recorded by tilt sensor T5 together with a rod reaching to the depth of the slip surface. After the first failure, the remaining part collapsed subsequently. The tilting behaviors of the slope in this progressive slope failure measured by tilt sensors are presented in Fig. 11. As shown in Fig. 11(b), an accelerating stage of tilting was first detected by T5, and then measured by T4 and T3. The tilting behaviors of the slope measured by T1 and T2 located in the upper part of the slope, were influenced by the deposition of the failed soil at the lower part as shown

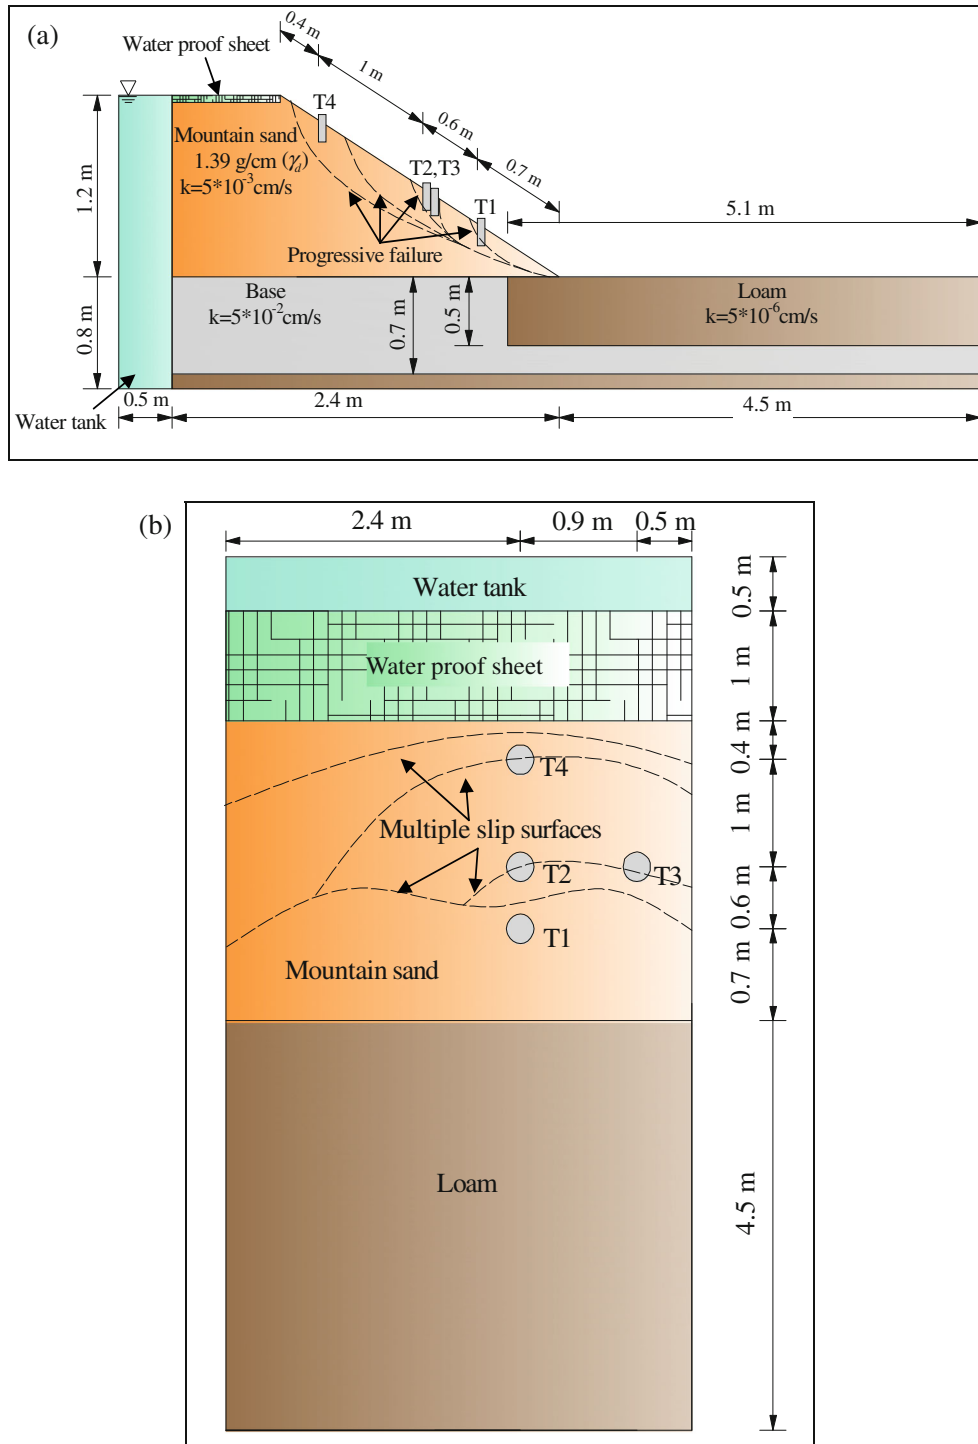
Fig. 4 Model Test 3: (a) The cross section of the slope and arrangement of sensors, (b) The front view of the slope and arrangement of sensors

Progressive slope failure also occurred in this test with multiple slip surfaces, which was triggered by water infiltration from the back of the slope as shown in Fig. 4. Figure 13 indicates the images of the slope model before and after the failure, while the time history of tilting of the slope surface measured by tilt sensors is presented in Fig. 14. The slope failure began at the toe of the slope where tilt sensor

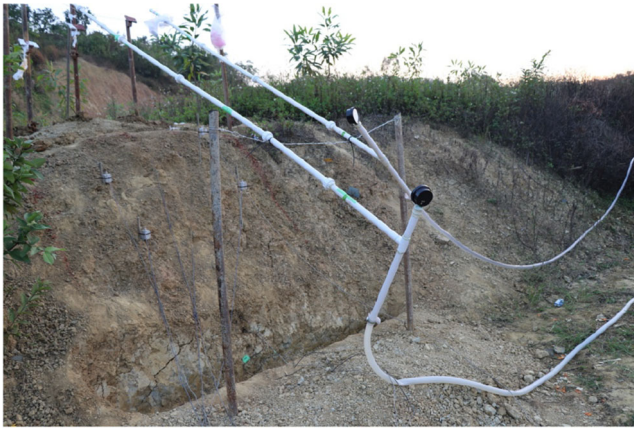
Fig. 5 The image of the testing slope in the field test

A field test was also performed on a natural slope in Baise city of Guangxi province, China (Fig. 5). The natural slope was comprised of weakly expansive clay and the particle size distribution of the material is provided in Fig. 1. The slope angle was around 40°, and the high slope stability at such a steep angle was attributed to the strong structure of the expansive clay. A trench was excavated at the toe of the slope with a depth of 0.2 m to make the slope easier to collapse. Six tilt sensors with different lengths were installed in the slope as shown in Fig. 6. After the installation of tilt sensors, artificial rainfall was applied with a constant rainfall intensity of 21 mm/h, and the major failure occurred in the middle part of the slope four hours later.

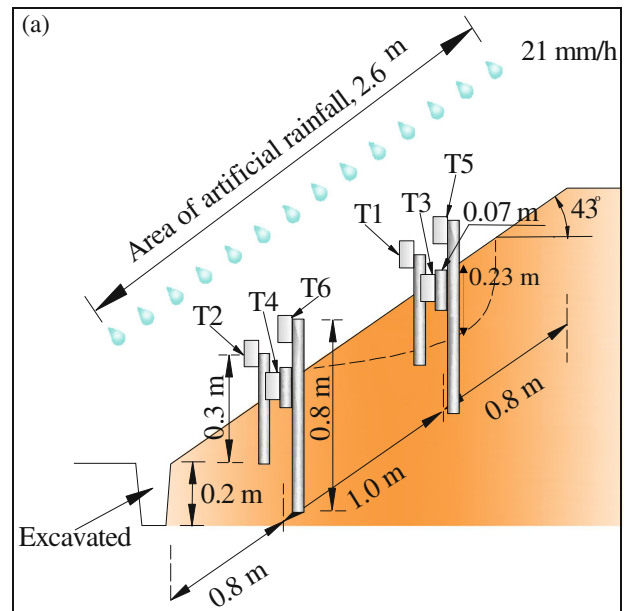
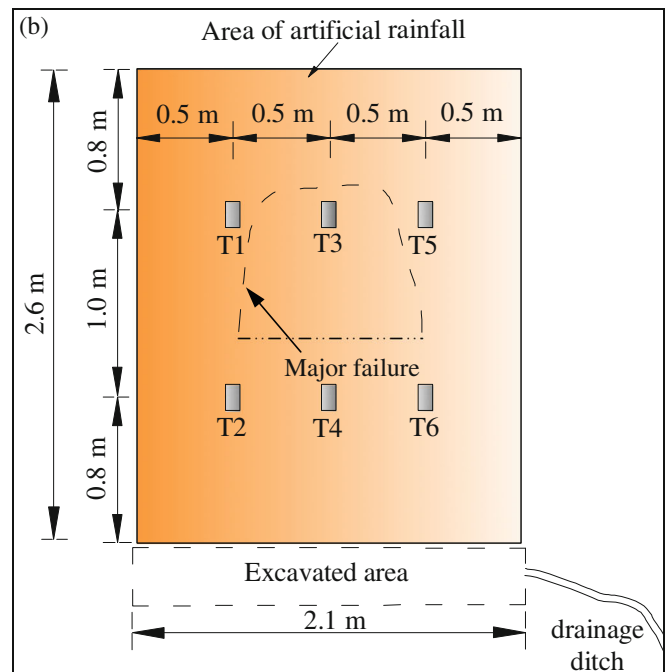
Fig. 6 The field test: (a) The cross section of the slope and setup of tilt sensors, (b) The front view of the slope and setup of tilt sensors

T3 together with a rod of 7 cm was installed. The failed part slid along the slip surface with a depth of 23 cm as shown in Fig. 6(a). The images of the slope before and after the failure are provided in Fig. 17, while Fig. 18 shows the cumulative tilting angle measured by tilt sensors, and an acceleration stage was detected by T3

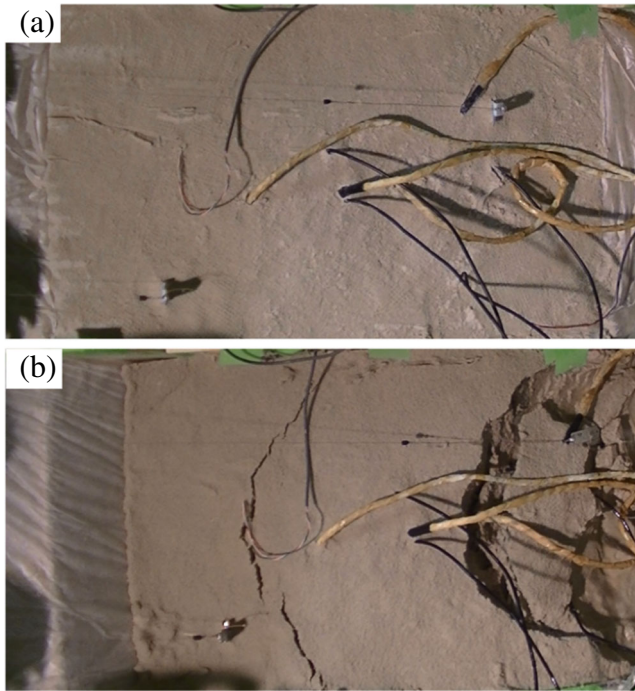
Fig. 7 Images of Model Test 1: (a) The image of the slope before failure, (b) The image of the slope after failure

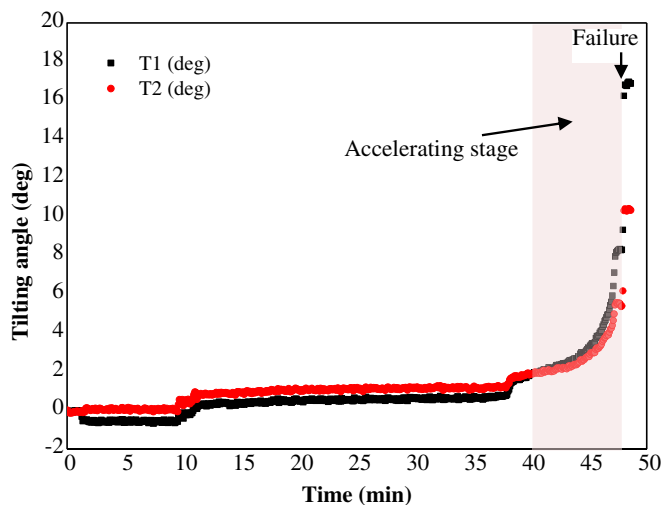
Fig. 8 Time history of tilting of the slope surface measured by tilt sensor, T1 and T2

In this test, the slope failure was triggered by applying artificial rainfall, and the slope slid along the pre-defined slip surface. The tilt sensors, T1 and T2, which were installed in the surface layer above the slip surface, tilted backward when the slope was sliding. In this study, if the tilt sensors tilt backward, positive tilting angles could be observed. Images of the slope before and after the slope failure are presented in Fig. 7. Figure 8 shows the time history of tilting measured by T1 and T2. As shown in Fig. 8, prior to the slope failure, an accelerating stage of tilting is indicated with the duration time of 7 min. In addition, the relationship between the reciprocal tilting rate and the time is presented in Fig. 9. The method for the calculation of the reciprocal tilting rate is provided in Appendix of this paper. Figure 9 reveals linear relationships between the inverse number of the tilting rate and time, and the fitting lines for the linear relationships are also indicated in this figure. Accordingly, the slope failure time can be predicted using the fitting line of T1 and T2 when the reciprocal tilting rate becomes 0 min/°. The predicted slope failure time calculated by utilizing the fitting line of T1 and T2, is 47.37 min and 47.47 min respectively, which is noticeably comparable to the actual failure time of the slope in this test, 47.28 min as shown in Fig. 9.

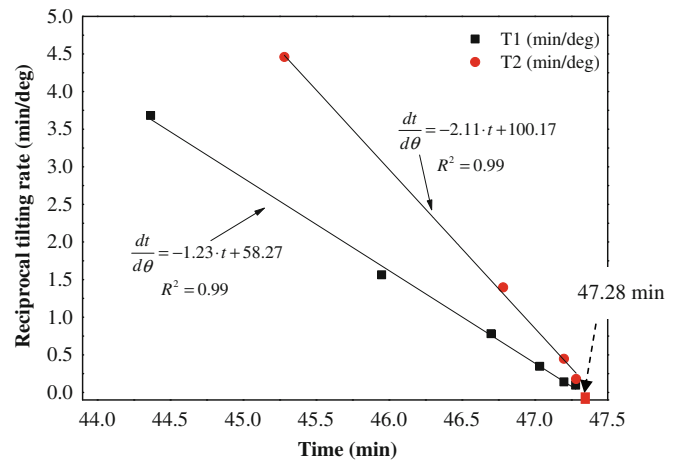
Fig. 9 The reciprocal tilting rate against time of the accelerating stage

In this study, Eq. (2) was validated by three typical model tests as well as a field test, and the test results are indicated in Fig. 9, Fig. 12, Fig. 16 and Fig. 19 respectively. These test results imply that the predicted failure time for the occurrence of landslides approached by Eq. (2) is consistent with the actual slope failure time in this study. Moreover, Eq. (2) shows a similar form to the landslide prediction methods based on surface displacement measurements as shown in Eq. (1) when α becomes 2 (Saito 1969; Fukuzono 1985; Voight 1988). The correlation between the landslide prediction method using tilting measurements at slope surfaces, and the forecasting method based on the slope surface displacement monitoring, has been rarely studied, and further researches should be carried out in the future.

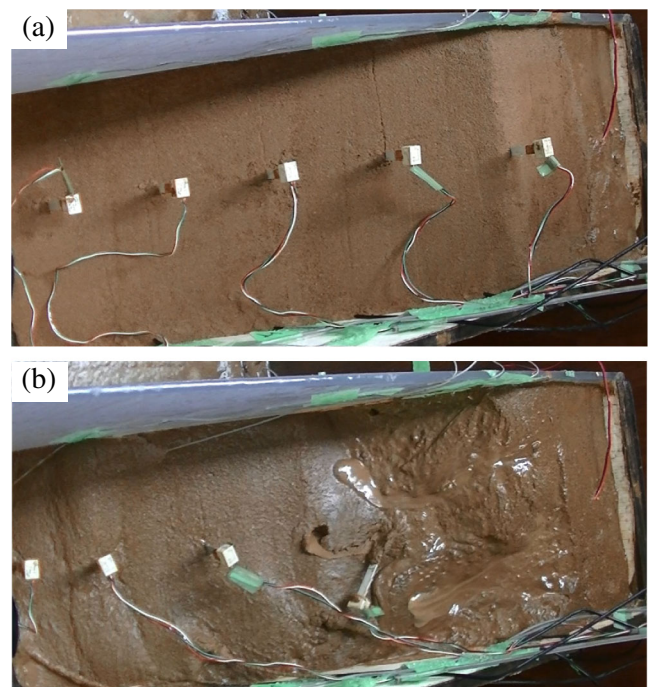
Fig. 10 Images of Model Test 2: (a) The image of the slope before failure, (b) The image of the slope after failure

The slope failure of Model Test 2 was also induced by applying artificial rainfall with the rainfall intensity of 70 mm/h. Figure 10 shows the images of the slope model before and after the landslide. The failure

in Fig. 10(b). Correlations between the inverse number of the tilting rate and time in the acceleration stage of tilting measured by T5, T4 and T3 are indicated in Fig. 12. Linear relations between the reciprocal tilting rate and time are revealed, and the fitting lines for these line relations are also presented in this figure. The slope failure time was computed by using the fitting line of T5, T4 and T3 when the reciprocal tilting rate becomes 0 min/deg, which is 46.33 min, 47.17 min and 46.57 min respectively. Although the slope failure time forecasted based on the data of T3 and T4 is also close to the actual failure time of the first slope failure (46.58 min), the authors suggest to predict the occurrence of landslips in the progressive failure process, using the monitoring data from first

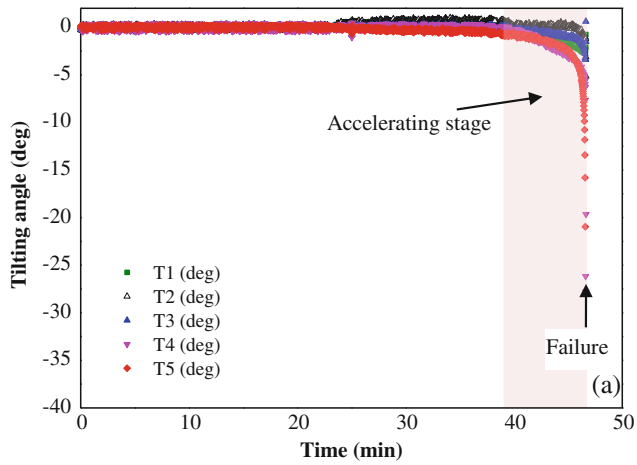
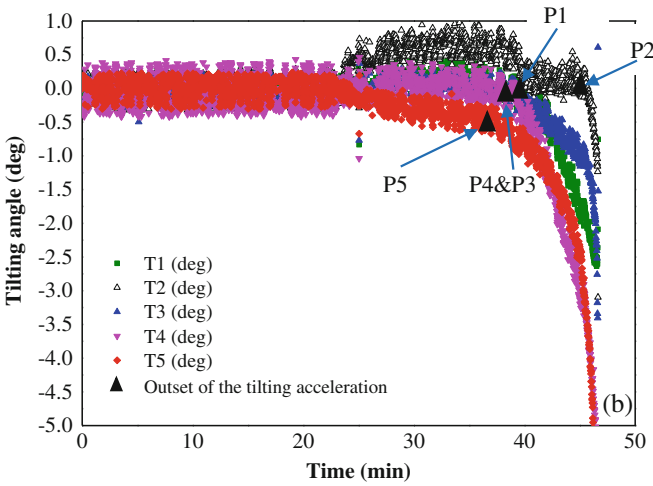
Fig. 11 Time series of the tilting angle: (a) Time history of the slope tilting measured by tilt sensors, (b) Enlargement of Fig. 11(a) with smaller ranges of tilting angles

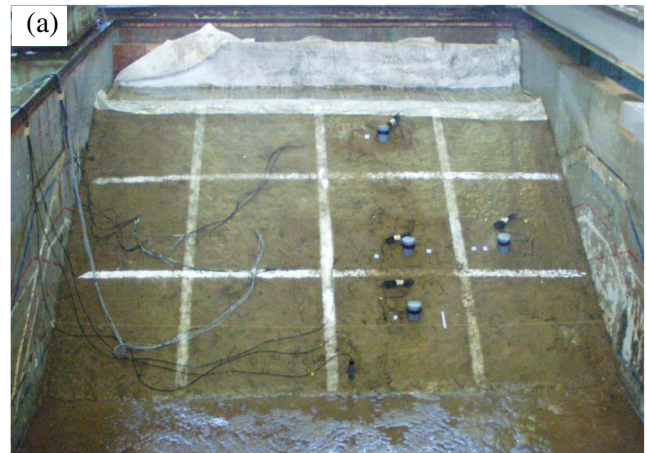
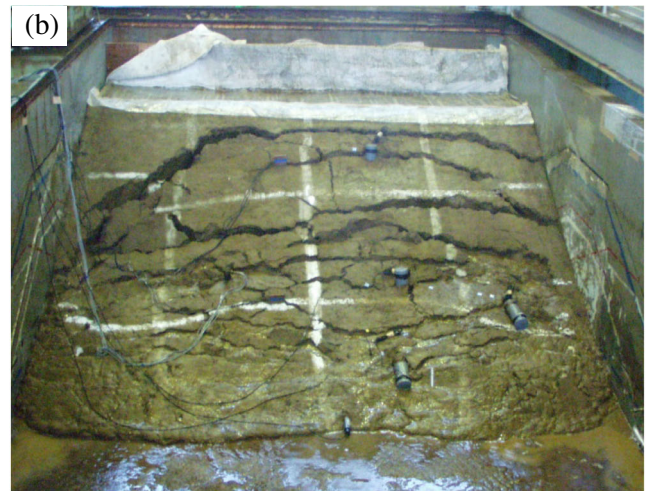
Fig. 13 Images of big scale model test: (a) The image of the slope before failure, (b) The image of the slope after failure

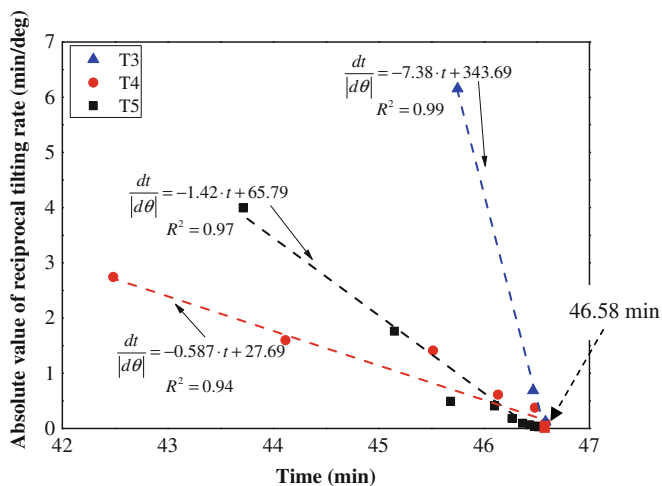
Fig. 12 The reciprocal tilting rate against time prior to the slope failure

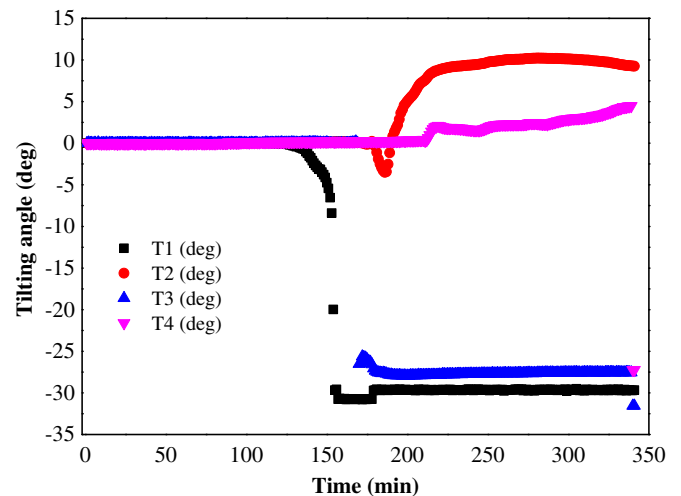
Fig. 14 Time history of tilting of the slope surface measured by four tilt sensors

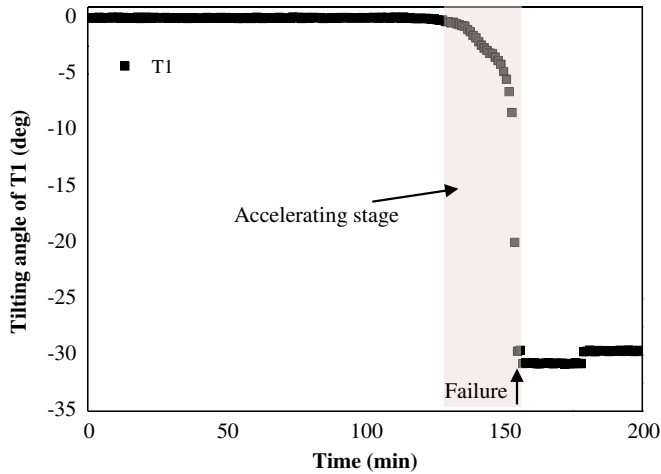
Fig. 15 Time history of tilting of the slope surface measured by T1

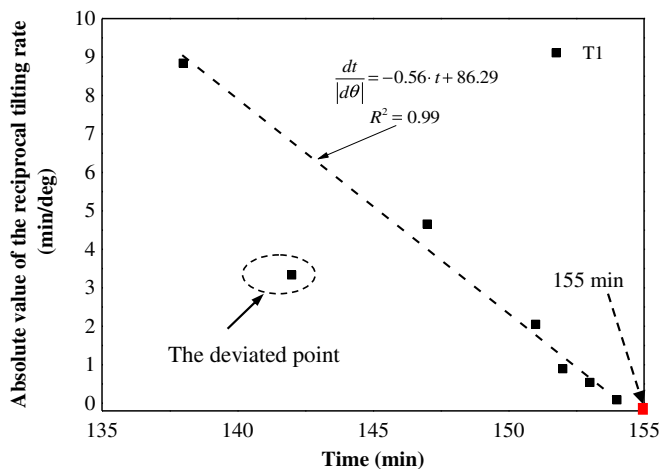
Fig. 16 The reciprocal of tilting rate against time prior to slope failure

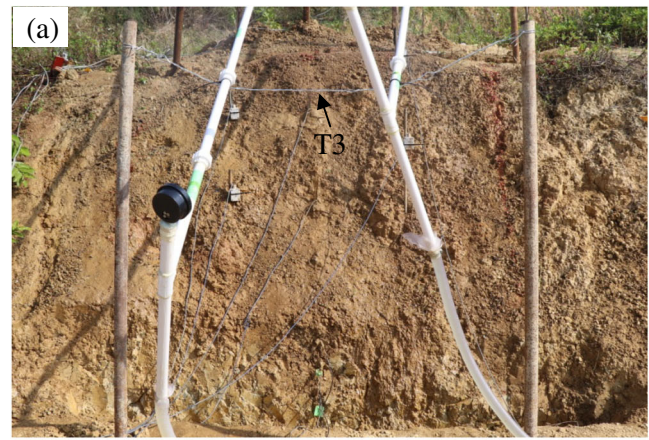
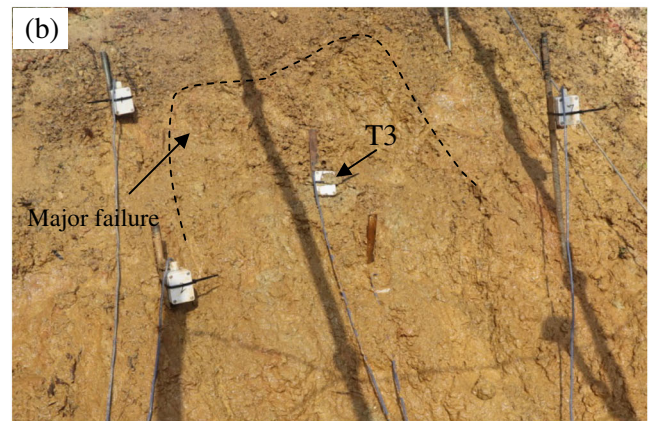
Fig. 17 Images of the field test: (a) The image of the slope before failure, (b) The image of the slope after failure

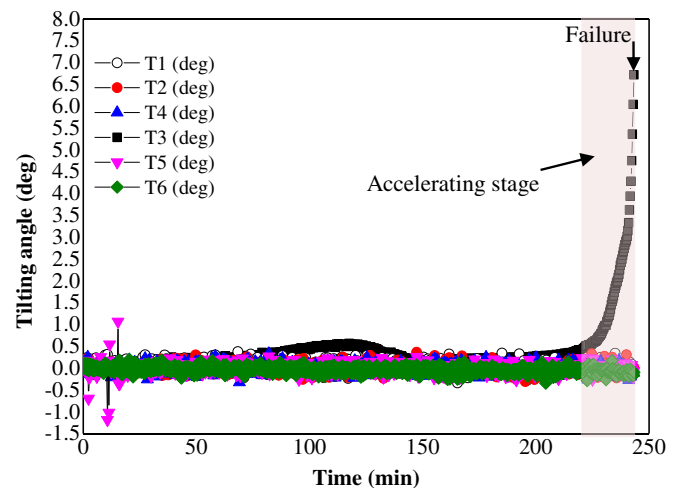
Fig. 18 Time history of tilting of the slope surface

located in the failed part. T3 tilted backward when the slope was sliding, and the result is implied in Fig. 18. Figure 19 reveals the relationship between the reciprocal tilting rate and time in the acceleration stage of tilting before the slope failure, and a linear trend is also indicated in this figure, consistent with the test results mentioned before. The predicted failure time was calculated based on the fitting line of T3 as shown in Fig. 19, which is 243.54 min coinciding with the actual slope failure time, 243.33 min.

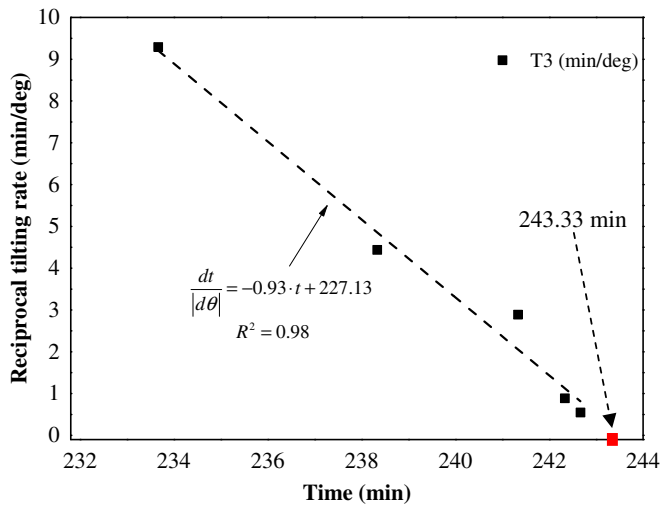
Fig. 19 The reciprocal tilting rate against time prior to slope failure

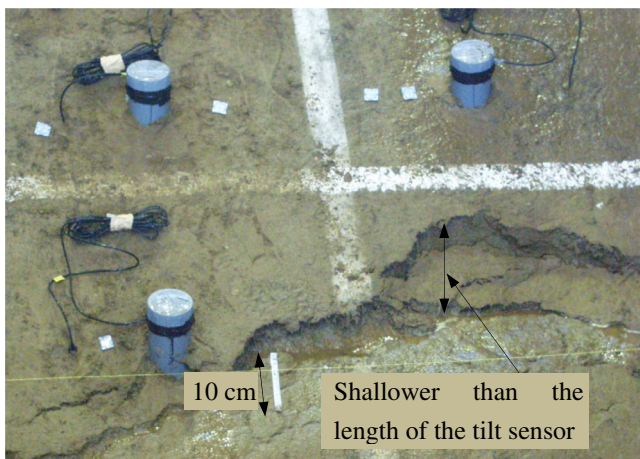
Fig. 20 The initial failure occurred at the toe of the big scale slope model

installed at the lower part of the slope in Model Test 3, also tilted forward, and the depth of the slip surface near T1 was less than 200 mm as shown in Fig. 20. In the field test, the major failure occurred in the middle part of the test slope, and the depth of the slip surface is around 230 mm. The pre-failure tilting behaviors of the sliding mass were detected by tilt sensor T3 which was attached to a rod of 70 mm. The test results as shown in Fig. 18 imply that T3 also tilted backward when the slope was sliding, consistent with the results revealed in Model Test 1.

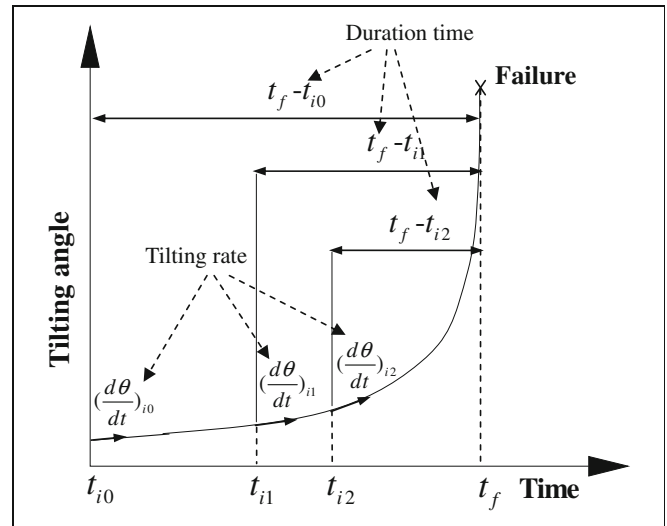
Fig. 21 Definition of the tilting rate and the duration time before slope failure

Additionally, the relationship between the tilting rate and duration remaining in the acceleration stage of tilting before slope failure was also investigated in this study. The physical meaning of the tilting angle rate and the duration time before the slope failure are presented in Fig. 21. As shown in Fig. 21, the tilting angle rate at t_{ij} is $(\frac{d\theta}{dt})_{ij}$, which can be calculated following the method introduced in Appendix of this study, and the corresponding duration time before the slope failure is defined as the time difference between the slope failure time t_f and the time t_{ij} , which is expressed as $t_f - t_{ij}$ as shown in Fig. 21.

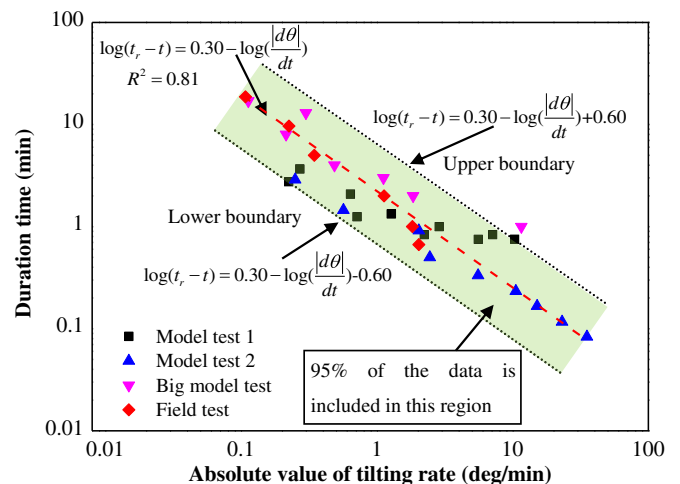
Fig. 22 The relationship between the absolute value of the tilting rate and duration time before slope failure

The authors plotted the tilting rate against the duration time in logarithmic space as shown in Fig. 22, and the data in this figure

were derived from the tests presented in this study. Figure 22 reveals that the duration time decreases with the increase of the tilting rate, and it also implies a linear trend between the tilting rate and duration time in logarithmic space. The relation for this linear trend based on Eq. (4) is also presented in Fig. 22, and the coefficient of determination (R^2) is 0.81. The expression for the relation is given as Equation ID=t=t

This fitting result gives the validation of Eq. (4). Additionally, Fig. 22 also indicates that most data is situated in a region with clear boundaries. In this study, the region was defined to contain 95% of the data sets, and the formulas for the boundaries of this region can be given as Equation ID=t=t b 10pt

Equation (6) can be considered as a potential method to evaluate the duration time within a range at an arbitrary tilting rate in the pre-failure stage. With the increase of data volumes, the precision of the formulas presented in Fig. 22 can be improved, as well as the confidence in evaluation of the duration time at any specific value of $\frac{|d\theta|}{dt}$.

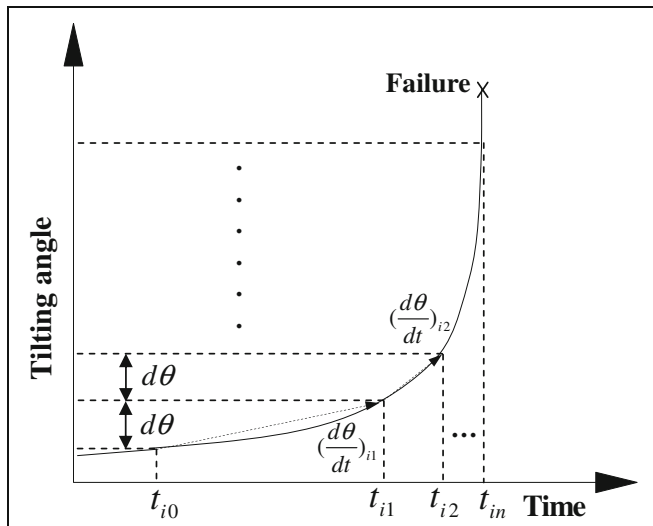
Fig. 23 The method of data selection for analysis in the accelerating stage of slope failure

In this study, the data series for analyzing were selected with an interval of 1° in the accelerating stage before slope failure considering the influence of noises as well as the fluctuation of the monitoring data which is close to 1° . As shown in Fig. 23, the tilting rate can be approximated using the following equation
