Landslides (2020) 17:191–204
 DOI 10.1007/s10346-019-01309-1
 Received: 30 June 2019
 Accepted: 24 October 2019
 Published online: 15 November 2019
 © Springer-Verlag GmbH Germany
 part of Springer Nature 2019

The September 16, 2017, Linjiabang landslide in Wanyuan County, China: preliminary investigation and emergency mitigation

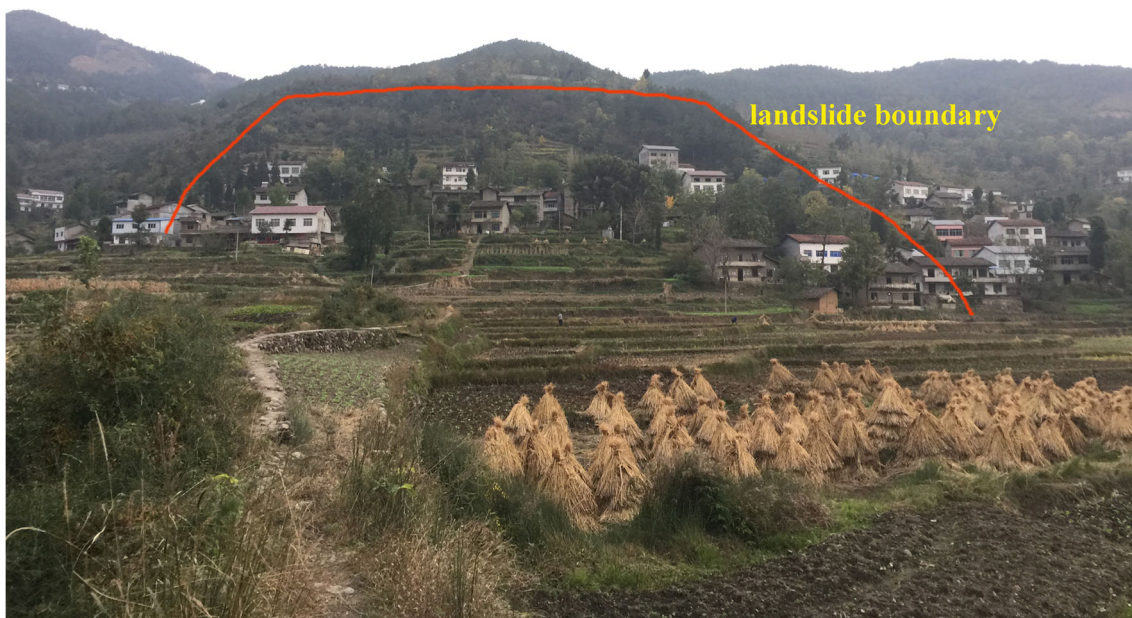
Fig. 2 Panoramic photograph of the landslide

The landslide occurred in Shuitianba village in Wanyuan County, Sichuan Province (Figs. 1 and 2). Shuitianba village is situated in the northeastern sector of Sichuan Province, on the southeast limb of the Shiziba anticlinorium. It is located approximately 541 km from Chengdu, the capital of Sichuan Province. The study area is located in the transition zone between the Tibetan Plateau and the Sichuan Basin, and its topography includes low–middle mountains and hills. Through field investigation, the bedrock exposed in the region is the Middle Triassic Badong Formation (T_2b), which consists of pelitic limestone intercalated with thin mudstone. A mantle of Quaternary deposits overlies the Badong Formation, and the deposits mainly consist of residual and diluvial deposits as well as reworked landslide deposits. According to the Dazhou Meteorological Bureau (<http://www.dzjzw.com/>) in Sichuan Province, this area belongs to a subtropical monsoon climate with a mean annual temperature of 14.7 °C. The annual average rainfall from 1985 to 2017 is 1232.7 mm, with a minimum of 771.2 mm in 1962 and a maximum of 2218 mm in 1988. The rainfall mainly concentrates in June to September and accounts for 65.94% of the annual rainfall.

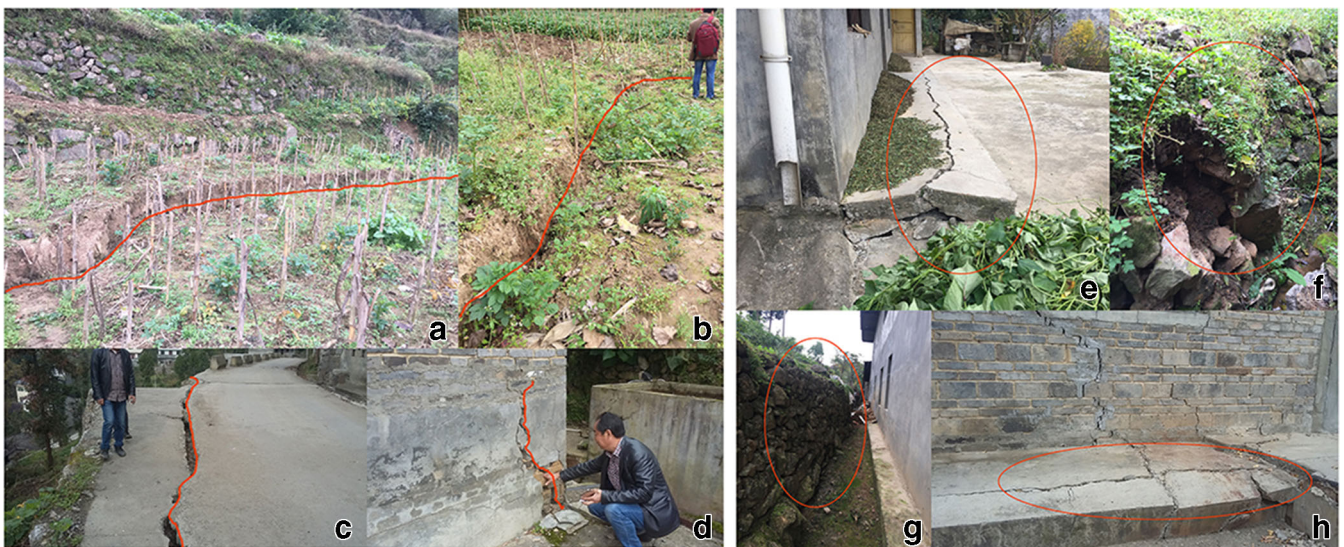
Fig. 4 Cracks and bulges have been observed within the landslide body. a Crack C1. b Crack C2. c Crack C5. d Crack C9. The locations of bulges are shown in Fig. 3

A significant number of tension cracks, minor scarps and bulges have been found on the landslide surface (Fig. 4). Detailed

site investigations and inquiring local inhabitants revealed ten tension cracks developed gradually at the middle and rear region of the landslide. These cracks have lengths of 7–95 m, widths of 5–30 cm, observed depths of 10–50 cm, and vertical displacements of 10–60 cm. The cracks caused damage to some houses; moreover, two long continuous tension cracks developed along the concrete road at an elevation of 824 m.

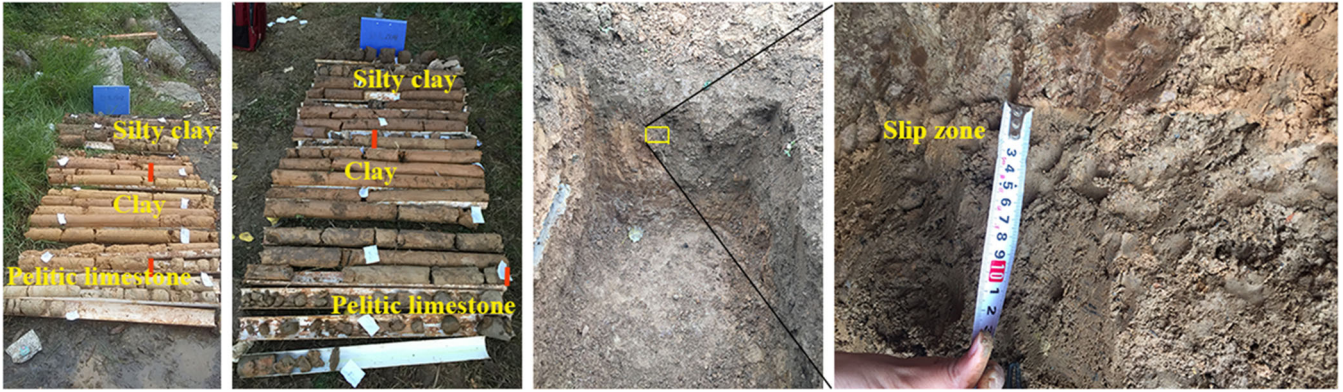
Fig. 5 Lithological stratigraphic logs of boreholes (B02 and B05) and the slip zone of the Linjiabang landslide exposed by exploratory trench

Boreholes and exploratory trenches are used to investigate the geological structure of the landslide and potential slide surfaces. The locations of the boreholes and the exploratory trenches are shown in Fig. 3. The landslide structure, including silty clay, clay, and pelitic limestone, is shown in detail in Fig. 5. Based on the boreholes and the exploratory trenches, two slip surfaces S1 and S2 were found (Figs. 5 and 6). The upper slip surface is a secondary slip surface at a depth of 2.5 to 10.8 m, and the lower one is the

entire slip surface along the interface between the bedrock and the overlying deposit at a depth of 10.3 to 18 m. The sliding zone is a continuous, 15- to 30-cm-thick zone. To obtain the shear strength parameters of the slide zone soil, the shear test was implemented with a direct shear apparatus. The friction angle and cohesion of the saturated sample were 8.5–9.7° and 18.1–19.4 kPa, respectively.

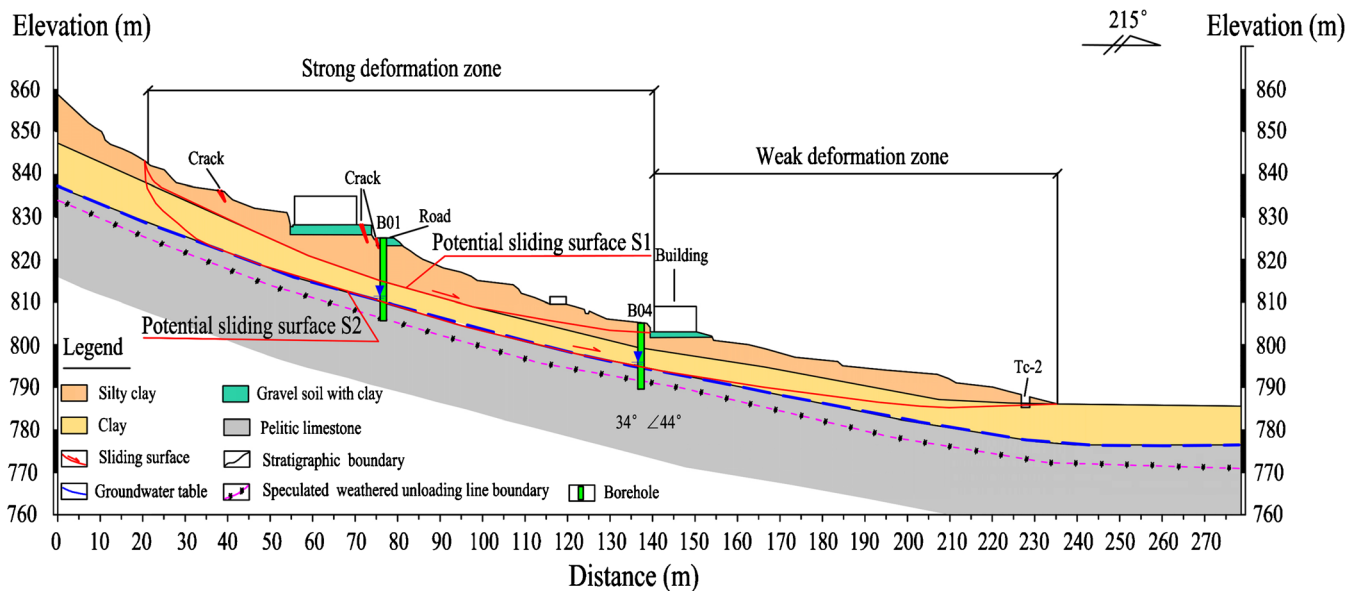
Fig. 6 Longitudinal geological profile 1-1' (Fig. 3)

Figures 6, 7, 8, 9, and 10 show the structure of the landslide material and the groundwater level in the landslide area. According to the stratum lithology and hydrogeologic conditions of this landslide, the groundwater in this area is mainly carbonatite karst water, which could be found in the contact zone between the bedrock and the overlying deposits. Groundwater is discharged to the ground surface in the form of a spring (Fig. 3). The spring on the southeast of the landslide yielded a flow of 0.1 l/s (6.0 l/min), which could be observed during the dry period every year.

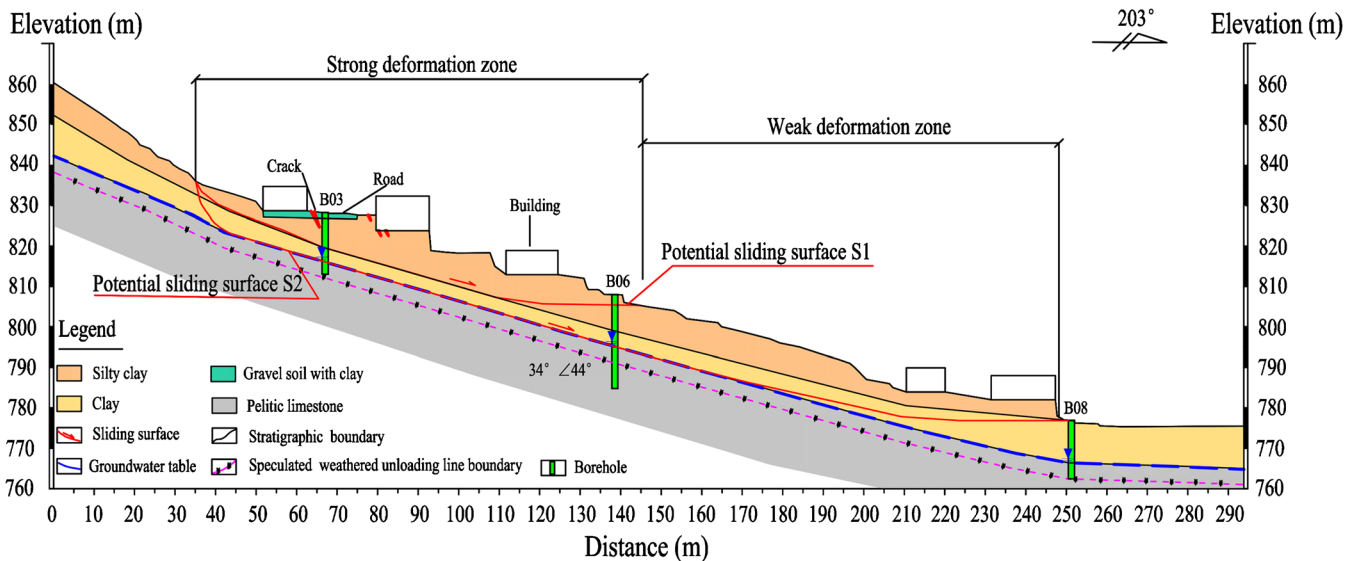
Fig. 8 Longitudinal geological profile 3-3' (Fig. 3)

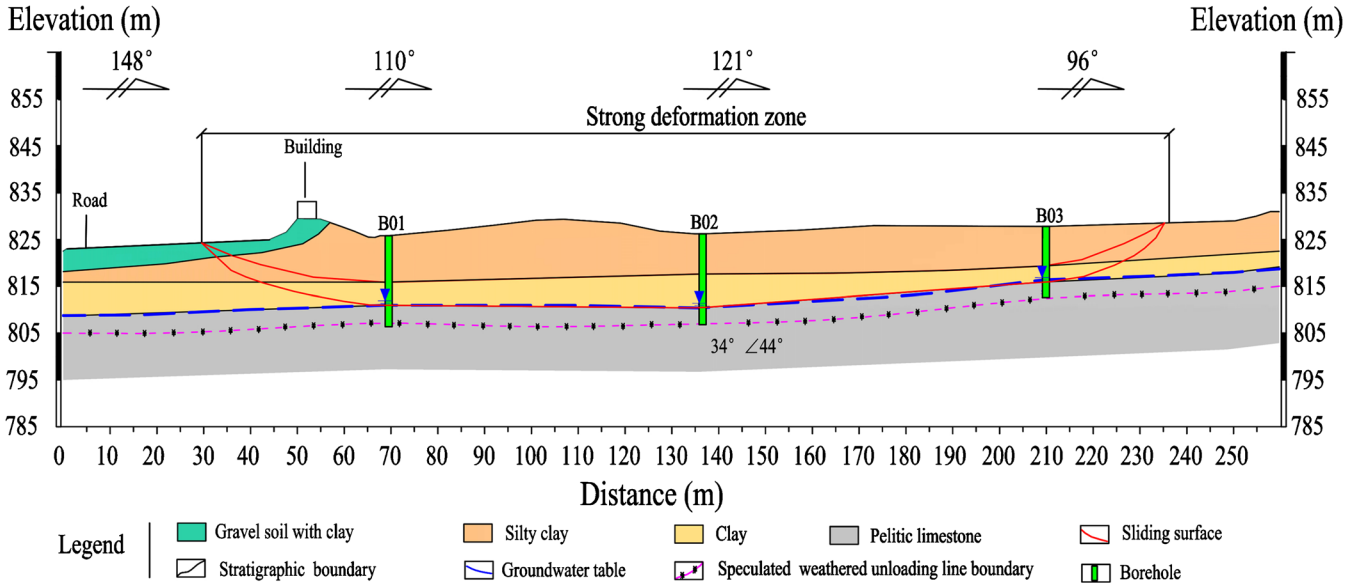
Fig. 9 Longitudinal geological profile 4-4' (Fig. 3)

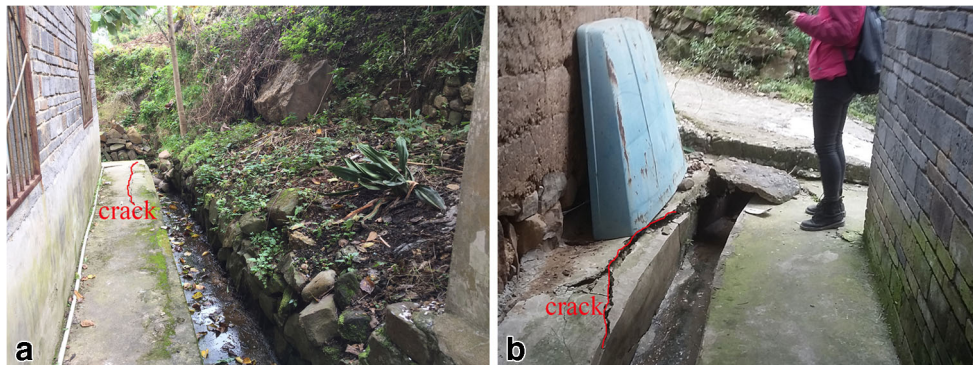
Fig. 14 Damage of drainage ditch. a The tension crack of drainage ditch and b the dislocation near the furrow bank

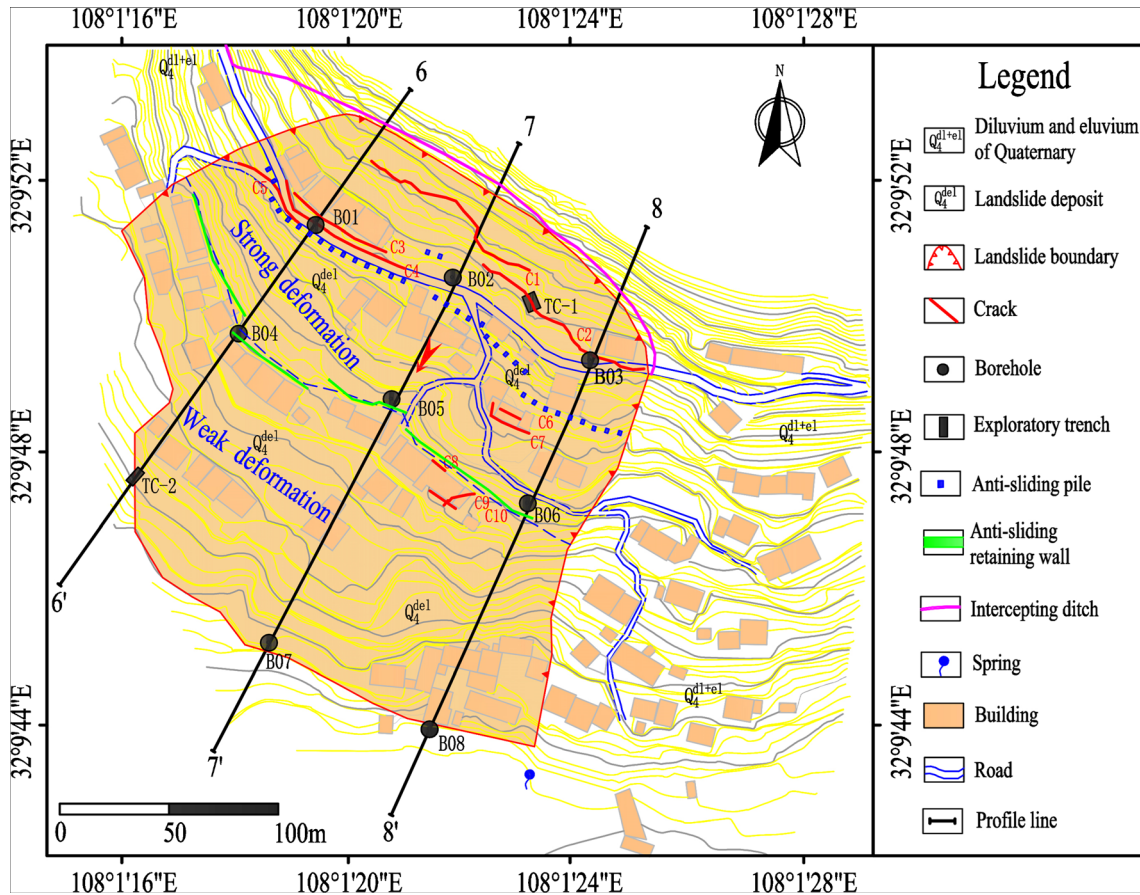
Fig. 16 Plan view of proposed engineering control measures to prevent landsliding

According to the landslide characteristics, the main engineering control measures include anti-sliding piles, an anti-sliding retaining wall, and intercepting ditch (Figs. 16, 17, 18, and 19). The anti-sliding piles and retaining wall provide resisting forces to reduce slope instability, and interception and drainage of

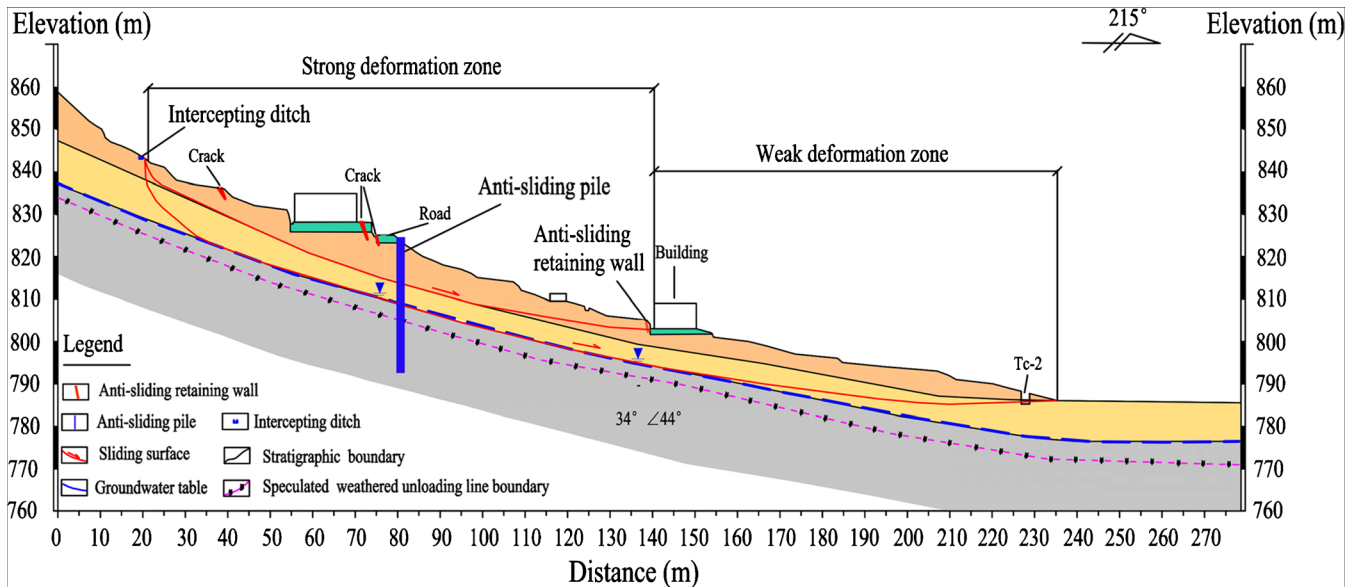
Fig. 17 Longitudinal geological profile 6-6' (Fig. 16)

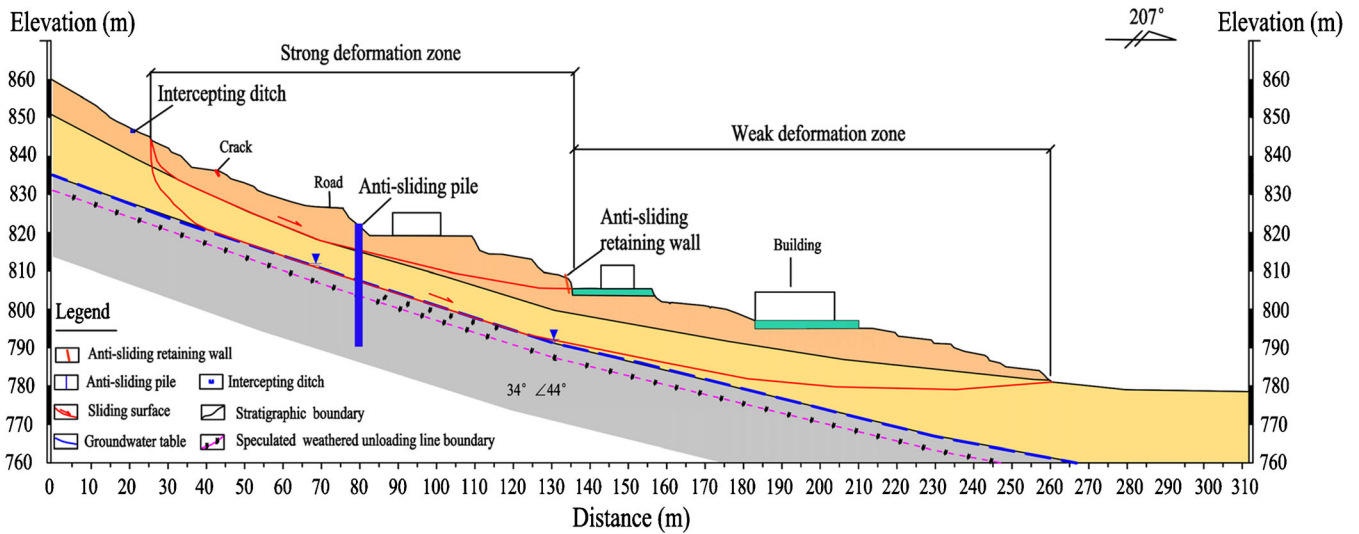
Fig. 18. Longitudinal geological profile 7-7' (Fig. 16)

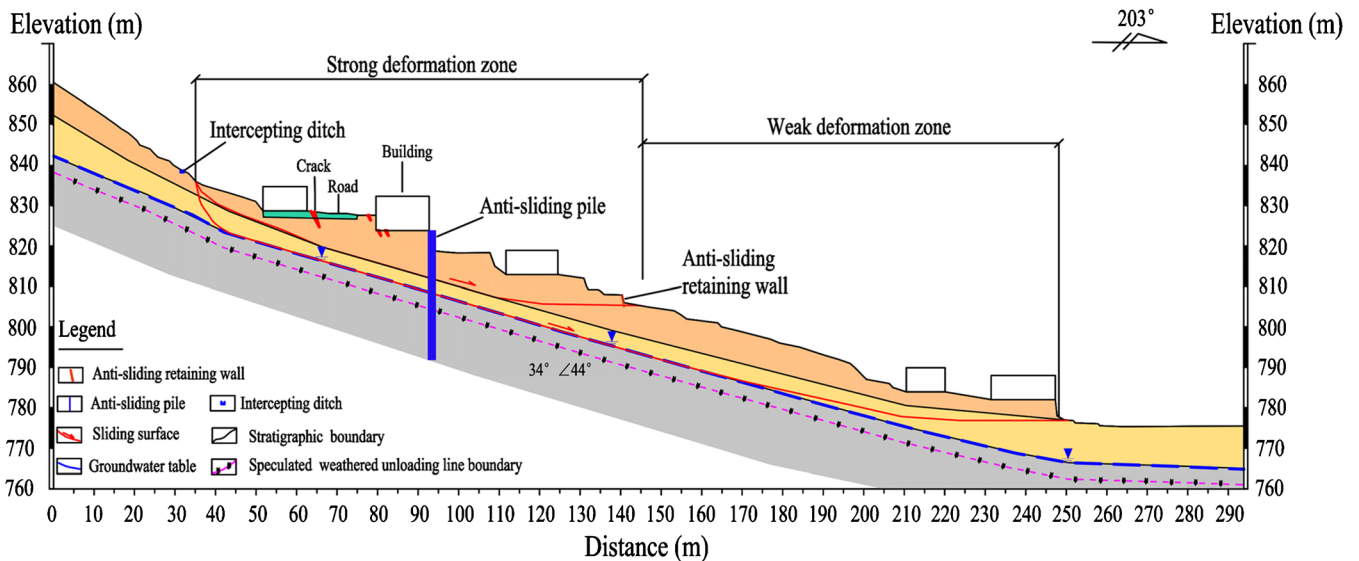
Fig. 19 Longitudinal geological profile 8-8' (Fig. 16)
