Landslides (2020) 17:755–776  
 DOI 10.1007/s10346-019-01316-2  
 Received: 19 March 2019  
 Accepted: 5 November 2019  
 Published online: 2 December 2019  
 © Springer-Verlag GmbH Germany  
 part of Springer Nature 2019

## Geomorphology and geological controls of an active paraglacial rockslide in the New Zealand Southern Alps

**Abstract** Geological structures precondition hillslope stability as well as the processes and landslide mechanisms which develop in response to deglaciation. In areas experiencing glacier retreat and debuttressing, identifying landslide preconditions is fundamental for anticipating landslide development. Herein, the ~ 150 M m<sup>3</sup> Mueller Rockslide in Aoraki/Mount Cook National Park, New Zealand, is described; and we document how preconditions have controlled its morphology and development in response to thinning of the adjacent Mueller Glacier. A combination of geomorphological and geotechnical mapping—based on field, geophysical and remote sensing data—was used to characterise the rock mass and morphology of the rockslide and surrounding hillslope. Mueller Rockslide is identified as a rock compound slide, undergoing dominantly translational fa

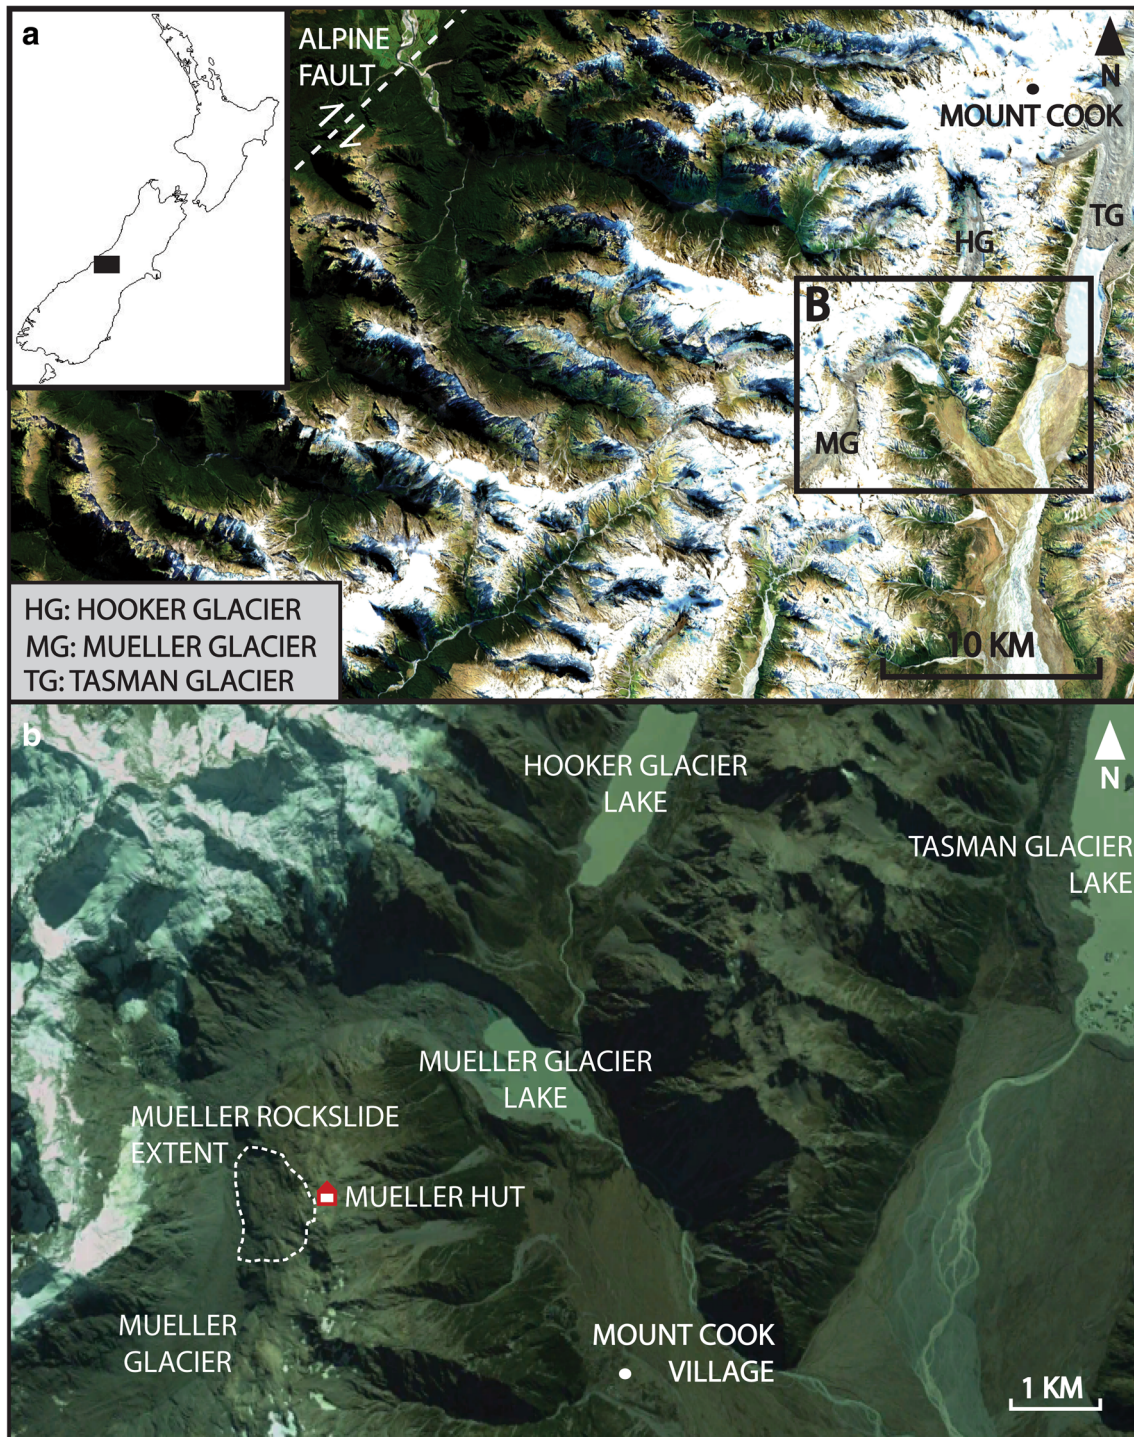
**Fig. 1** (A) Location map of Mount Cook and surrounding area. (B) Mount Cook Village and surrounding area. Mueller Rockslide estimated boundary is represented by the dashed white line with Mueller Hut sitting to the east

Mueller Rockslide is in Aoraki/Mount Cook National Park, New Zealand (Fig. 1), situated on the western flank of the Sealy Range. The rockslide was first identified by Hancox (1994), as part of a study on the stability of an alpine mountain hut. At that time, the hut (referenced as Old Hut herein) was situated on the eastern edge of the Sealy Range, which was experiencing localised subsidence in a large slump block. Due to safety concerns, the hut was removed and rebuilt 500 m south-west along the range in 2003. During the investigation, Hancox (1994) identified and described a

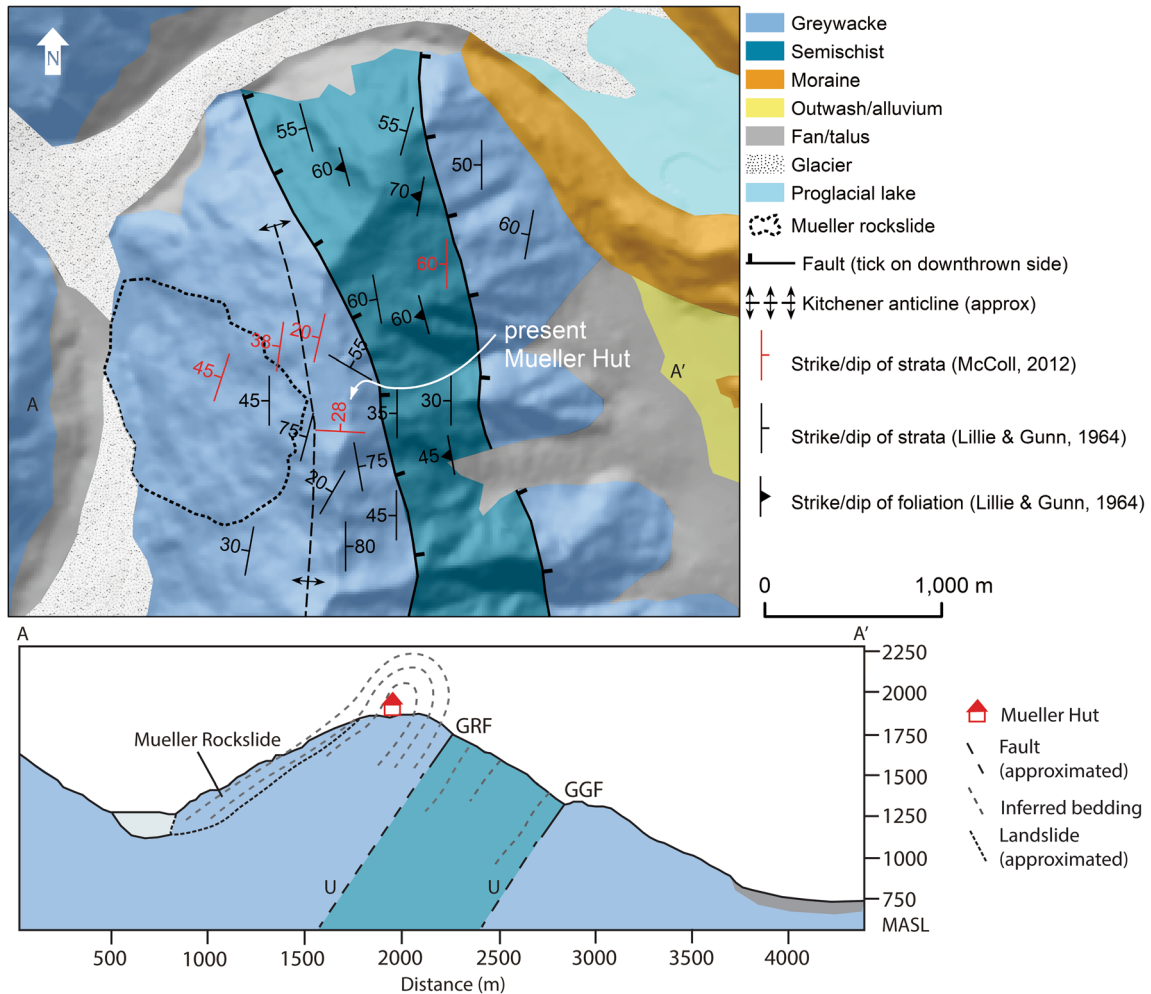
**Fig. 2** Geological map of Sealy Range and cross-sectional profile of the Kitchener Anticline (informed by mapping by Lillie and Gunn 1964 and McColl 2012a). Glacier extent and Mueller Rockslide outline are as mapped in this study, based on aerial imagery from 2010–2017. GRF and GGF highlight the Green Rock Fault and Great Groove Fault

The shape and stability of the Sealy Range reflects its history of tectonic and glacial processes. The range is about 25 km east of the boundary between the Pacific and Australian tectonic plates, which for the past 5 million years has been expressed by the Alpine Fault. Regional shortening and compression have resulted in faulting, folding and fracturing of the Torlesse Group greywacke sandstones and argillite and semischist (low-grade schist of textural zone IA, IIB) which make up the Sealy Range (Cox and Barrell 2007). The Mueller Rockslide is located on the western side of the Sealy Range, on the western limb of the tightly folded north-plunging Kitchener anticline (Lillie and Gunn 1964), which formed initially from east-west compression (Fig. 2). Within and near the rockslide body, bedding dips westward at roughly 30–60°, with the Mueller Rockslide forming within the dip slope of the interbedded greywacke (Lillie and Gunn 1964; McColl and Davies 2013) although most of this is heavily mantled with debris material. Currently, the Mueller Rockslide abuts onto the margin of the Mueller Glacier, which is undergoing rapid thinning and terminus retreat. The Mueller Glacier has retreated by over 1 km (Gellatly 1985; Kirkbride and Warren 1999) since the Little Ice Age (LIA) ~ 200–250 years ago (Fig. 1), but it is still approximately 3.5 km down-valley from the Mueller Rockslide (Winkler 2018). Glacier debuttressing has occurred through thinning of the glacier and has been in the order of some 100 m since the LIA, as inferred here from abandoned lateral moraine ridges on the slopes near the rockslide as well as documented at the terminus (Gellatly 1985; Kirkbride and Warren 1999). The remaining thickness of the glacier at the toe of the Mueller Rockslide is unknown, but based on valley cross section extrapolation, it is estimated to be < 100 m thick at the southern (upper valley) end of the rockslide. The glacier at the northern end may have melted completely, becoming disconnected from the down valley end of the glacier (Fig. 2).

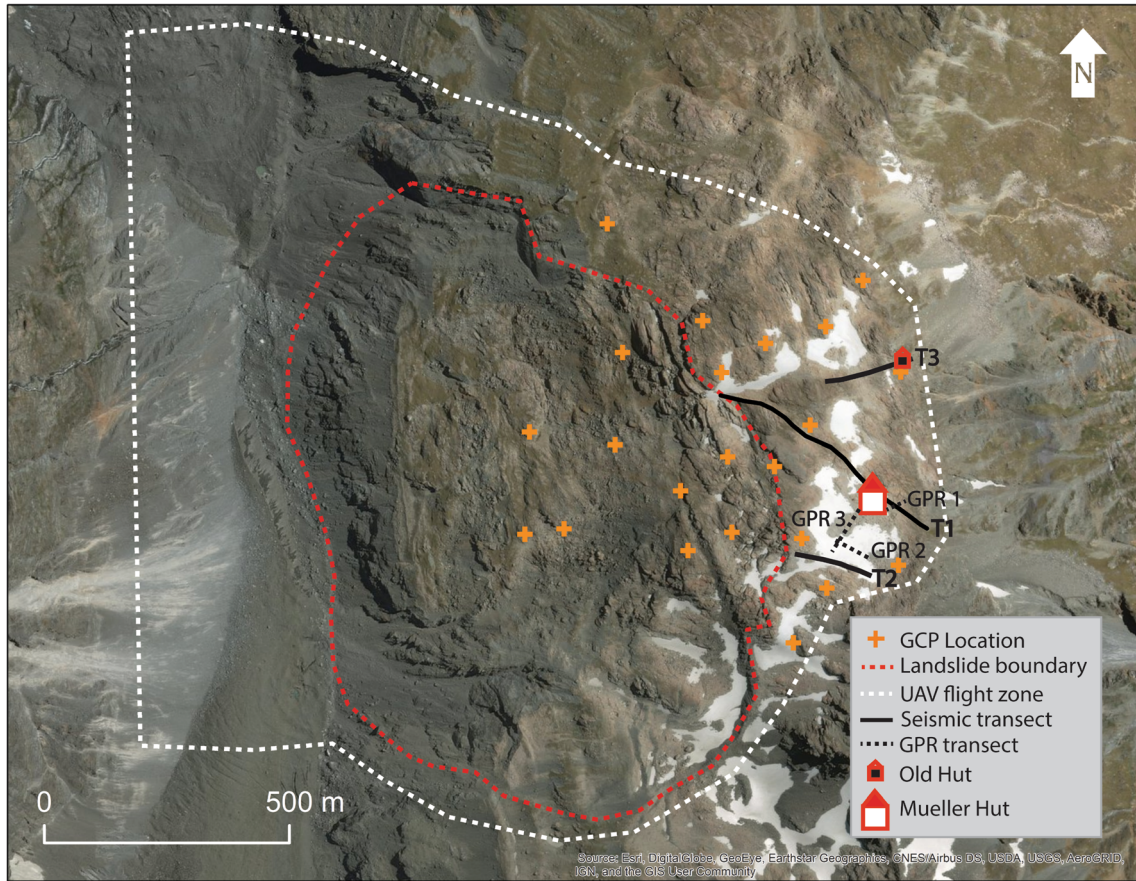
**Fig. 3** Approximate rockslide outline, extent of the UAV flights for photogrammetry and ground control points (GCPs), spot height survey marks used in Table 1, and the geophysics transects. Imagery is 0.75 m LINZ aerial photo (~ 2004–2010)

High-resolution topographic data and an orthophoto mosaic were obtained using structure-from-motion (SfM) photogrammetry (Fig. 3) for mapping the rockslide and surrounding slopes. Photos were collected in February 2017 from a DJI Phantom 3 Professional unmanned aerial vehicle (UAV). Photos were captured from an above ground altitude of 60–120 m, in both oblique (30° from nadir) and nadir camera orientations to achieve a minimum of 75% forward and 60% side photo overlap. The SfM software Agisoft Photoscan was used to produce a dense point cloud that was decimated to a 0.25-m resolution DEM, and a 5-cm pixel-resolution orthomosaic image. The georeferencing of the SfM

southern slopes of the rockslide (Fig. 3). The Photoscan estimate of GCP vertical uncertainty was an RMSE 0.156 m. We provided an independent assessment of this modelled error by comparing the modelled DEM elevations with our own 10 independent spot height elevations measured with RTK GPS. The mean difference and RMSE we calculated were 0.35 m and 0.59 m respectively, with a maximum of 1.75 m (Table 1). These vertical error values are

Three combined geophysics transects using SRT and GPR were deployed along Sealy Ridgeline in a roughly east-west direction (T1–T3 in Fig. 3), targeting major fractures visible at the surface, and where possible, following accessible bedrock outcrop. In addition, 3 GPR transects were completed in the immediate area of Mueller Hut (Fig. 3). Transect 1 (Mueller Hut transect) extends from the eastern Sealy Range ridgeline, past the present-day Mueller Hut to the main rockslide headscarp. Transect 2 (Mount Ollivier transect) is located farthest to the south, stretched east-west along the northern slope of Mount Ollivier. Transect 3 (Old Hut transect) is nearer to the northern end of the rockslide and stretches from eastern Sealy Range ridgeline near the former Mueller Hut, west to the rockslide headscarp. SRT was completed using repeated overlapping transects of 24 geophones. Transect 1 had geophone spacing of 6 m and consisted of 4 overlapping transects (each 138 m long) resulting in a total length of 531 m. Transects 2 and 3 had a geophone spacing of 8 m with 3 additional offset shots after geophone 24 resulting in a total transect length of 204 m. Different geophone spacing resulted in different resolutions for the seismic tomographies which range from 1.5 m at T1 to 2 m at T2 and T3.

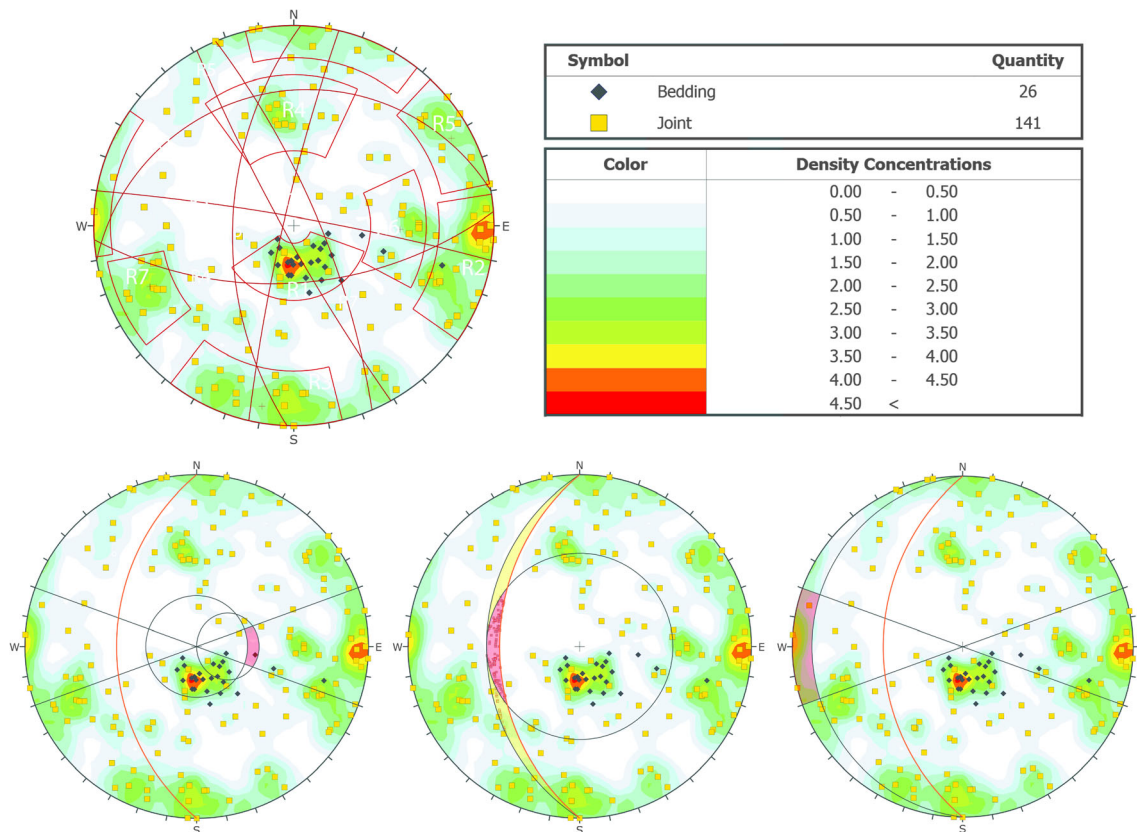
**Fig. 5** (A) Joint sets (R1–R7) and corresponding planes for discontinuities within the retrogressive development zone of the rockslide. Kinematic analysis was completed for planar sliding, wedge and flexural toppling respectively (B, C, D)

Stereographic projections of discontinuity orientations are presented as well as kinematic analysis for planar sliding, wedge and flexural toppling (Fig. 5). Discontinuities are grouped into two structural domains (1) ridgetop/retrogressive zone (Fig. 5) and (2) headscarp and rockslide body zones (Fig. 6) with several discontinuity sets identified within each domain. Identified discontinuities are divided into bedding, joints and faults.

Seven discontinuity sets are identified within the retrogressive zone (Fig. 5a). R1 is a strongly defined bedding set dipping north with an average dip of 30°. R2 is a near vertical joint set trending north-south and dipping predominantly to the west from 80 to 90° although several joints dip steeply to the east. R3 is a minor joint set dipping steeply north at 85°. R4 is a minor joint set striking east-west and dipping at approximately 50° to the south. R5 strikes northwest and dips steeply to the southwest at 75–90°. R6 strikes north-south, similar to R2 but with a shallower dip of 60–70° to the west. R7 strike northwest like R5 but dips east at 70–80°.

For the retrogressive zone (Domain 1), the kinematic analysis shows that potential for planar failure is minor (Fig. 5b) with only one bedding point (3.8% of total bedding measurements) falling within the failure envelope. Wedge failure analysis shows the

potential for failure along the intersection of R3–R6 and R4–R6 joint sets (Fig. 5c); however, the failure envelope falls just outside the definitive intersection of these joint sets. Flexural toppling analysis shows potential toppling along the R4 eastward dipping discontinuities (Fig. 5d).

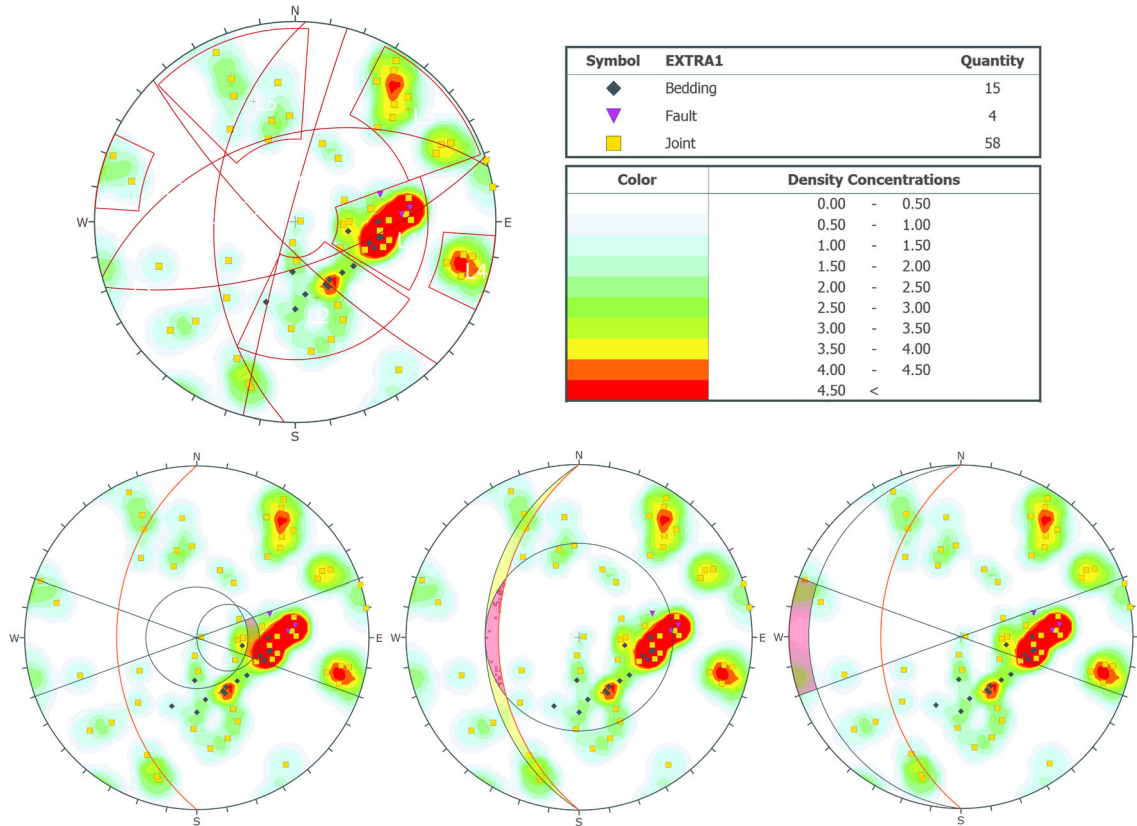
**Fig. 6** (A) Joint sets (L1–L5) and corresponding planes for discontinuities within the landslide and headscarp zone of the Mueller Rockslide. (B–D) Planar, wedge and flexural toppling kinematic analysis respectively

Discontinuities mapped within the rockslide body and headscarp differ from those identified along the ridgeline (Fig. 6a). In total, 5 discontinuity sets are identified. L1 is a predominantly defined by bedding, dipping to the west from 30 to 70° with an average dip of 50°. L2 is a minor joint set again strongly defined by bedding although this set dips to the north-west at approximately 45°. L3 strikes northwest and dips to the south-west at 80°. L4 is an east-west trending joint set, similar to R2 in orientation with joints dipping to the west with an average dip of 80 to 85°. L5 is a minor joint set dipping to the south-east at approximately 80°.

For Domain 2, the kinematic analysis showed marginal potential for planar sliding although no discontinuities fall in the failure window; several L1 discontinuities are at the margin or just outside of the failure window. Wedge failure analysis shows potential for L1–L3 and L1–L5 intersections within or just outside the failure envelope (Fig. 7c) (2.2% within failure window). Flexural toppling analysis shows L4 discontinuities falling within the failure envelope when the slope angle is 40° (Fig. 7d) (1.3% total discontinuities and 16.7% of L4 discontinuities)

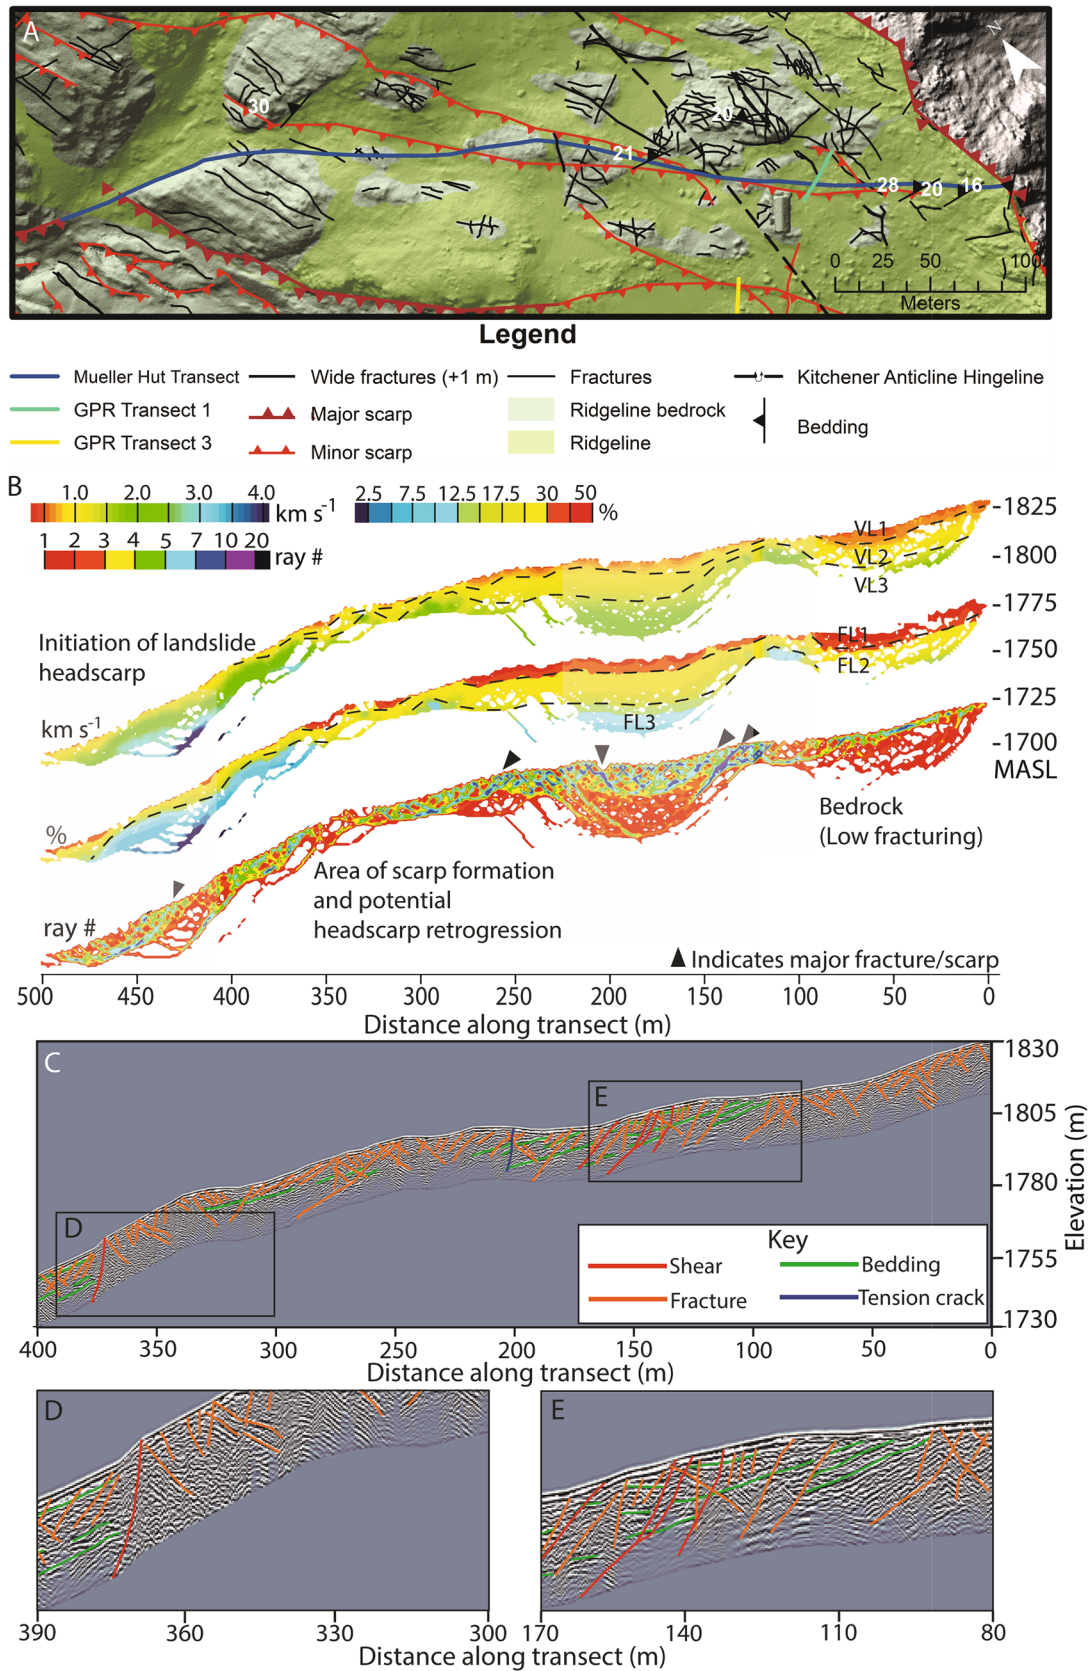
**Fig. 7** Mueller Hut seismic transect (T1). (A) Geomorphic map of the transect. (B) SRT transect consisting of P-wave velocity, fracture percentage and ray density. High ray density indicates clustering of linear features (black arrows) indicating potential scarp or fracture development. (C) GPR transect for 0–400 m. (D) Beginning of the block toppling and headscarp zone. (E) GPR directly adjacent to Mueller Hut (105 m)

The Mueller Hut transect (T1) extends from 100 m east of Mueller Hut in the upper ridge to the rockslide crown for a total length of 500 m (Fig. 4). There are three distinct velocity layers recognisable along the seismic transect (Fig. 7). The near-surface p-wave velocity layer (0.5–0.95 km s<sup>-1</sup>) is predominantly located within the first 100 m of the transect to a depth of 5 to 7 m below ground level and from 140 to 380 m to a depth of 3–5 m. A second, faster, velocity band (0.95 to 1.7 km s<sup>-1</sup>) is observed predominantly from 140 to 380 m, through localised areas of bedrock outcrop and in the final 150 m of the transect towards the rockslide

crown. The third and fastest velocity band ( $> 1.7 \text{ km s}^{-1}$ ) is found between 400 and 480 m along the transect.

Fracture density results show high values in the first 100 m of the transect as well as between 140 and 280 m, coinciding with the low p-wave velocities outlined above and areas of blocky debris seen on the surface. Fracture density decreases rapidly with depth under areas of scree and in areas of bedrock from 30–50% in scree zones to 10–30% in bedrock and the underlying rock mass. The last 150 m of the transect shows lower fracture densities particularly in relation to the debris-mantled ridgeline.

Ray density analysis shows the percentage of rays per  $1.5 \times 1.5 \text{ m}$  grid spacing with high ray density indicating the presence of linear features or discontinuities. In the first 100 m, of the transect, ray density appears to be related to scree and suggests an absence of large, persistent fractures within the bedrock. Farther down the transect, high ray densities are detected from 140 to 280 m with increased ray density at the surface and moderate density at depth to  $\sim 30 \text{ m}$  indicating the presence of large, persistent structures (black arrows in Fig. 7b). High ray density also indicates a large persistent fracture at 430 m is also indicated by high ray density.

The corresponding GPR profile for transect 1 is 400 m long, extending almost to the rockslide crown. Evidence of bright reflectors which coincide with areas of bedrock at 100–200 m are interpreted as bedding planes. Reflectors with a similar signature can be seen at depth at 175 m along transect and at 380 m (Fig. 7c, d). The first 210 m of the transect which bypasses Mueller Hut also shows extensive orthogonal fracturing with apparent dips to the east and west. A highly fractured zone from 140 to 210 m along the transect is marked by significant fractures which extend for  $\sim 8 \text{ m}$  through the GPR profile. A scarp identified in the geomorphic mapping and in the field at 140 m is hard to identify within the GPR transect due to both being oriented in a north-west direction however there is evidence of shear planes and displaced bedding around 140 m.

From 210 to 310 m, fractures appear to dip predominantly westward as the transect moves towards the crown of the Mueller Rockslide. A highly fractured zone can be seen between 220 and 245 m (Fig. 7c) which coincides with where the two minor scarps either side of Mueller Hut intersect and with several large fractures identified on the geomorphic map. Bright linear reflectors identified between 290 and 320 m are interpreted as bedding. From 310 m, fractures have an apparent dip to the east, coinciding with the transition to block toppling as the transect nears the headscarp.

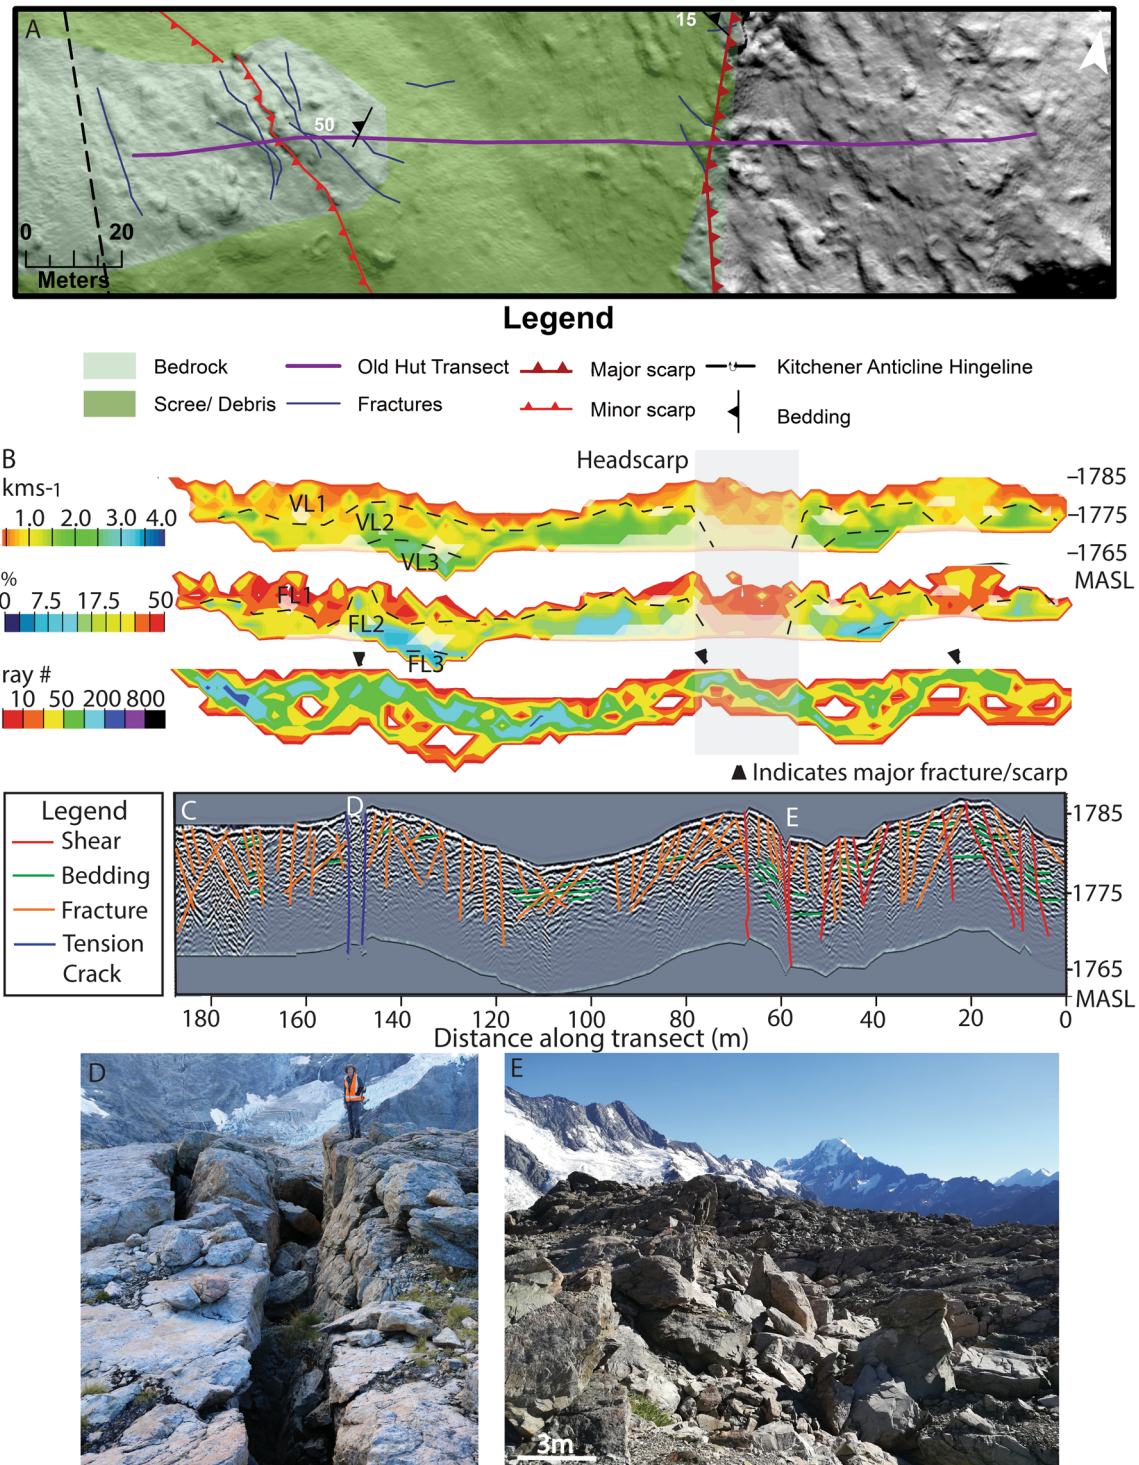
**Fig. 9** Old Hut seismic transect. (A) Geomorphic map of the transect and surrounding area. (B) SRT showing P-wave velocity, fracture percentage and ray density. (C) GPR. (D) Large tension crack 150 m along the transect. (E) Headscarp for the eastern slope failure which is partly obscured by block fill

The Old Hut transect (T3) is located to the north of Mueller Hut extending for 200 m from the eastern headscarp through the ridge-line (Fig. 9). P-wave velocity analysis has identified 3 dominant velocity bands. The first, and slowest, velocity band ( $0.5$  to  $0.95 \text{ km s}^{-1}$ ) is found through the upper 1–4 m depth of the majority of the transect particularly in areas mapped as debris or scree. The second band ( $0.95$  to  $1.7 \text{ km s}^{-1}$ ) is at 30 m from 0 to 12 m deep, at 70 m from 2 to 15 m deep and 160 m distance from 5 to 17 m deep (Fig. 9b). The third and fastest p-wave velocity band ( $> 1.7 \text{ km s}^{-1}$ ) can be found from 0 to 10 m, 40 to 60 m and 80 to 150 m.

Fracture density patterns show fracture zones at 30, 70 and 160 m distance display very high fracture densities of greater than 30% with the fracture zone at 70 m exceeding 50% fracture density (Fig. 9b). This fracture zone is characterised by fracture widths at the surface of greater than 0.5 m. At 150 m, both methodologies identified a large fracture zone which also corresponds to high ray densities that the existence of persistent fractures.

GPR results again have highlighted an extensive network of fracturing. Due to the blocky surface in this area and lack of outcrop, identified fractures are mainly isolated to the first 100 m of the transect near the main eastern scarp, and to an isolated but highly fractured bedrock zone from 130 to 170 m (Fig. 9e). The most extensive zone of fracturing is located from 25 to 70 m marked by several crossed eastward and westward dipping fractures and one major failure zone (Fig. 9e; red lines) which extends through the GPR profile, marking the headscarp of the eastern rift/graben. Although graben is block-filled, vertical displacement of  $\sim 5 \text{ m}$  is estimated from the GPR profile, consistent with the height of the graben scarp. Minor fracturing from 90 to 130 m in the GPR profile is hidden in the field, the area covered with blocky debris. Strong gently-west-dipping, reflectors through this zone are interpreted as bedding which extends from 85 to 135 m along the transect. Bedrock outcrop from 130 to 170 m largely consists of minor superficial fracturing with fractures appearing to only extend for several metres. However, from 155 to 165 m, there are two very large parallel vertical dislocations extending through the radargram and marked at the surface by two large ( $\sim 30 \text{ m}$  long and 0.5 m to 3 m wide) open fractures with a bedrock wedge in between. The wedge sits 2 m lower than the surrounding bedrock and the surfaces corresponding to the dislocations extend for at least 10 m deep in the radargram. There is no obvious vertical displacement between each side of the wedge (i.e. no scarp).

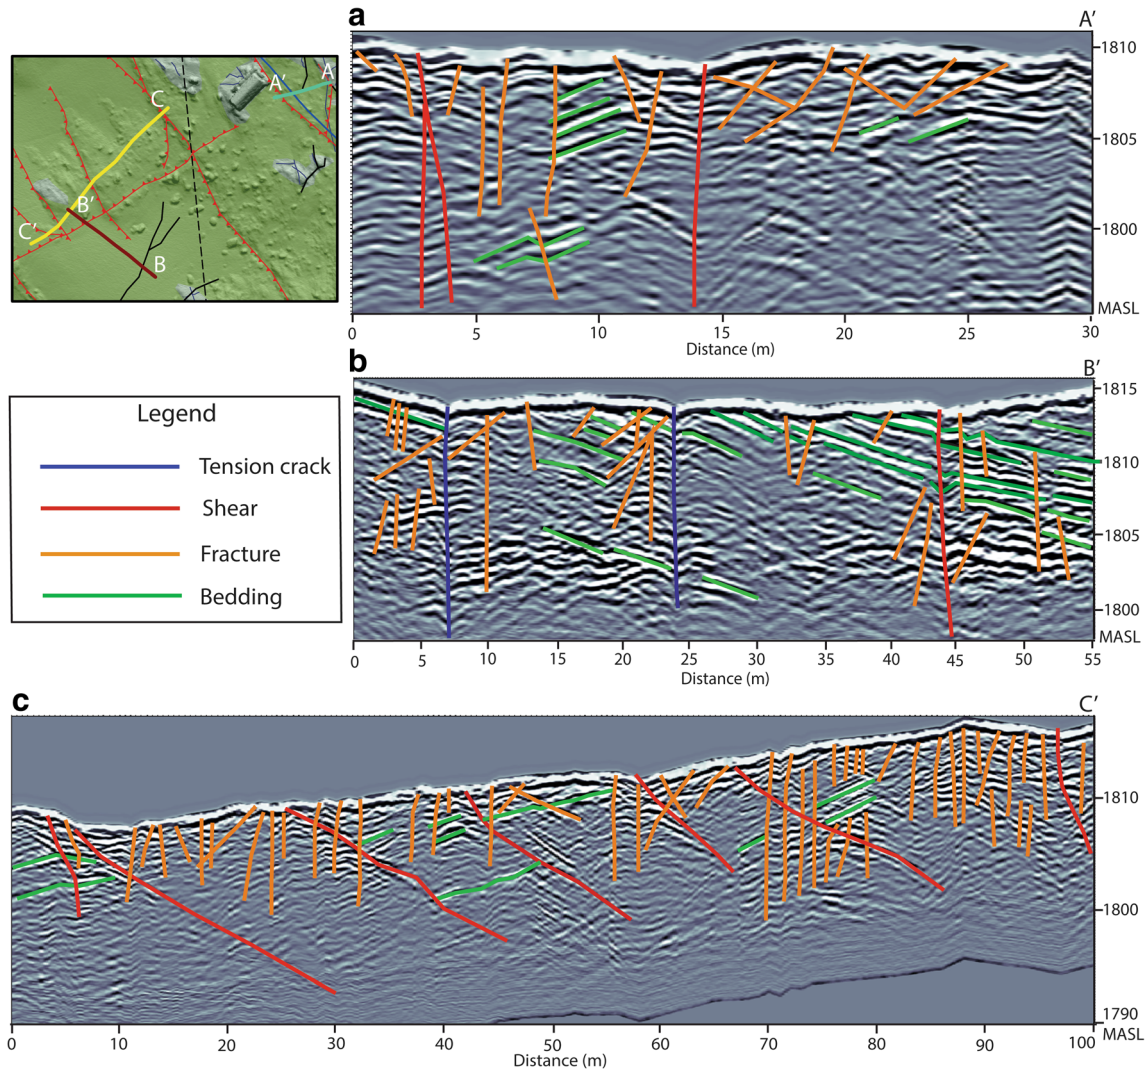
**Fig. 10** GPR transects from the Mueller Hut area. (A-A') Transect 1 going NE-SW approximately 20 m from Mueller Hut. The two shear features identified in the left of the image are considered to be the eastern most scarps for the rockslide retrogressive zone. (B-B') Transect 2 going E-W through the northern limit of a large tension crack. (C-C') Transect 3 going N-W through several large shear features directly south of Mueller Hut

Radargrams from the three additional GPR transects, in proximity to Mueller Hut, are presented in Fig. 10. Transect 1 reveals the scarp identified at the surface is associated with two near vertical shear surfaces that extend through depth of the transect (Fig. 10a). Several near vertical fractures can be identified within the graben

between the two shears while fractures outside the graben appear to have a shallower dip.

Transect 2 crosses a large north-south trending scarp as well as the large tension crack identified in the Mount Ollivier seismic transect. The tension crack appears to split into at least two large fractures at depth (Fig. 10b). Distinct bedding can be seen dipping

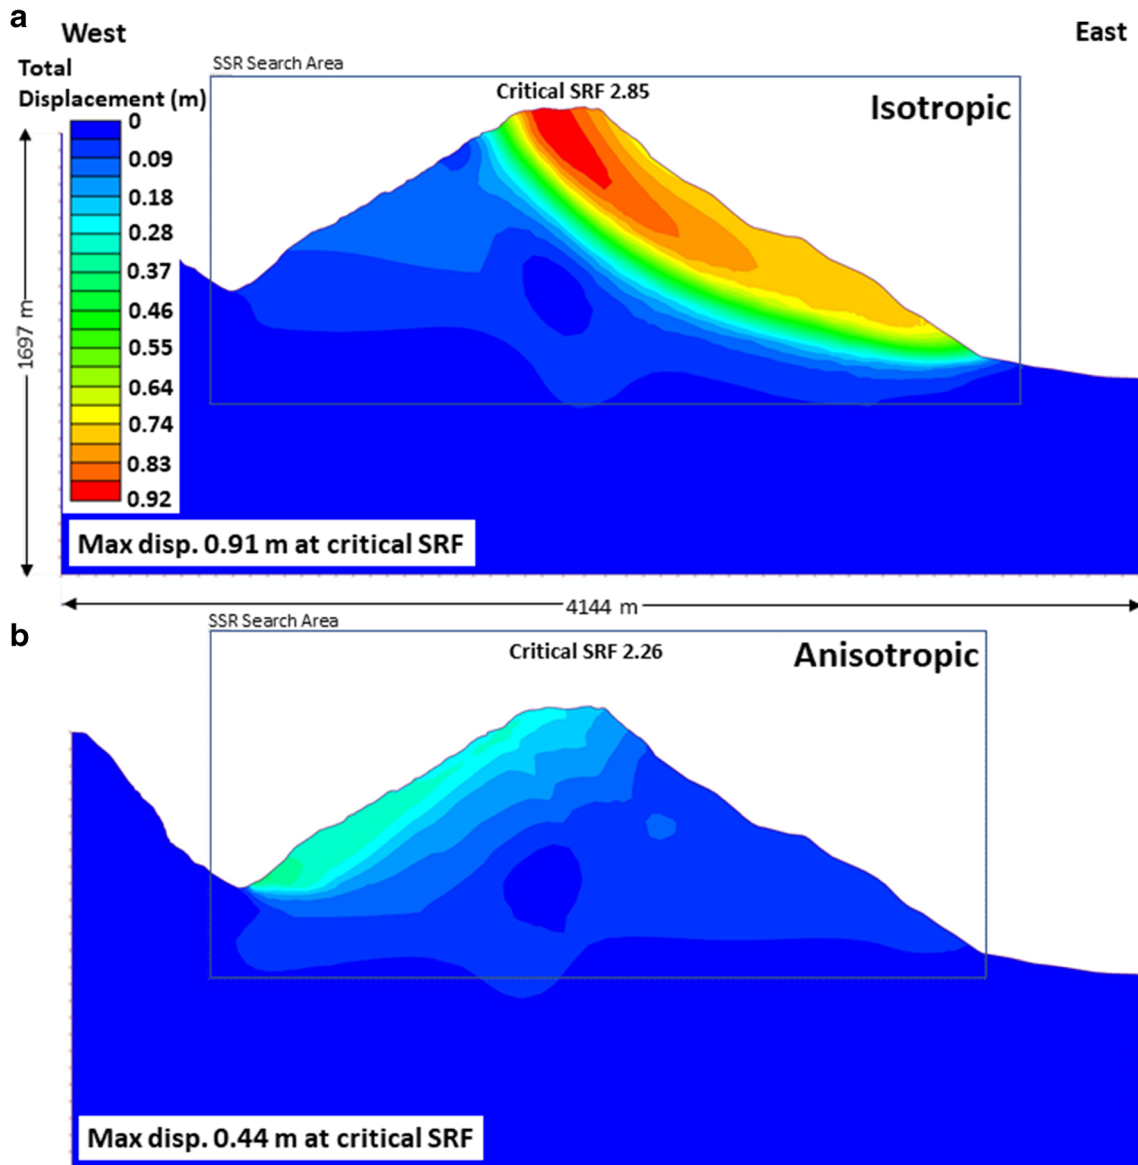
**Fig. 11** Total displacement magnitude across Mueller Ridge at the critical strength reduction factor for an (A) isotropic and (B) anisotropic models. Location of the cross section is equivalent to the one shown in Fig. 2

To help evaluate the importance of rock mass anisotropy (i.e. bedding) in influencing the stability conditions and development of the Mueller Rockslide, we used the two-dimensional finite element software RS2 (Rocscience 2019). A cross section equivalent to that shown in Fig. 2 was used to set the topographic boundaries of the model. The assumed geomechanical properties (Table 2) were selected to be representative of greywacke in New Zealand (compilation in Cook, 2001) and conditions observed at the Mueller Rockslide. Equivalent elastic perfectly plastic Mohr-Coulomb strength parameters were estimated using RocLab (Rocscience, 2017). To evaluate the influence of the bedding orientation on the displacement and stability condition at Mueller Ridge, a model with isotropic strength material (no bedding) was compared with a model assuming an anisotropic direction 40° dipping to the west (bedding). The frictional strength along the anisotropy plane was assumed to be 33° using the tilt test results from McColl (2012b). The critical shear reduction factor (SRF; Matsui and San 1992) was calculated to assess the relative stability of both the isotropic and anisotropic models.

These results appear to contradict the simplified modelling results presented in Fig. 11 which indicates failure to be unlikely. However, this model does not account for the influence of toe debuttressing, seismicity and ground water fluctuations. While failure along bedding is feasible, our results indicate it will not occur without external forcing, or through progressive loss of strength. Similar results have been seen within the Moosfluh Landslide and other rock slope instabilities surrounding the Aletsch Glacier. Grämiger et al., 2017 and Glueer et al. 2019 show incremental damage associated with repeat glacier cycles play a significant role in gradually weakening rock masses. In addition, while glacier debuttressing has been identified as a preparatory

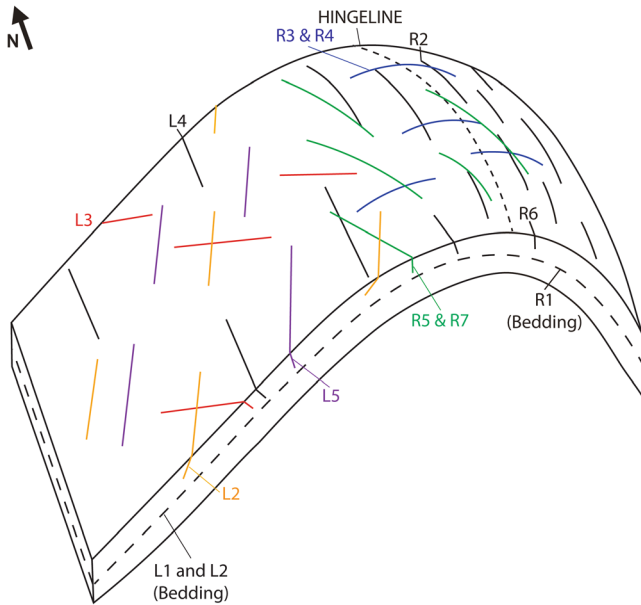
**Fig. 12** Primary discontinuity sets seen within the Sealy Range and northward plunging Kitchener Anticline. Adapted from Price and Cosgrove 1990

Excluding bedding, discontinuity sets identified along the ridgeline align parallel (R<sub>2</sub>, R<sub>6</sub>) and perpendicular (R<sub>3</sub>, R<sub>4</sub>) to the main anticline hingeline (Figs. 5 and 12) and are classed as extensional joint sets. R<sub>5</sub> and R<sub>7</sub> are orthogonal fractures in the retrogressive zone and are classified as shear fractures. Discontinuity sets within the landslide zone are predominantly orthogonal to the main hingeline and dip to the northwest (L<sub>2</sub>), southeast (L<sub>5</sub>) and southwest (L<sub>3</sub>) and are interpreted as shear fractures.

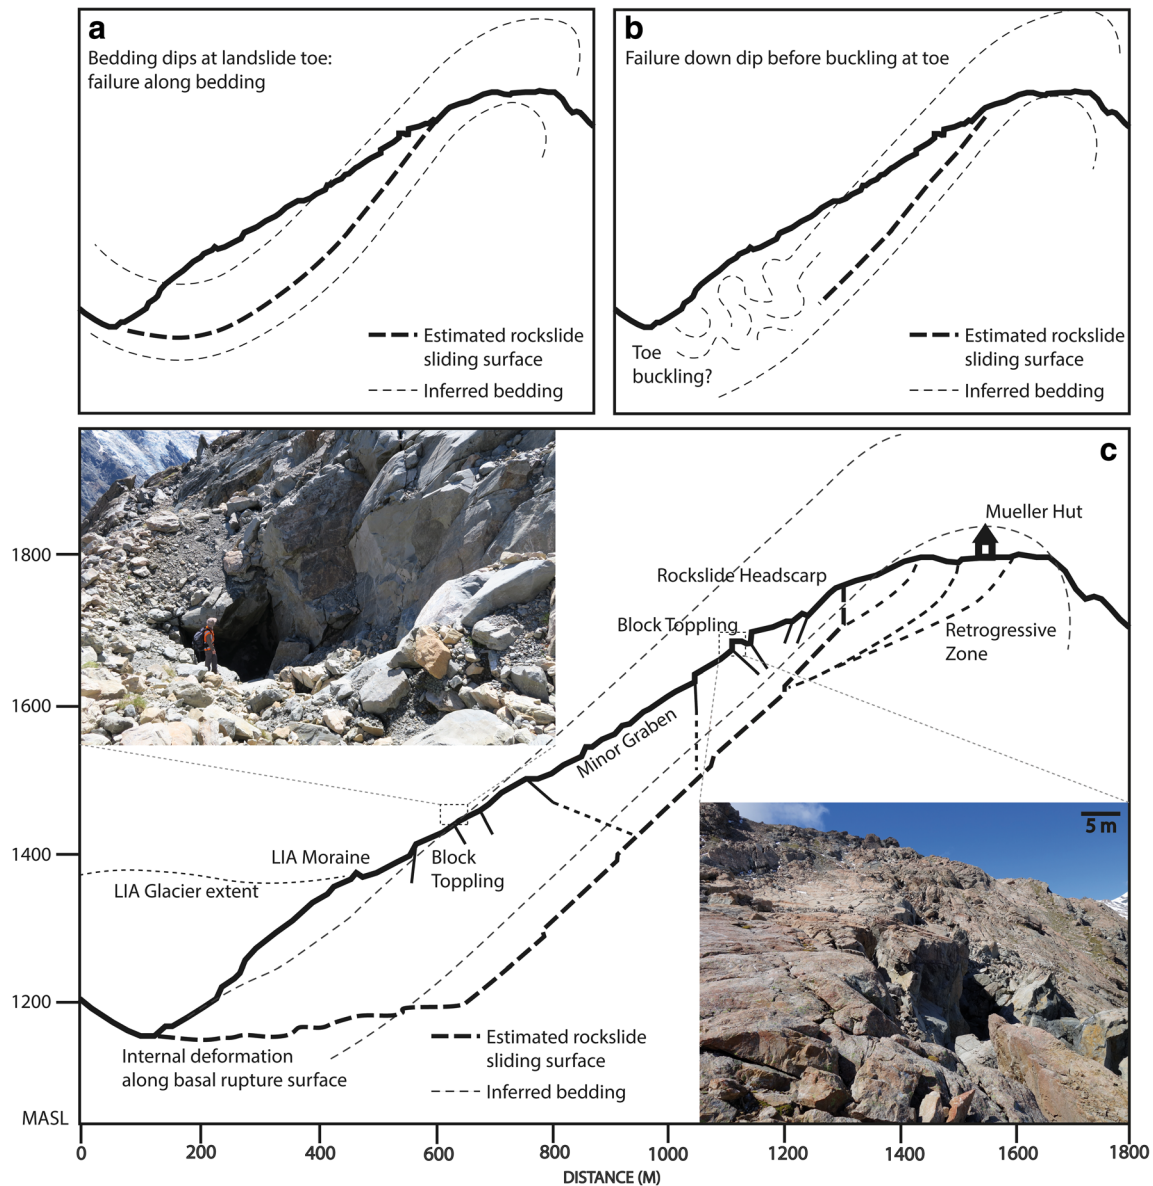
**Fig. 13** Cross section and models of the Mueller Rockslide. (A) Bedding inferred to dip into valley allowing for kinematic release and failure along bedding. (B) Failure along bedding and movement accommodation by ductile deformation and toe buckling at base of slope. (C) Stepped failure approximately down-dip with deformation at toe accommodated by release along fractures. Top image shows block toppling in the lower rockslide (looking north). Bottom image shows the main headscarp and blocking toppling (looking south). Given the height of the headscarps (30 m), plus the identification of a zone of retrogressive development extending 150–200 m east of the headscarp, we assume rockslide thickness to be several tens of metres deep near the top of the rockslide. An increasing thickness downslope is inferred from the observation that bedding dips at a steeper angle than the rockslide slope

different. Consequently, bedding may curve into the slope face at the toe of Mueller Rockslide, facilitating kinematic release and sliding along bedding into the valley (Fig. 13a). Alternatively, movement may be accommodated at the toe by ductile deformation (buckling; Fig. 13b) or release along one or more fractures (Fig. 13c).
